Space Station Control Moment Gyroscope Lessons Learned

Abstract

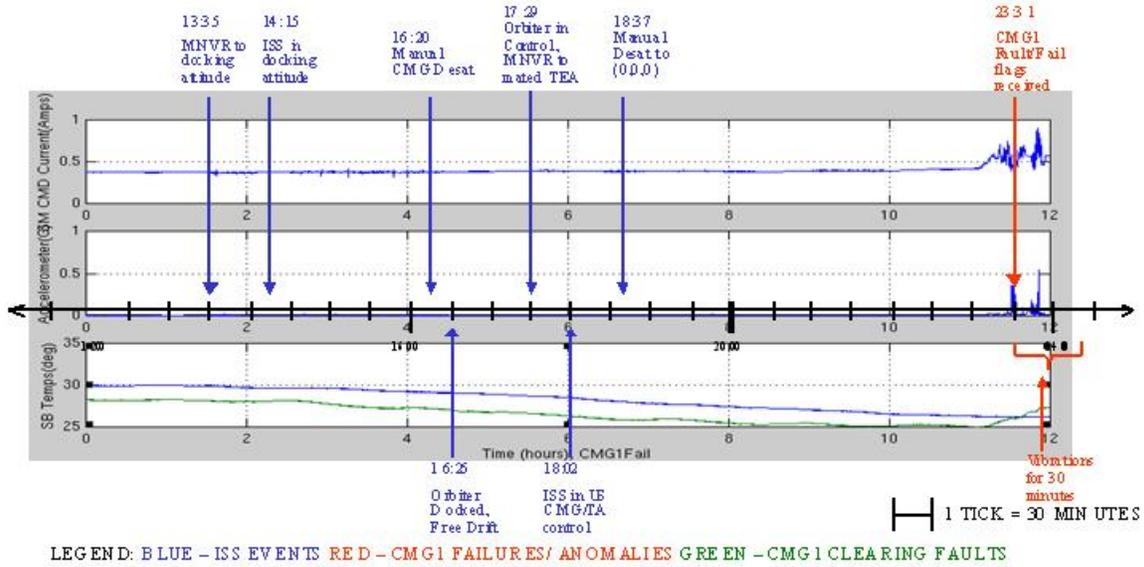
Figure 5. First Indication of Anomalous Behavior GMT 158/2002/12:00-24:00

At the end of May 2002; the ISS was in a high solar beta X-POP period. The ISS attitude was transitioned from X-POP to LVLH on June 7th, several hours prior to shuttle docking. In order to accomplish this re-orientation and docking, large gimbal rates within design requirements were imparted to the CMG due to desaturations. Approximately 6 hours after the docking at ~23:00 on GMT Day 158, 2002, CMG1's Spin Motor Command Current (SMCC), the indicator of the combined bearing torques, started increasing over a 14-minute period. This increase in SMCC was later concluded to be the start of the failure. The increase in SMCC was caused by an increase in the Hall Resolver side bearing torque. This was confirmed by the increase in bearing temperature that indicated the Hall Resolver side bearing may be in distress. During the course of the next 15 hours, CMG1 showed signs of good and bad bearing performance, with the ultimate failure occurring at 14:57 on GMT Day 159, 2002. Several hours after docking, the flight control team noted a flag that indicated the accelerometer on CMG1 had measured 0.5 Gs. The rise in SMCC and associated Hall Resolver temperature was repeated twice during the next 16 hours. Then, following a 30-minute period with no ground communication, telemetry showed that the CMG1 SMCC was at its maximum value, 1.6 Amps, and the wheel-speed was decreasing. After several seconds of maximum current and wheel-speed reduction, Fault Detection and Isolation software declared the CMG failed and automatically shut down the Spin Motor. Normal shut down would result in the flywheel speed decelerating to 0 rad/s in approximately 12 hours. However, during this event, the flywheel stopped 72 minutes after Spin Motor shutdown because of the bearing failed condition. During this run-down period, the Hall Resolver bearing temperature exceeded the maximum telemetry value of 93°C (199.4°F) while the Spin Motor bearing temperature reached only ~30°C (86°F), indicating major distress in the Hall Resolver bearing. Data was retrieved from the on-board data recorders to fill in the missing telemetry for analysis purposes. The timeline of events is given with SMCC and spin bearing temperatures shown in Figure 5, Figure 6 and Figure 7. The CMG1 was later returned to L-3 for disassembly and formal failure investigation.

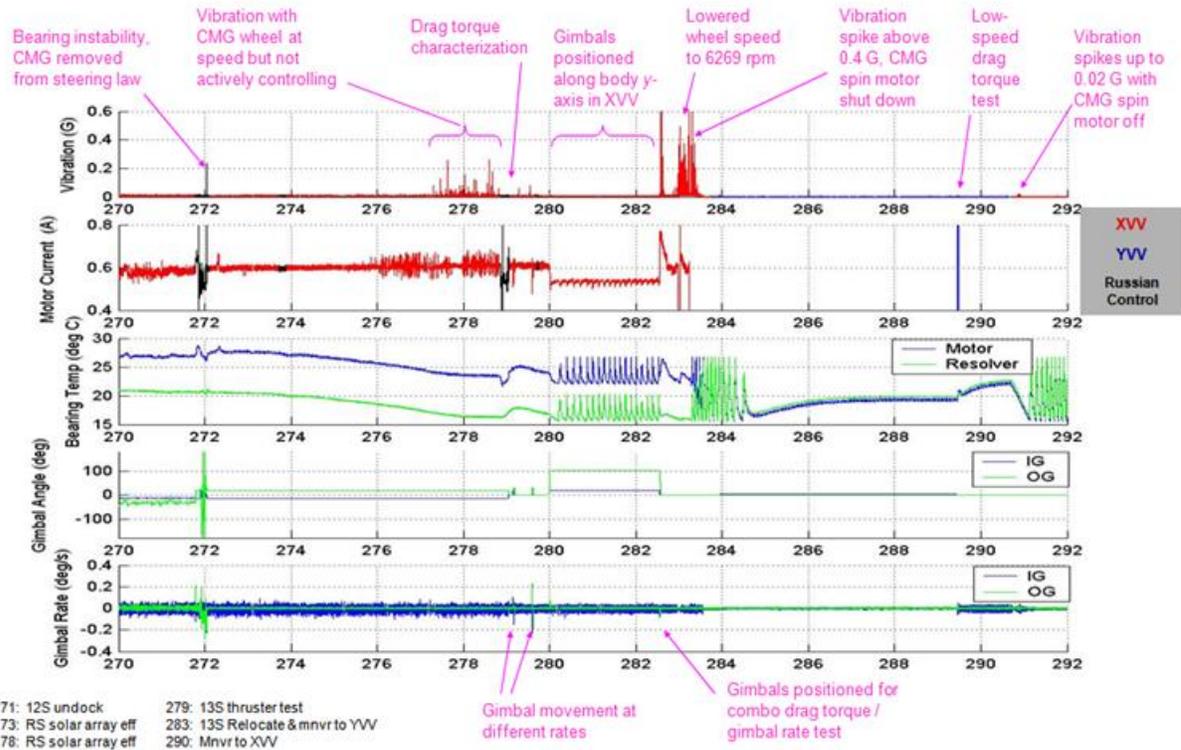
Figure 8. CMG3 Time Line to Shutdown

CMG3 operated continuously at 691 rad/s (6600 rpm) from its activation on February 12, 2001 until the unbalance sensor level reached the criteria (0.2 g) for removal from the active steering law on Day 272, September 29, 2006. This occurred as the CMGs were being pre-positioned for Momentum Management startup in the XVV flight attitude. CMG3 was kept out of the steering law pending further analysis. Several times the unbalance sensor levels reached 0.2 g while the CMG was operational but not used to actively control the ISS. On Day 283, October 10, 2006, the unit was shut down because the unbalance sensor reached the shut down criteria of 0.4 g. Figure 8 shows the performance signatures and events that preceded the shut down of CMG3. CMG3 was returned to L-3 Communications Corporation Space & Navigation (L-3 S&N) on March 11, 2008 for disassembly and a failure investigation.

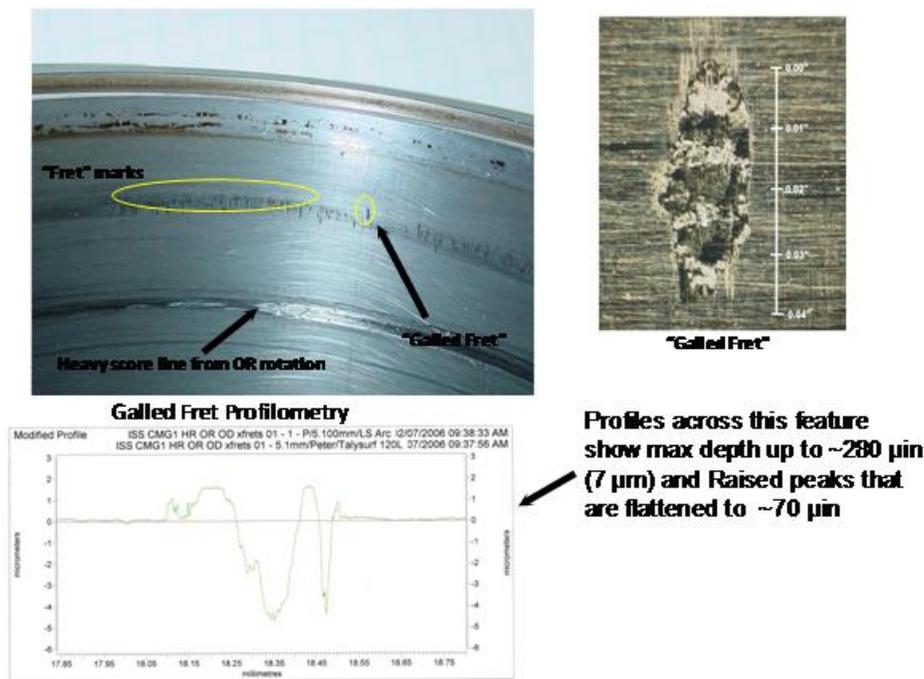
Figure 9. HR Side Bearing Housing Steel Sleeve

1. Some "fretting" type marks were observed on the steel sleeve of the SM bearing cartridge steel sleeve. The fretting marks were 180 degrees apart from the area on inboard section to the area on the outboard section, an indication of bore misalignment. If these conditions occurred before the failure, either during on earth acceptance testing or during operation, this misalignment would have affected the preload system. In addition, a particular mark coined a "galled fret" was observed on the CMG1 HR steel sleeve. This galled fret may have specifically been the one that prevented the outer race to slide properly which would compromise preload and initiate ball skidding.

- Fretting/galling at the bearing Outside Diameter (OD)/Steel Sleeve interface inhibited free motion of bearing preload mechanism, this reduced bearing preload to a threshold level to initiate ball skid which ultimately caused failure.

1. Change the sleeve material to a harder dissimilar metal than the bearing outer race to prevent fretting and galling
2. Add Rheolube grease to the bearing/steel sleeve interface to improve long term lubrication, reduce wear/galling/fretting, and improve sliding
3. Change the preload nut material from A286 to harder 52100 to prevent wear/record grooving
4. Add flats to the Belleville preload spring to reduce contact stresses and prevent wear/record grooving of the preload nut
5. Improve the inner gimbal cover/inner gimbal interface to reduce gimbal distortion and maintain bearing bore alignment
6. Improve the cleaning process of bearing housing sleeves to minimize/eliminate hard particles that may have contributed to the repetitive marks in the bearing raceway and that may have lodged between the outer race and steel sleeve resulting in locked outer races

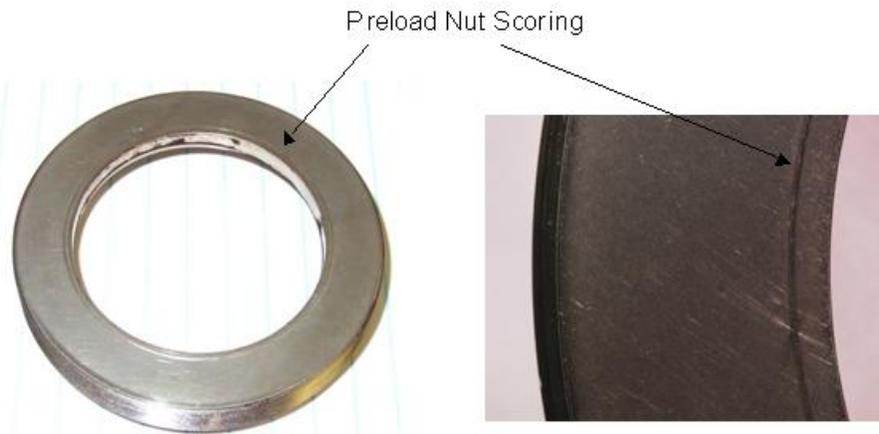
Figure 10. Pre-Load “Record Grooving”

2. Some scoring (record grooving) on both the Spin Motor and Hall Resolver side preload nuts has been observed. This condition inhibited the spring action to react properly during the load and release cycle during axial motion of the flywheel. Preload was reduced to cause ball skid.

- Scoring (record grooving) on the Spin Motor and Hall Resolver side preload nuts adversely affected the bearing preload and bore alignment also contributing to a compromised preload that initiated ball skid.

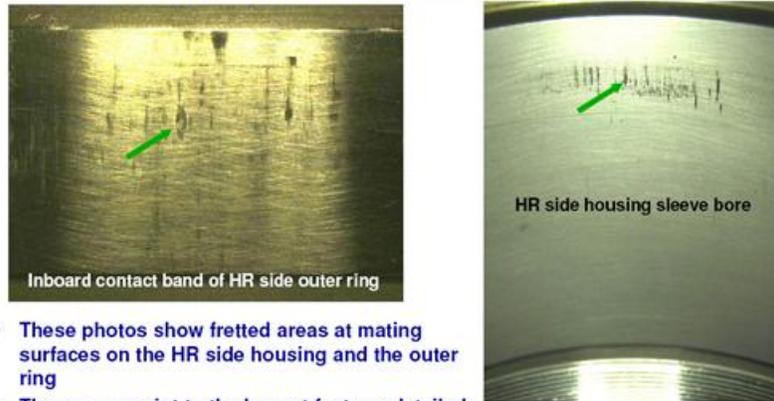
HR Side Outer Ring / Housing Interface

1. Similar “fretting” type marks were observed on the steel sleeve of the bearing cartridge steel sleeves (Figure 11). The fretting marks were near 180 degrees apart from the area on inboard section to the area on the outboard section, an indication of bearing bore misalignment. If these conditions occurred before the failure, either during on earth acceptance testing or during operation, this misalignment would have affected the preload system.

- These photos show fretted areas at mating surfaces on the HR side housing and the outer ring
- The arrows point to the largest feature, detailed on the next chart
- There were generally fewer frets here than on CMG1 and ADP
- There was some evidence of wear marks 180 degrees apart from these on the outboard end of the bore, but this was not as distinct as in CMG1 and qual unit

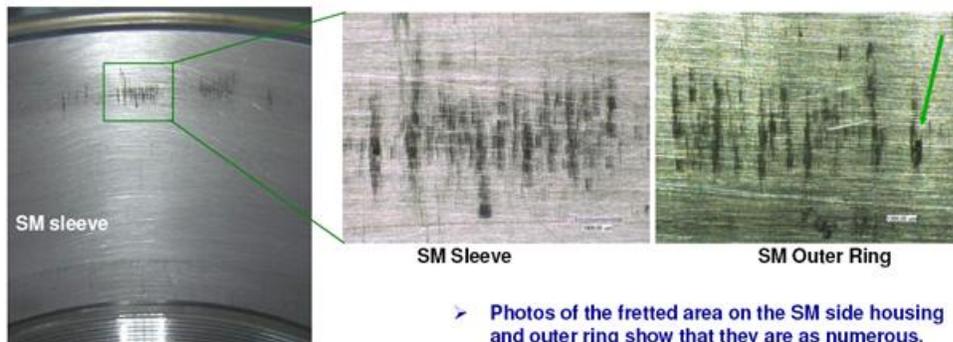
SM Side Outer Ring / Housing Interface

- Photos of the fretted area on the SM side housing and outer ring show that they are as numerous, but not as severe as on the HR side housing
- The profile shown here was scanned across the corresponding surface of the outer ring inboard contact band
- This profile confirms that the wear is not as severe, but it shows a persistent mildly abrasive contact

Figure 11. Typical Cartridge Fretting

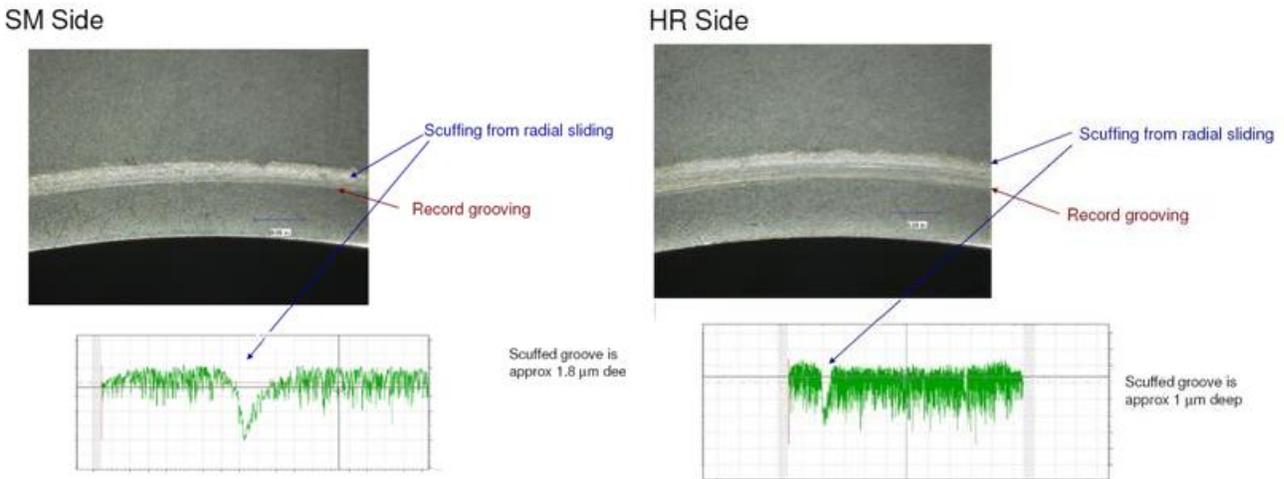
Figure 12. Typical Preload Nut Record Grooving

- Some scoring (record grooving) on both the Spin Motor and Hall Resolver side preload nuts has been observed (Figure 12). This condition inhibited the spring action to react properly during the load and release cycle during axial motion of the flywheel. Preload was reduced to cause low preload and ball skid.
