NASA/TM-2010-216840
NESC-RP-10-00608

Wilkinson Microwave Anisotropy Probe (WMAP) Battery Operations Problem Resolution Team (PRT)

*Keys, Denney J./NESC
Goddard Space Flight Center, Greenbelt, Maryland*

August 2010

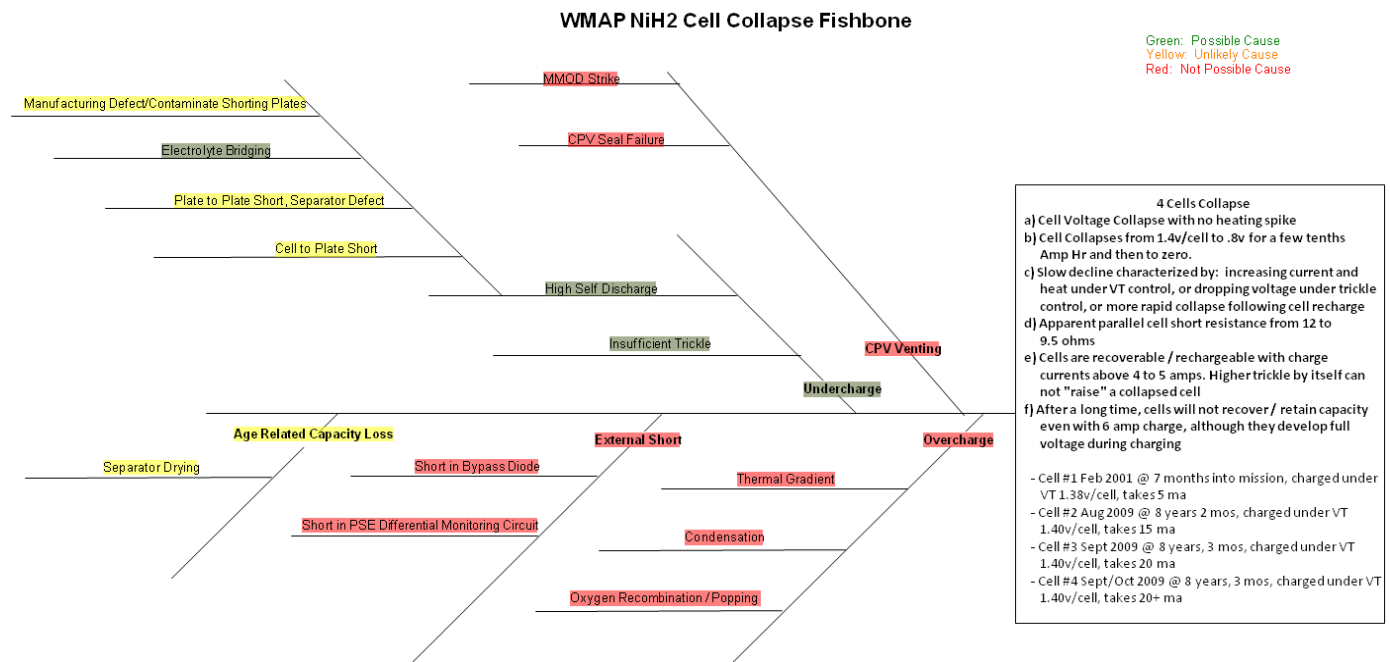
Figure 4.0-1. WMAP NiH₂ Voltage Collapse Fishbone

Potential causes for the observed cell collapses considered during this assessment are believed to be limited in nature based on team member experience. The basic causes identified and considered have been captured in the fishbone chart Figure 4.0-1. Generally speaking, most external causes identified are able to be readily dismissed because they would have affected the battery at a CPV level (2 series cell voltage impacts) as opposed to the observed behavior limited to one of the two internal cells in the CPVs for each event.

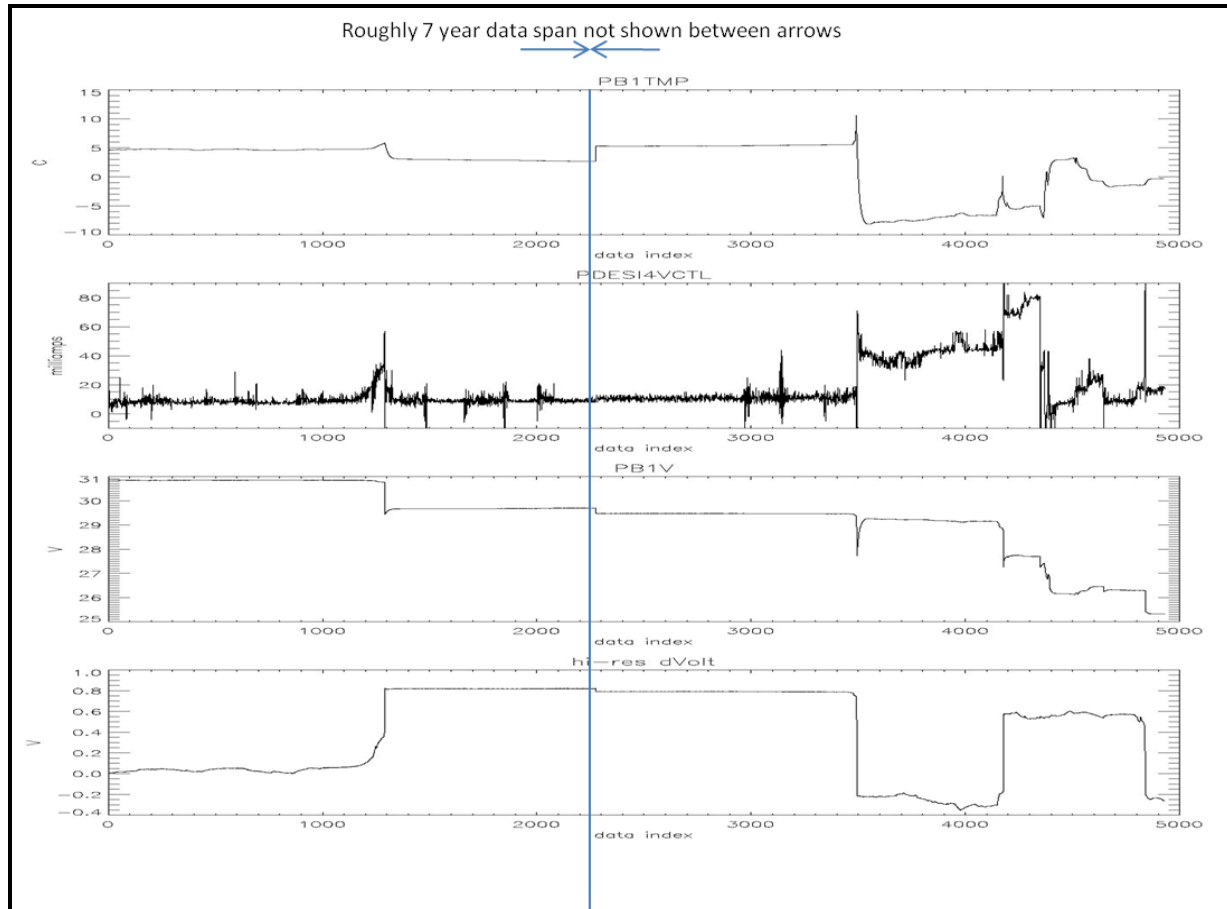
Figure 6.2-2. Historical Perspective of Electrical Power System Operations Up to Anomaly

Figure 6.2-2 shows the battery related telemetry values received from WMAP over the course of the mission up to the events triggering this assessment. From top to bottom, the plots display the primary battery cell temperature measurement, charge or discharge current, battery voltage, and differential voltage (corrected for the uneven distribution of cells). The differential voltage telemetry value represents a corrected voltage measurement comparison of the 2 halves of the battery utilizing a voltage tap incorporated in the middle of the battery. Since the battery is designed with an uneven number of CPVs (11), the actual differential measurement tap is between the 5th and 6th physical CPVs and the comparison circuit in the PSE appropriately designed (offset) to accommodate the difference of one CPV voltage between the two halves. This measurement parameter is typically designed to provide insight into differential changes within the battery such as cell voltage divergence.

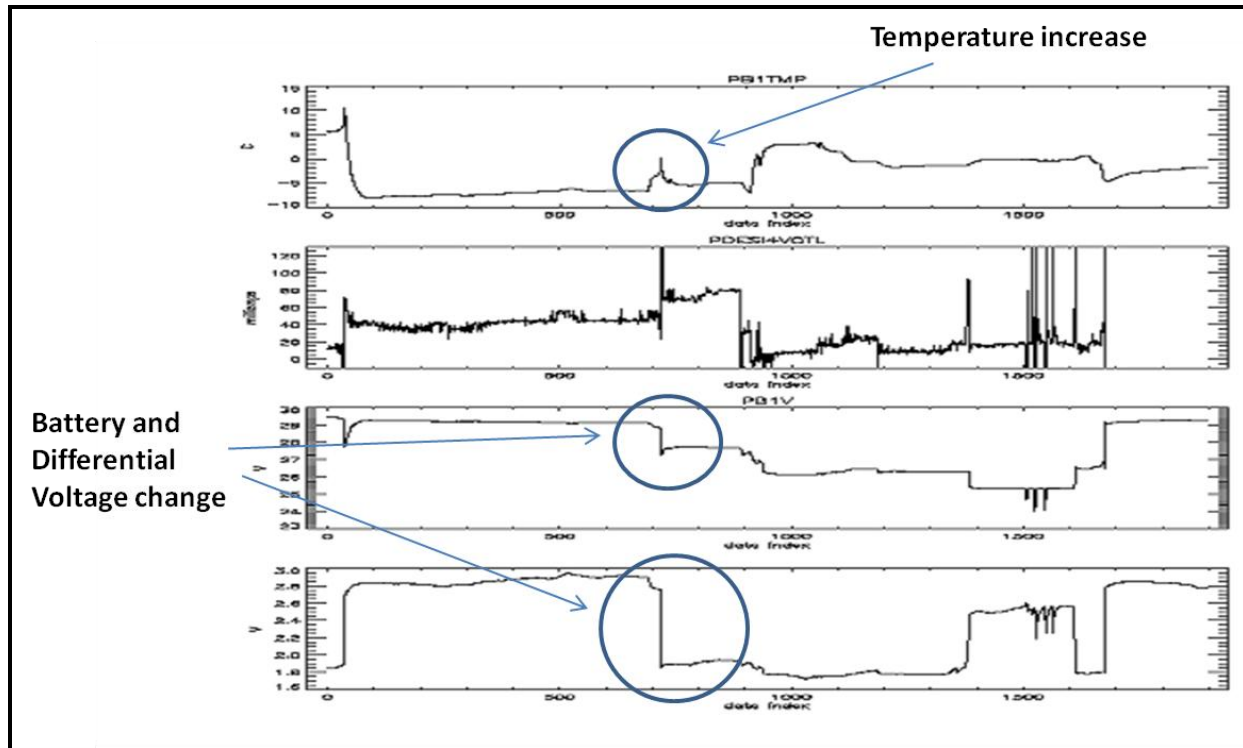
Figure 6.2-3. Close-up View of Typical On-Orbit Cell Collapse Events

Of note, during the events encountered is the characteristic increase in temperature before (and during) the event coupled with the charge current response from the power system attempting to maintain the commanded V/T clamp voltage. According to information provided by the WMAP project team regarding nominal operations, the power system was not designed to attempt to recover any particular cell voltage collapse during the event but, instead was designed to mitigate the possibility of overcharging the battery if an internal cell short were to occur. Therefore, when the on-board software algorithm sensed a sudden shift of more than approximately 0.5V in the differential voltage it responded by lowering the commanded clamp voltage by roughly the equivalent of one cell in voltage (response designed in the failure detection and correction software would lower the V/T level by 3, or approximately 1.2V). A plot of standard V/T curves associated with NiH₂ cells is included in Appendix D for reference.

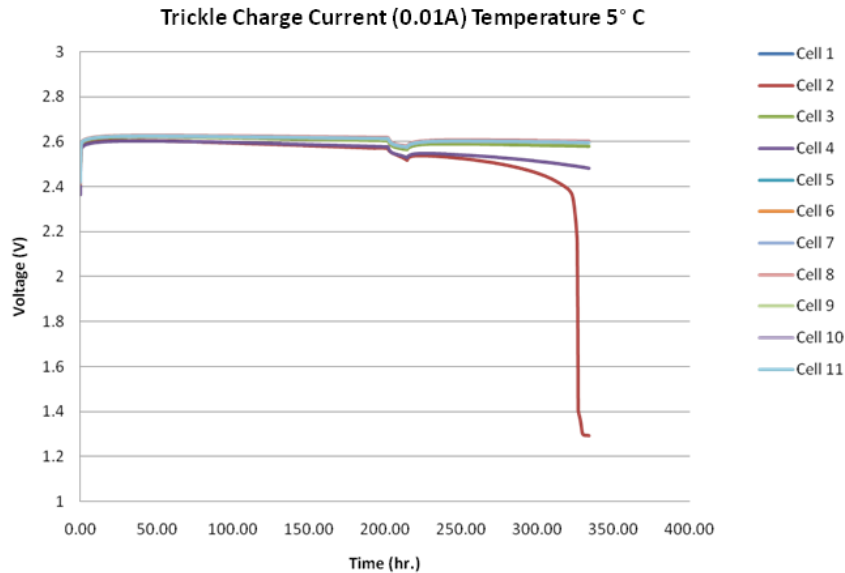
Figure 7.2-1. Test Battery Voltage Collapse under Low Trickle Charge Conditions

Simulated on-orbit conditions successfully duplicated a cell voltage collapse while using low trickle charge conditions similar to that experienced on-orbit.

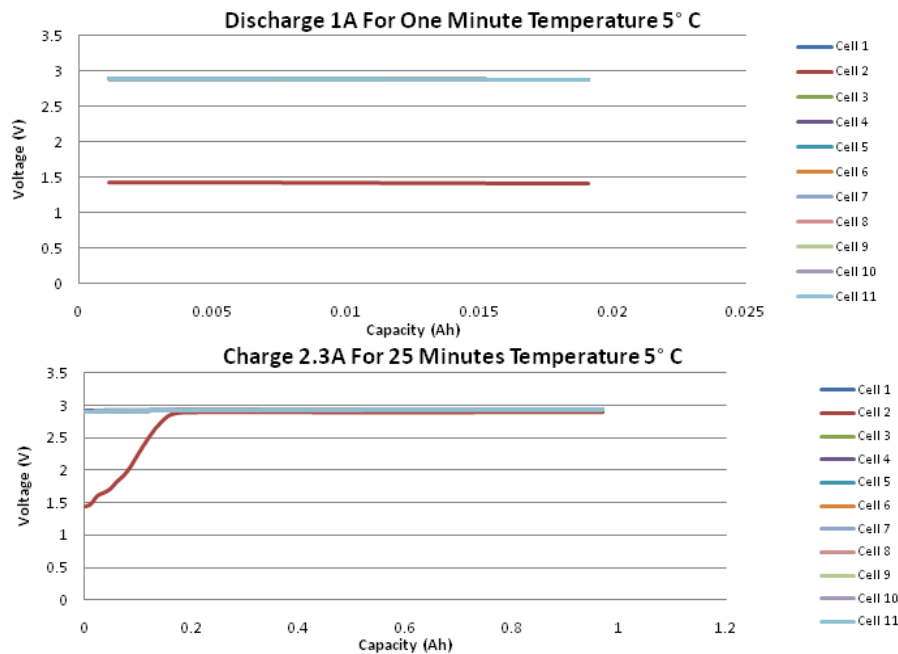
Figure 7.2-2. Recovery of Collapsed Cell Using Discharge/Charge Cycle

Small discharge followed by a C/10 charge in the test battery recovered the collapsed cell.

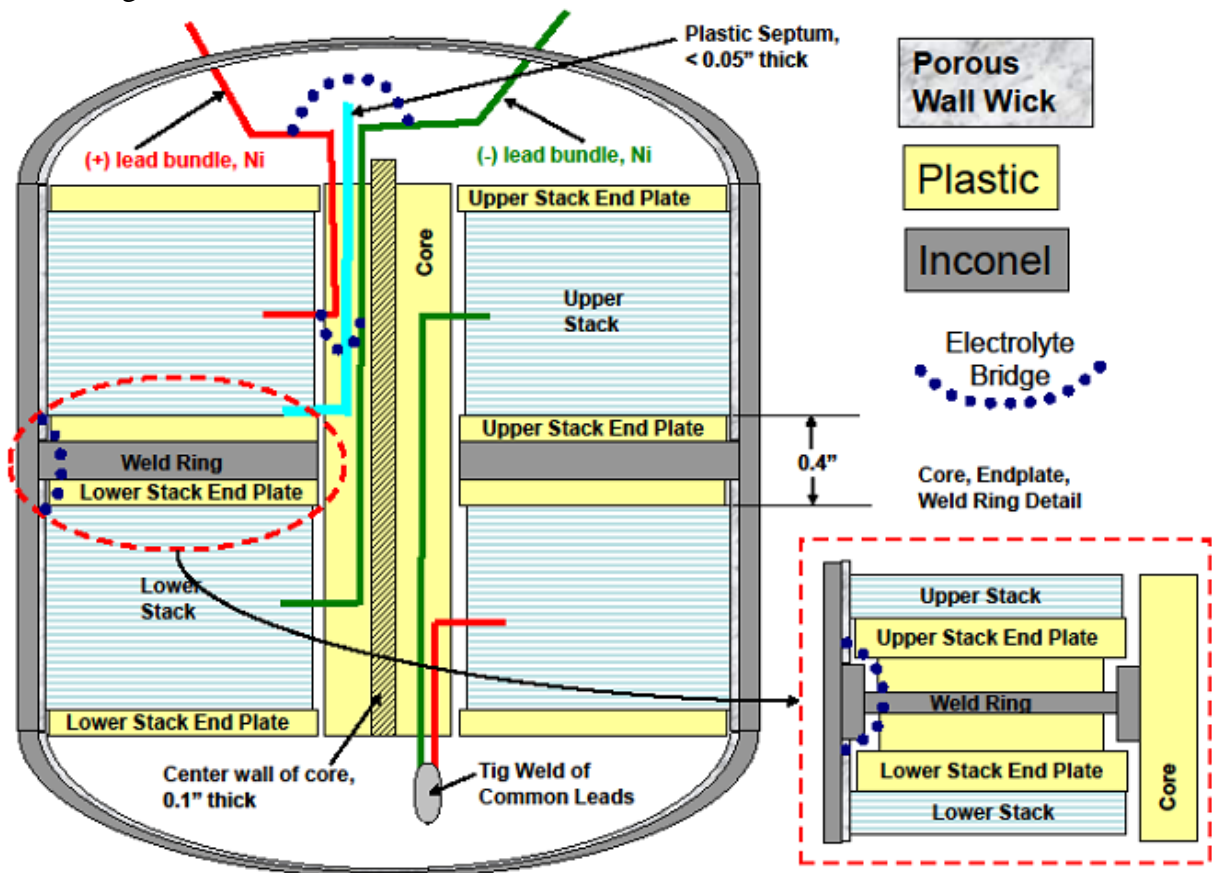
Figure 7.3-1. PRT Consensus Theory of Cell Anomaly

Most likely locations for the possible bridging causing anomalous WMAP battery behavior are shown in Figure 7.3-1.

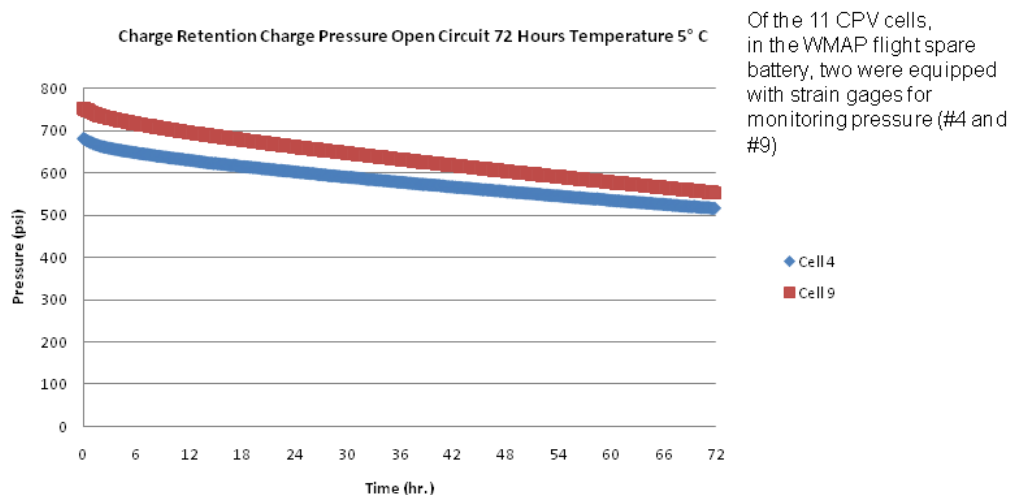
WMAP Flight Spare (Test) Battery Charge Retention Test Results- Pressure (at 5°C)

Flight spare battery indicated larger than expected rate of capacity fade during open circuit stand testing (expected approximately 10-15%) based on available strain gage measurements.

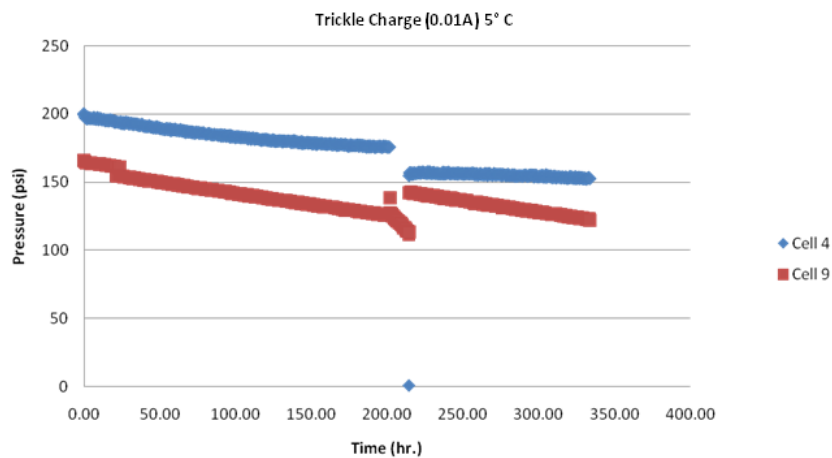
WMAP Flight Spare (Test) Battery Pressure (Capacity) Under Low Trickle Charge at Low SOC (at 5°C)

After reducing state of charge to roughly 10% of capacity, pressure (capacity) continued to fall using low trickle charge rate (discontinuities due to strain gage anomalies).

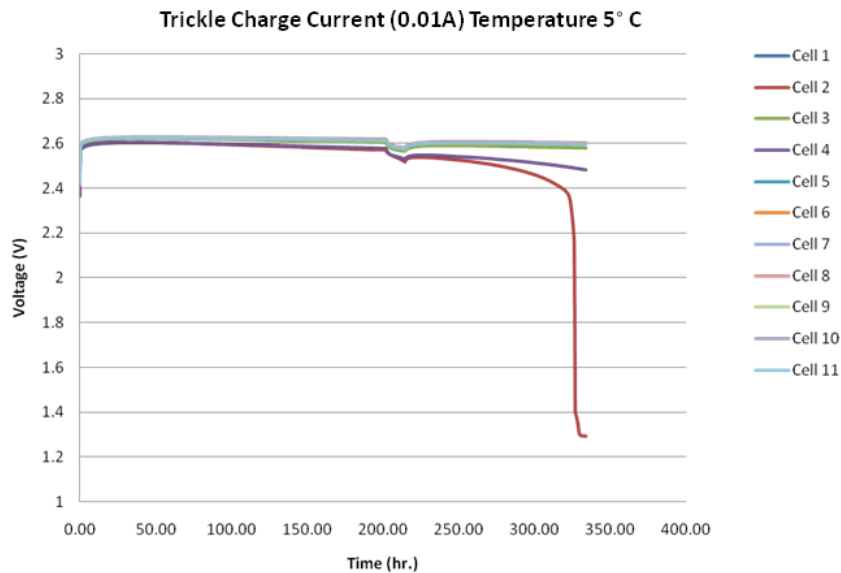
WMAP Flight Spare (Test) Battery Voltage Under Simulated On-Orbit Low Trickle Charge (C/2300) at Low SOC (at 5°C)

Simulated on-orbit conditions successfully duplicated a cell voltage collapse while using low trickle charge conditions similar to that experienced on-orbit.

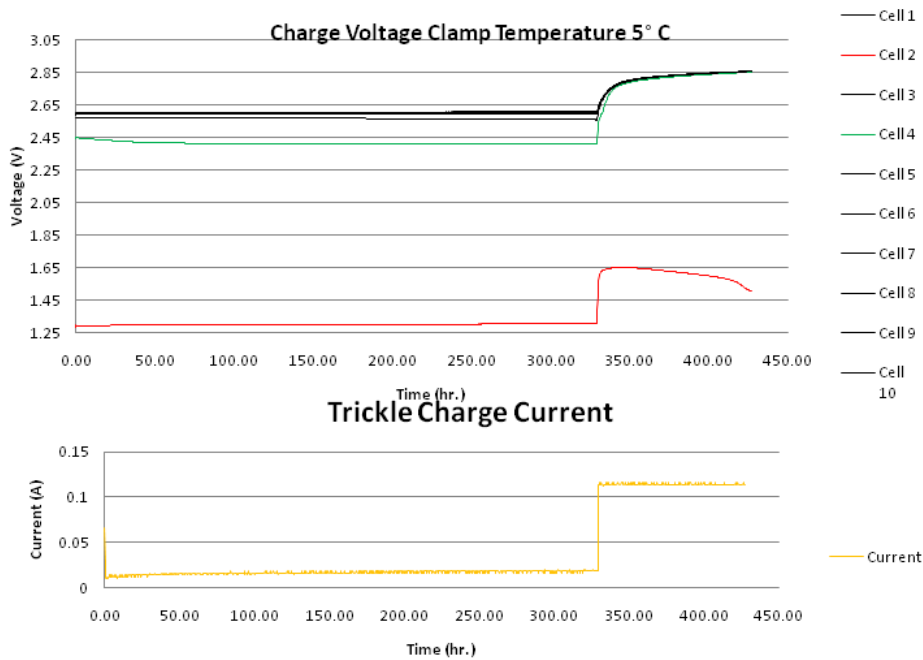
Flight Spare (Test) Battery Switch from Voltage Clamp to Fixed
Trickle Charge (C/200)

Similar to the on-orbit experience, when just the trickle charge rate was increased there were initial benefits but soon after more divergence occurs.

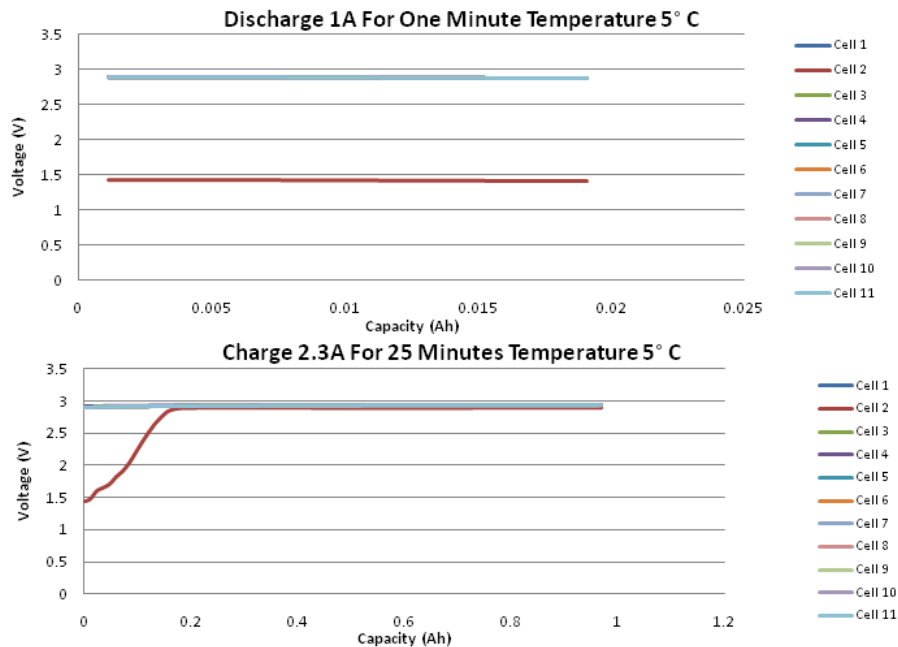
Flight Spare (Test) Battery Response to Discharge/Charge Cycle

Small discharge followed by a C/10 charge in the test battery recovered the collapsed cell.

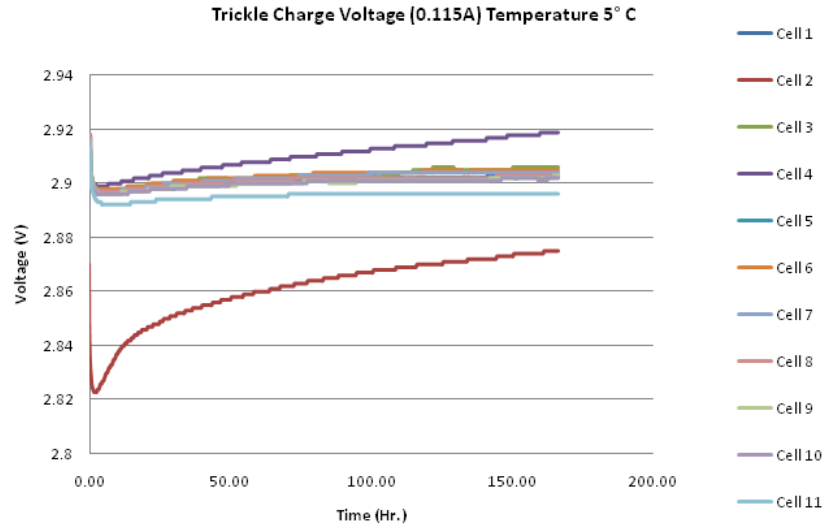
Flight Spare (Test) Battery Response Post Discharge/Charge Cycle

Previously collapsed cell has been recovering to near normal while voltage divergence is also being experienced.

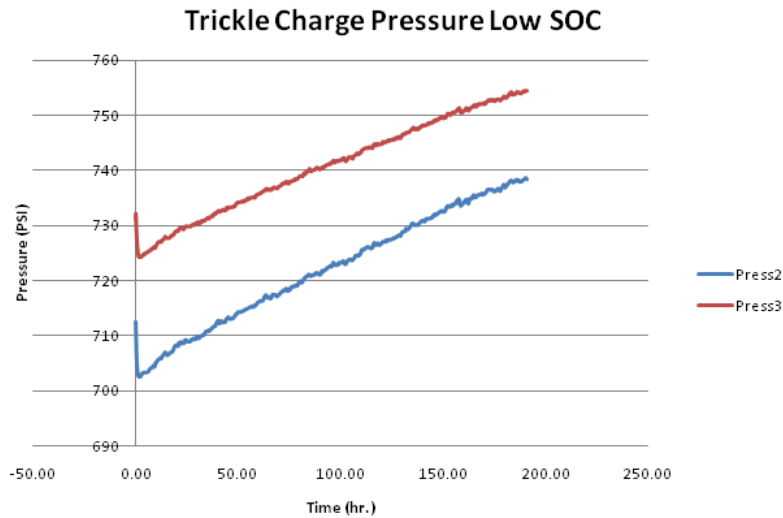
Low SOC Low Trickle Charge Test Results on HST Cells - Pressure (Capacity) (at 5°C)

Unlike WMAP test battery, after lowering state of charge to 10%, pressure increased in HST cells while subjected to low trickle charge rate (indicating charging).

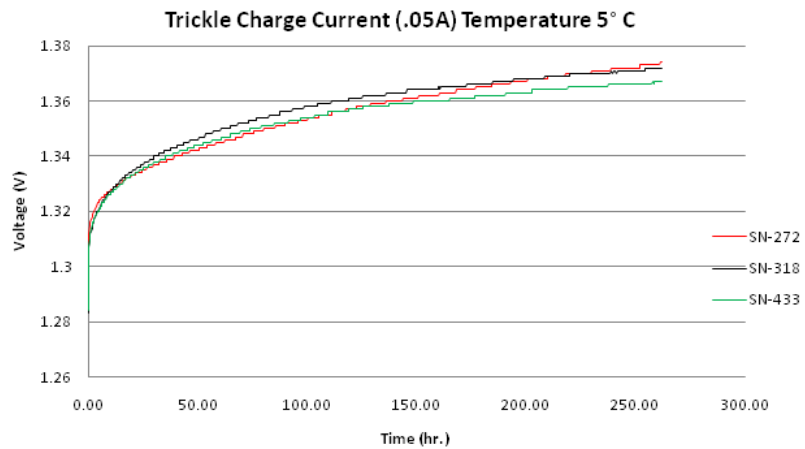
Low SOC Low Trickle Charge Test Results on HST Cells – Voltage (at 5°C)

Also unlike WMAP test battery, after lowering state of charge to 10%, voltage also recovered on sample HST cells while subjected to low trickle charge rate.

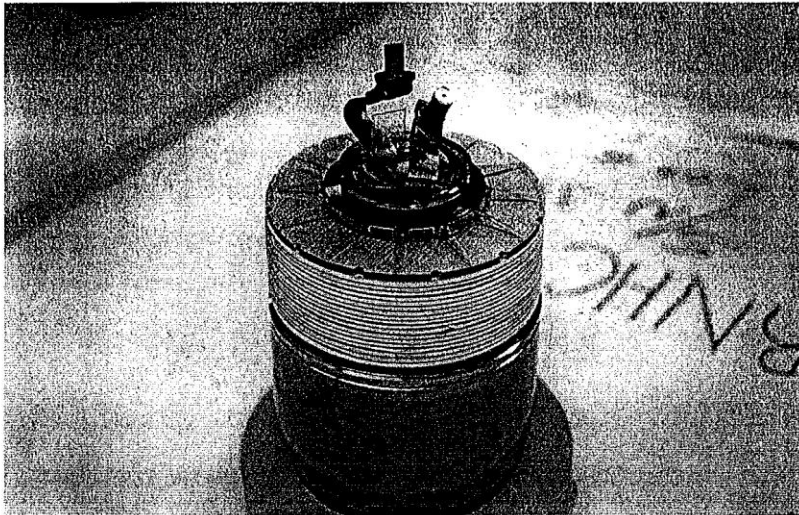
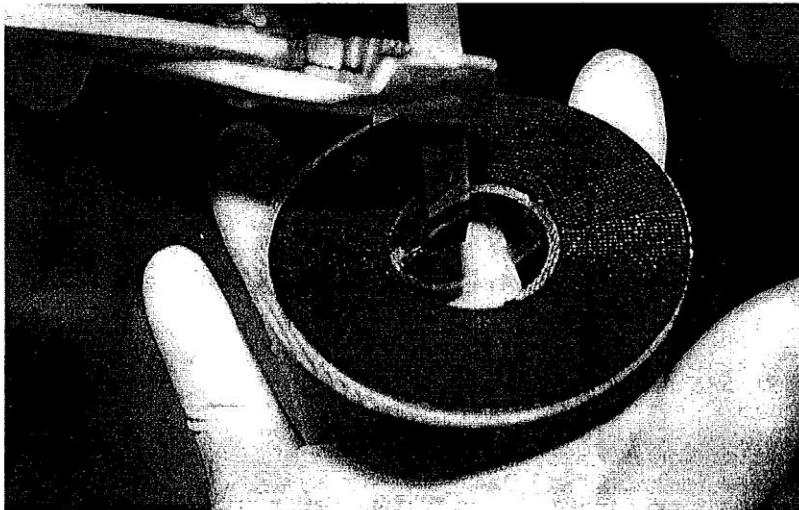
Negative electrode tab area found misaligned during disassembly. Most likely resulted in the tear (hole) found in the separator, and allowed a shorting path to the adjacent positive electrode.
