Status of the Regenerative ECLS Water Recovery System

Layne Carter¹

NASA Marshall Space Flight Center, Huntsville, AL 35812

The regenerative Water Recovery System (WRS) has completed its first full year of operation on the *International Space Station (ISS)*. The major assemblies included in this system are the Water Processor Assembly (WPA) and Urine Processor Assembly (UPA). This paper summarizes the on-orbit status as of May 2010, and describes the technical challenges encountered and lessons learned over the past year.

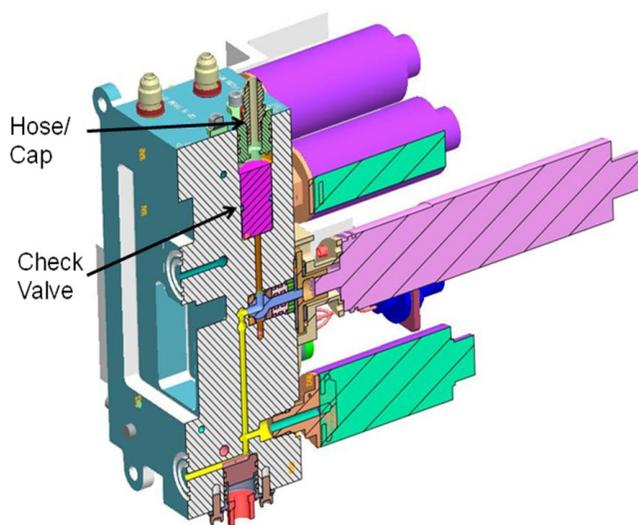
Figure 4. FCPA Manifold

A separate anomaly also discussed in the previous paper (1) was the failure of the FCPA check valve. The purpose of this check valve is to prevent backflow from the WPA waste tank into the DA. On April 23 2009, the check valve failed closed during normal operation of the fluids pump, and repeated attempts to open it by operating the pump were unsuccessful. Since this check valve is a redundant control against backflow (and not required as a safety control), engineering personnel determined that it should be removed from the hardware on ISS. This allowed for the first intermediate-level (I-level) activity on UPA. I-level refers to on-orbit maintenance of hardware internal to an ORU, which avoids the costly effort to return and resupply an entire ORU on ISS that has failed due to a single component. The check valve is an inline component in the FPCA manifold (see Figure 4). Due to this design, the valve could be removed by first removing the inlet flex hose/cap to the manifold, then the check valve, and finally replacing the flex hose. Implementation of this procedure was challenging because the required tools were not available on ISS, requiring creative solutions by the ISS engineering/operations personnel. The flex hose/cap (hose not shown in Figure 4) is held in place with two fasteners. After the fasteners were removed, the cap was removed by gently pulling on the base of the hose with a pair of pliers to overcome the resistance of the two radial o-rings. The inline check valve is held in place by a separate radial o-ring. Threads at the inlet to the check valve are provided for removal, but require a bolt with the mating threads (not present on ISS). Instead, operations personnel identified a plastic nozzle from a foam applicator available on ISS with threads slightly smaller than the required bolt. These threads were then wrapped with Kapton tape to better match the threads in the check valve (see Figure 5). Despite the use of the modified hardware as tools, the crew was successfully able to remove the check valve and therefore return the UPA to operation.

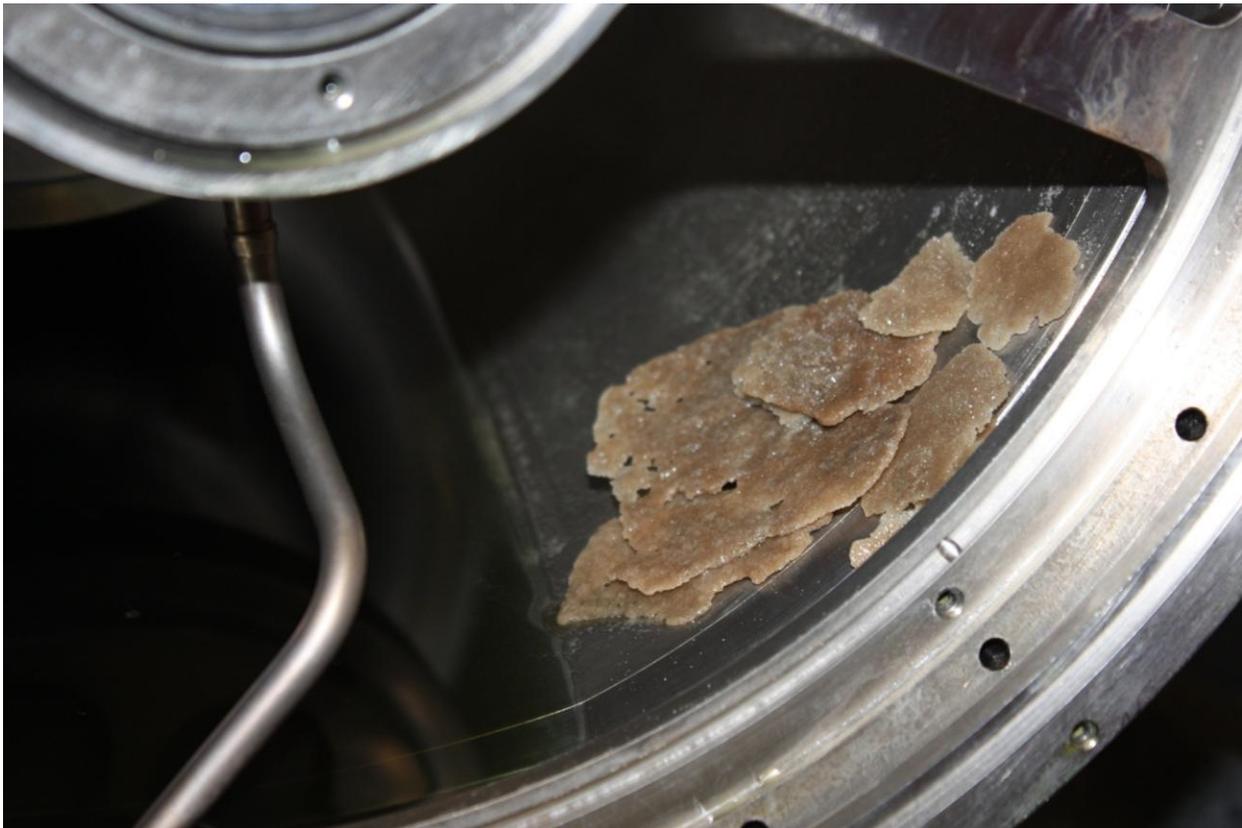
Figure 6. Precipitation in the Distillation Assembly Evaporator

After return to the Marshall Space Flight Center in December 2009, the DA was disassembled. The root cause of the anomaly was found in the evaporator, which contained a significant quantity of solids (see Figure 6). These solids had blocked the brine pitot tube, resulting in flooding the DA. In addition, the urine brine had passed through the demister and the compressor lobes, and was found in the DA's condenser and the stationary bowl.

Subsequent analysis of the solids determined that they were primarily comprised of calcium sulfate. Calcium is present in the urine primarily due to bone loss from the crew, whereas sulfate is present primarily due to the use of sulfuric acid in the urine pretreatment. Calcium levels on ISS are elevated compared to ground urine due to the absence of gravity. During ground testing, the UPA was proven to have no issues with recovering 85% of the water from pretreated urine. However, at 85% recovery on ISS, the higher concentration of calcium resulted in calcium sulfate exceeding its solubility limit. Since calcium sulfate solubility is lower at elevated temperature, it precipitated in the DA where the fluid is at the maximum temperature in the recycle loop.

Based on these observations, engineering personnel agreed that 85% recovery of water from the pretreated urine was not viable. A rigorous statistical analysis of urine chemistry was performed by personnel at the Johnson Space Center (JSC) and MSFC using analysis of samples taken on ISS. This analysis defined a 90% upper confidence limit on the calcium concentration as 283 mg/L. Given this concentration, a 70% recovery has been specified for future operation of the UPA, which accepts an 8% risk of reaching the calcium solubility limit over a given crew increment. Though this approach has some risk, 70% recovery was deemed necessary to meet logistics requirements for RFTA refurbishment and water resupply. In parallel with this modification to on-orbit operations, NASA personnel will investigate options for either removing calcium from the urine prior to introduction to the UPA, or introducing chelating agents into the pretreated urine that will inhibit precipitation of the calcium sulfate.

In addition, the rebuild of the DA S/N 02 will incorporate modifications to the demister. Water vapor generated by the evaporator flows through the demister before entering the compressor. The function of the demister is to collect liquid droplets in the vapor stream and sling them back into the evaporator. The investigation of the failed DA determined that the demister was not effective in removing liquid from the vapor stream, resulting in precipitation of solids on an inlet screen to the compressor. This ultimately caused elevated compressor temperature when the DA flooded and the inlet screen was almost completely blocked with precipitation. The demister redesign will address deficiencies in the demister functions to insure liquid droplets are effectively collected and returned to the evaporator, thus protecting the compressor from ingesting liquid.

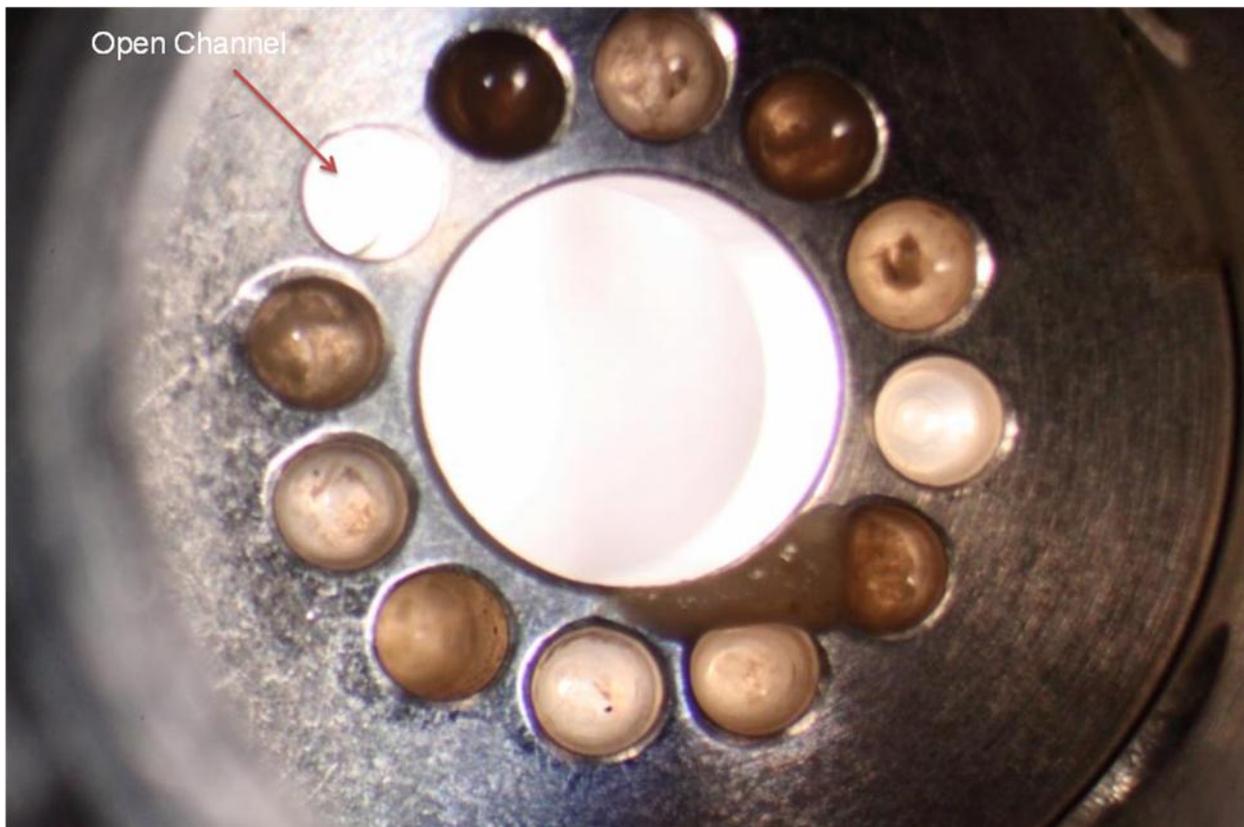
Figure 7. Biomass Present in MLS Inlet Solenoid Valve

The failed ORU was disassembled at Hamilton Sundstrand the week of February 22, 2010. Though the plumbing internal to the ORU exhibited no significant indication of biofouling, the MLS inlet solenoid valve was found to be significantly occluded with biomass. This biomass had accumulated in the valve between the poppet and the valve seat, obstructing the clearance in this region and causing the excessive pressure drop. Figure 7 provides a view of section of the valve that feeds the poppet, illustrating the accumulation of biomass in all but one channel.

Based on this investigation, engineering personnel are pursuing multiple efforts to insure the continued operation of the WPA on ISS. First, additional filters have been shipped to ISS as spares for the filter currently installed upstream of the MLS. Filter life is being tracked to determine if this approach is viable for long term WPA operation. Currently, after two months of operation on ISS, no significant increase in pressure drop has been

observed. If the current filter life is deemed unacceptable, a modified filter design will be delivered to ISS that provides additional filter surface area. Also, an additional solenoid valve may be built and delivered to ISS to be replaced by the crew if the failure occurs again.

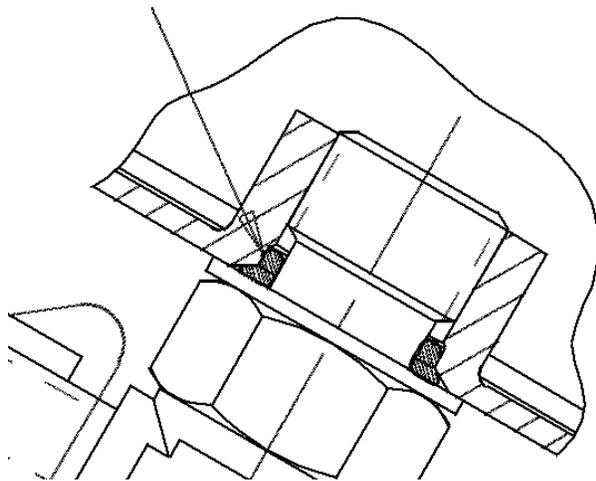
Figure 8. Standard MS Boss Fitting

The spare Catalytic Reactor ORU S/N 02 was delivered to ISS on Shuttle Discovery in April 2010 and installed in the WPA on April 11, 2010. The failed Catalytic Reactor ORU S/N 01 was returned on the same Shuttle for a subsequent failure investigation. After initially completing a Computerized Tomography (CT) scan at MSFC to confirm the configuration of the seals in the reactor tube fittings, the hardware investigation was completed at Hamilton Sundstrand. An initial leak test of the reactor confirmed the location of the leaks identified on ISS, and also identified an additional leak at the other end of the reactor tube. All leaks occurred through a standard MS Boss fitting, a cross section of which can be found in Figure 8. This fitting uses an o-ring made of ethylene propylene diene monomer (EPDM), which is the optimum rubber to be used in aqueous applications at temperatures above 65 C (Catalytic Reactor operating temperature is 130 C). In an ideal application, the o-ring is pushed by the jam nut and washer into the annulus between the female bore and the male gland as shown in Figure 8. Figure 9 shows an o-ring from an ambient temperature application in the Catalytic Reactor ORU after 8 years in place. As expected, the o-ring has slightly deformed to fill the annulus and thus provide the seal against external leakage.

To support refurbishment of Catalytic Reactor ORU S/N 01, the hardware is being redesigned to eliminate the overfill condition of the o-ring in the gland at the elevated temperature. This is accomplished with some combination of modifications, including an alternate EPDM o-ring with less swell, a custom o-ring with a smaller

cross section, and/or a machined fitting with a smaller diameter. The objective for the refurbishment of this ORU is to return it to ISS on Shuttle Endeavor in October 2010 if the schedule permits.

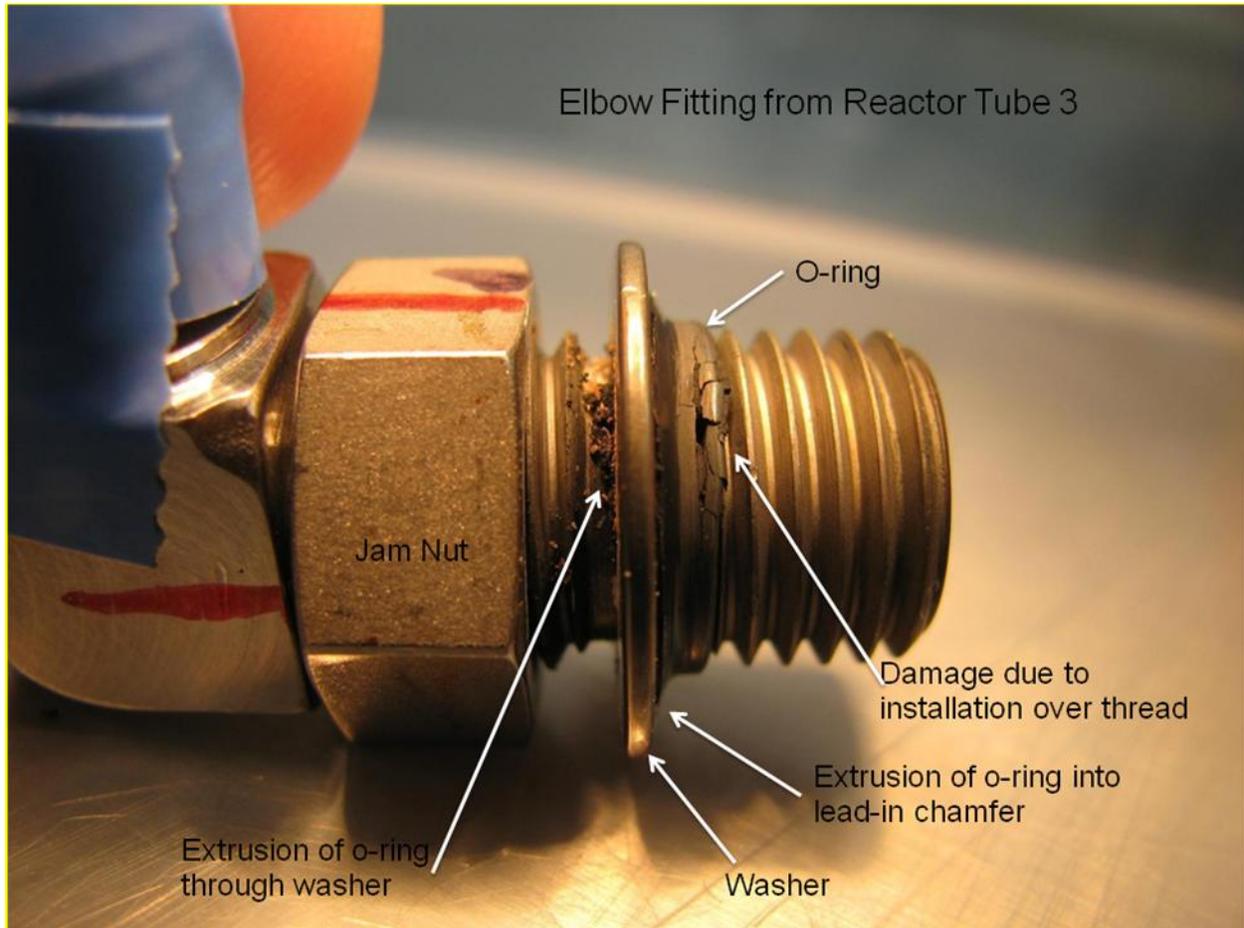
Figure 10. View of Damaged O-ring

However, the o-ring selected for this application did not take into account expansion of the o-ring due to swell (water absorption) or thermal expansion at the elevated temperature application. Therefore, the o-ring volume exceeded the available gland volume at elevated temperature, ultimately resulting in compression set. Figure 10 shows the fitting from the 3rd reactor tube, which was the location for the highest leak rate. In addition to the compression set (note the o-ring was deformed to the available gland volume), this o-ring had also been installed over the bottom thread. Also, the o-ring had even extruded through the inside diameter of the washer because of the fact that it exceeded the available gland volume at the elevated temperature.
