Ultrasonic Monitoring of Ply Crack and Delamination Formation in Composite Tube Under Torsion Load

P. H. Johnston, C. W. Wright, J. N. Zalameda
NASA Langley Research Center
Hampton, VA, USA
Patrick.H.Johnston@nasa.gov

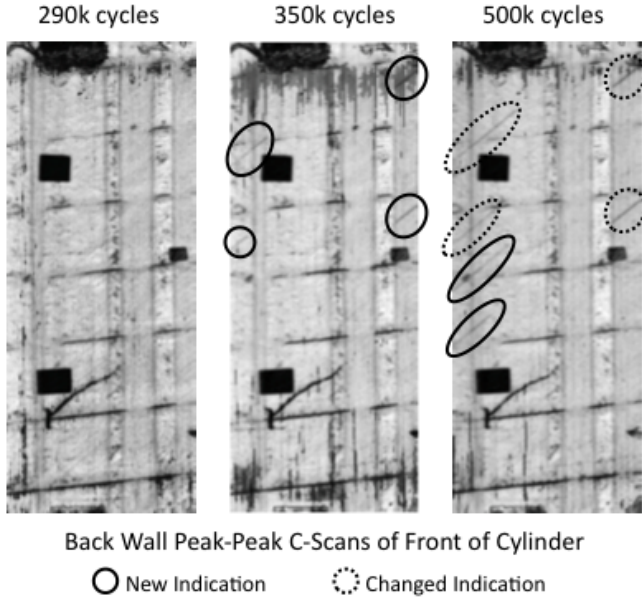
Figure 3. Ultrasonic back-wall C-scans of the front quadrant at 290k, 350k and 500k cycles. At 290k cycles, only pre-existing details are observed (inserts, linear surface marks and some areas of porosity). At 350k cycles, new linear 45° indications appear (circled). Continued cycling to 500k cycles cause these to grow and more new cracks to appear.

No damage indications were observed though 290,000 cycles. The scan performed after 350,000 cycles several +45° linear indications, manifest as 5-40% attenuation of the back wall echo, with no observable interior echoes. These linear indications, circled in Fig. 3, were consistent with ply cracks in the innermost +45°-oriented lamina. At 500,000 cycles, these cracks had extended in length and additional cracks had formed in the innermost lamina. No delamination growth was observed near the Teflon inserts.

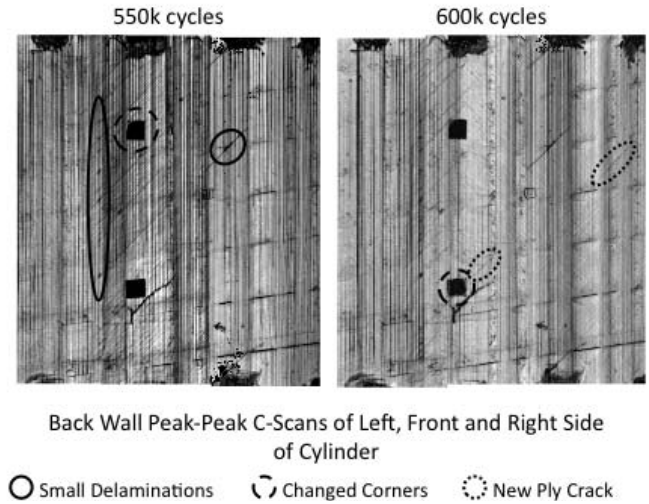
Fig. 4 presents C-scans made up from scans of the left, front and right quadrants of the cylinder at 550,000 and 600,000 cycles. During this period of loading, new innermost lamina ply cracks continued to form. At several locations, small interior delaminations began to form adjacent to the previously formed ply cracks. No delaminations were observed adjacent to the Teflon inserts. However, after 550,000 cycles, the corners of the inserts A and C, which lay near the outer surface of the cylinder, began to transmit ultrasound, where they had previously blocked it, suggesting the development of substantial compressive residual stresses at those locations.

Figure 4. Ultrasonic back-wall C-scans of the left, front and right quadrants taken at 550k cycles and 600k cycles. New ply cracks (dotted ovals) continue to form with loading. Small interior delaminations (solid ovals) begin to form adjacent to the 45° ply cracks. The corners of Teflon inserts A and C (dashed circles) begin to pass ultrasound, suggesting high compressive stress.

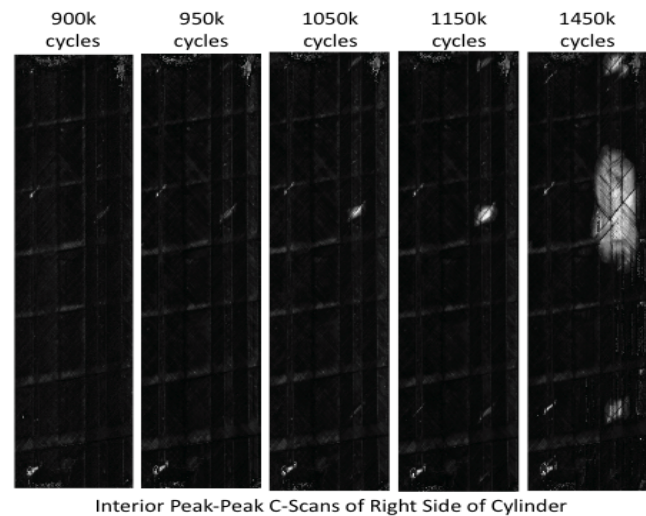
Fig. 5 presents a progression of delamination initiation and growth from 900,000 cycles to 1,450,000 cycles in the right side quadrant of the specimen. For these C-scans, the gate was placed between the front and back wall echoes, such that signals from interior delaminations appear brighter against a normally dark background. A small delamination is observed just above and to the right of the center of the image, steadily growing in area as the cycling continues. By 1,450,000 cycles this delamination grows rapidly and jumped to other ply interfaces. Two smaller delaminations form grow above and below it.

Figure 5. Ultrasonic C-scan images of the right side quadrant of the test cylinder from 900k cycles to 1,450k cycles, showing the initiation and growth of several multi-layer delaminations.

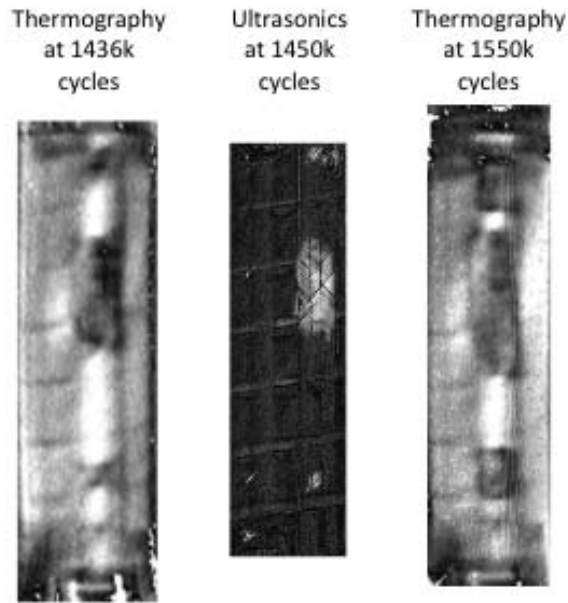
Figure 6. Thermal (left and right) and ultrasonic (center) images showing the delamination growth occurring between 1,436k cycles and 1,550k cycles

Fig. 6 shows the ultrasonic data at 1,450,000 again alongside thermographic images taken during cyclic loading at approximately 1,436,000 and 1,550,000 cycles. The three delaminations observed in the ultrasonic data are also seen in the thermal images. As the cyclic loading was continued past 1,450,000, the delaminations continue rapid growth in the axial direction and eventually linked up to cause failure of the cylinder at approximately 1,600,000 cycles. A photograph of the failed specimen, split along the $+45^\circ$ orientation, is presented in Fig. 7.

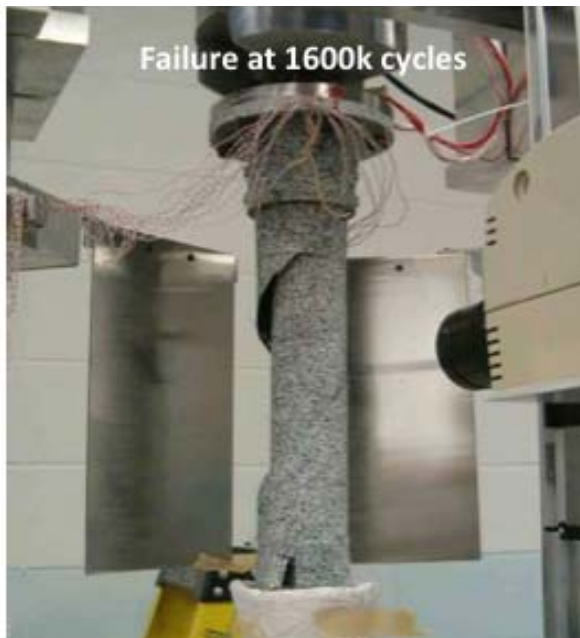
Figure 7. Photograph of the cylinder after failure at 1,600k cycles.
