HYPERGOLIC PROPELLANTS: THE HANDLING HAZARDS AND LESSONS LEARNED FROM USE

B. Nufer

NASA Kennedy Space Center, Engineering Directorate, Fluids Division, Hypergolic and Hydraulic
Systems Branch

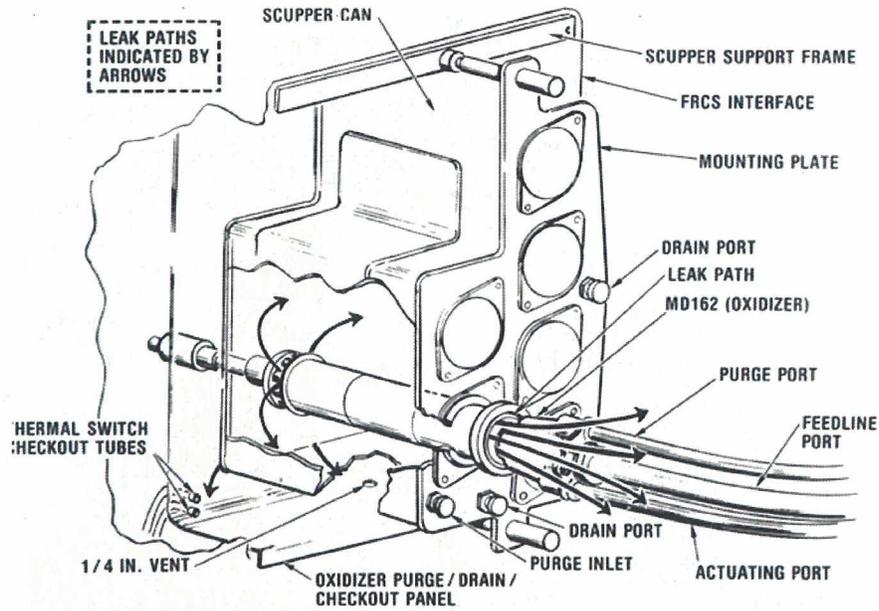
Figure 12: Drawing of AP28-12 Door and Failed MD162 GHC

At 1:13 AM on September 22, 1981 an N₂O₄ spill occurred at Pad 39A. The proximate cause of the spill was a failed ground half coupling (GHC), MD162, at the AP28-12 door (shown in Figure 12) on FRC2 of OV-102 (Columbia). Failure of the GHC was a result of iron nitrate build-up between the probe and the dynamic head of the GHC along with the tight tolerances of the GHC. See Figure 13 for a description of the AHC and GHC and also the failure location. Between 15 to 20 gallons of oxidizer was released into the attached scupper, which subsequently overflowed onto the vehicle. Damage to thermal tile adhesive resulted in the removal of 370 tiles (shown in orange in Figure 14). The photograph in Figure 15 shows the thermal tiles and the underlying vehicle structure along with the scupper and QD flexhoses going into the AP28-00 door (second FRCS oxidizer servicing door just beneath the AP28-12 door when the vehicle is in the vertical orientation).

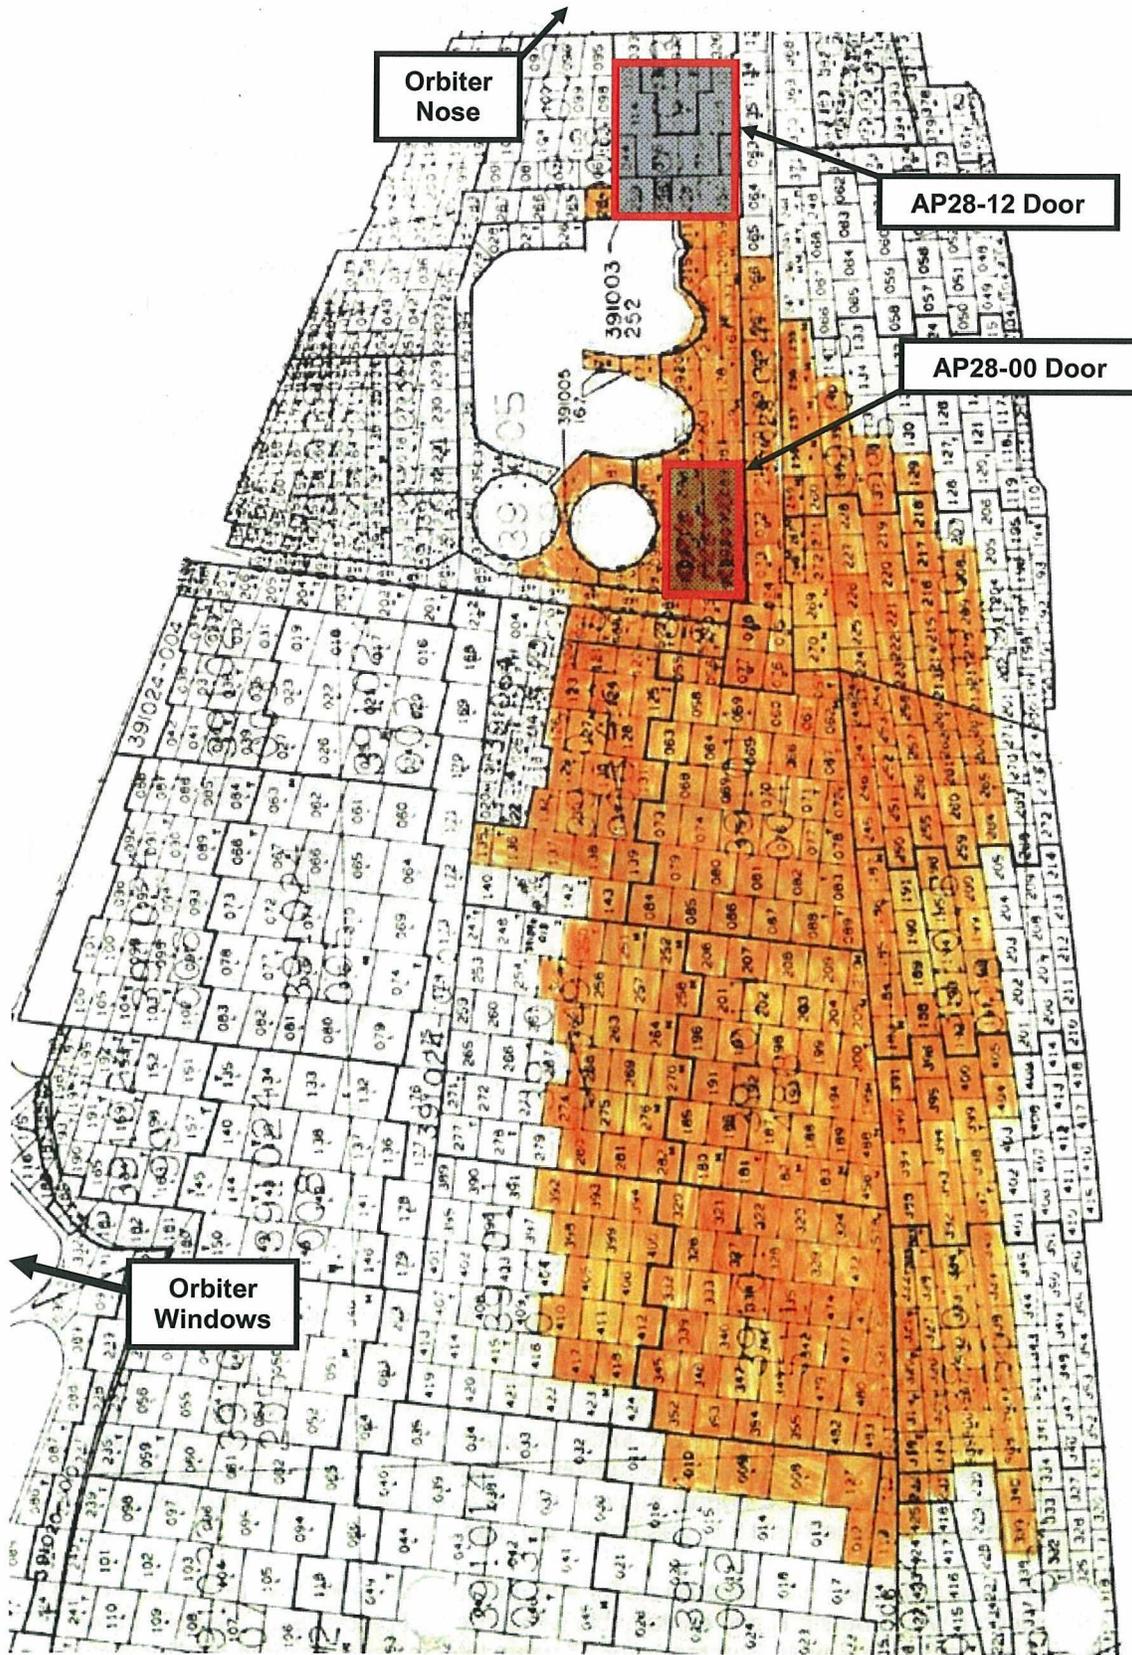
Figure 14: Removed Tile from OV-102 Following STS-2 N_2O_4 Spill

The spill protection was not suitable for a large leak. It was incorrectly assumed that if a spill did occur; it would be small and containable within the spill protection. The spill protection still in use on the Space Shuttle Program over 27 years later is very similar to the "temporary" redesigned spill protection following the STS-2 N_2O_4 spill.

The launch was delayed by about one month while repairs were made to the vehicle, which remained at the launch pad. Many of the thermal tiles were baked in an oven and reinstalled onto the orbiter, which is a standard procedure to remove the N_2O_4 or NO_2 from thermal tiles when they become impregnated with oxidizer vapors. Several damaged thermal blankets located inside the forward module were replaced at the pad by accessing them through two doors adjacent to the orbiter windows.

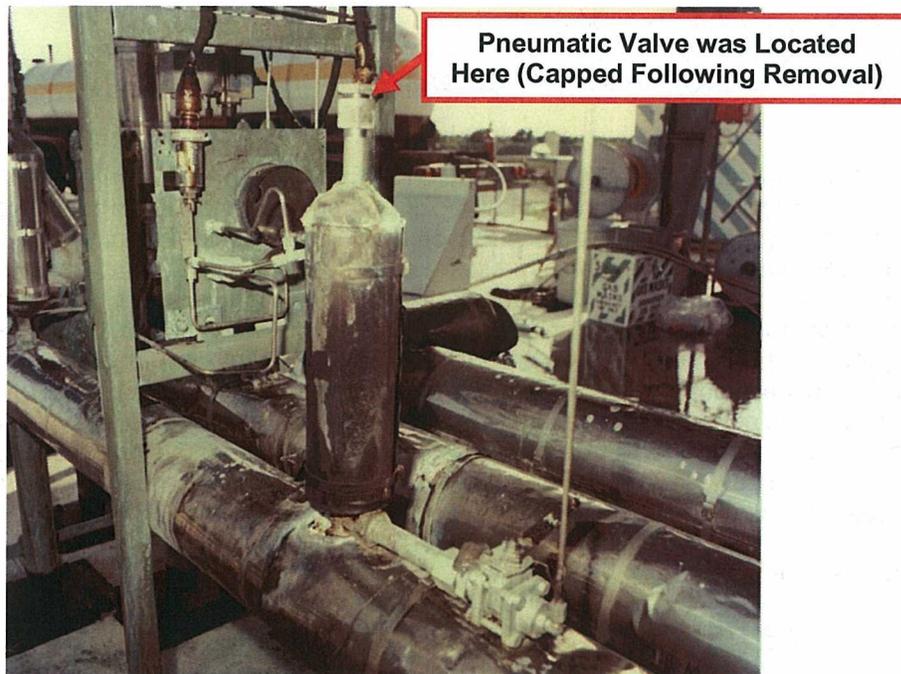
Figure 16: Photograph of Fuel Farm Following Fire

- The procedure was not written or reviewed by an experienced engineer prior to the task
- The engineer on console was making changes to the procedure real-time while monitoring another task in parallel
 - Improper adherence to the procedure and the procedure approval process are also root causes of this incident
- There was only one engineer on console supporting the hazardous operation
 - The engineer had to leave the communications channel to talk to the test conductor and in doing this missed some reports from the personnel at the fuel farm
- There was not a charged water line nearby when the fire occurred

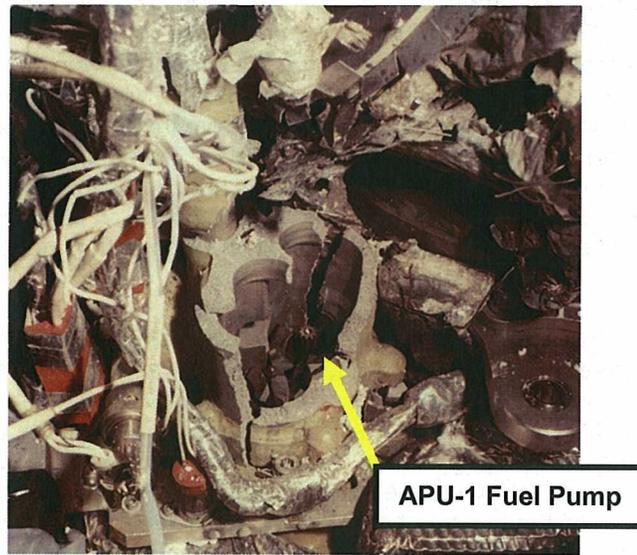
Figure 18: APU 1 Fuel Pump Explosion Following STS-9

The APU failures most probably resulted from a crack in the injector stem caused by corrosion of the sensitized inside diameter surface. The corrodant is probably carbazic acid or some similar substance which can be derived from air, moisture, CO₂, hydrazine and/or ammonia. The corrosion is time dependent and the crack progressed under sustained stress levels from the inner diameter surface toward the outer diameter surface until mechanical or thermal fatigue conditions could [complete] the crack rupture.”

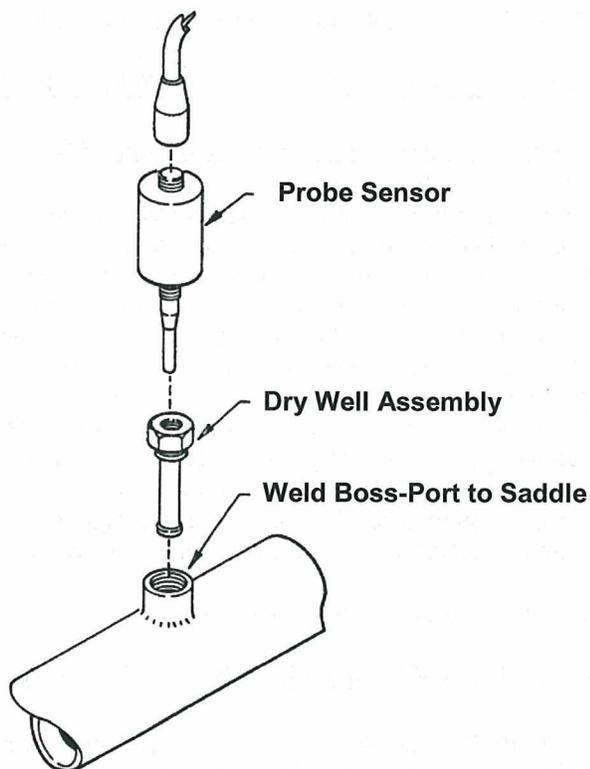
Figure 22: Transducer and Dry Well Assembly

“The LSOC hypergolic mechanical technician actually performing the task of transducer removal used incorrect shop practice and loosened the wrong nut. Instead of using a one-inch wrench to retain the dry well in place while loosening the transducer lock nut that threads into the dry well, he used the wrench to loosen the dry well. He then used his hand to unscrew the transducer thinking he was extracting the transducer from the dry well while he was actually unscrewing the transducer dry well assembly from the three-inch MMH line. A mixture of fluid and vapor MMH immediately erupted from the line sending a column 10 to 12 feet in the air.”

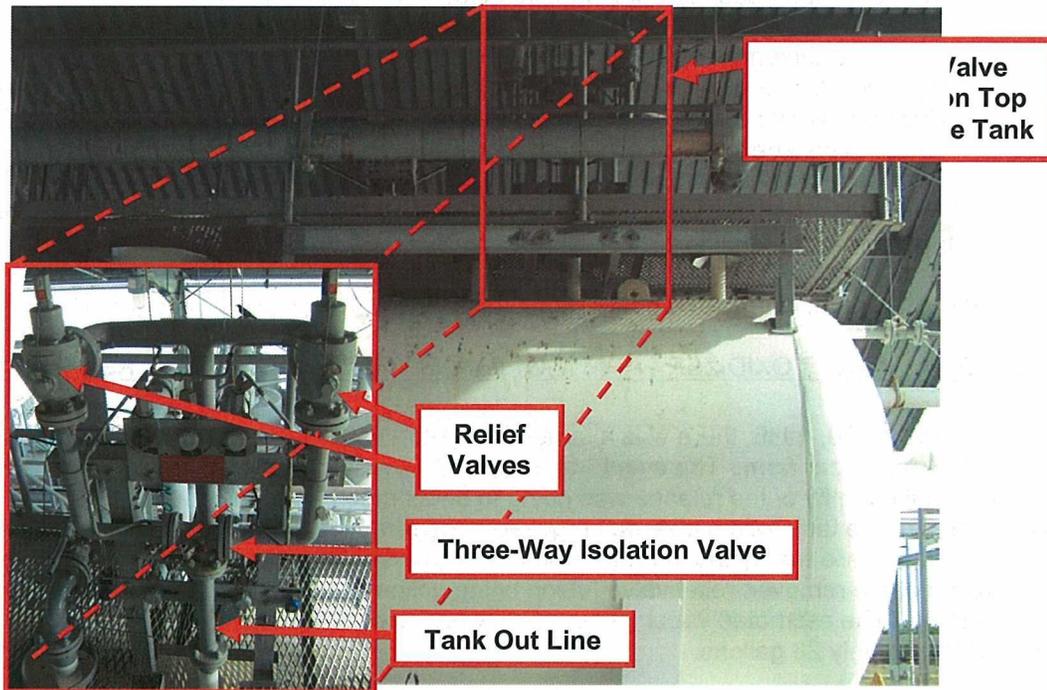
Figure 23: Dual Relief Valve Modification Location

An improper GSE design and operational human error were the root causes of this incident. About ten months prior to this relief valve removal and replacement operation, a formal request had been submitted by engineering to install a dual relief valve system onto the storage tank with a three-way isolation valve to prevent a vapor release during component removal. This request was denied. Following the large vapor release, the modification was implemented at both launch pads, greatly reducing the possibility of any future hazard. This dual relief valve modification allowed for isolation during the relief valve annual maintenance. The modification was also implemented on the fuel storage tanks at both launch pads. Figure 23 is a photograph of the relief valve locations on the top of the N_2O_4 storage tank with a close-up photograph of the relief valve three-way isolation valve modification.

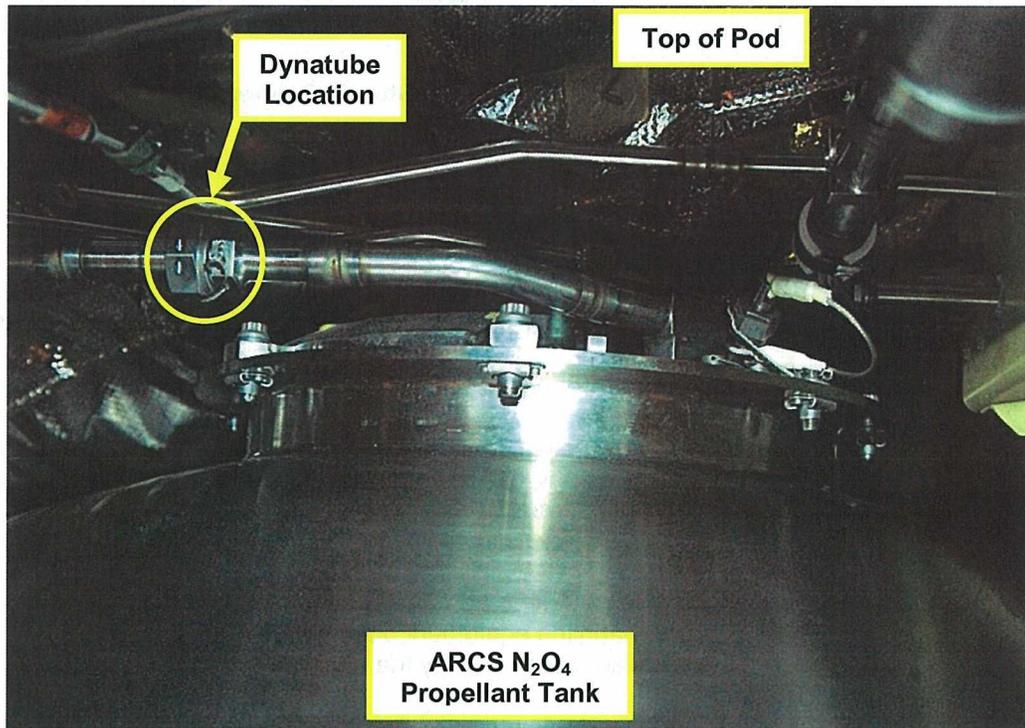
Figure 27: Dynatube Location on ARCS N₂O₄ Tank

First, the exact location of the leak within the pod had to be found (a cutaway view of the Space Shuttle OMS pod can be seen in Figure 25). This was difficult because the internals of the aft pods and forward module are not meant to be accessed while the vehicle is at the launch pad. The location of the leak had been isolated to the LRCS N_2O_4 system or the associated tubing through monitoring of the instrumentation in the LCC. The leak was measured to be 0.26 psi per hour (about 800 standard cubic centimeters per hour) and a TVC found the concentration of NO_2 vapor to be 15 ppm at the vehicle vent door. This later decreased to 3 ppm. An access door was removed on the pod's outer skin and several internal thermal blankets were removed. A long section of PVC pipe was then inserted into the pod to function as a guide for a borescope. Using a borescope, the leak was finally isolated (after a six hour search) to a ½-inch dynatube fitting on the MD224 leg (the N_2O_4 propellant tank ullage vent). A cross-section view of a dynatube is shown in Figure 26 and a photograph of the leak location can be seen in Figure 27.

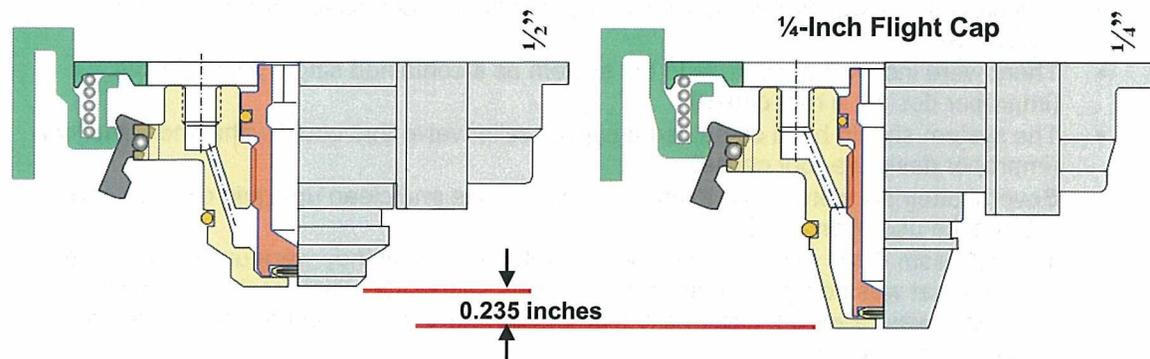
Figure 30: ¼-inch and ½-inch Hypergolic Flight Cap Cutaway View

- The appearance of a ¼-inch AHC cap is such that it could be mistaken for a ½-inch AHC cap to an untrained technician
 - The technician was undergoing on the job training under the direct supervision of an experienced technician, but the distinction between a ¼-inch cap and a ½-inch cap was not explained to him
- Age and wear made part number identification on the AHC cap difficult
- Work instructions should be written to include positive identification of interface equipment
- AHC cap mating should not be considered a benign activity; therefore, PPE should be used to protect the employees from credible releases of propellants
- Future designs should consider keying of AHC caps to preclude incorrect size/commodity installation

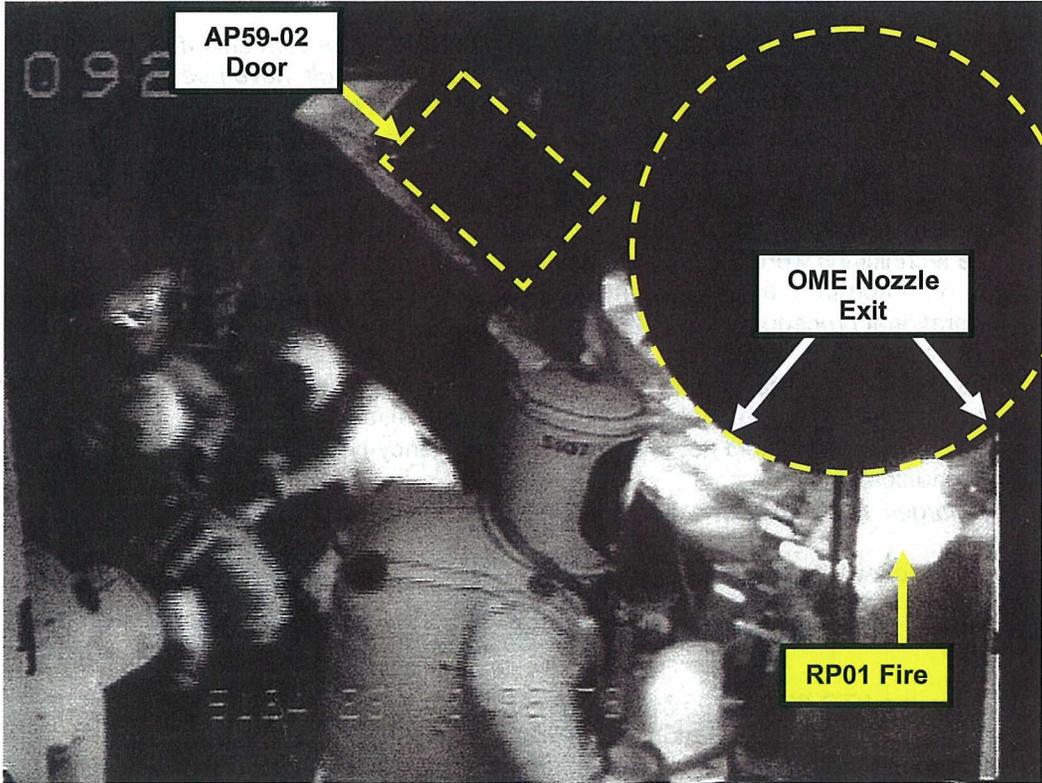
Figure 34: Still Photograph from Video of RP01 Fire

The technicians managed to put the fire out with a parts rinse bucket nearby, which they had to refill several times with water in the safety shower. Apparently, there was not a charged water line in the vicinity. Once the fire had been reduced in size from a large flame to a small flame at the open end of the dynatube, a technician cupped the end of the dynatube with his SCAPE suit glove and placed the aspirator in the flame, which immediately put out the fire.

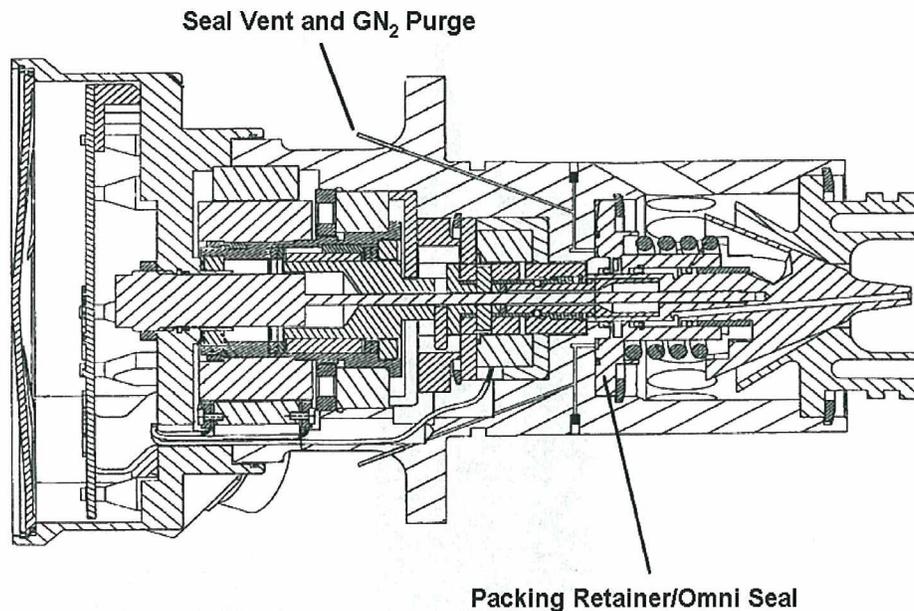
Figure 39: Titan IV A TVC FCV Cutaway View

The degradation of the omniseal resulted in liquid N_2O_4 flowing into the FCV's electronics compartment and out the purge port. There were no leaks found within the TVC propellant tank or the associated system plumbing.

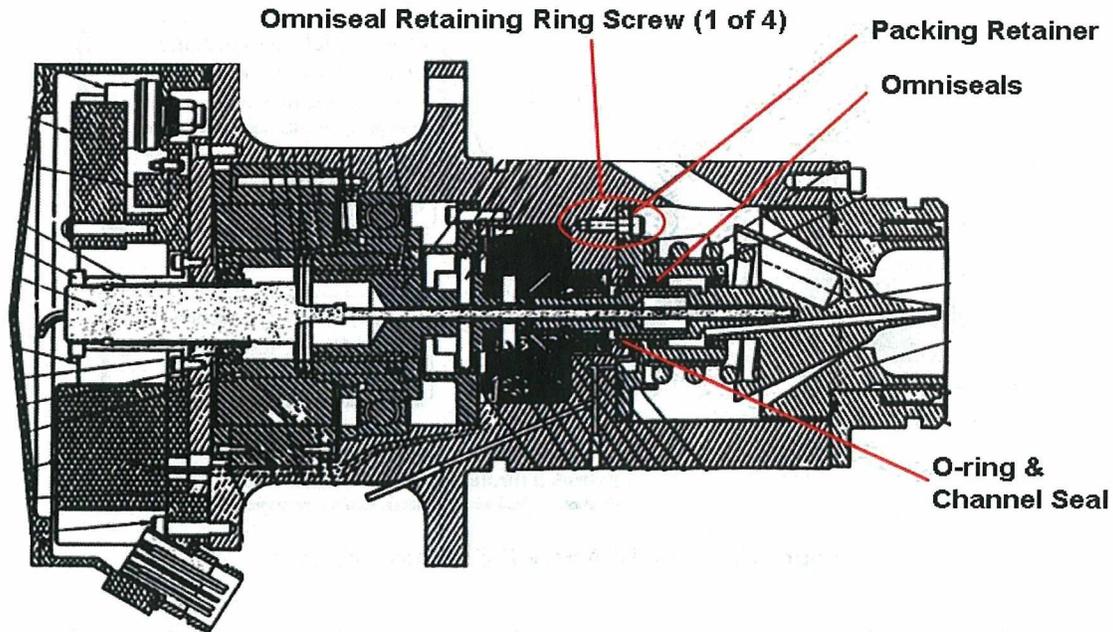
Figure 40: Titan IV A TVC EMV Cutaway View

enough gap between the component surfaces that the liquid Bio T-200A cleaning solvent was able to accumulate on the omniseal spring.

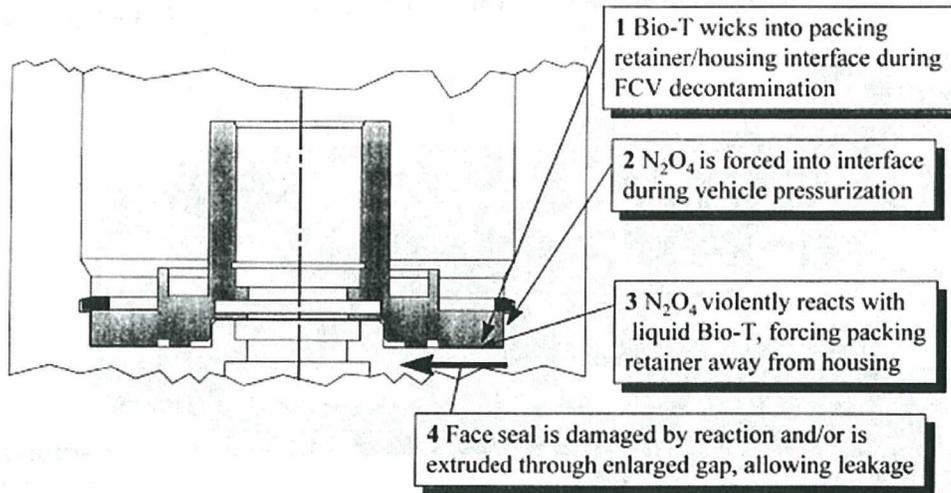
Figure 41: Titan IV A FCV Failure Description

- The force of the increased system pressure overcame the remaining, compromised integrity of the seal components and thus flowed past the seals to atmosphere.

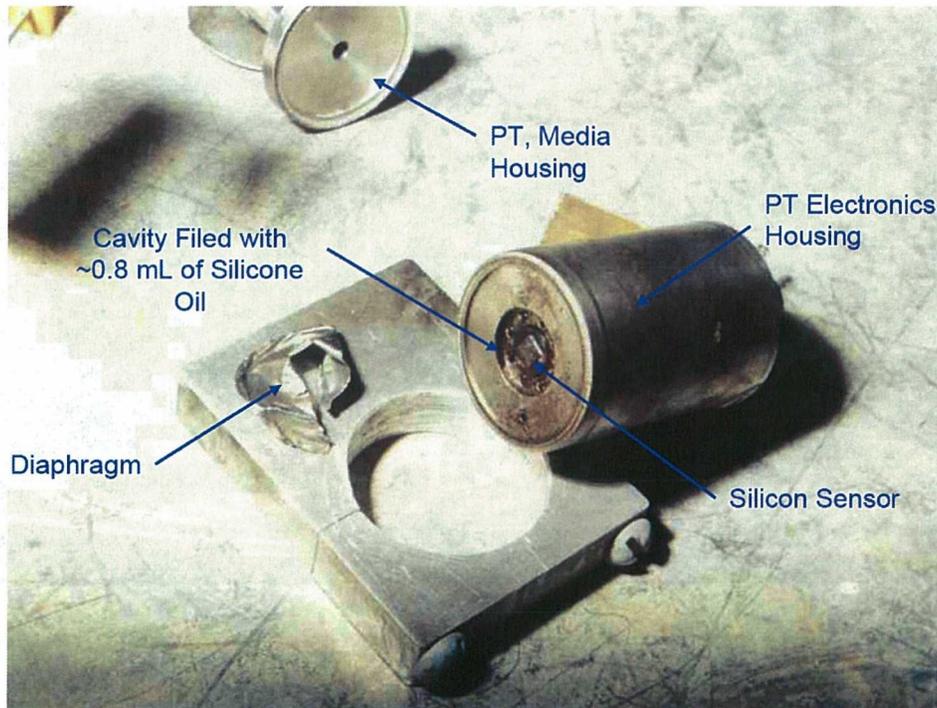
Figure 46: Failed Pressure Transducer

Initial inspections of the pressure transducer indicated that the transducer failed as a result of one of the following: over-pressurization, inadequate design, or cyclic fatigue at a highly stressed location. Since the pressure transducer failed, data from it at around the time of the failure may be suspect; therefore, the investigation included a detailed inspection of the nearby system tubing to determine if there was an over-pressurization event. Close inspection of the pressure transducer itself would indicate if the transducer failed from cyclic fatigue or was subject to a ductile failure from a single overload event.

The presence of the silicone oil was not mentioned in the pressure transducer specification from the manufacturer. This is the case for many pressure transducers of this specific design. Close scrutiny of specifications during hypergol component procurement is extremely important. This incident was difficult to prevent since the WSTF personnel did not know that there was silicone oil in the pressure transducer, but an improper GSE design (component procurement) is designated as the root cause. The wind corridor was also assessed and, as a result of this incident, it was altered to reduce the risk to the surrounding buildings from an oxidizer vapor release.

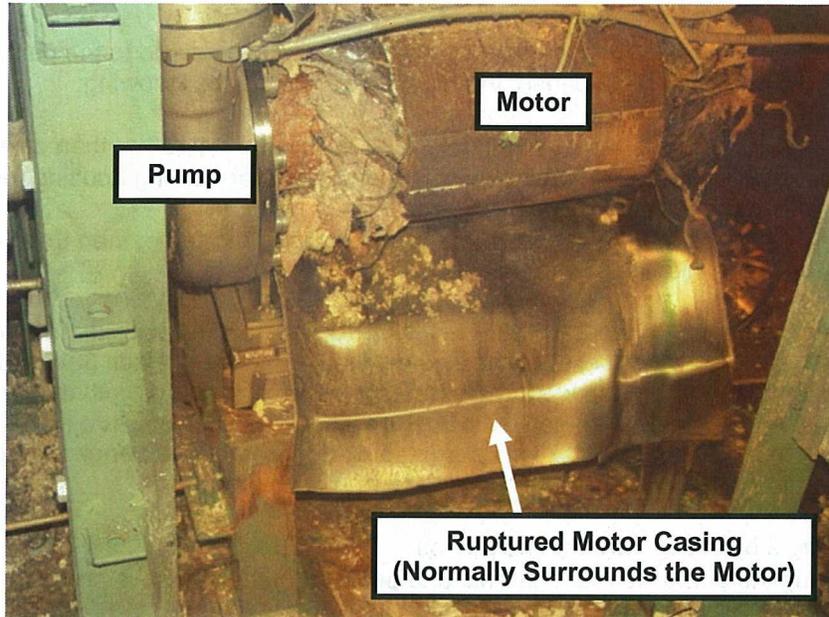
Figure 48: Pump and Motor After Explosion

The incident failure analysis concluded, according to Crass, that there was a “cooling anomaly at the [carbon graphite journal] bearings...leading to [an explosion] in the stator can winding area.” It was found that the most likely contributor to this was a clogged filter in the pump recirculation loop that circulates liquid through the rotor cavity to cool the front and rear bearings as illustrated in Figure 49. Data analysis showed that the upstream and downstream temperature transducers indicated an increase in temperature of 8 °F across the pump. The low flow rate of 40 gpm and high ambient temperatures (high of 86 °F for 8/12/2003) accelerated the failure of the pump. At these flow conditions, the pump was not able to be properly lubricated as a result of the high vapor pressure of liquid N_2O_4 (these particular pumps are designed to be lubricated with the liquid that they are pumping). The excessive bearing wear led to damage to the stator liner can, allowing oxidizer to leak onto the hot copper windings. The N_2O_4 reacted with the copper winding insulation and caused the coil wire to short, which was the proximate cause of the explosion.

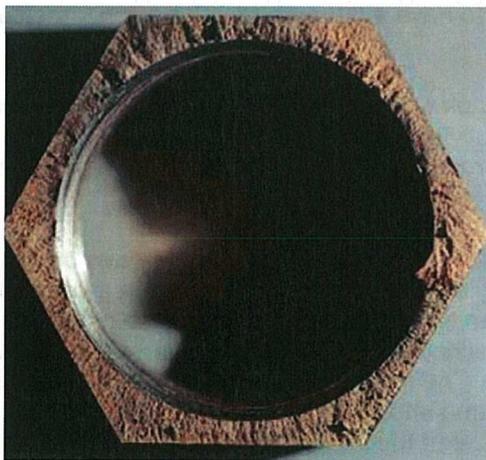
Figure 50: Lower Bonnet Fragment

On September 30, 2005, at WSTF TC 844B during a low pressure test, a ½-inch manual valve bonnet (handle) failed catastrophically. The failure caused the valve bonnet and stem to be ejected from the assembly, thus spilling approximately 74 gallons of liquid N_2H_4 into the test cell (proximate cause of the N_2H_4 spill). Most of the liquid N_2H_4 was captured in the floor drains which were connected to a 1,500 gallon secondary containment tank; however, some was lost as vapors into the air. There were no reported injuries. Figure 50 is a photograph of the lower bonnet fracture surface.
