Failure Analysis of Space Shuttle Orbiter Valve Poppet

Materials Science and Technology 2010
October 20, 2010
Houston, Texas

Rick Russell
Materials and Processes Engineer
Materials Science Division, NE-L4
Kennedy Space Center, Florida

Failure of Space Shuttle Orbiter Flow Control Valve (FCV) Poppet

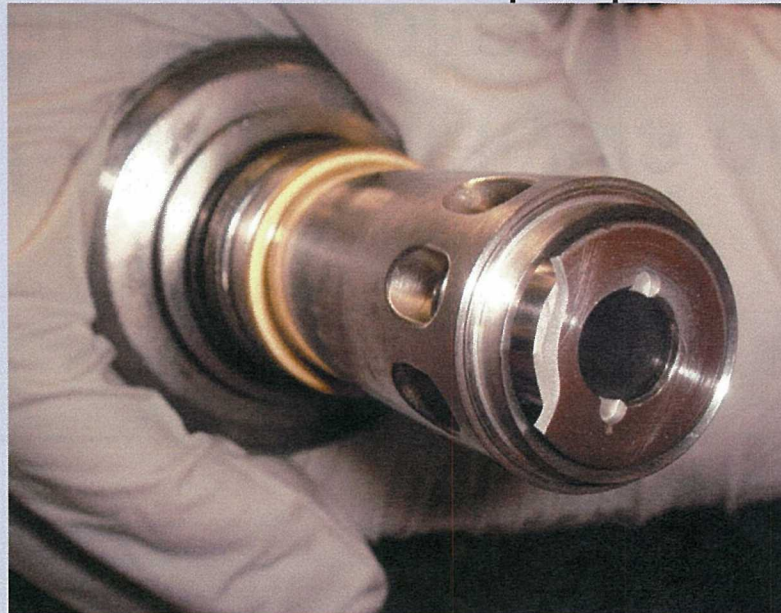
- During the ascent of *Endeavour* (OV-105) on Space Shuttle mission STS-126, the main propulsion system (MPS) engine #2 GH_2 flow control valve (FCV) appeared to make an un-commanded transition from the low-flow to high-flow position
 - This anomaly did not impact mission success
 - Post-mission disassembly of the FCV revealed that the poppet was fractured and a crescent-shaped piece was missing

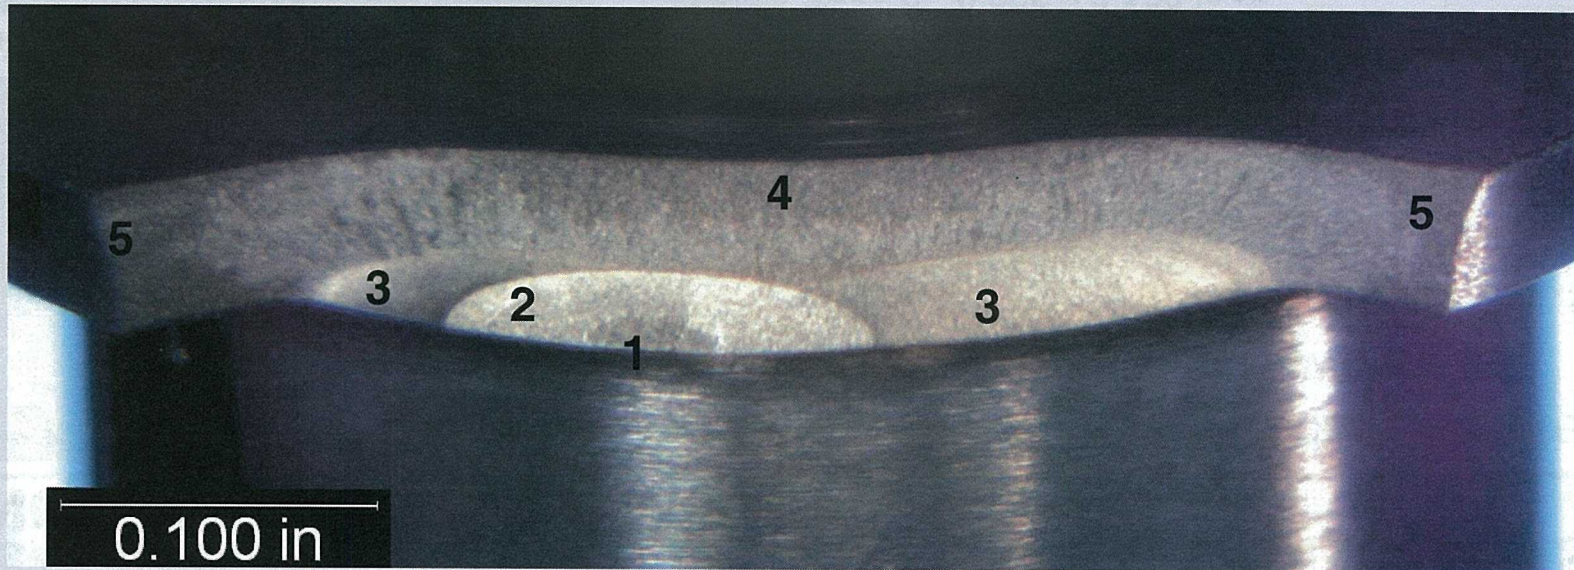
- Poppet fracture surface exhibited five (5) distinct zones:
 - Zones 1 & 2: Initial “thumbnails”
 - Zone 3’s (2): Circumferential propagation
 - Zone 4 & 5: Propagation through the flange and final fracture
- Fracture initiation occurred at middle of the body-to-flange radius and primarily propagated circumferentially along the radius, then through the flange thickness
 - The general plane of the fracture was $\sim 45^\circ$ from the flange face

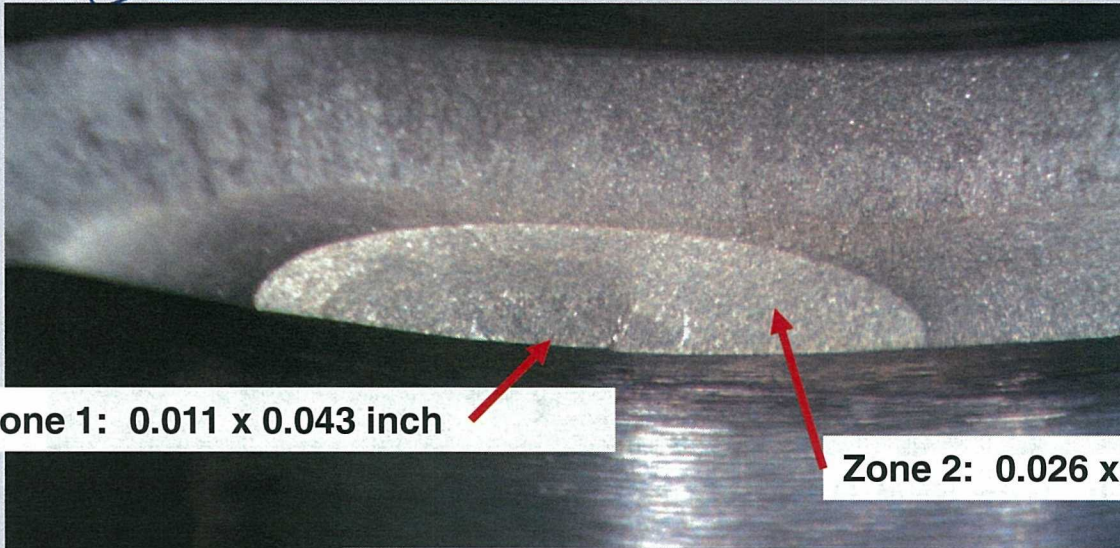
Zones 1 & 2: Initial thumbnails

Zone 1: 0.011 x 0.043 inch

Zone 2: 0.026 x 0.133 inch

- Fracture initiated on two planes along the radius surface, then merged together into one plane

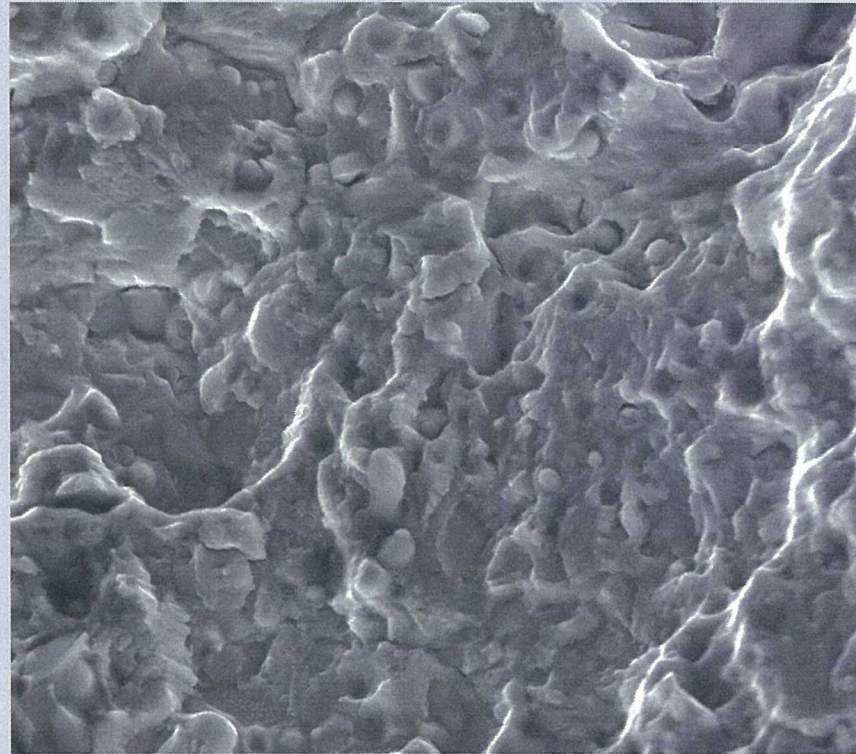
- Scanning electron fractography revealed:
- small, semi-planar areas
- rounded ridges
- exposed carbide particles,
- “divots”, which presumably resulted from spherical carbides being pulled out (i.e., carbide decohesion).
- No substantial secondary or intergranular cracking
- No striations

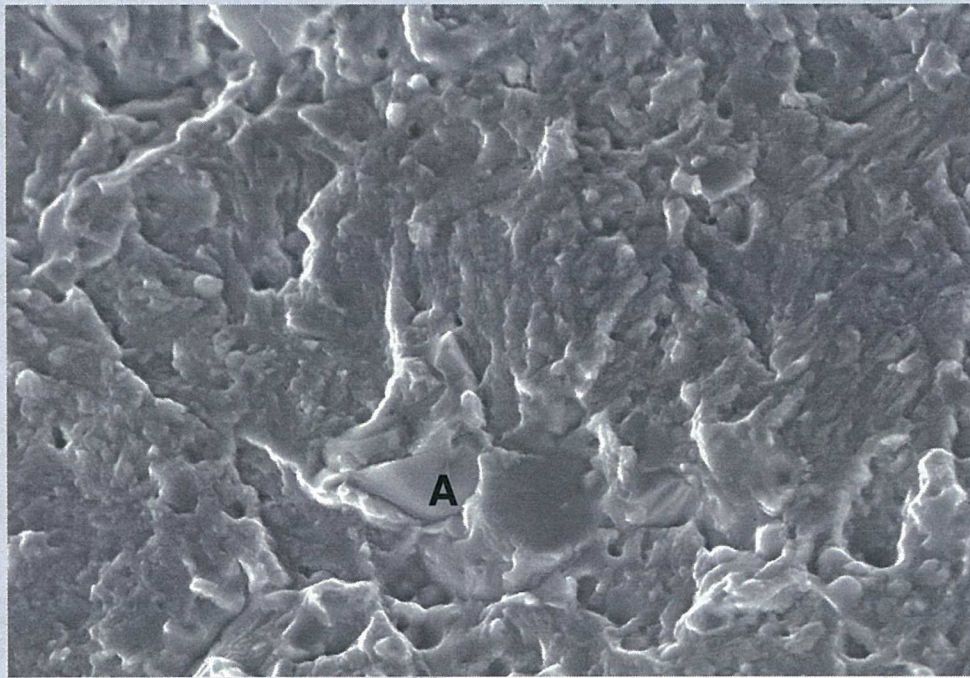
- In Zone 2, the fracture propagated on a less torturous path, exhibiting larger “semi-planar” regions, consisted with the smooth, shiny optical appearance. Otherwise, the features were fairly consistent with that of Zone 1.

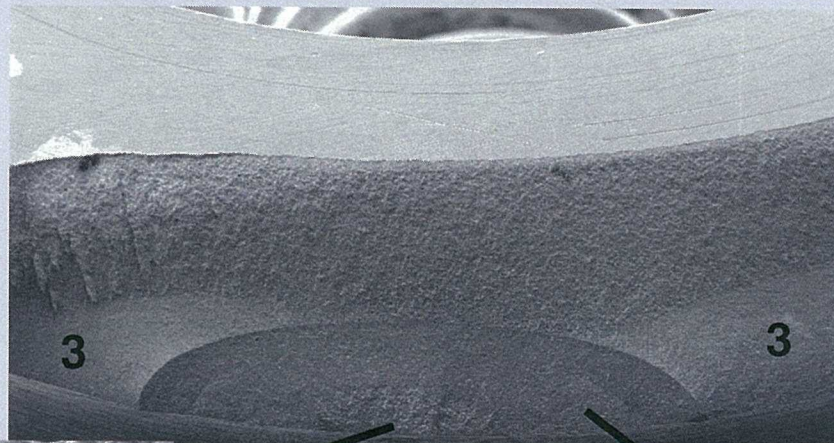
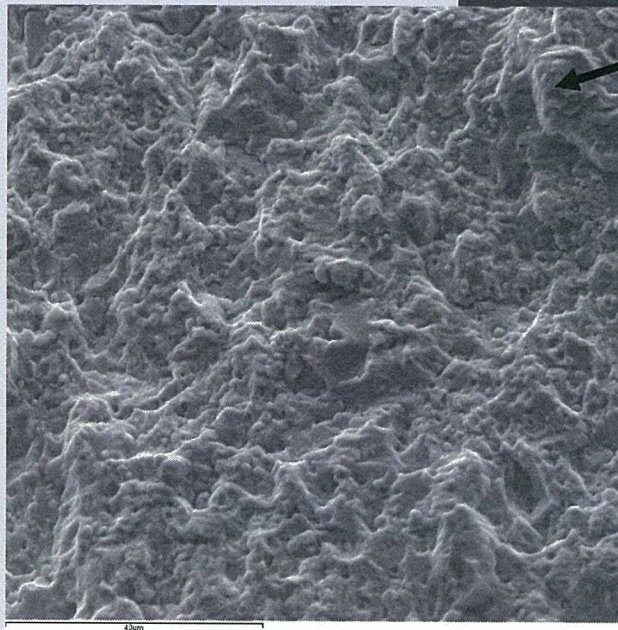
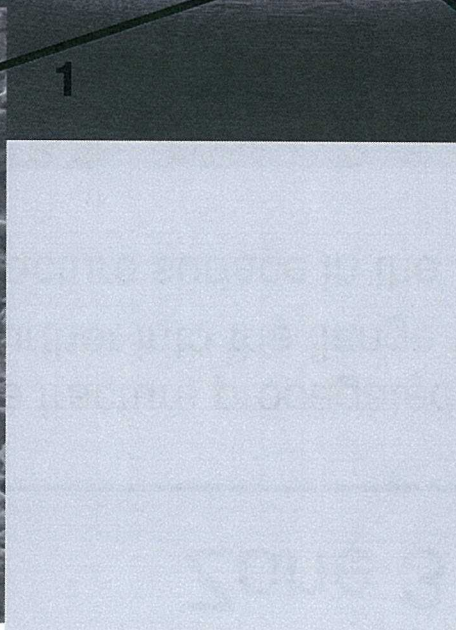
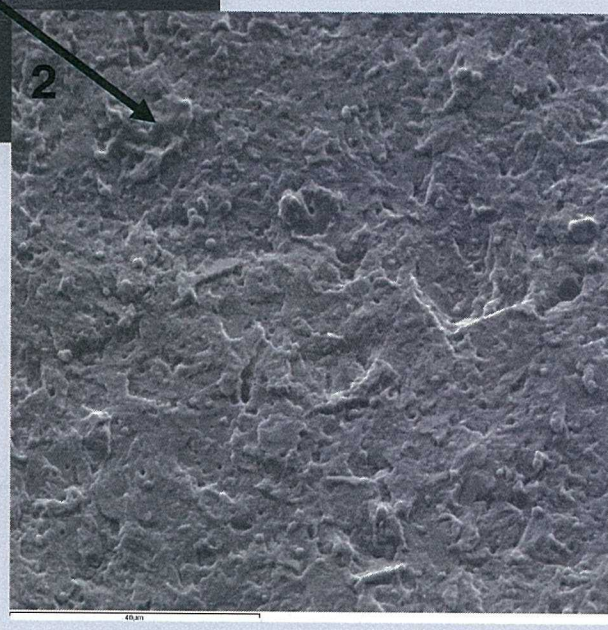
Zones 1 & 2

**A. Large
blocky carbide
typical of
CRES 440**

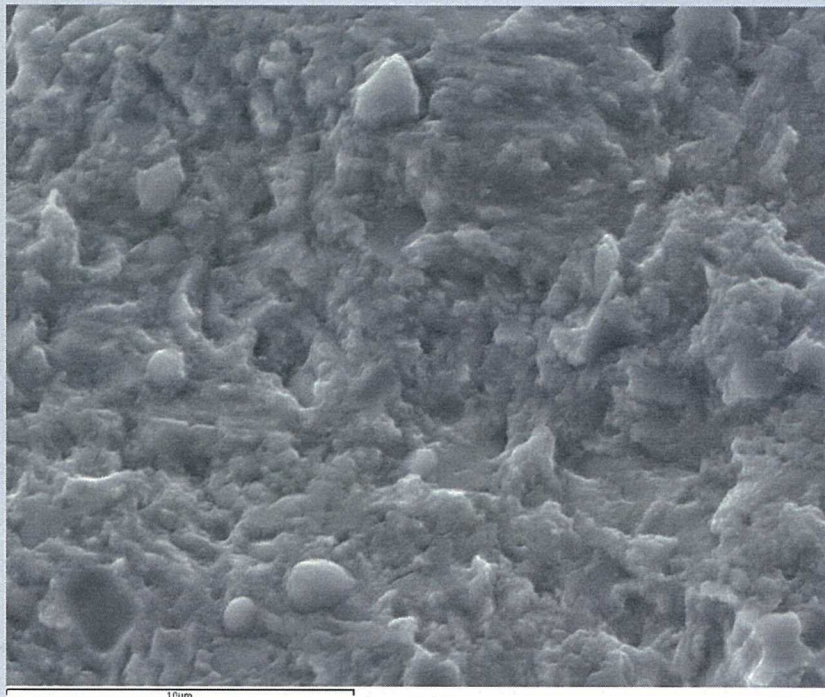
- From the thumbnails, the fracture propagated circumferentially along the radius, not penetrating further into the flange thickness
- The topography of the fracture surface in the Zone 3 wings was similar to that of Zone 1

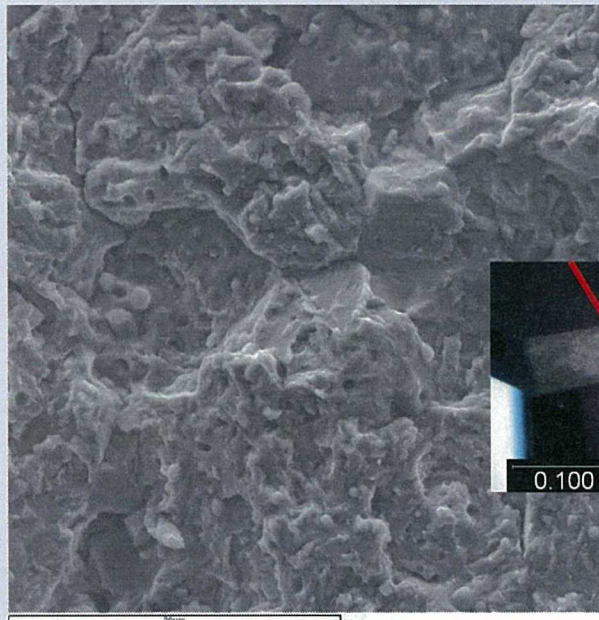
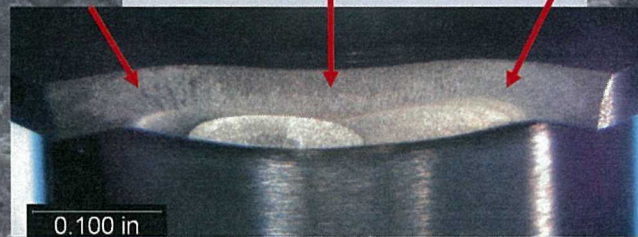
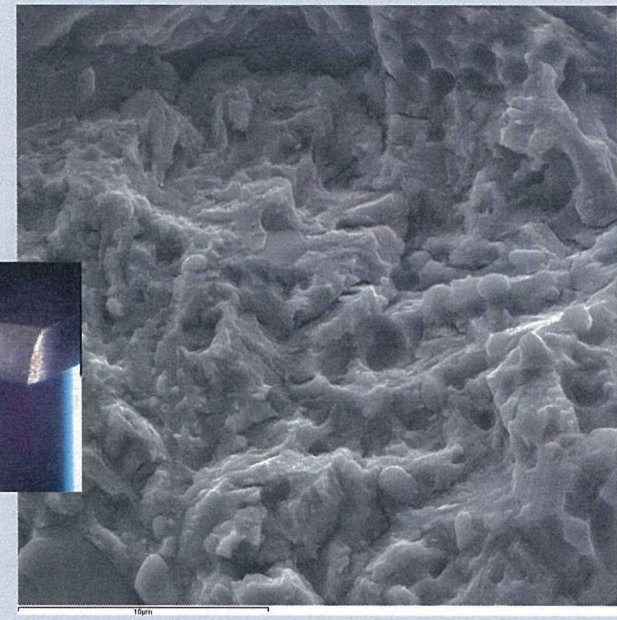
Zone 4: Propagation through the flange

- The fracture surface increased in general roughness in Zone 4
 - Exhibited some secondary cracking
 - Sharper, more angular features
- Fracture toughness testing of 440A at NASA-MSFC in a 3400 psig GH_2 environment clearly demonstrated that the features of Zone 4 were consistent with a sustained load cracking mechanism

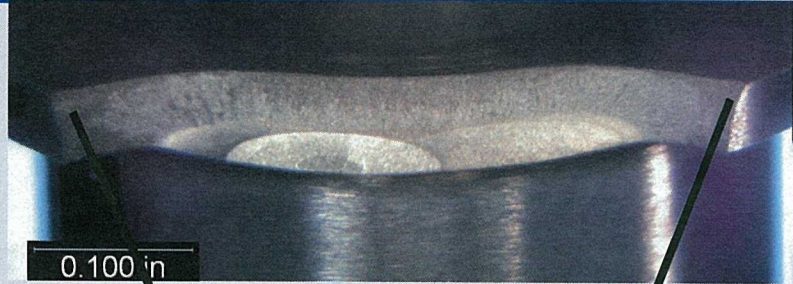
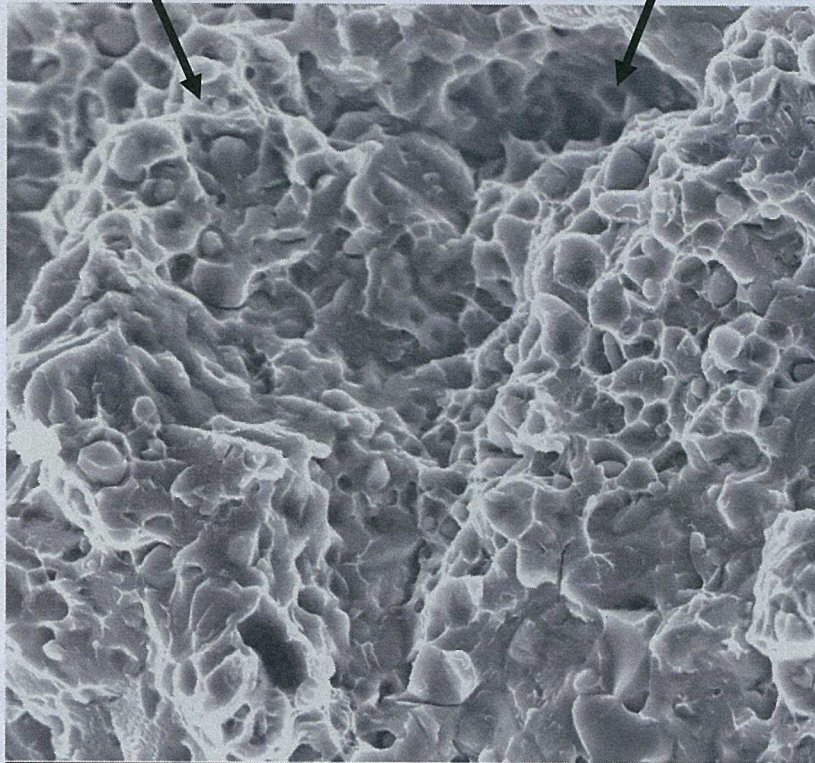
Zone 5: Final fracture

- The Zone 5 “corners” exhibited a fracture surface typical of final, rapid overload
 - Primarily dimpled rupture

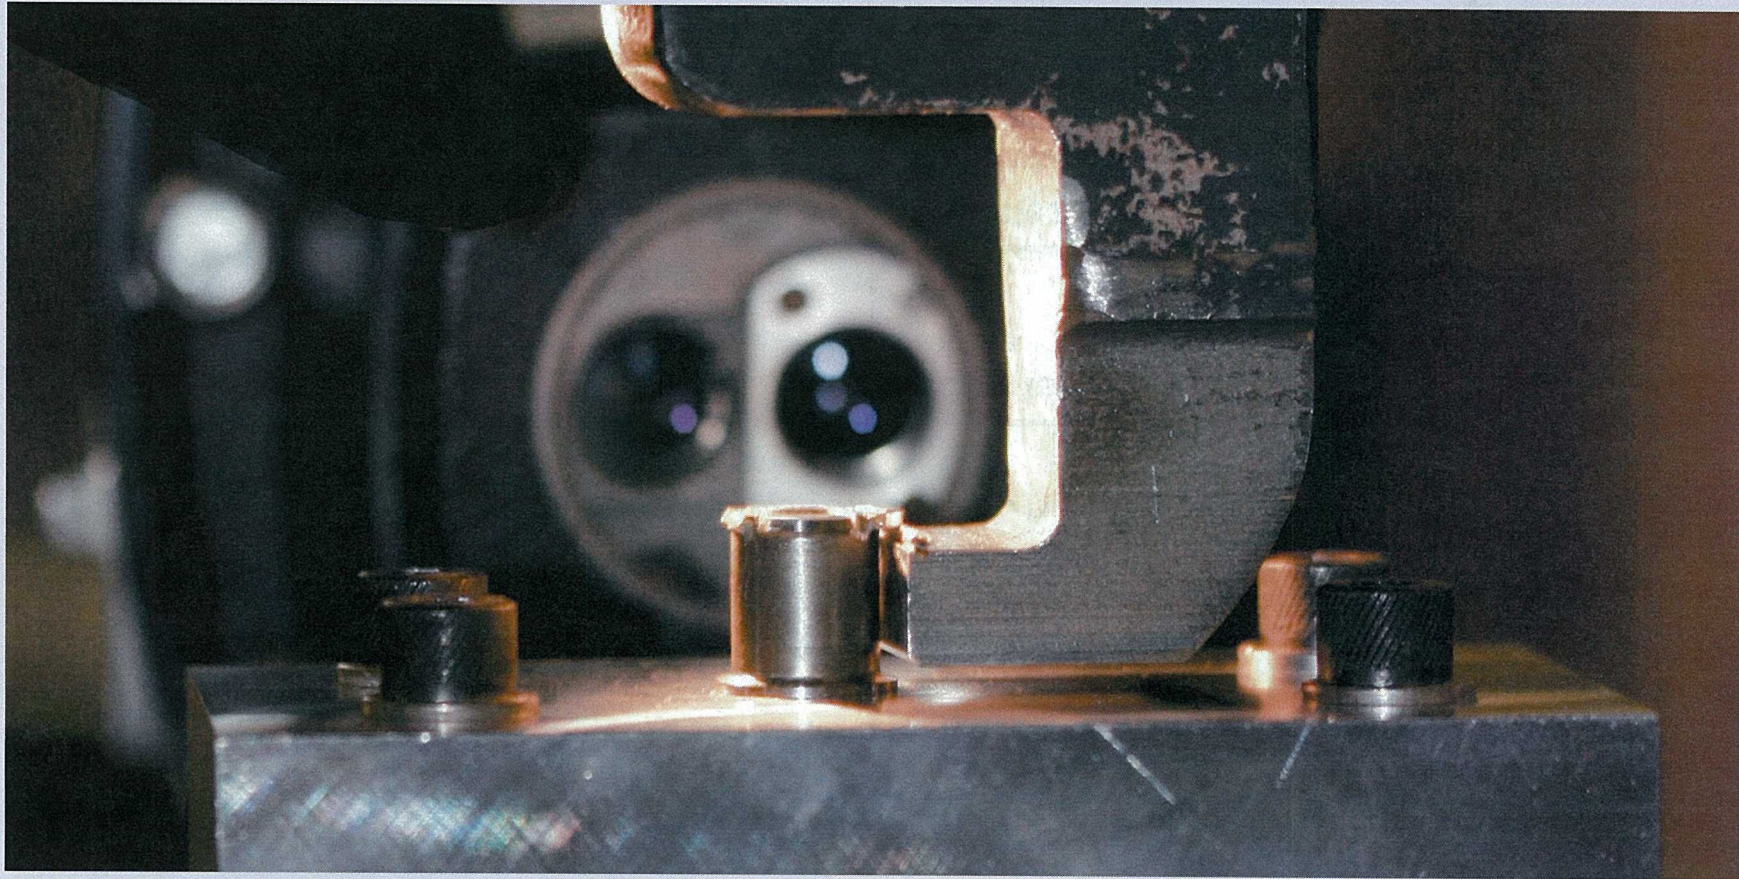
- At the time the failure occurred, there was no known cyclic loading of the poppet to explain the fatigue failure
 - Also unknown was whether the fracture surfaces indicated a high cycle fatigue mechanism consistent with flow-induced vibration or a low cycle mechanism consistent with poppet actuation (translation from low to high flow)
- A test program was conducted using obsolete poppets that were no longer in service
 - To acquire results quickly, the testing was performed with mechanical loading of the flange, as opposed to performing a series of flow tests
 - A hook mechanism was used to pull on the poppet flange, loading the radius in tension

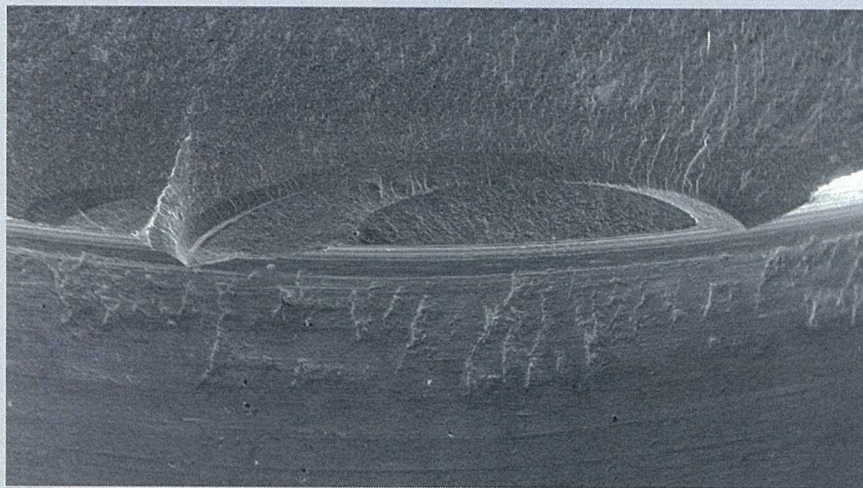
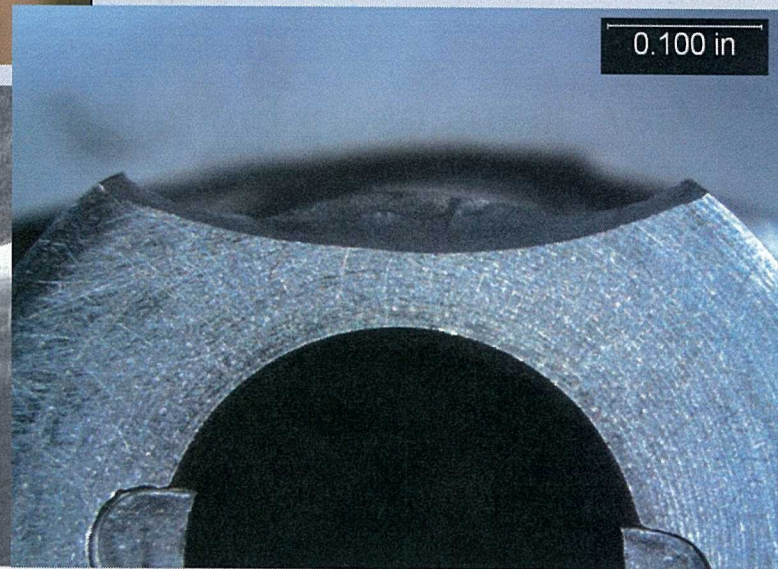
The thumbnail zones of the test articles exhibited fracture features that were very similar to that of the original failure
