# The Reconstruction and Failure Analysis of The Space Shuttle Columbia

Aircraft Airworthiness and Sustainment Conference – Australia

August 20, 2010

NASA Materials Science Division

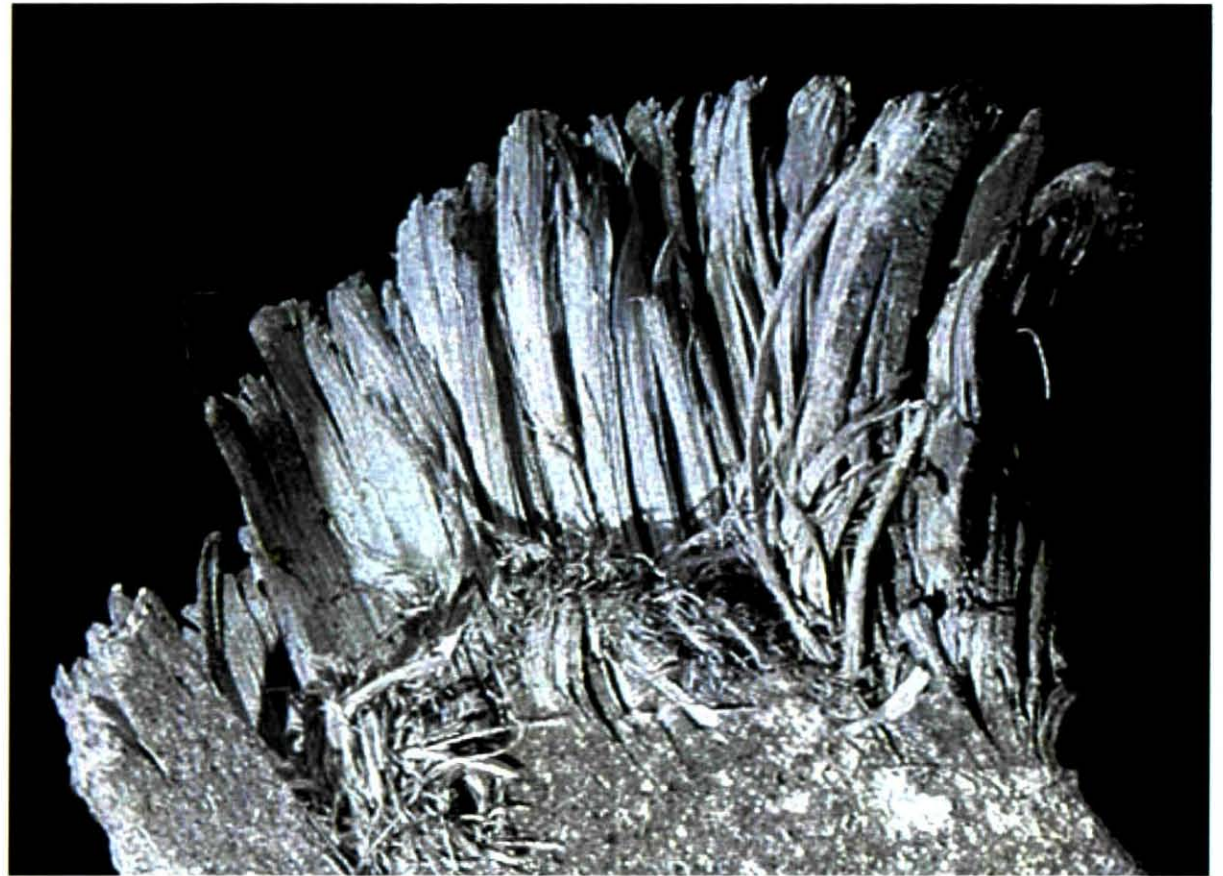
# Aluminum Pathfinder

- Intergranular fracture primary failure mode

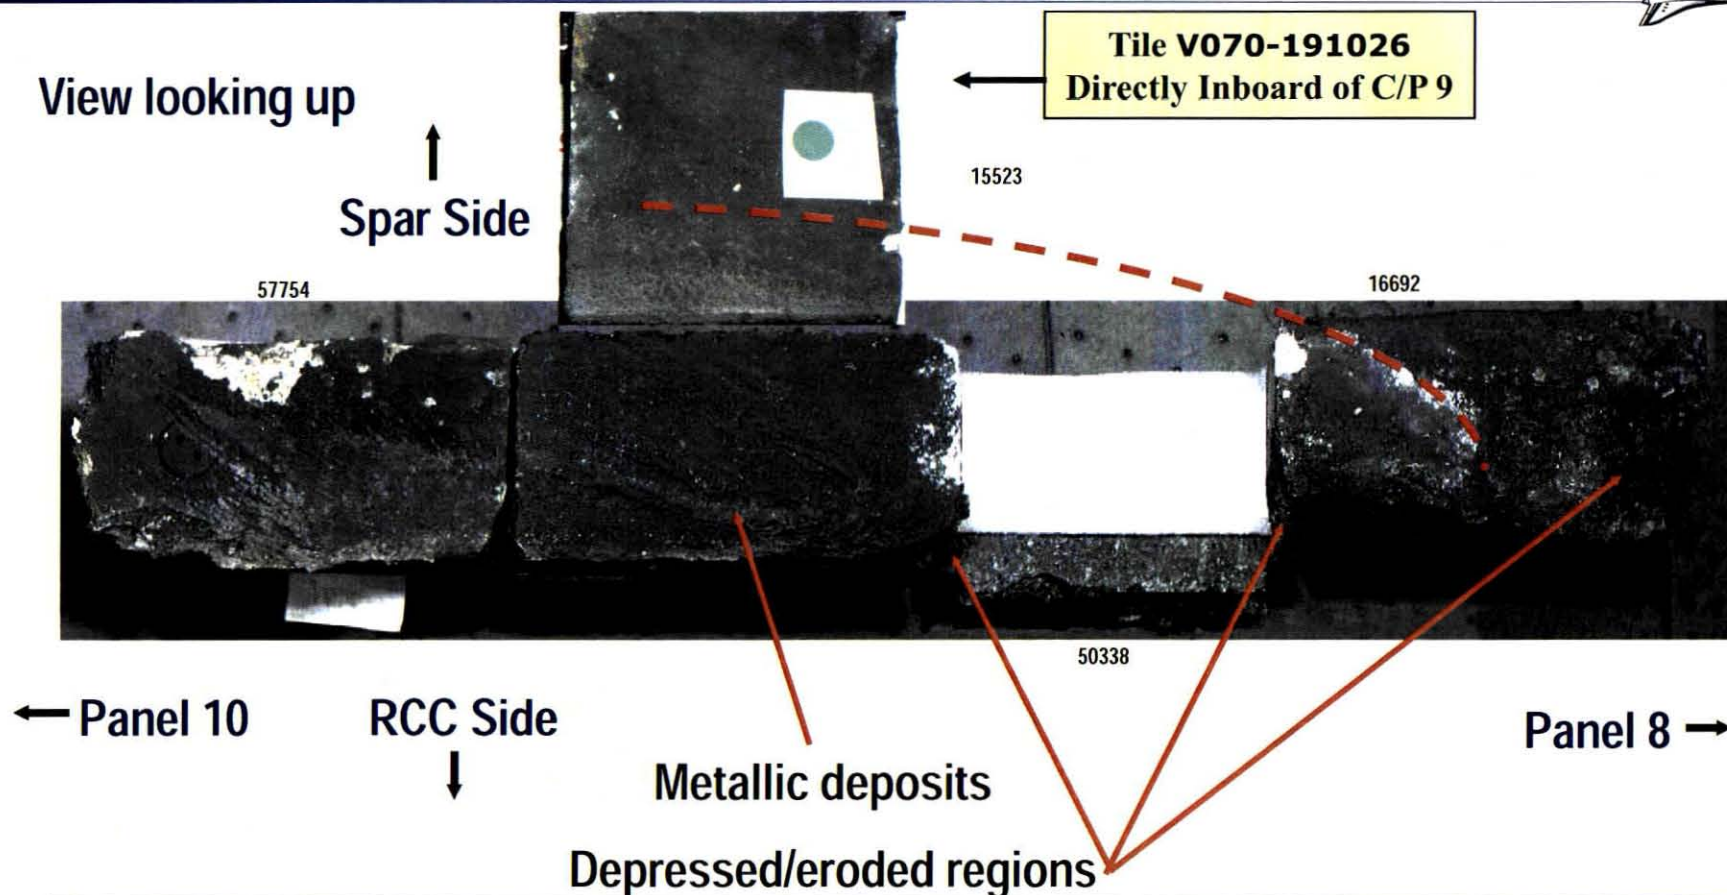
# Reconstructed View of LC/P 9 Tile with I/B Tile

**Flow Patterns Indicates C/P 9 Was Not Dropped Down Into Flow**  
**Open question: Location of Plasma Flow From Panel 8 to tiles on 9?**

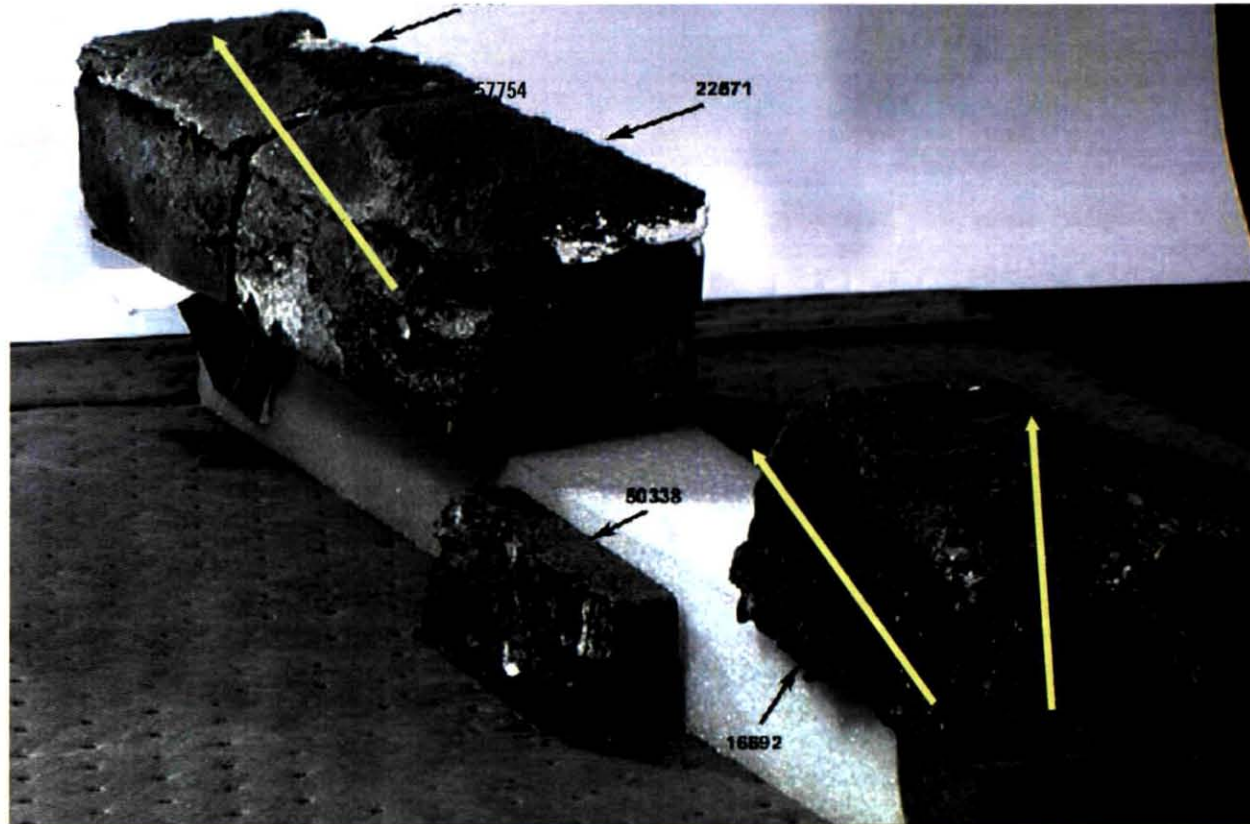
# Reconstructed View of Lower C/P 9 Tile

Slumping and erosion patterns suggest plasma flow across the carrier panel tile (from 8 toward 10)

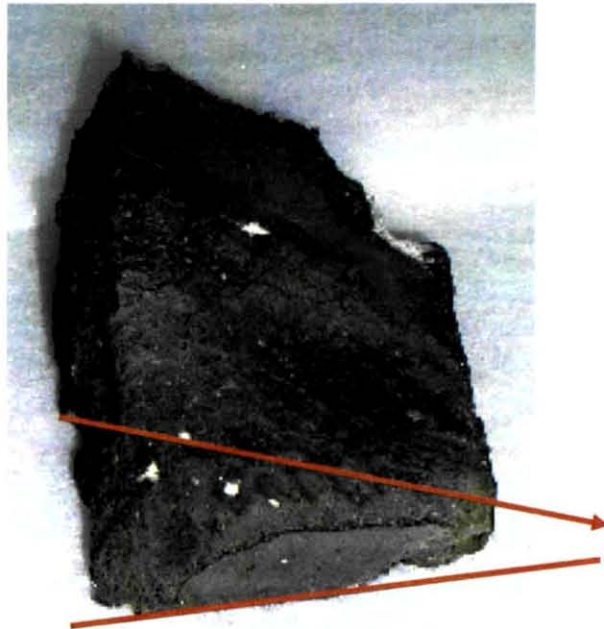
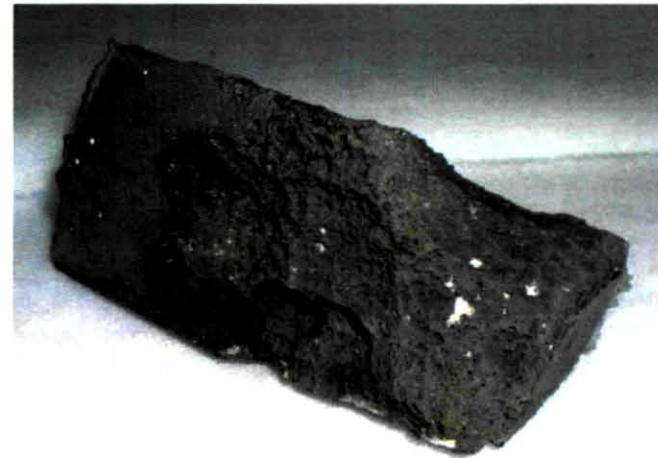
Item 50336 (V070-199715-074)

Slumping and erosion patterns suggest plasma flow out of leading edge cavity (consistent with vent)

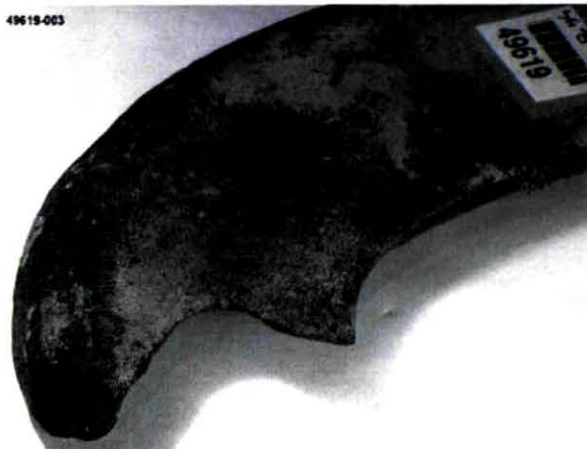
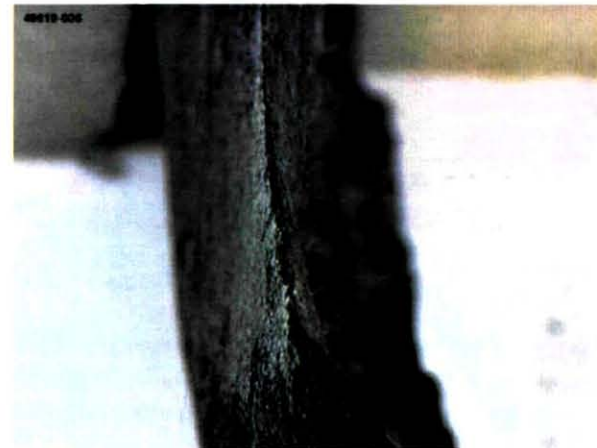
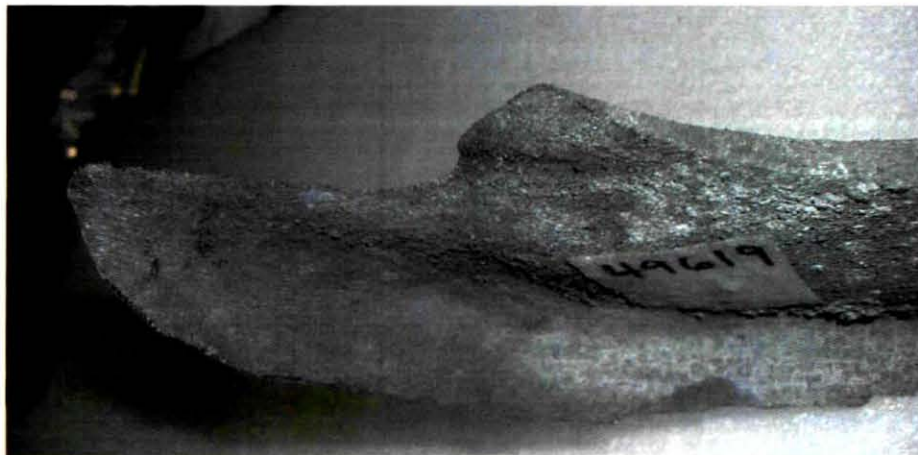
Item 49619

Close-ups of knife edge,  
note fibers not visible on  
internal surface of panel  
due to deposits.

Rib tapers from design  
thickness of .365" to .05".

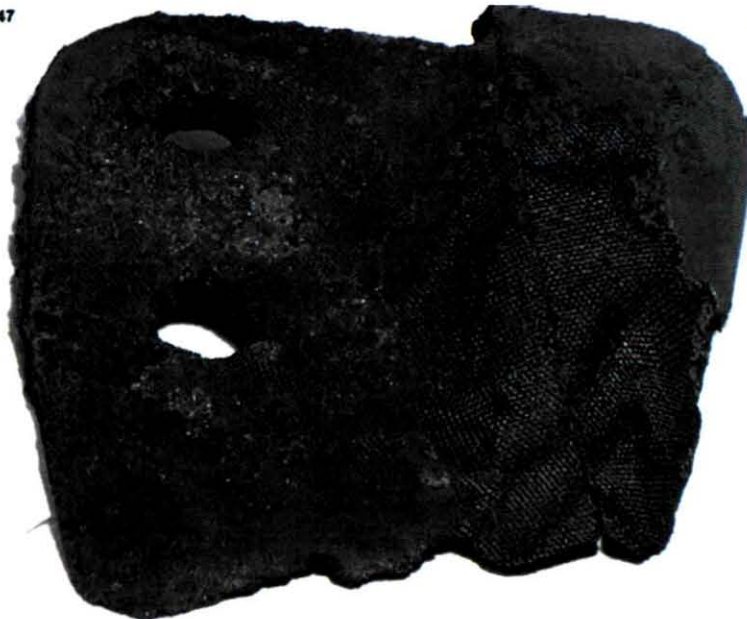
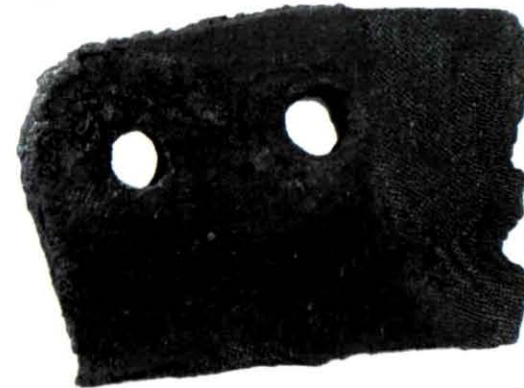
24724-047

Lug fragment tapers from design thickness of .499", to a Knife Edge with a minimum thickness of 0.063"

- Matching eroded plies between items 24724 and 58291, shows heat flow external to the panel while panel heel and lug were attached
- Metallic deposits at lug attach points - evidence that metallic deposited after lug no longer attached to fitting
- Inconel bushings missing at holes

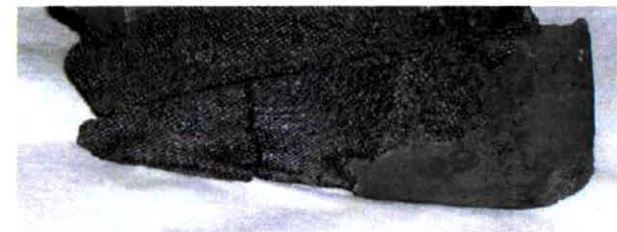
Heel fragment tapers from design thickness of .233", to a Knife Edge with a minimum thickness of 0.052"

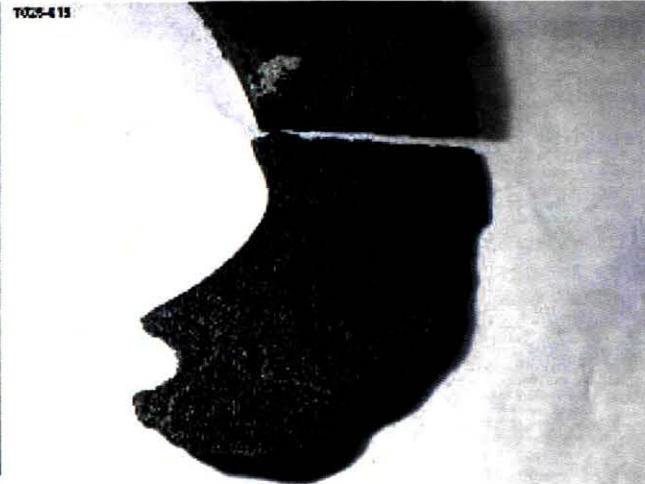
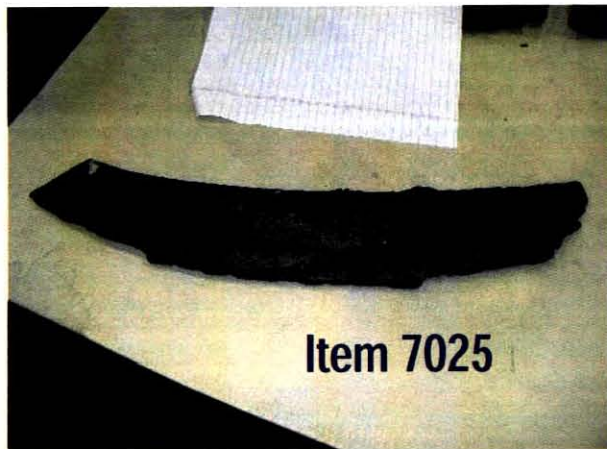
Item 52018

7025 to 52018 interface shows severe thermal erosion – thickness ranges from 0.270 to knife edge of 0.040

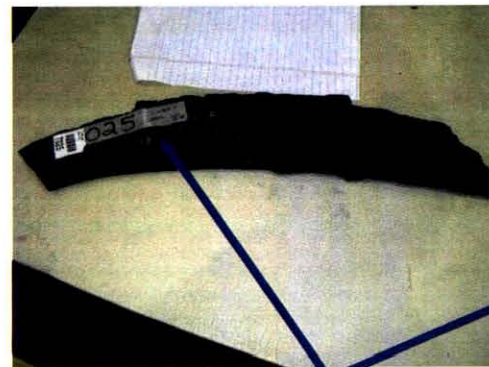
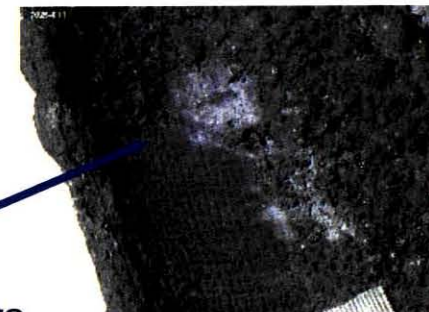
Item 7025

7025 internal side shows presence of metallic deposits

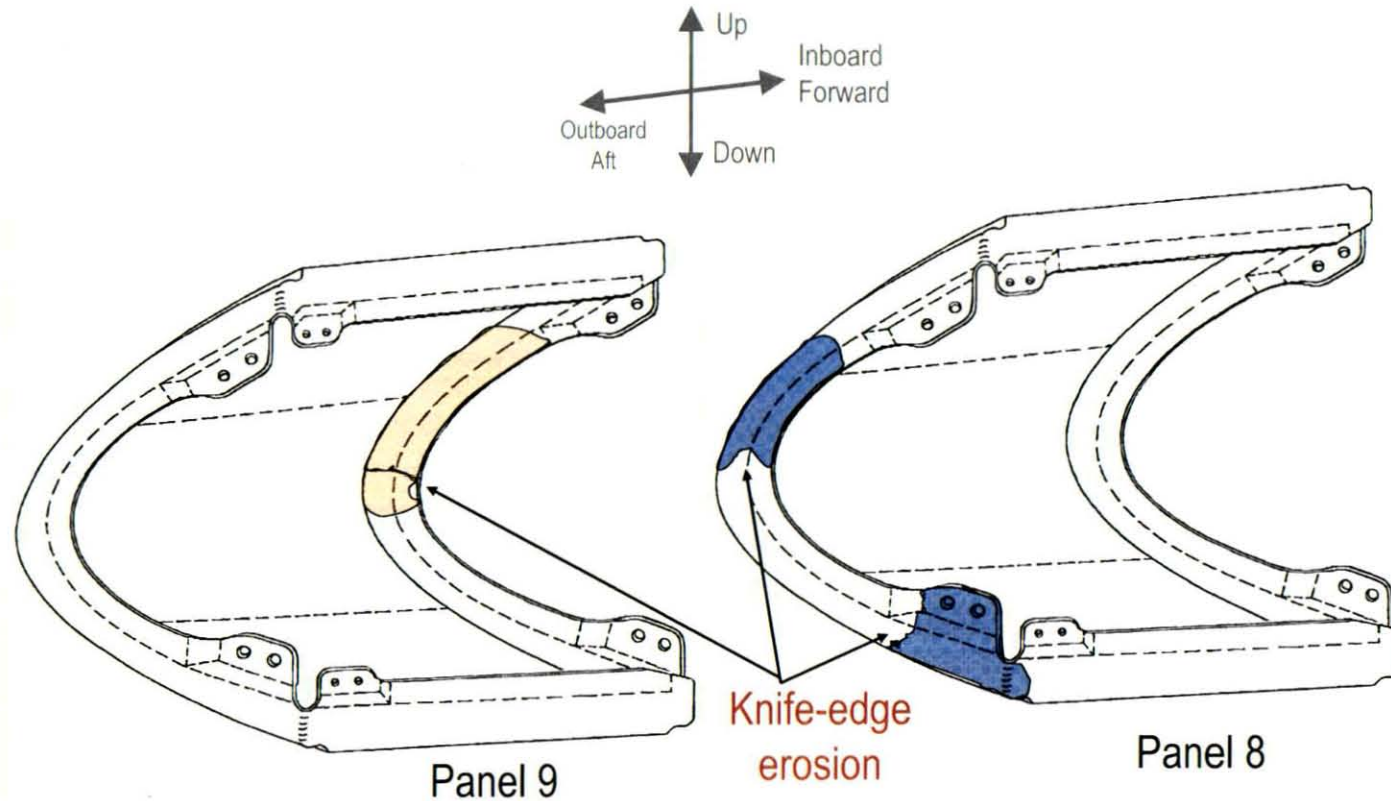
# RCC Panels 8 & 9 Erosion Features

Erosion indicates prolonged exposure in the panel 8-9 joint area.

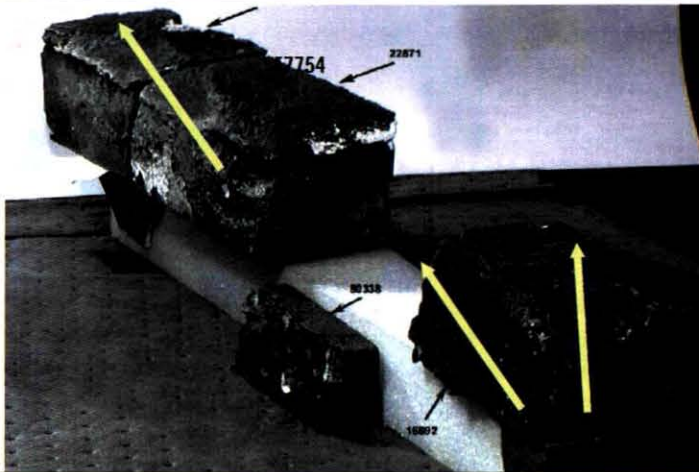
Slumping and erosion patterns suggest plasma flow across the carrier panel tile (from 8 toward 10)

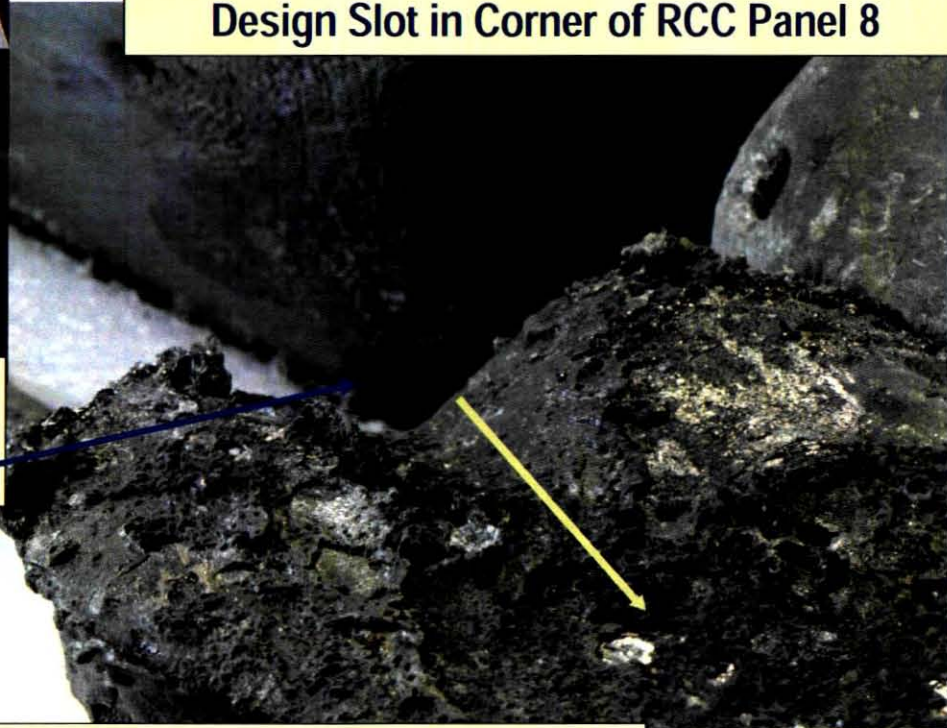
Slumping of C/P 9 Tile #1 Corresponds with Design Slot in Corner of RCC Panel 8

Evidence of Hot Gas Flow Exiting Design Slot Indicates Significant Breach Was Into Panel 8

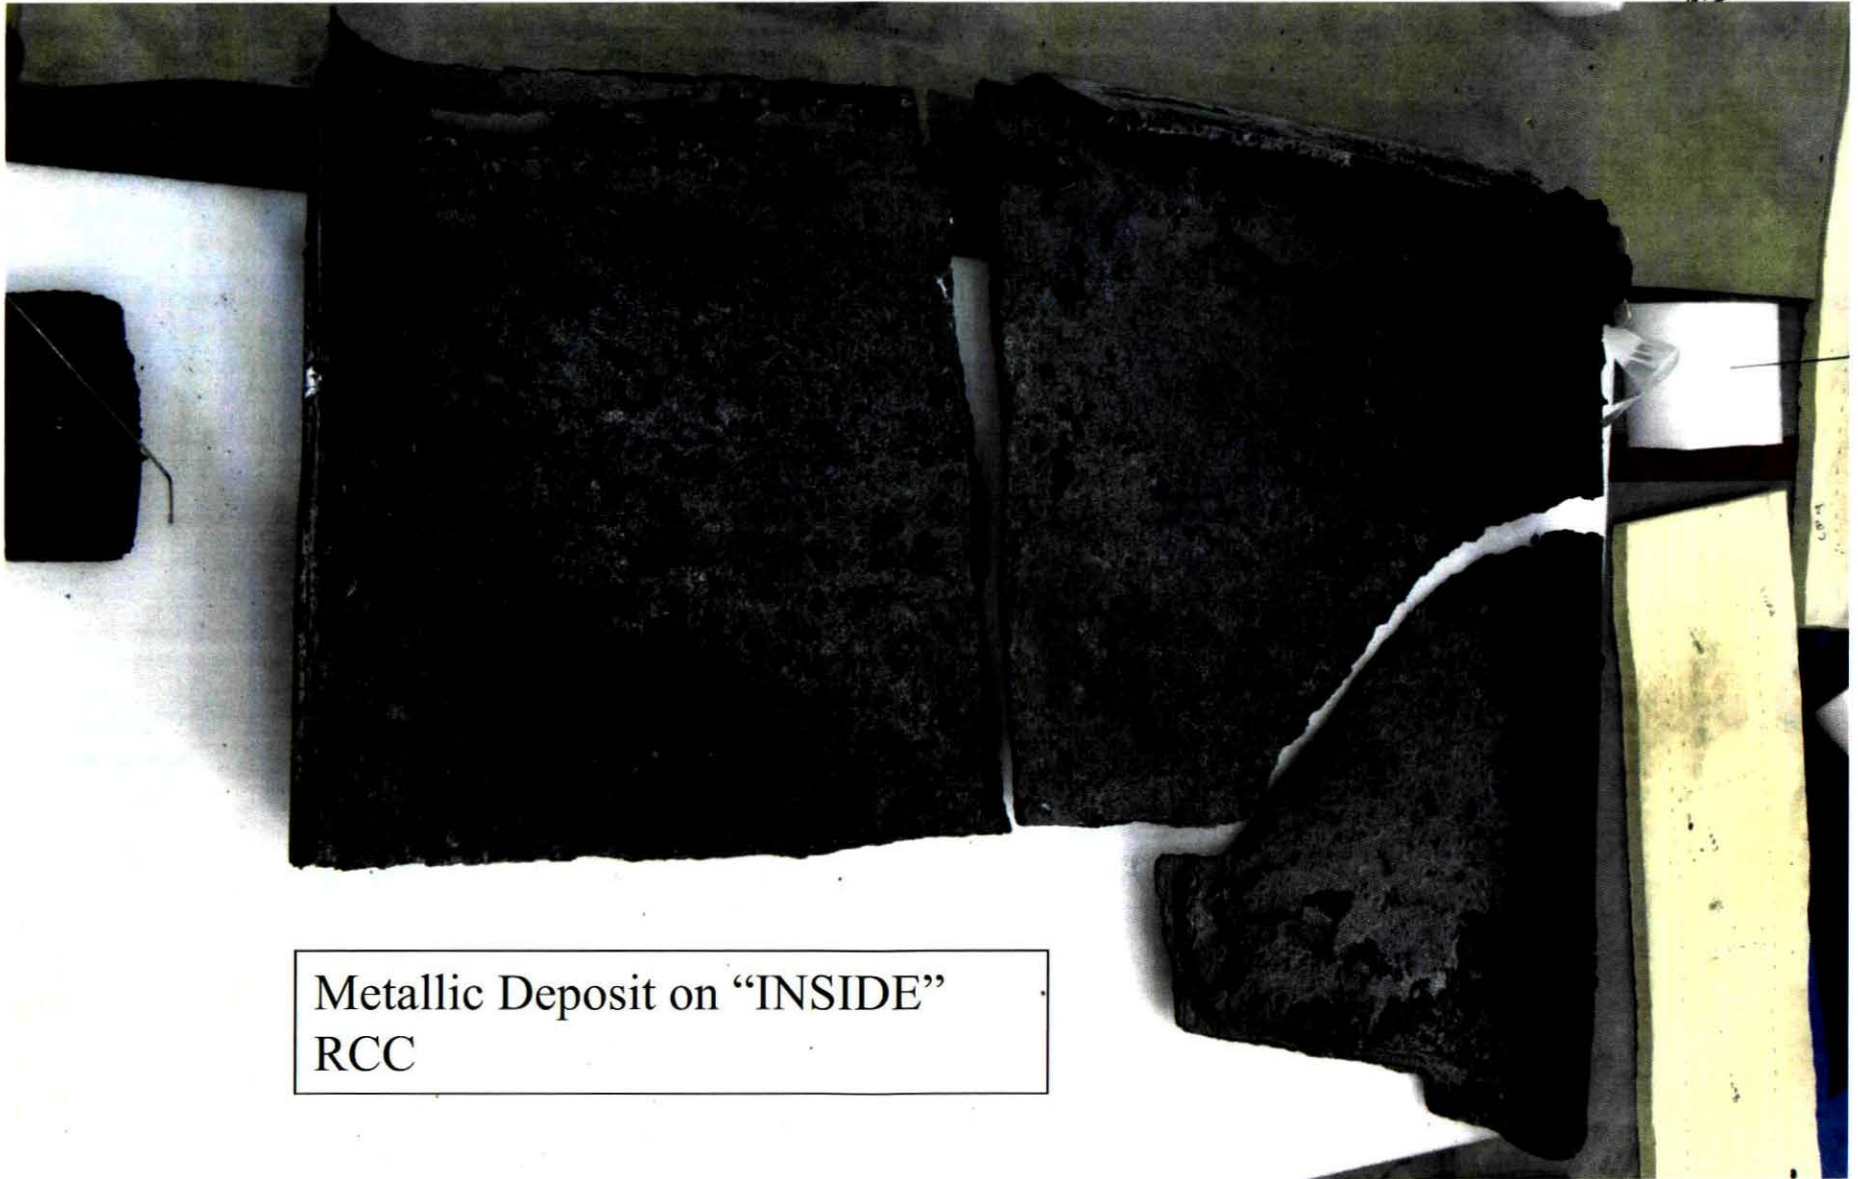
# Metallic Deposit Example, LH RCC 8

Metallic Deposit on "INSIDE"  
RCC

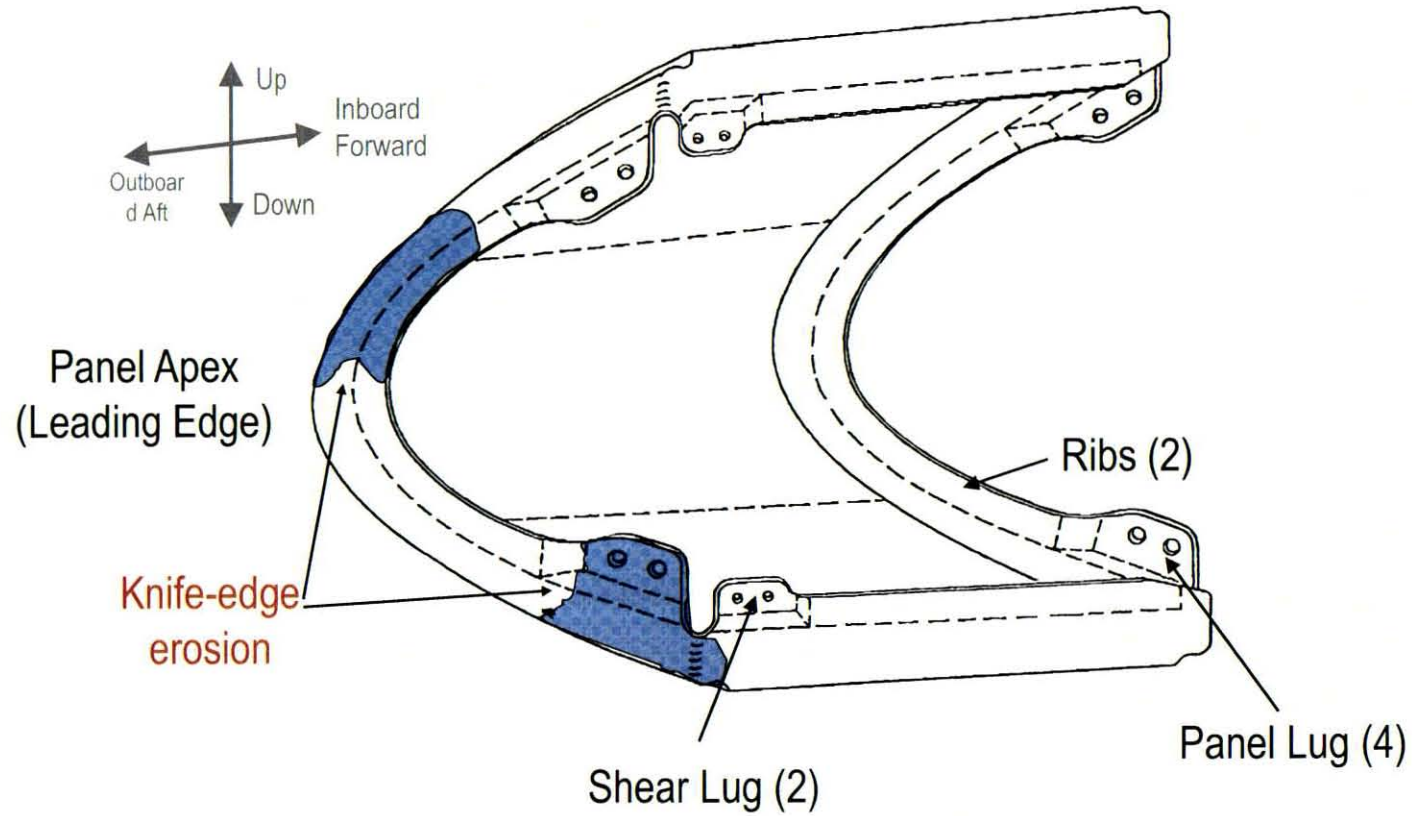
# RCC Panel 8 Erosion Features

Erosion indicates prolonged exposure to plasma heating

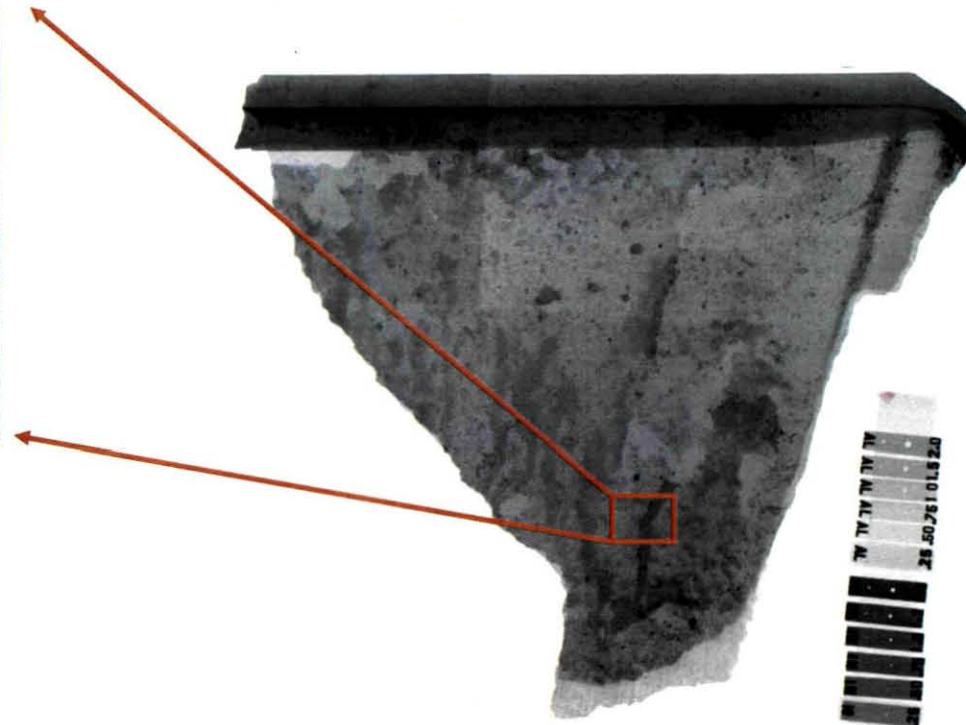
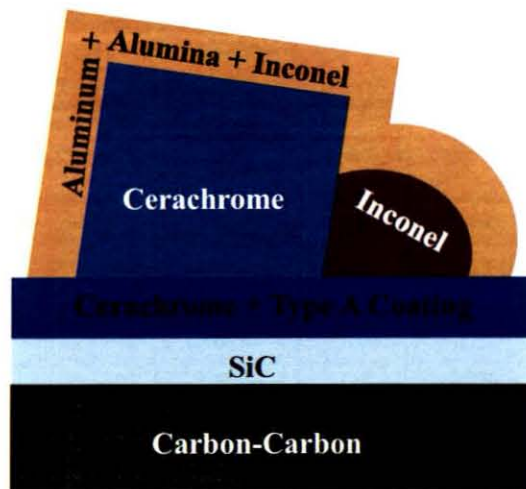
Item 43709, Sample 2A1

# LH RCC 8 – Deposit Feature: Thick Tear Shaped

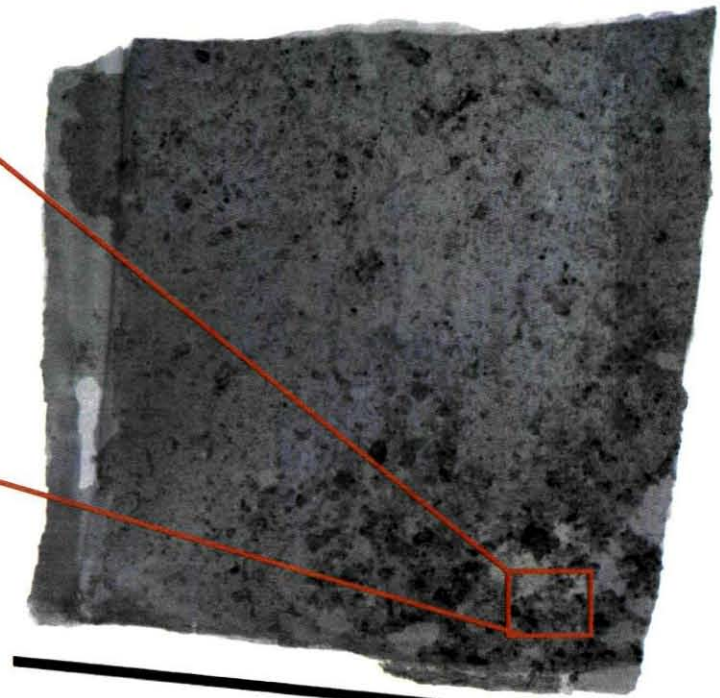
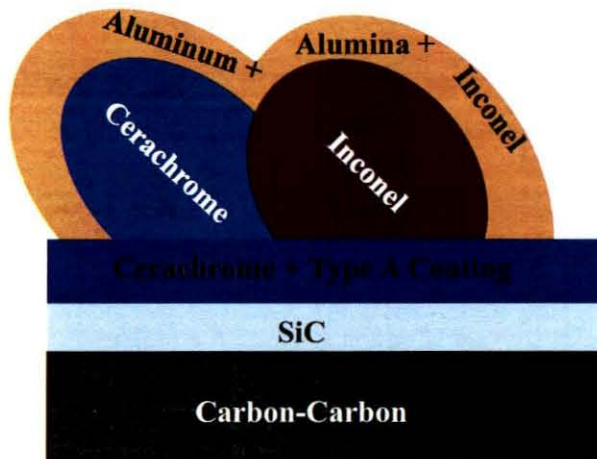
Item 2200, Sample 6A1

# LH RCC 8 – Deposit Feature: Thick Globules

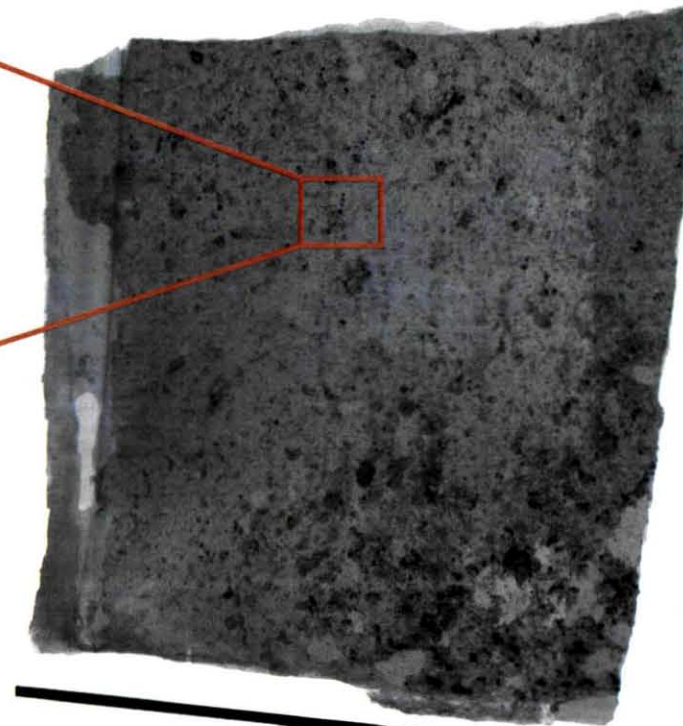
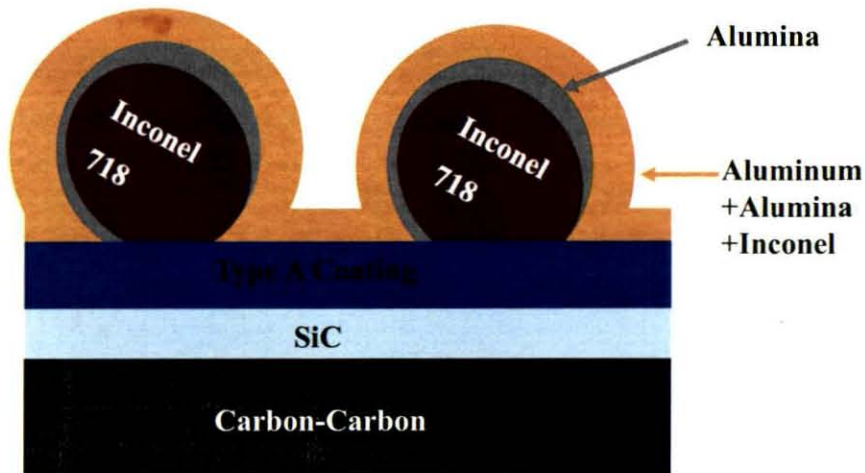
Item 2200, Sample 6C1

# LH RCC 8 – Deposit Feature: Spheroids

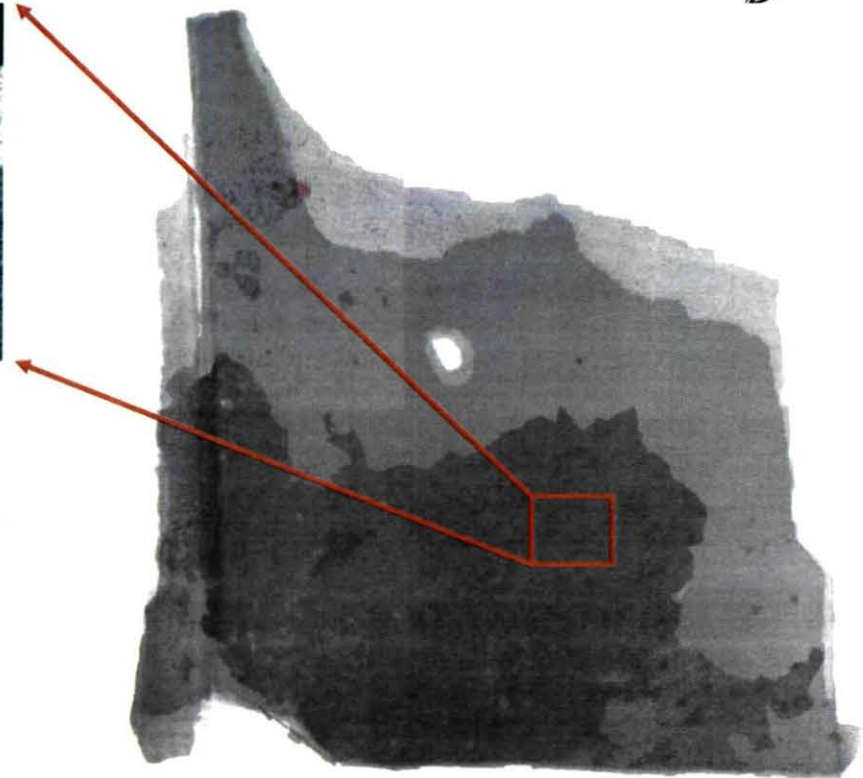
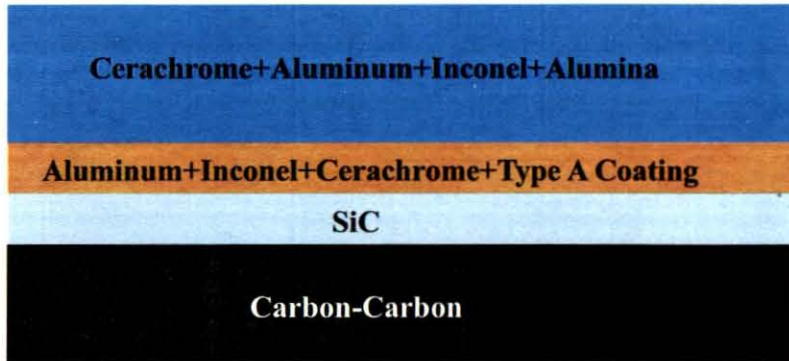
Item 16523, Sample 4A1

# LH RCC 8 – Deposit Feature: Uniform Deposit

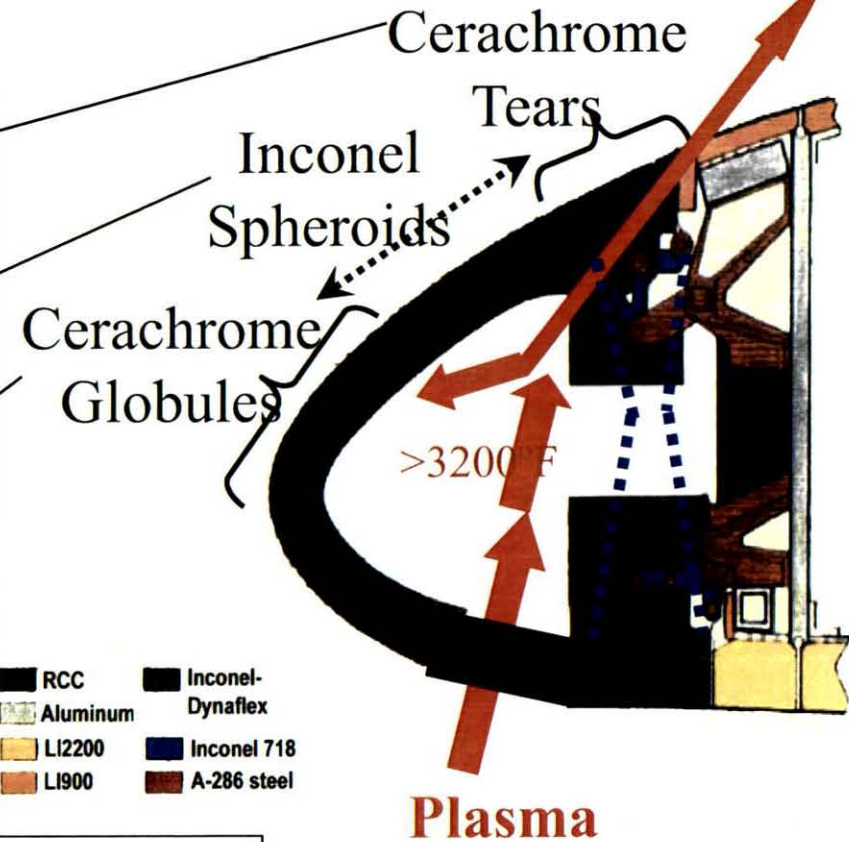
Flow Exiting through RCC 8 on to lower Carrier Panel 9 tiles
