AIAA Space 2011 Conference

NASA/MOD Operations Impacts from Shuttle Program

# NASA/MOD Operations Impacts from Shuttle Program

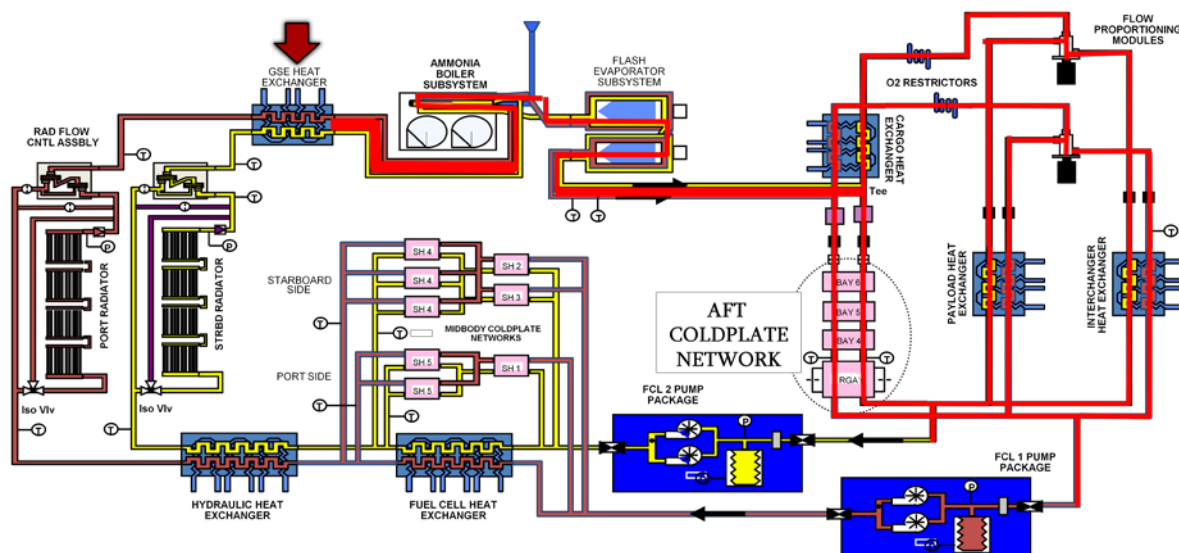
**Figure 1. Space Shuttle Freon Coolant Loop schematic.**

As seen in Fig. 1, the Space Shuttle has two Freon Loops, both of which are typically running at all times. Post-landing, the ground Cooling Cart is connected to the Orbiter at the GSE Heat Exchanger, represented by the red arrow at top left. The Freon continues clockwise in this schematic, reaching the Ammonia Boiler and the FES before splitting into legs cooling the aft coldplates, the payloads, and the water coolant loops. A Flow Proportioning Valve can set the flows to be a ratio of either 90% at the Water/Freon Interchanger and 10% at the Payload Heat Exchanger, or 57% to 43%. From these legs, the Freon goes through a pump package, heat exchangers for the Fuel Cells and midbody coldplates, and finally the radiators before reaching the GSE Heat Exchanger again. The Water/Freon Interchanger at far right is where all of the Orbiter's coolant loops intersect, and if the Freon temperature is cold enough it could freeze the water, rupture the interchanger, and cause the complete loss of cooling to the Orbiter.

- The KSC Ground Team had also recently changed Cooling Cart procedures so that the ground cooling was recirculated inside the Cooling Cart, generating a very cold fluid. When this fluid was introduced into the Shuttle GSE heat exchanger it caused the Shuttle Freon Loop temperatures to drop quickly.

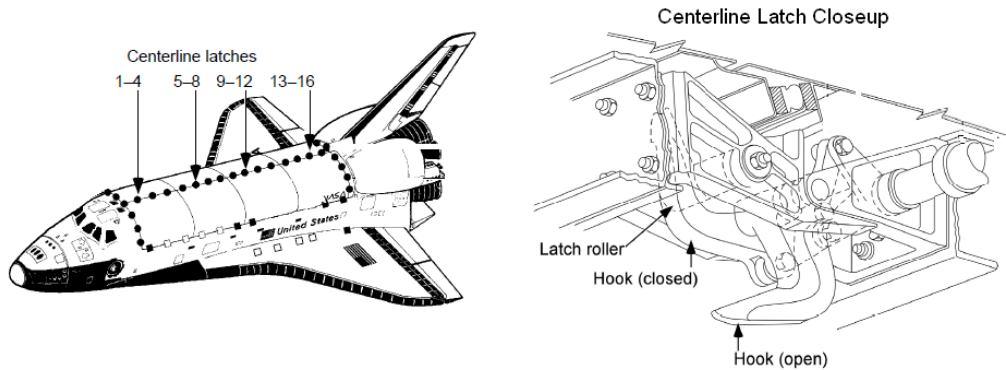
**Figure 2. Payload Bay Door Centerline Latch location and hook schematic.**

During the PLBD opening procedure in the Deorbit Prep Backout on STS-76, both of the Centerline Latch 9-12 Release microswitches REL A and REL B failed to indicate Open (or Released) after the motors drove for single motor time (40 seconds). See Fig. 2 for the location of the latches. This condition resulted in an “S63 PBD SEQ FAIL” (Payload Bay Door Auto-Sequence Fail) alarm, which stopped the latch drive.

As a result of this failure, the Deorbit Prep Backout procedures were changed to separate the opening of centerline Latch Gangs 5-8 and 9-12 by driving them sequentially instead of simultaneously. Since both Latch Gangs drive one motor each on ac buses 1 and 3, by opening the Latch Gangs separately the currents are not overlaid and can be monitored individually to verify if the Latch Gang actually drove to the release position.

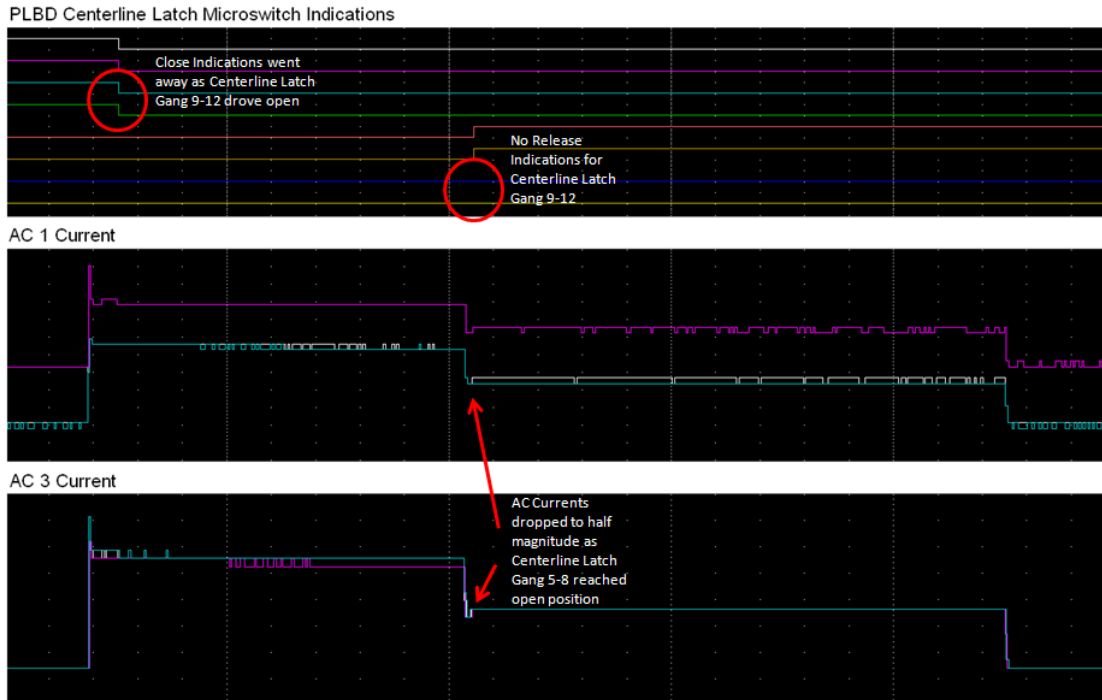
**Figure 3: Payload Bay Door Centerline Latch Gang 5-8 and 9-12 microswitch and ac motor data**

The MMACS team quickly concluded that the missing microswitch indications after single motor drive time triggered the “S63 PBD SEQ FAIL” alert message. However, the plots of ac current traces indicating the motor drive were difficult to interpret. Normally, Payload Bay Door operations drive Centerline Latch Gangs 5-8 and 9-12 simultaneously, and each Latch Gang has two motors, one driven by ac bus 1 and the other on ac bus 3. Thus, two motors drive on each ac bus. It was obvious from the ac plots that both Latch Gangs had initially started driving. The open position was indicated at the nominal time for Latch Gang 5-8 with an expected drop in current on both ac buses 1 and 3, as the microswitches removed power from the motor at the end of travel. See Fig. 3 for microswitch and ac motor traces.

When the microswitches for latches 9-12 never triggered the open microswitches, ac buses 1 and 3 both continued to show a current level that could be expected with either nominal motor drive or the motors driving into the built-in slip clutches; the current from Latch Gang 5-8 drive had masked critical current draw information for the 9-12 gang. With any level of certainty, it was impossible to tell the position of Latch Gang 9-12 using the data in the MCC.

Several hours later, the two failed centerline latch 9-12 release microswitch indications recovered and showed the nominal open position. This indicated the loss of these indications was likely due to thermal effects and/or misrigging, which had been seen on previous flights.

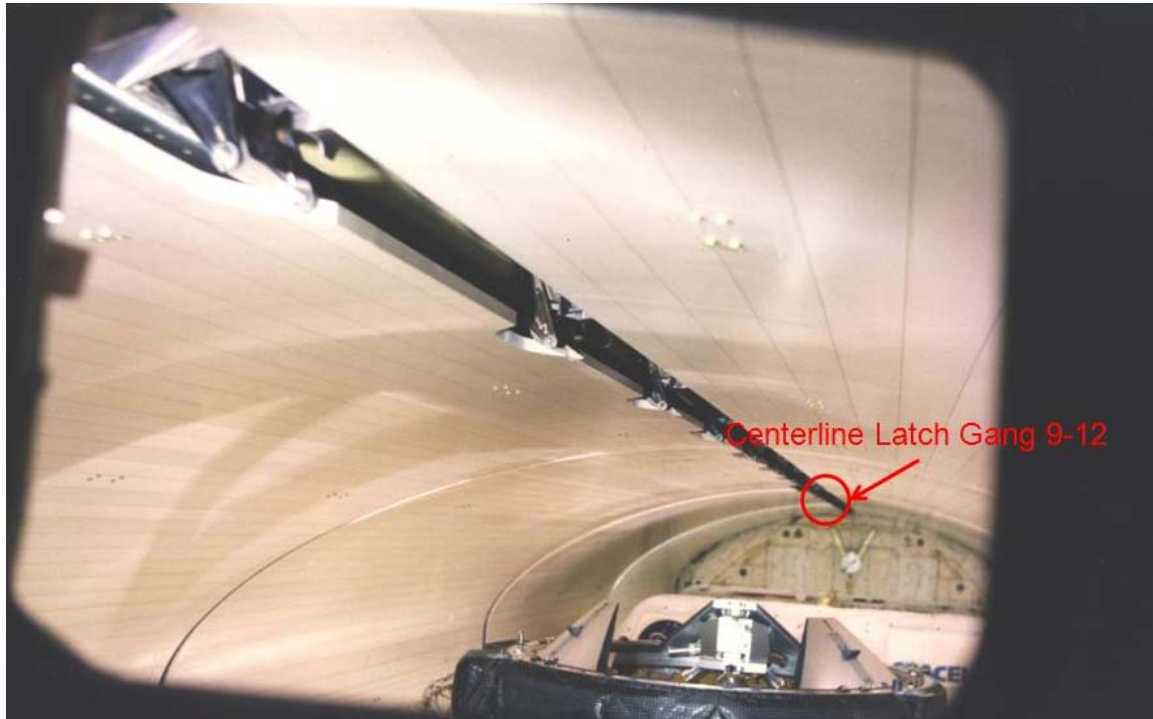
**Figure 4: View from Port Aft Flight Deck Window with Payload Bay Doors closed.**

Because the available microswitch and ac current trace data was inconclusive, the MMACS team relied on the preplanned procedure to have the crew visually verify the Latch Gang position, and compare it to a drawing in the procedure. This requires the crew to look out the aft flight deck windows at the centerline latches toward the aft of the vehicle. The MMACS team had the crew working on verifying the latch position while the ground team investigated further troubleshooting. The crew had binoculars at their disposal to investigate the position of the latch. See Fig. 4 for view out aft flight deck window.

From the aft windows of the flight deck, the crew reported that Latch Gang 9-12 appeared to be open, but due to the distance away from the window, they were not entirely certain, even using binoculars. The MMACS team asked the crew to ingress the SpaceHab module (which required opening the hatch from the middeck into the airlock) and look out the overhead viewport. The crew reported that the 9-12 Latch Gang was definitely open; they confirmed this by visually comparing to Latch Gang 5-8 which was already confirmed to be in the open position and to a diagram in an orbiter systems data book. The MMACS team then had the crew drive the 9-12 centerline

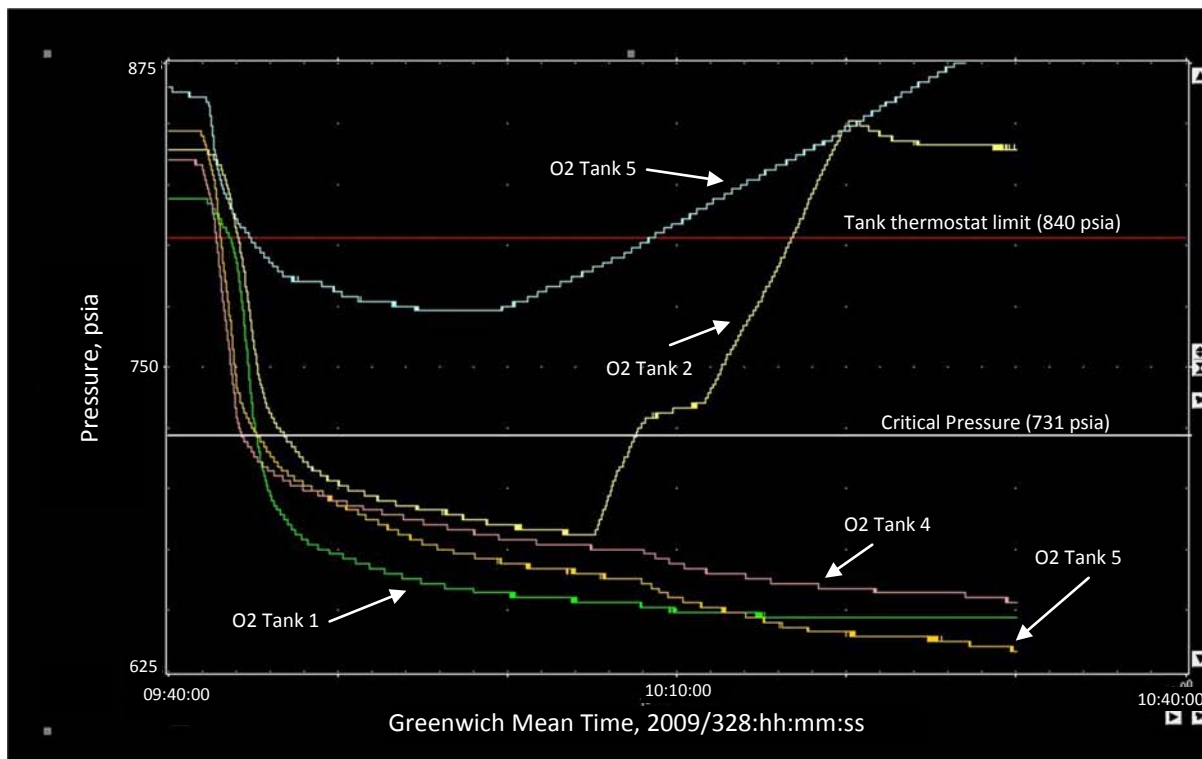
**Figure 6: Cryo O2 Tank Pressure vs. Time**

Typically a pressure drop will be seen across one or two tanks; to see all five was alarming and had never been seen before. Predicting which tanks would be expected to drop and how much they recover is difficult. The team expected Tanks 3 and 4 to drop due to their quantity being closest to a value known to cause trouble during destrat

Heaters in Tanks 3 (already in Auto) and 4 activated when the pressure fell below 840 psi, but could not keep up with the rapidly falling pressure. Only the pressure in Tank 5 stabilized with heaters. The EGIL team began to consider whether the heaters in 3 and 4 should remain on below the approaching critical pressure, and ultimately decided to take tanks 3 and 4 to OFF.

See Fig. 6 for a plot of cryo pressure vs. time.

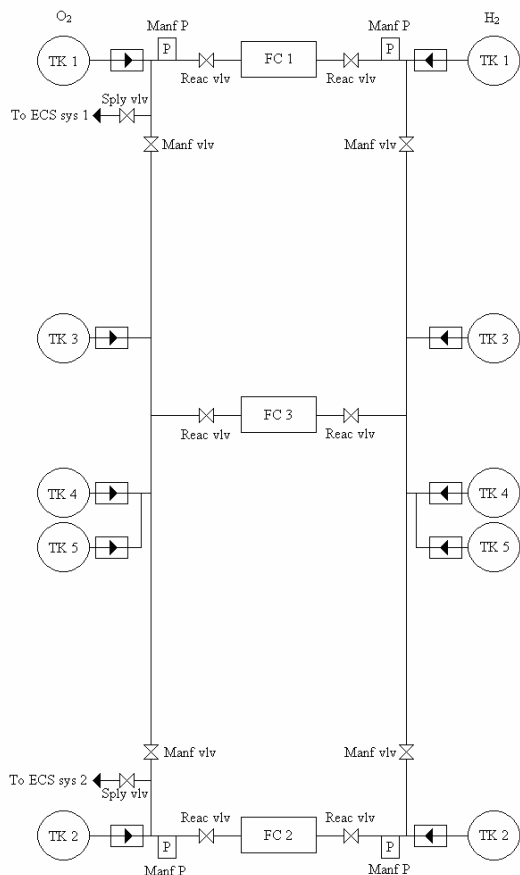
**Figure 7: Cryo and Fuel Cell manifold schematic**

The EGIL team determined that the limited amount of usable fluid in tank 5 (the only tank whose pressure was above the critical pressure) would not last the night, and that they needed to activate heaters in another tank to have enough usable fluid to supply the Fuel Cells with reactants needed to make electricity, and found themselves in a risk/trade case. They knew they could either take heaters on immediately and raise pressure, thereby exposing themselves to the risk of having heaters on in a tank that is below the critical pressure, or they could wait and hope that natural heat leak from outside the tank would cause the pressure inside the tank to slowly rise, but fast enough to be able to be usable before Tank 5 ran dry. However, the team could not know when that would start happening, and knew they would have to research past flight data for destrat events to be able to predict how the tank pressures would react for various heater configurations and changes in orbiter attitude. The team had to make their best decision given the information available at the time.

mission. See Fig. 7 for a schematic of the cryo/Fuel Cell manifold, showing the three Fuel Cells (FC), the locations of the manifold valves, supply valves (which provide oxygen to the cabin for crew breathing via the Environmental Control System), and the reactant valves (which provide O2 and H2 to the Fuel Cells).

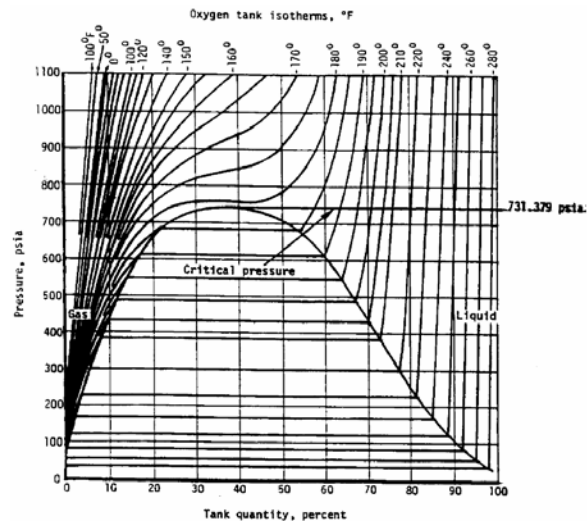
**Figure 8: Isotherm plot of cryo O2 temperatures relative to pressure and quantity.**

At approximately 56% quantity in tanks 1-4, the two phase saturation pressure (or dome) was 660 psi, well below the critical pressure of 731 psi but more importantly below the current tank pressure. See Fig. 8 for the isotherm plot of cryo O2 temperature, pressure, and quantity from the EGIL Console Handbook used in MCC to determine critical pressure.

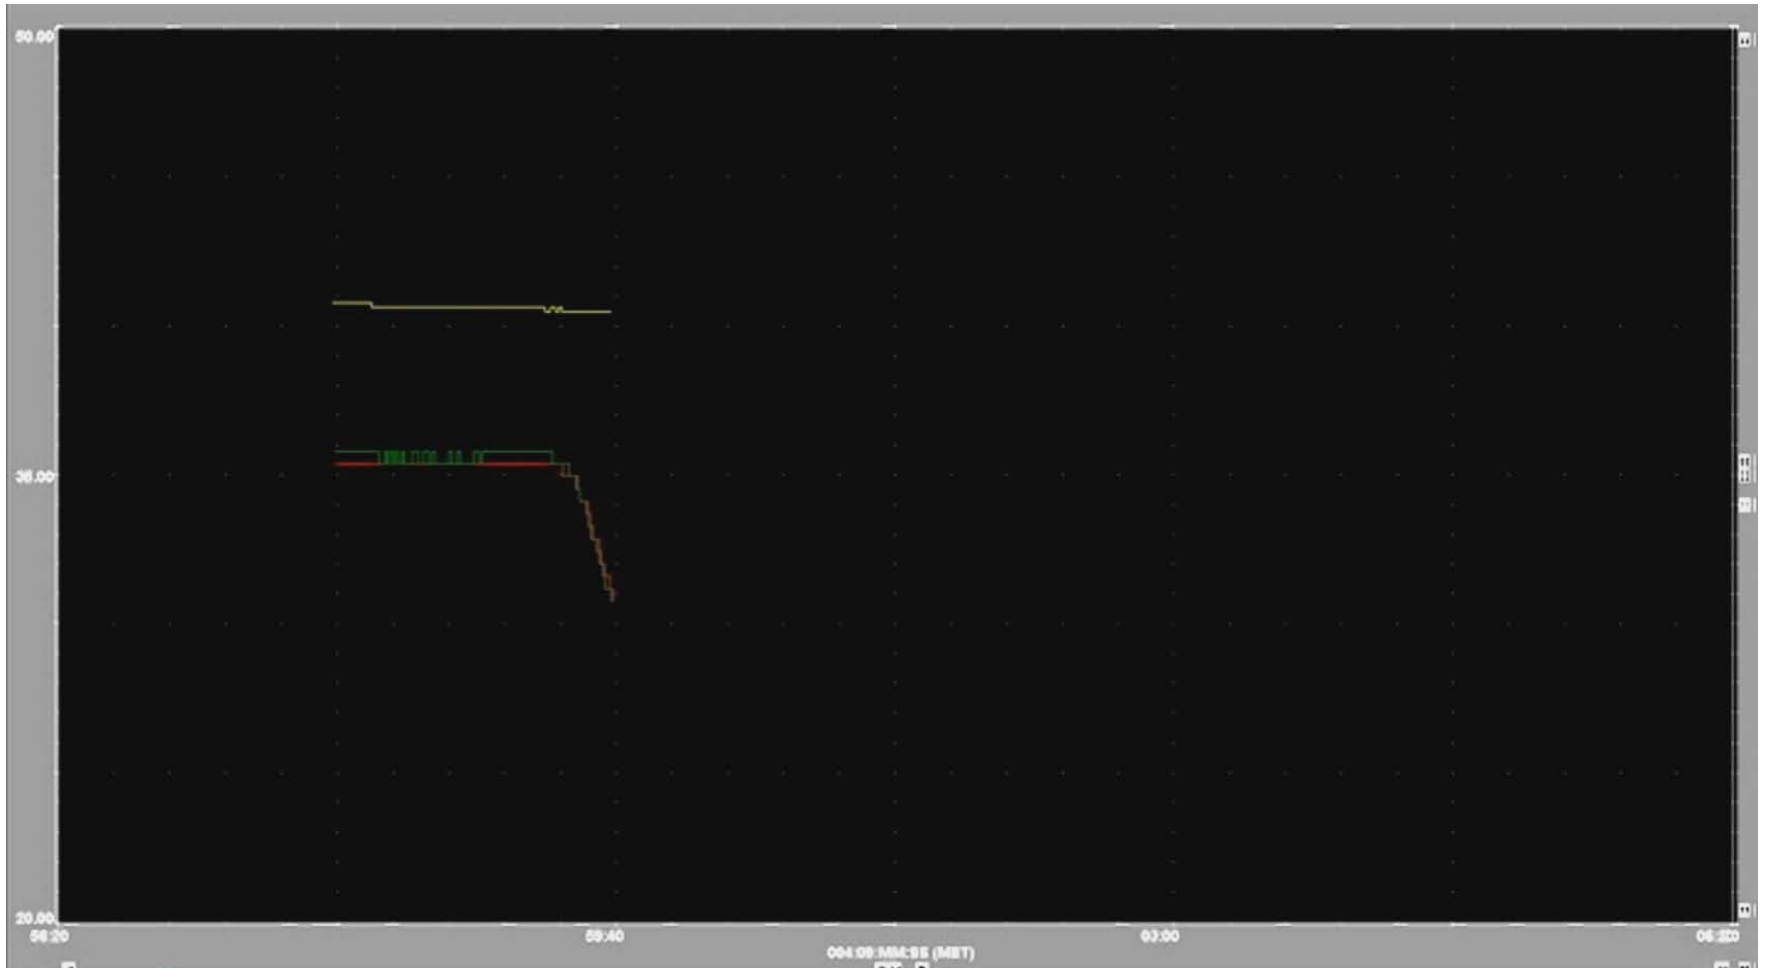
# Evap Out Temperatures

- After the 45 seconds had elapsed, the Evap Out T sensors plummeted to below 32° F, confirming a true undertemp condition and that the Interchanger was in danger of freezing. Both the KSC ground team and the EECOM team in the MCC noted this change in the data.

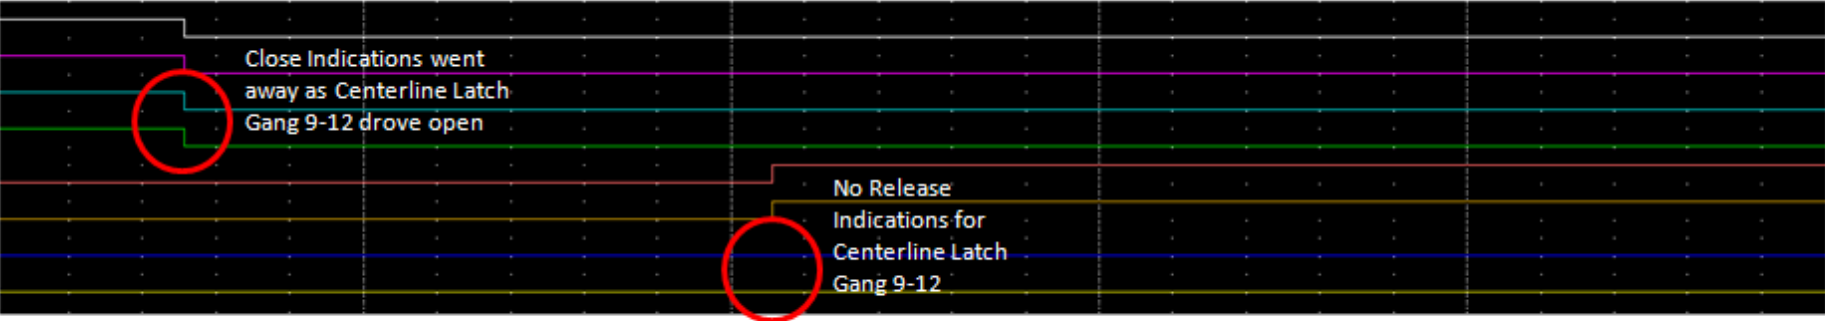
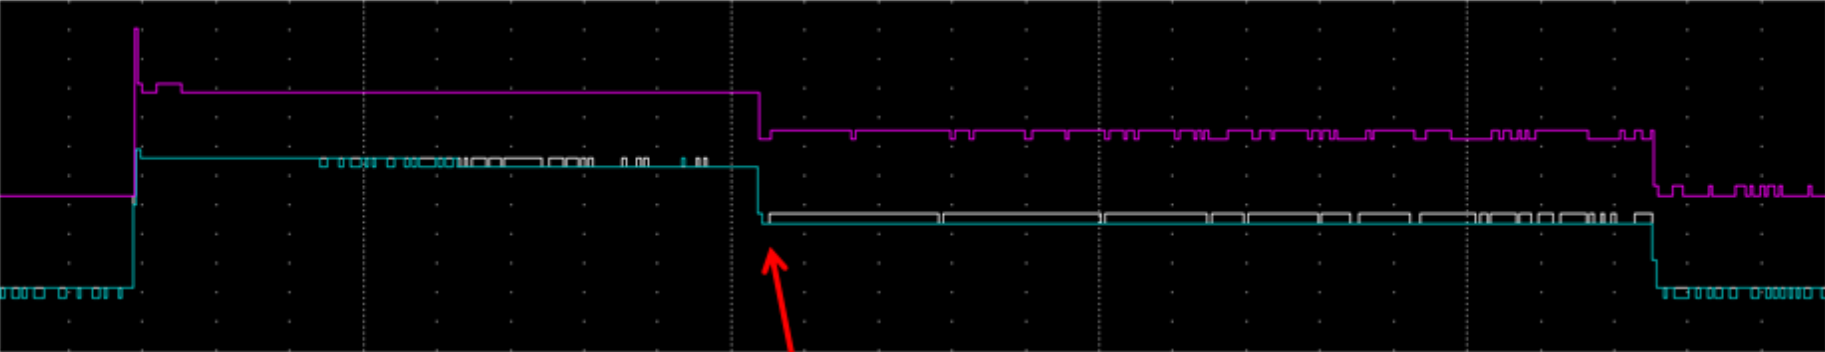
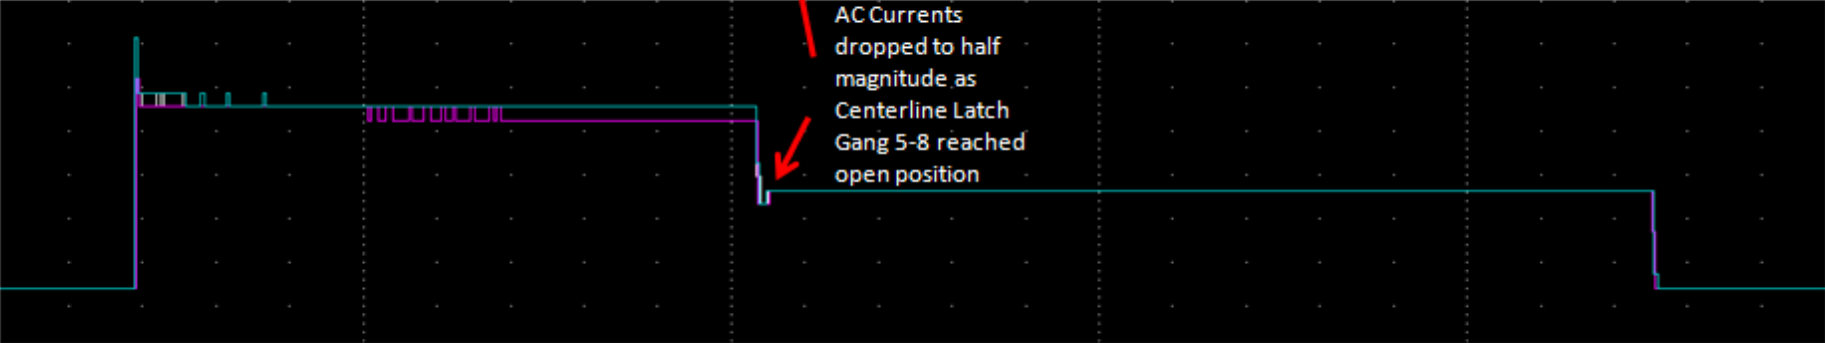
PLBD Centerline Latch Microswitch Indications

- PLBD centerline latch gang 9-12
  - Came off two closed microswitches
  - Did not receive two open microswitches
  - Alternating current traces were inconclusive
    - Latch gang 5-8 and 9-12 were driven simultaneously
      - Latch gang 5-8 reached end of travel at the expected time
- PLBDs cannot be opened with one centerline latch gang closed
- Potentially unsafe to open PLBDs with centerline latch gang at undetermined position
- NEED TO DETERMINE THE LATCH POSITION

- Team was unable to determine latch position with microswitch data
  - Latch may have been fully open with two microswitch failures
  - Latch may have been at a position mid travel
- AC trace data was inconclusive
  - Current magnitude dropped to approximately 50% magnitude when latch gang 5-8 reached end of travel
    - Latch gang slip clutch may have been slipping for entire drive time
    - Latch may have starting slipping half way through drive
    - Latch may have been driving the entire time

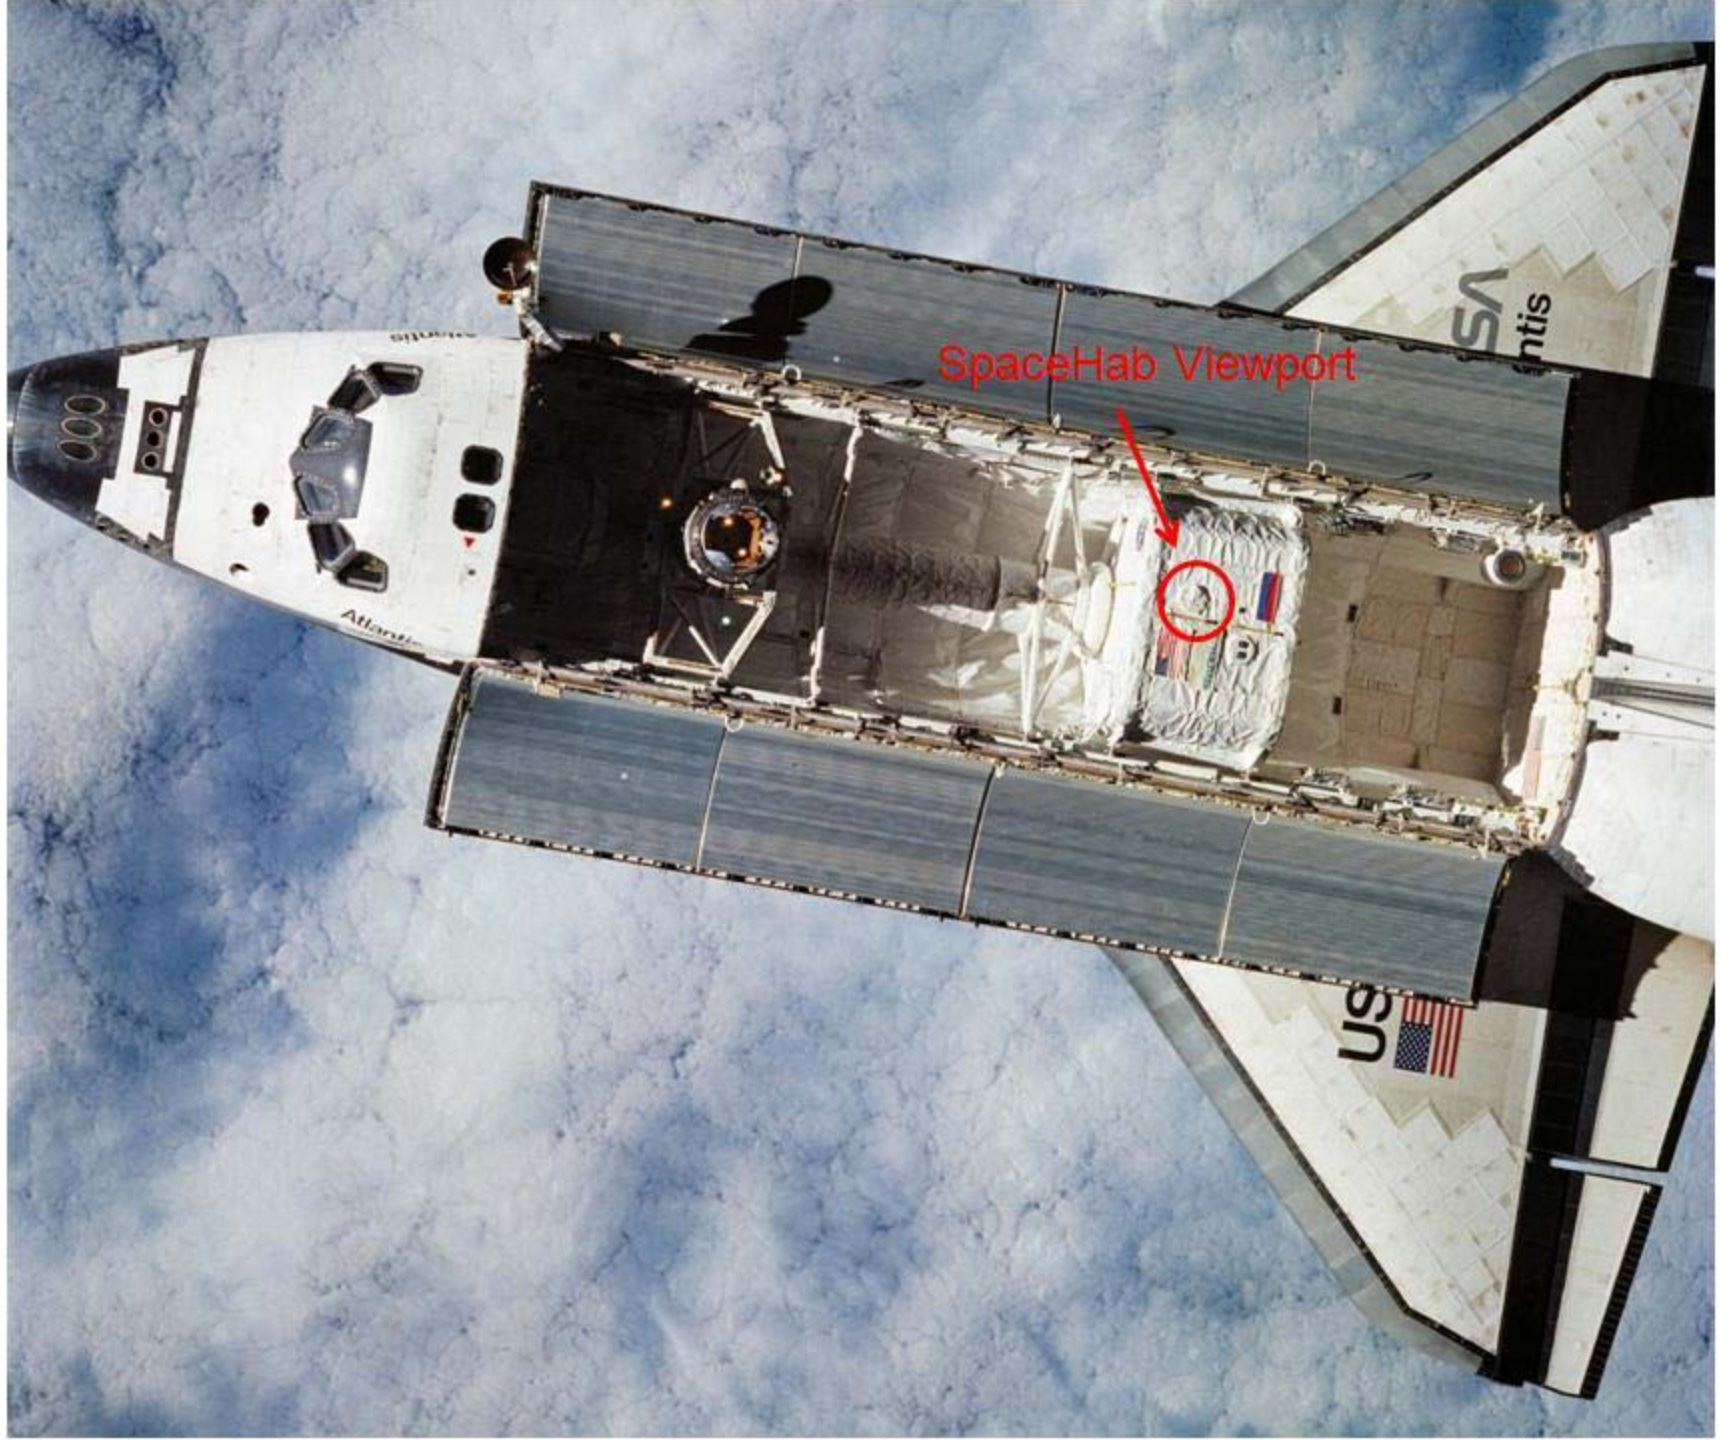
SpaceHab Viewport

- Team needed another way to determine the latch position
  - Looked at back windows
  - Ingressed the SPACEHAB module to look out the viewport
    - The 9-12 latch gang was directly above viewport
  - Used preplanned visual verification procedures and aids on board to verify position
- Using multiple visual cues, the crew was able to determine the latch gang was in the fully open position
  - Problem was a dual microswitch failure
  - Crew was able to open the PLBDs and regain radiative vehicle cooling
