NASA/TM-2011-217072/Volume II  
NESC-RP-09-00506

# Space Shuttle Program (SSP) Orbiter Main Propulsion System (MPS) Gaseous Hydrogen (GH<sub>2</sub>) Flow Control Valve (FCV) Poppet Eddy Current (EC) Inspection Probability of Detection (POD) Study

## *Appendices*

<b>NASA Engineering and Safety Center Technical Assessment Report</b>	<b>Document #:</b> <b>NESC-RP- 09-00506</b>	<b>Version:</b> <b>1.0</b>
<b>Title:</b> <b>STS-126 MPS#2 GH<sub>2</sub> Flow Control Valve Broken Poppet</b>			<b>Page #:</b> <b>1 of 538</b>

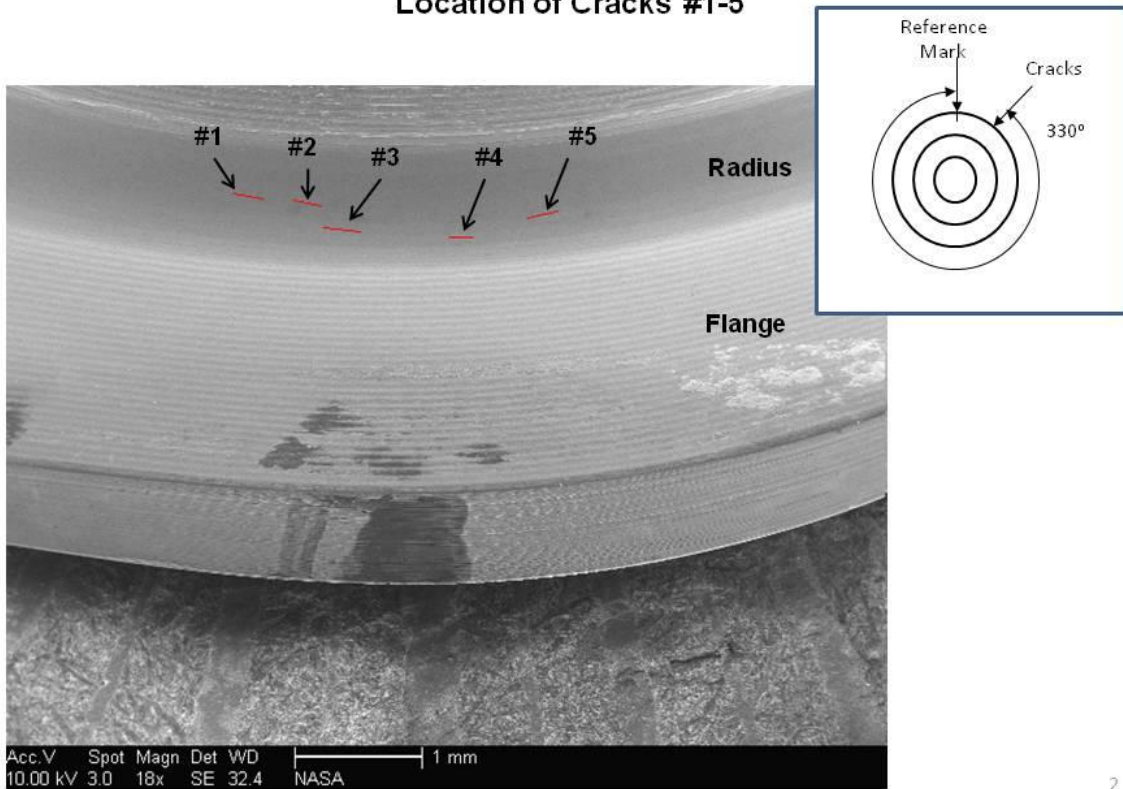
### Location of Cracks #1-5

Poppet #1		
Crack Number	Size (inch)	Angle (degrees)
1	0.007	330
2	0.001	330
3	0.007	330
4	0.002	330
5	0.002	330
6	0.008	150
7	0.002	150
8	0.005	150
9	0.008	150

Note: Cracks at the 330° location were not detected by eddy current inspections

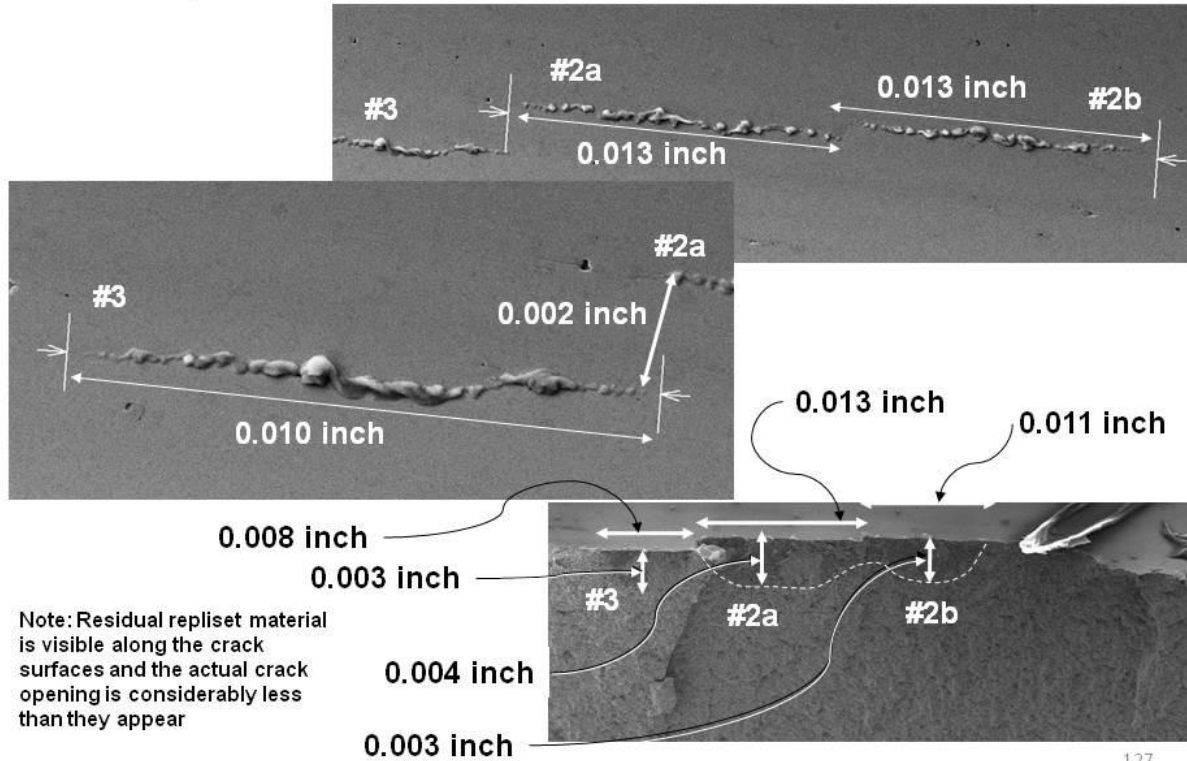
Crack depth and correlation with surface measurements for Cracks #2 & 3

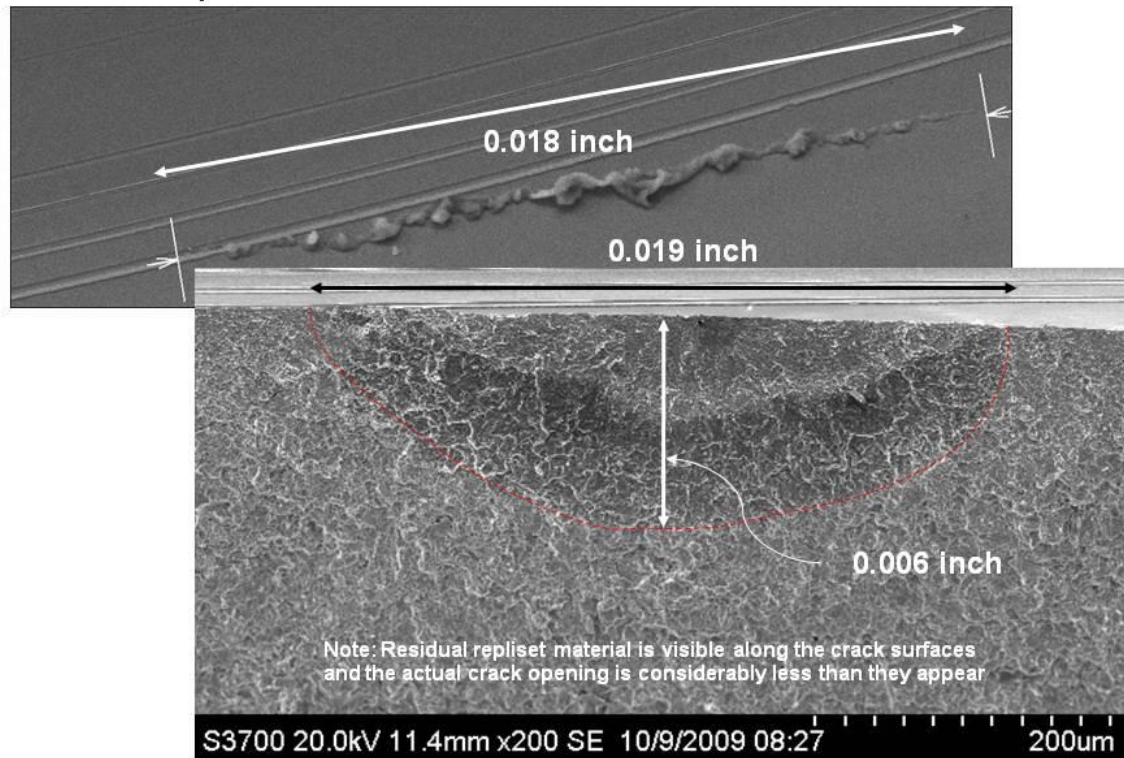
Crack depth and correlation with surface measurements for Crack #3

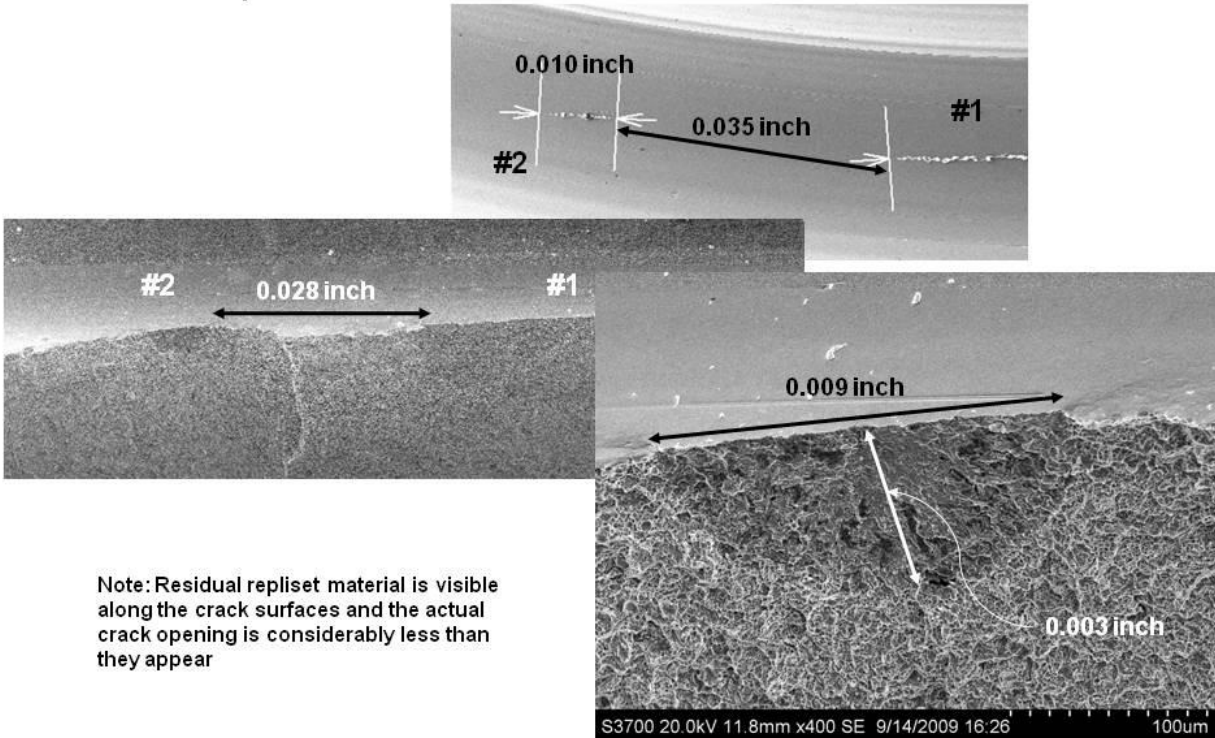
Crack depth and correlation with surface measurements for Crack #2

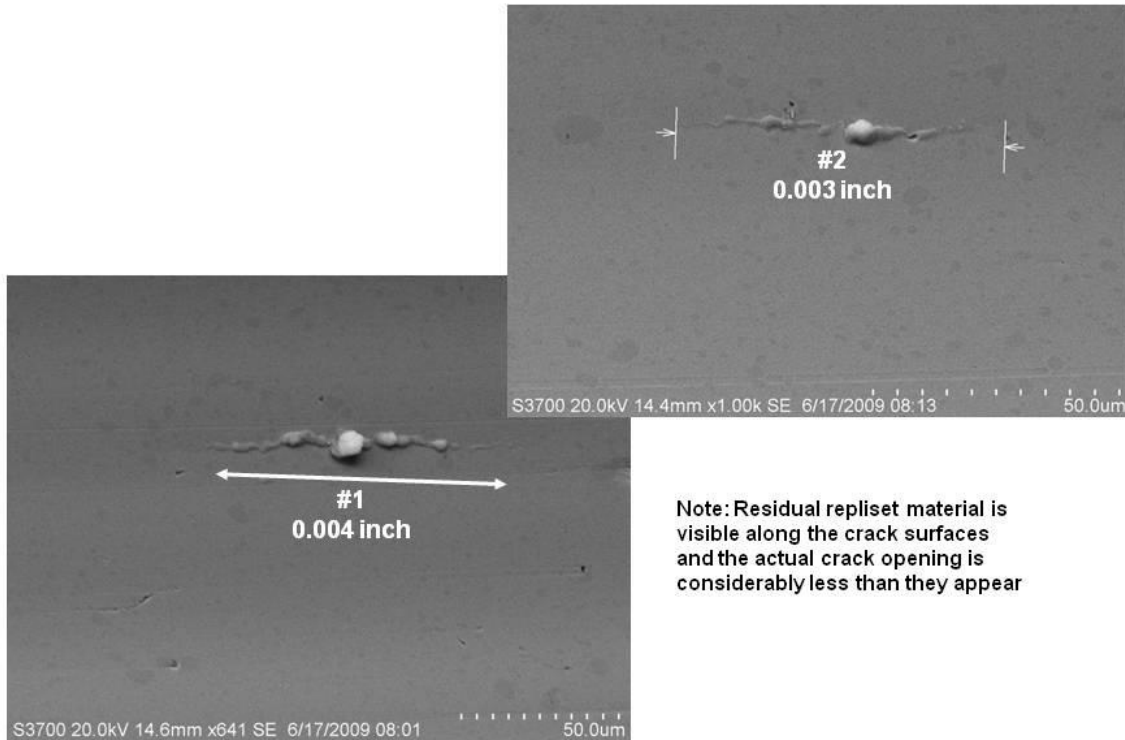
Size of Cracks #1 and 2

Note: Residual repliset material is visible along the crack surfaces and the actual crack opening is considerably less than they appear

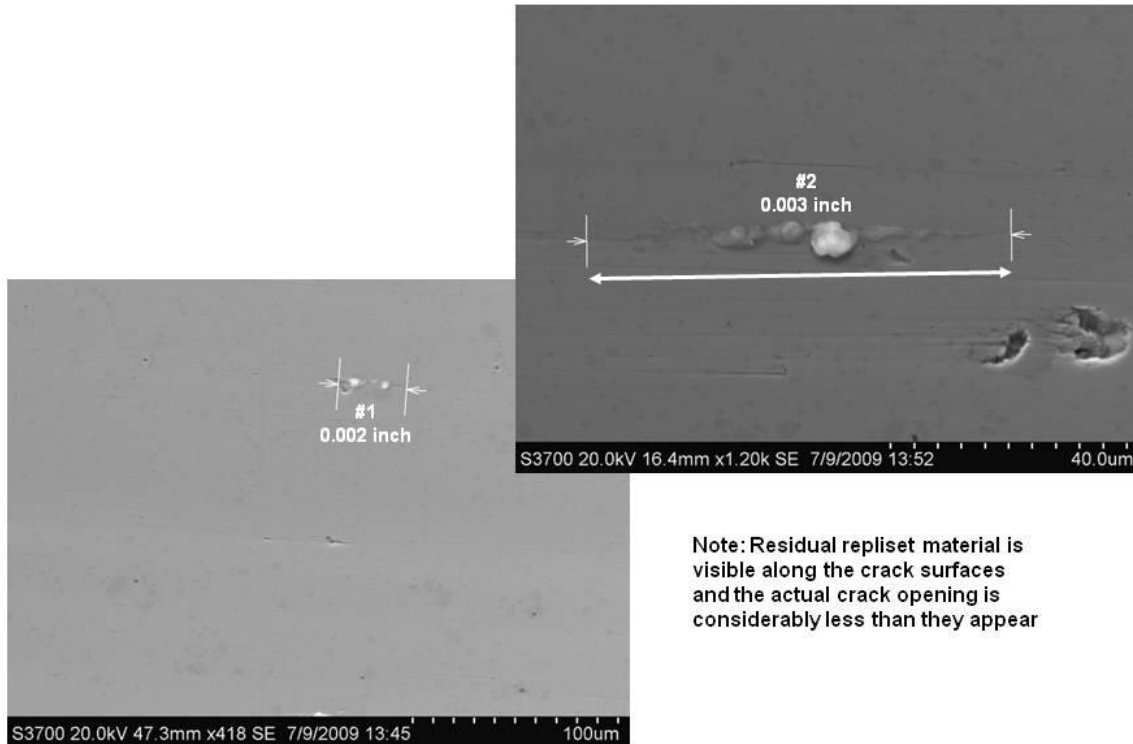
### Size of Cracks #1 and 2

Note: Residual repliset material is visible along the crack surfaces and the actual crack opening is considerably less than they appear

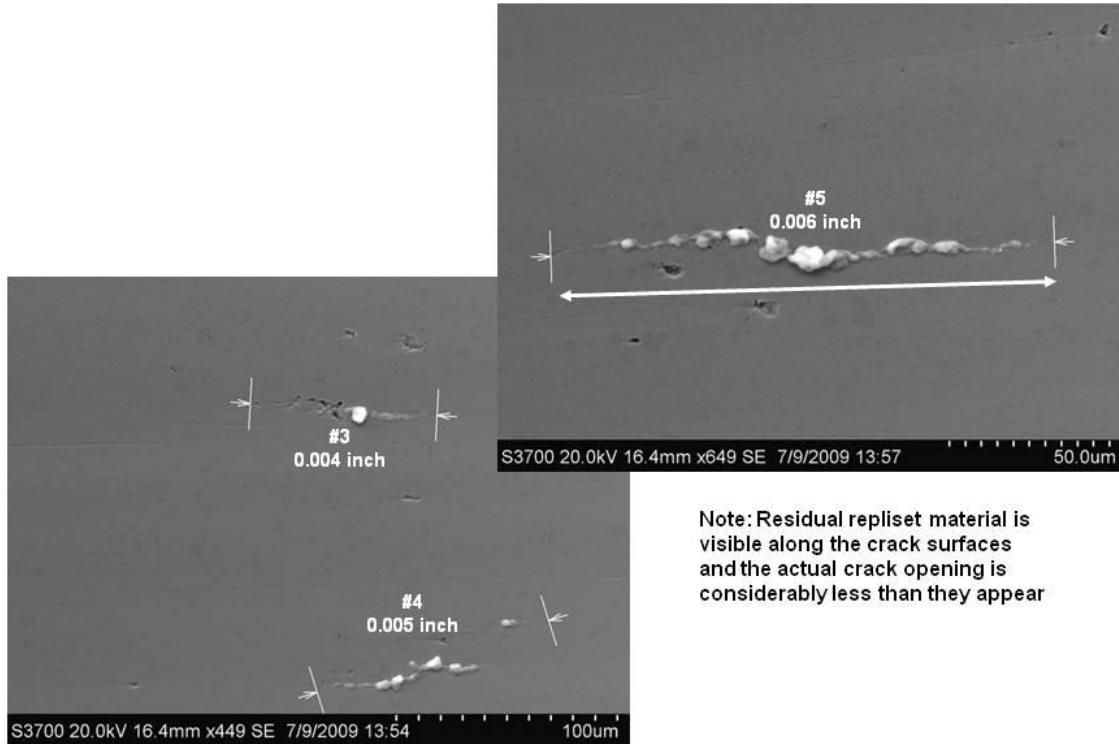
### Size of Cracks #3-5

Note: Residual replet material is visible along the crack surfaces and the actual crack opening is considerably less than they appear

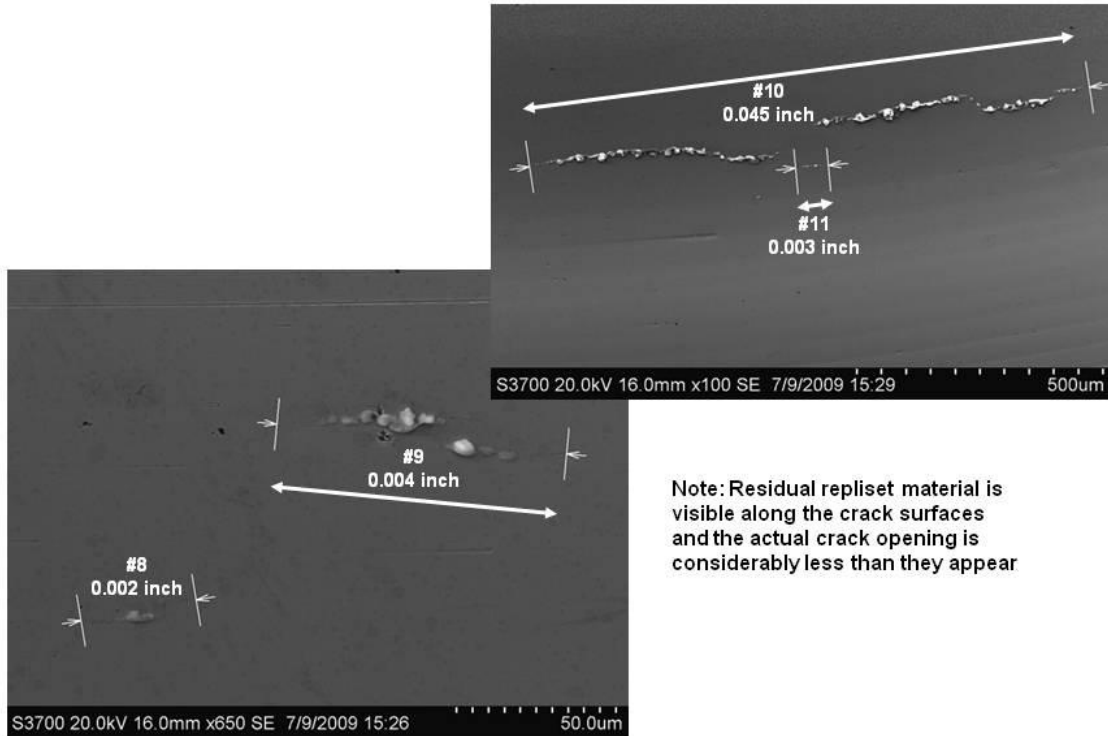
### Size of Cracks #8-11

Note: Residual replet material is visible along the crack surfaces and the actual crack opening is considerably less than they appear

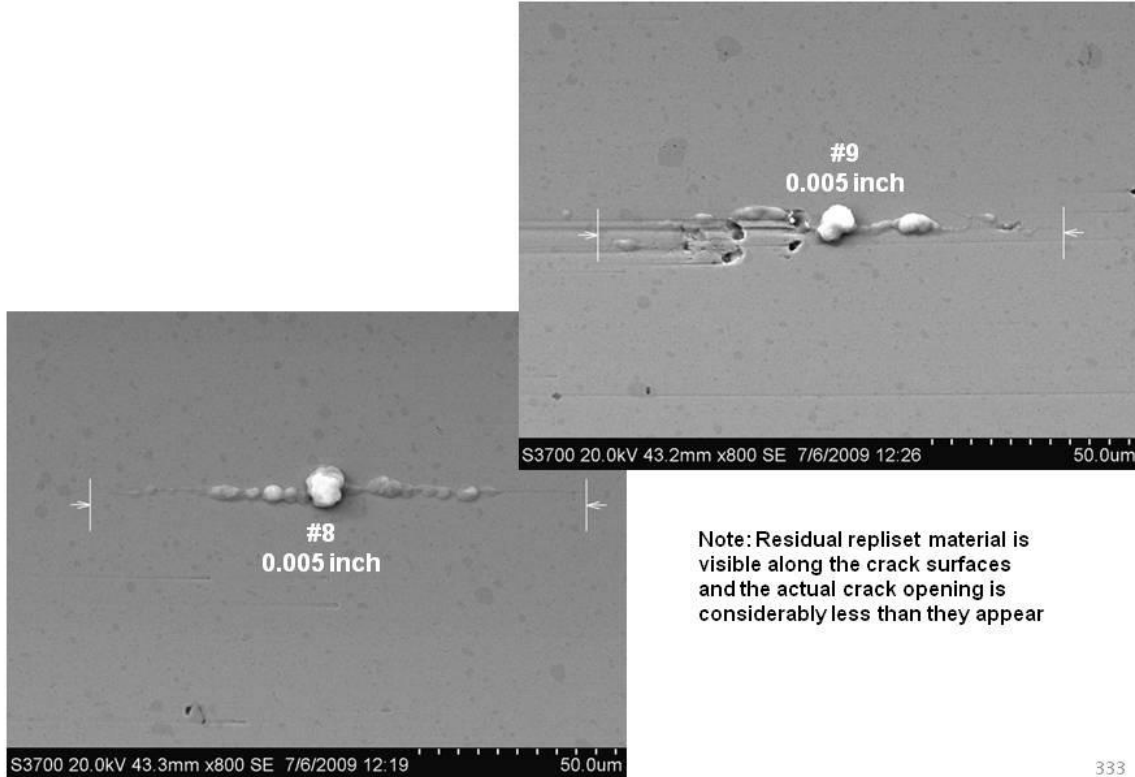
Size of Cracks #8-9

Note: Residual repliset material is visible along the crack surfaces and the actual crack opening is considerably less than they appear

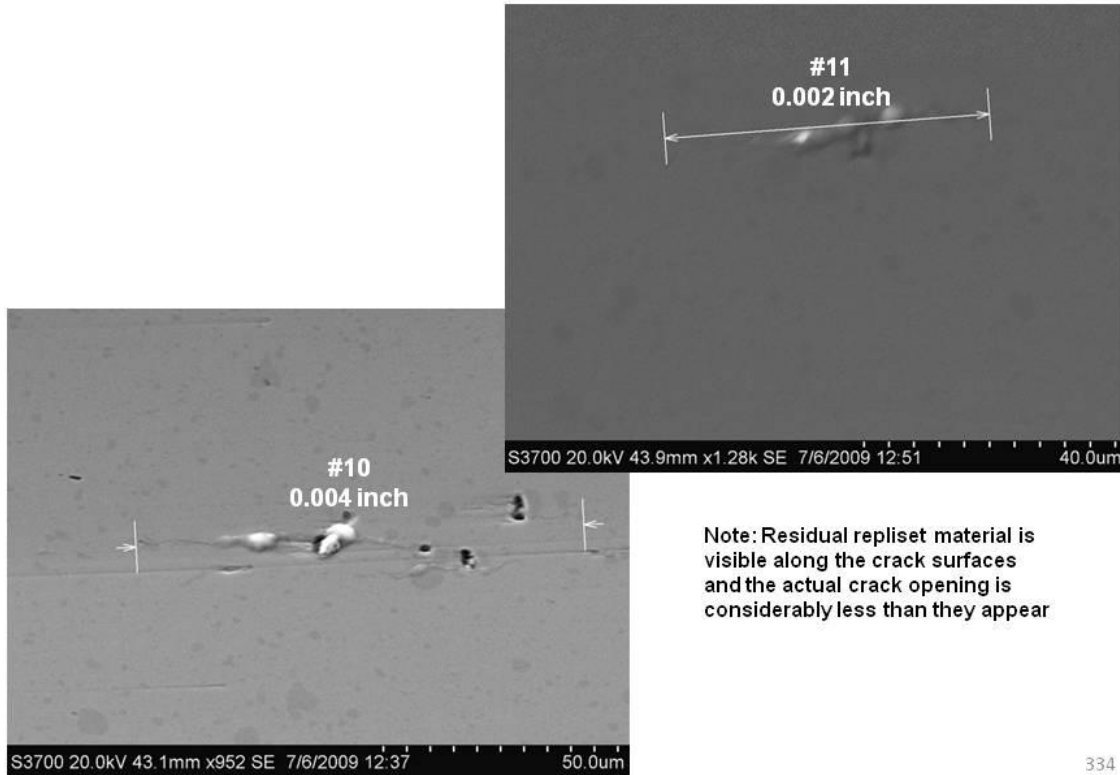
Size of Cracks #10-11

Note: Residual replet material is visible along the crack surfaces and the actual crack opening is considerably less than they appear

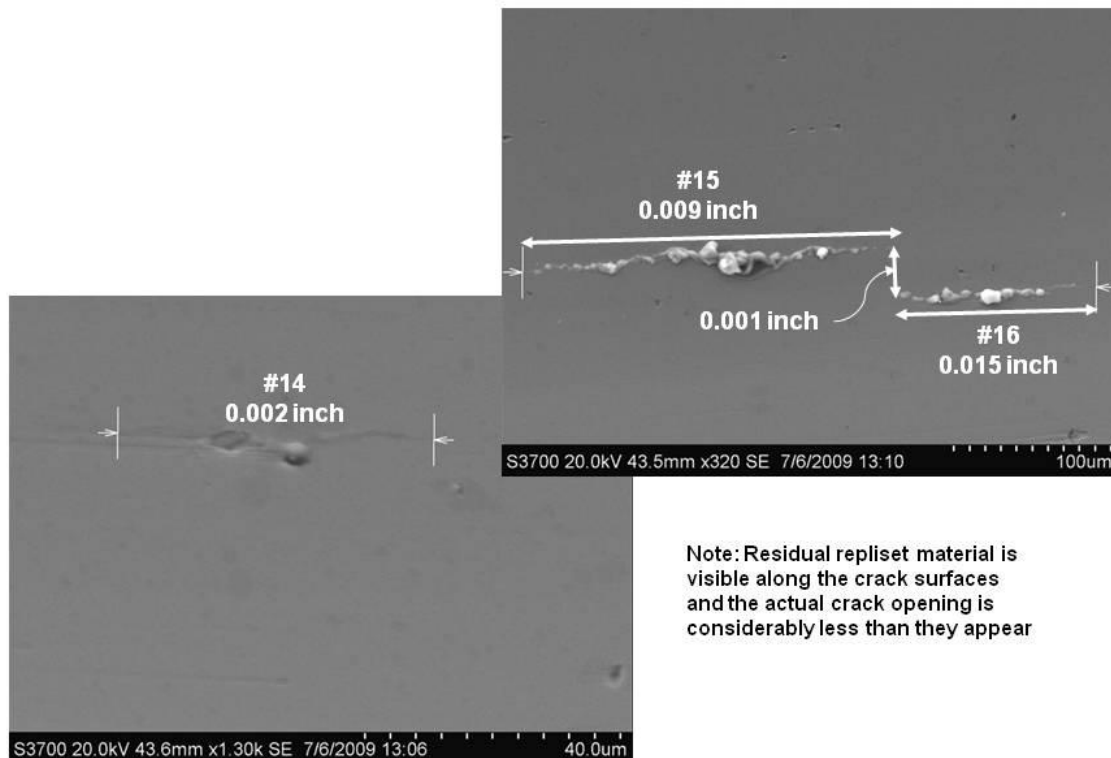
Size of Cracks #14-16

Note: Residual replet material is visible along the crack surfaces and the actual crack opening is considerably less than they appear

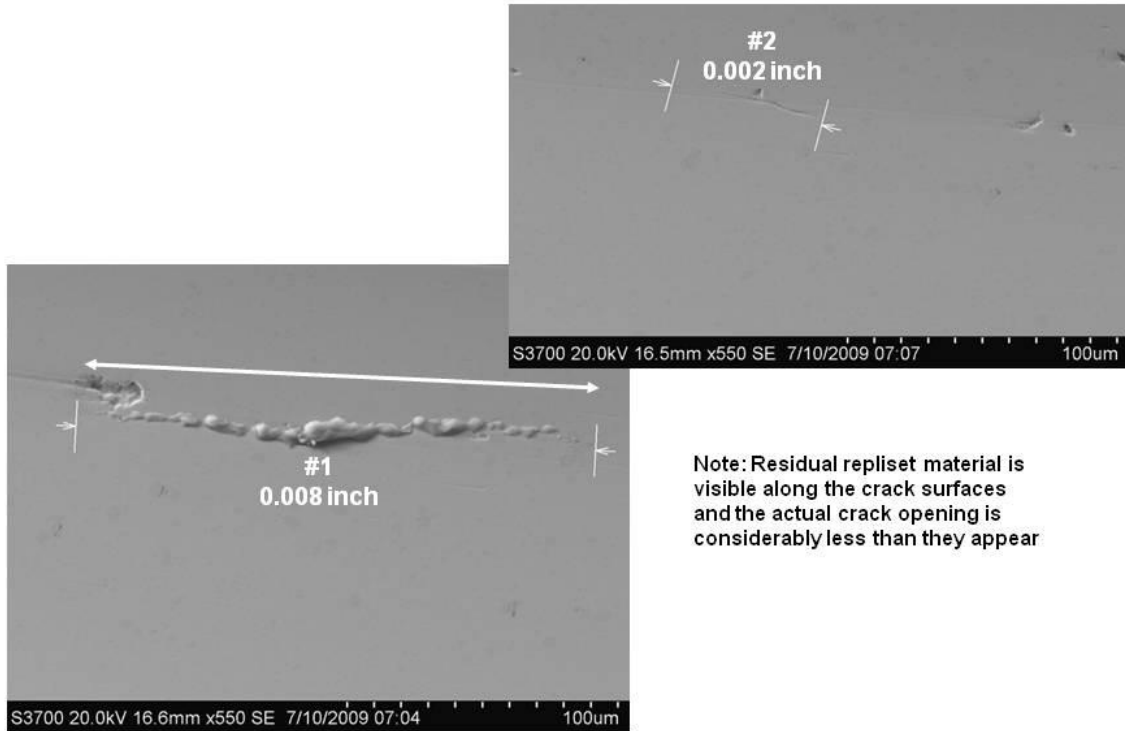
### Size of Cracks #1 and 2

Note: Residual replet material is visible along the crack surfaces and the actual crack opening is considerably less than they appear

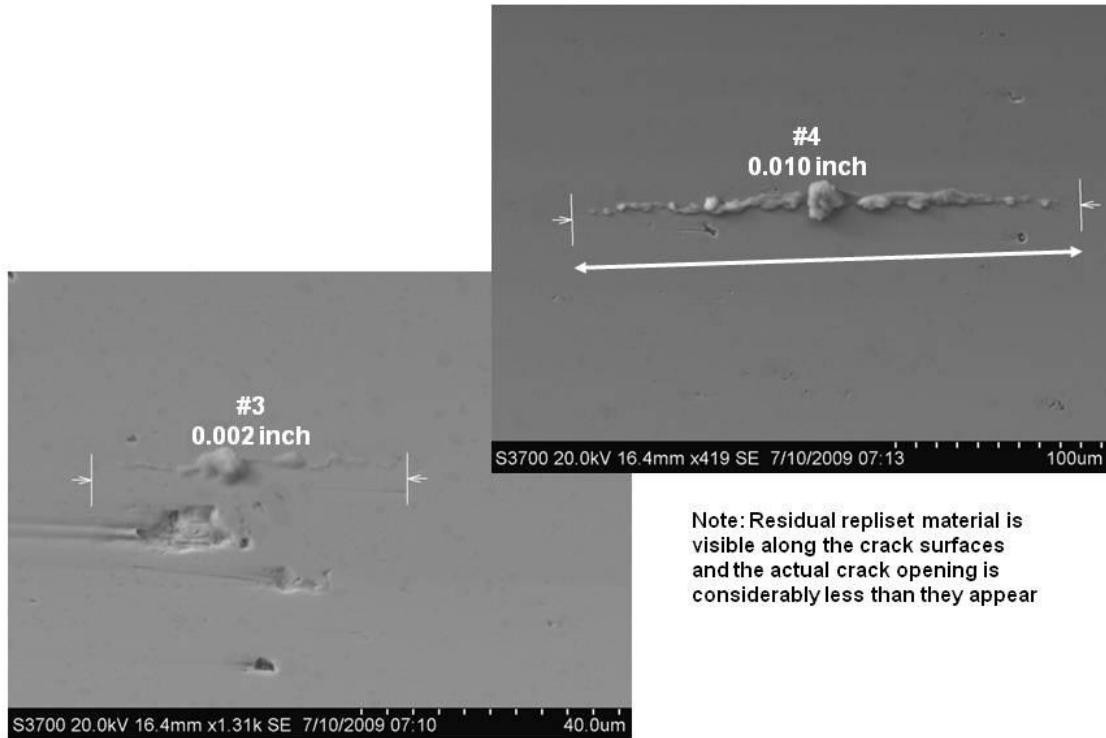
### Size of Cracks #3 and 4

Note: Residual repliset material is visible along the crack surfaces and the actual crack opening is considerably less than they appear

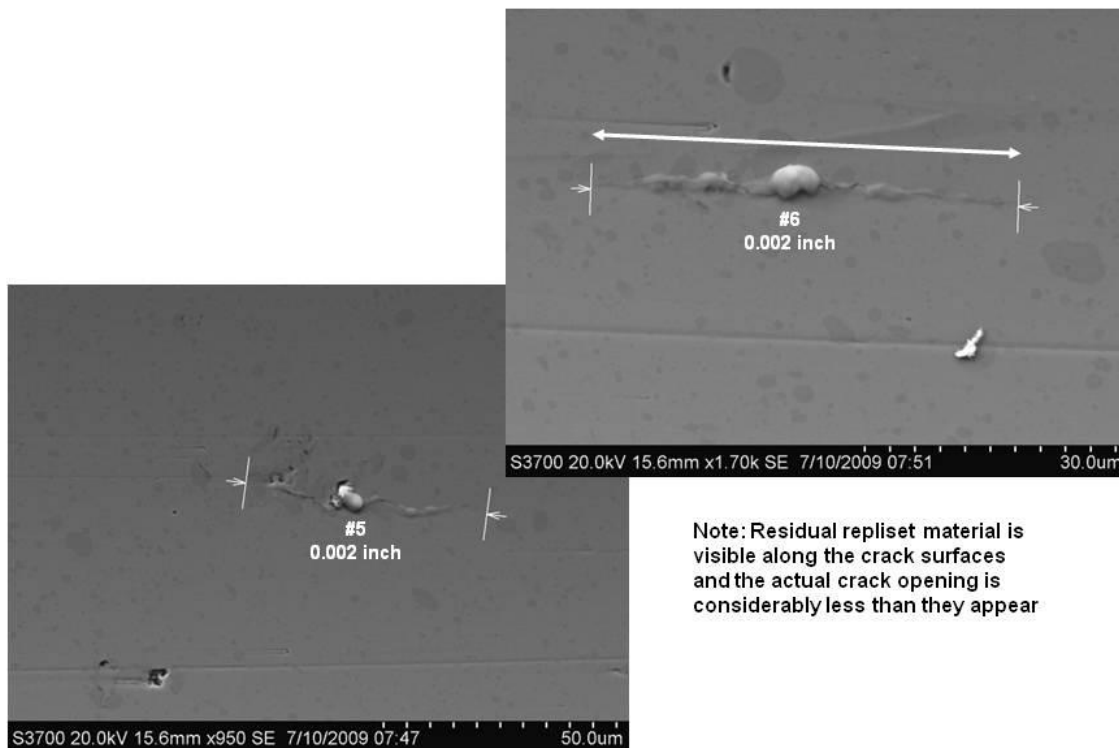
Size of Cracks #5-6

Note: Residual repliset material is visible along the crack surfaces and the actual crack opening is considerably less than they appear

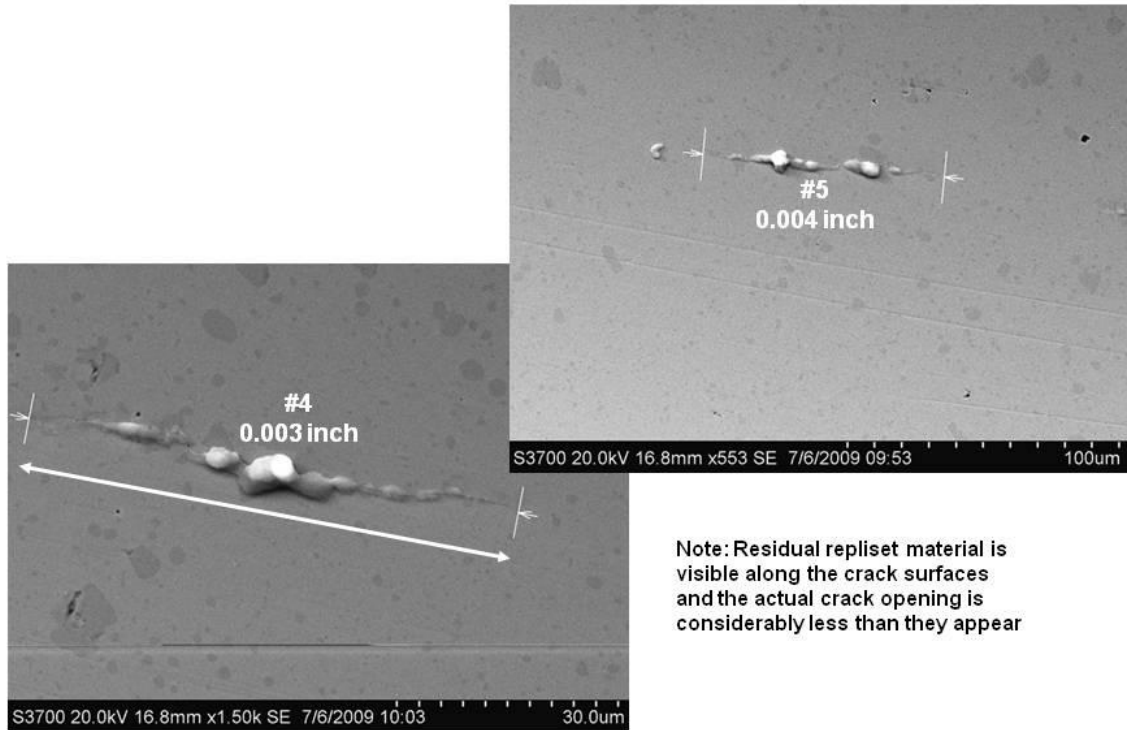
Size of Cracks #4 and 5

Note: Residual replet material is visible along the crack surfaces and the actual crack opening is considerably less than they appear

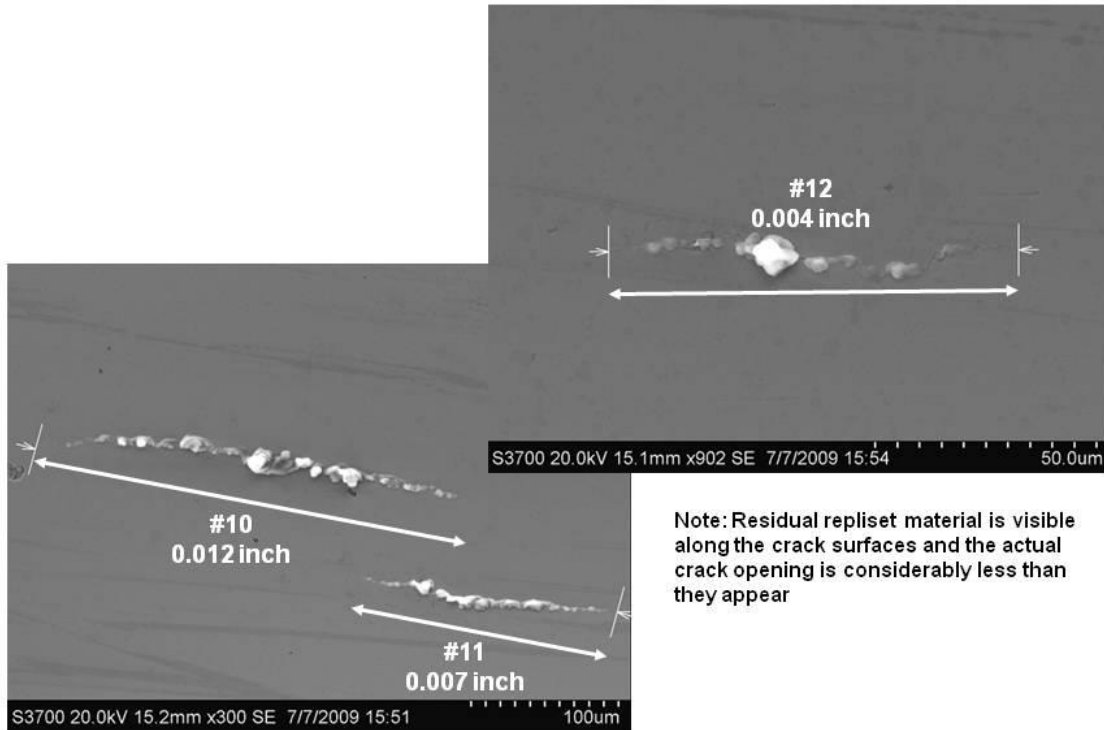
Location and size of Cracks #10-12

Note: Residual repliset material is visible along the crack surfaces and the actual crack opening is considerably less than they appear

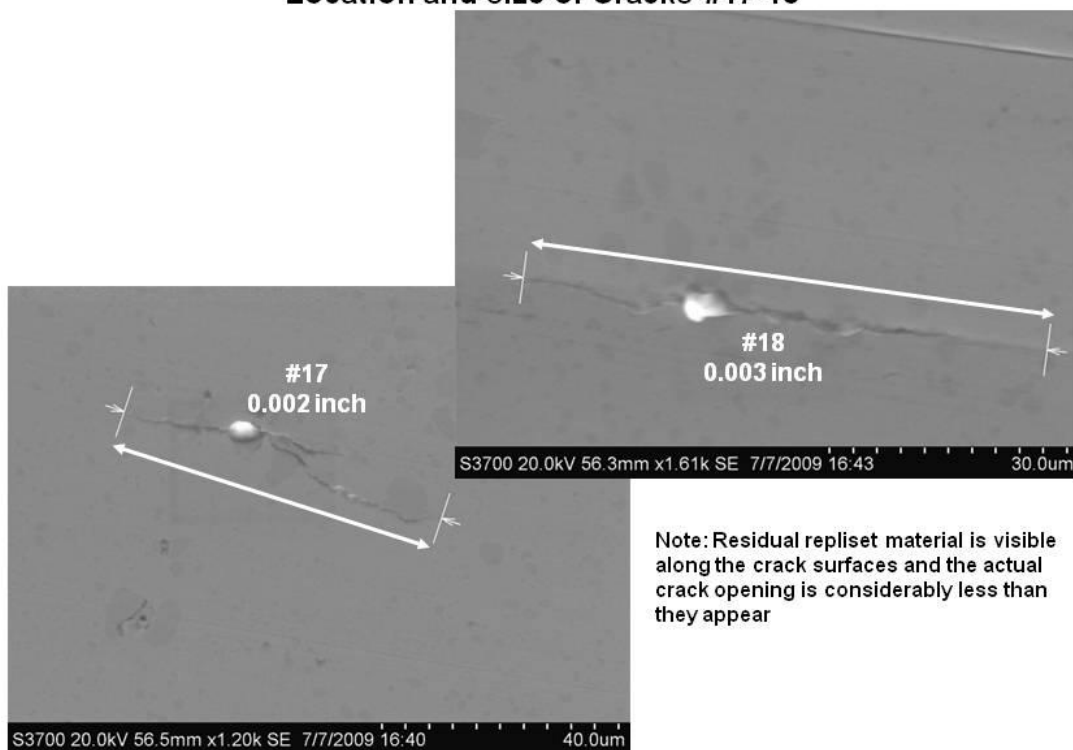
Location and size of Cracks #17-18

Note: Residual repliset material is visible along the crack surfaces and the actual crack opening is considerably less than they appear

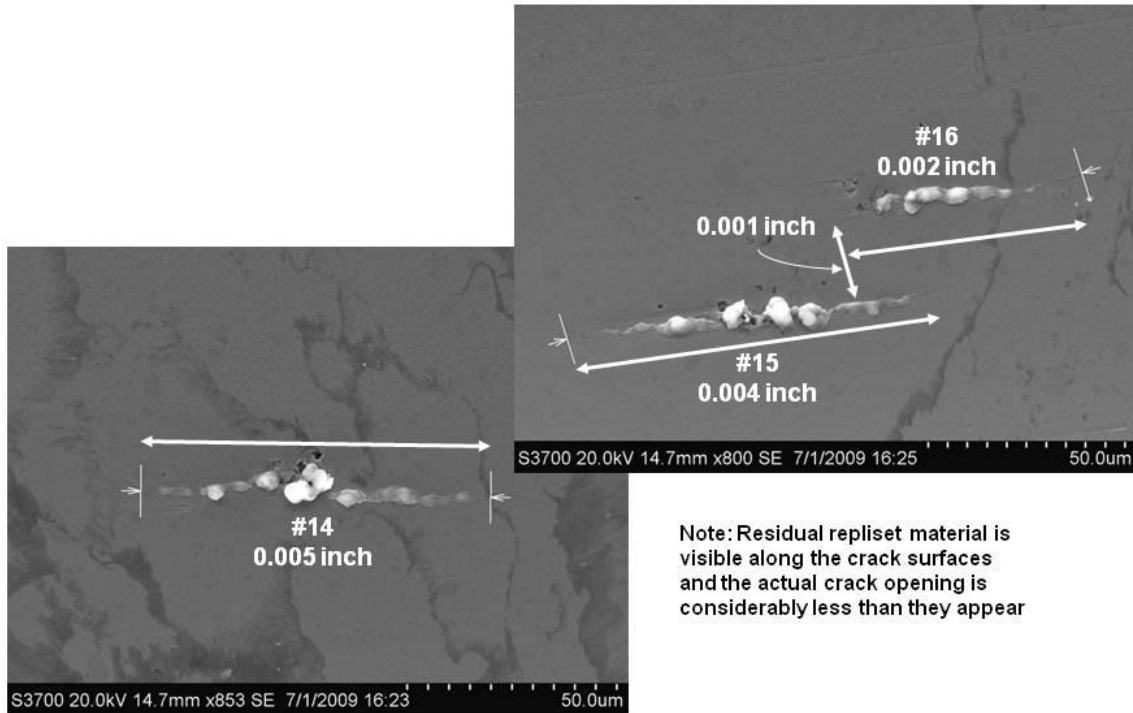
Location and size of Cracks #14-16

Note: Residual replet material is visible along the crack surfaces and the actual crack opening is considerably less than they appear

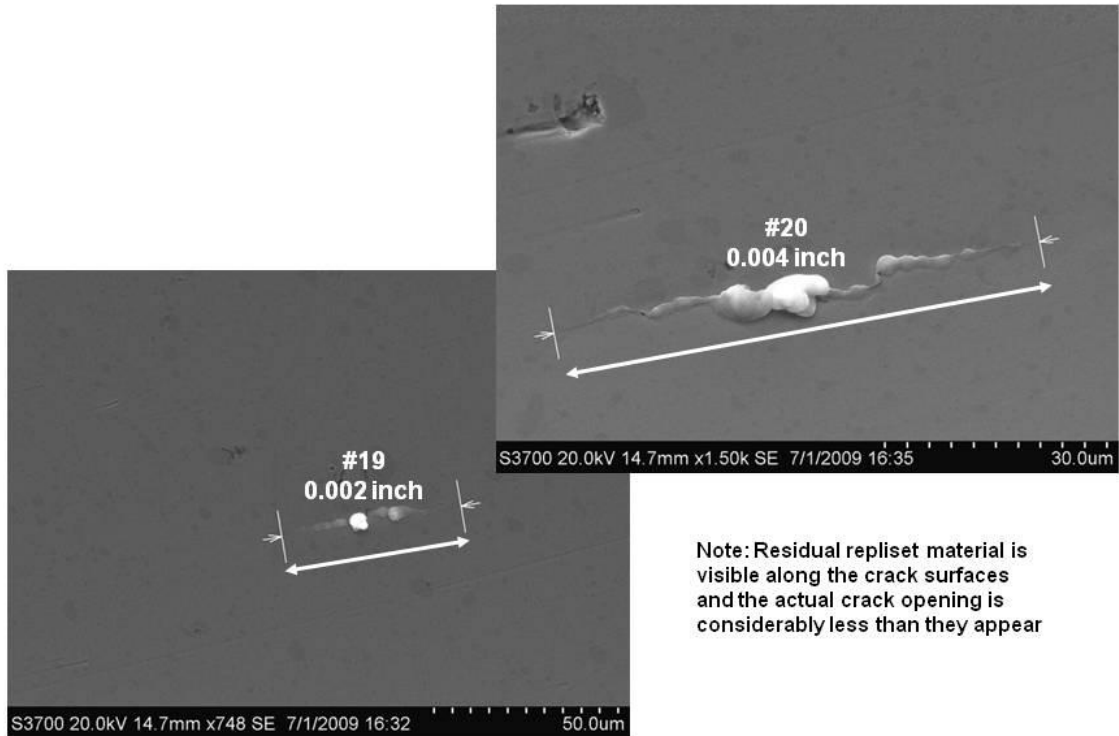
### Size of Cracks #19 and 20

Note: Residual repliset material is visible along the crack surfaces and the actual crack opening is considerably less than they appear

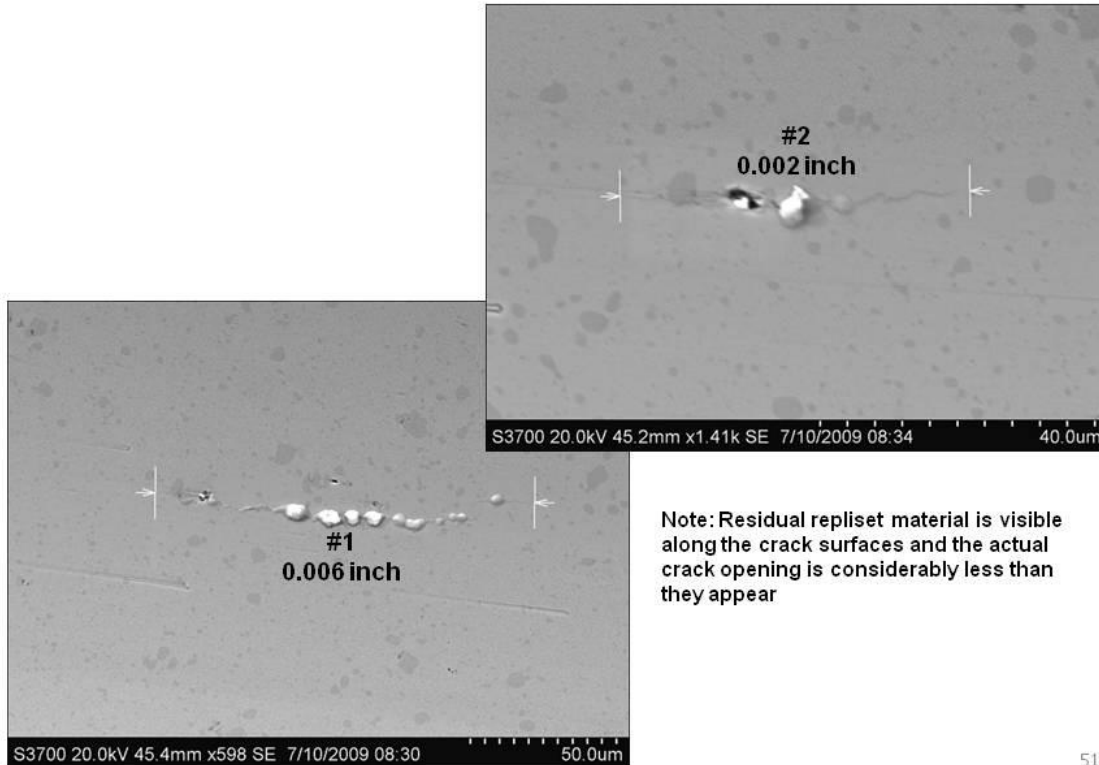
Location and size of Cracks #1 and 2

Note: Residual replet material is visible along the crack surfaces and the actual crack opening is considerably less than they appear

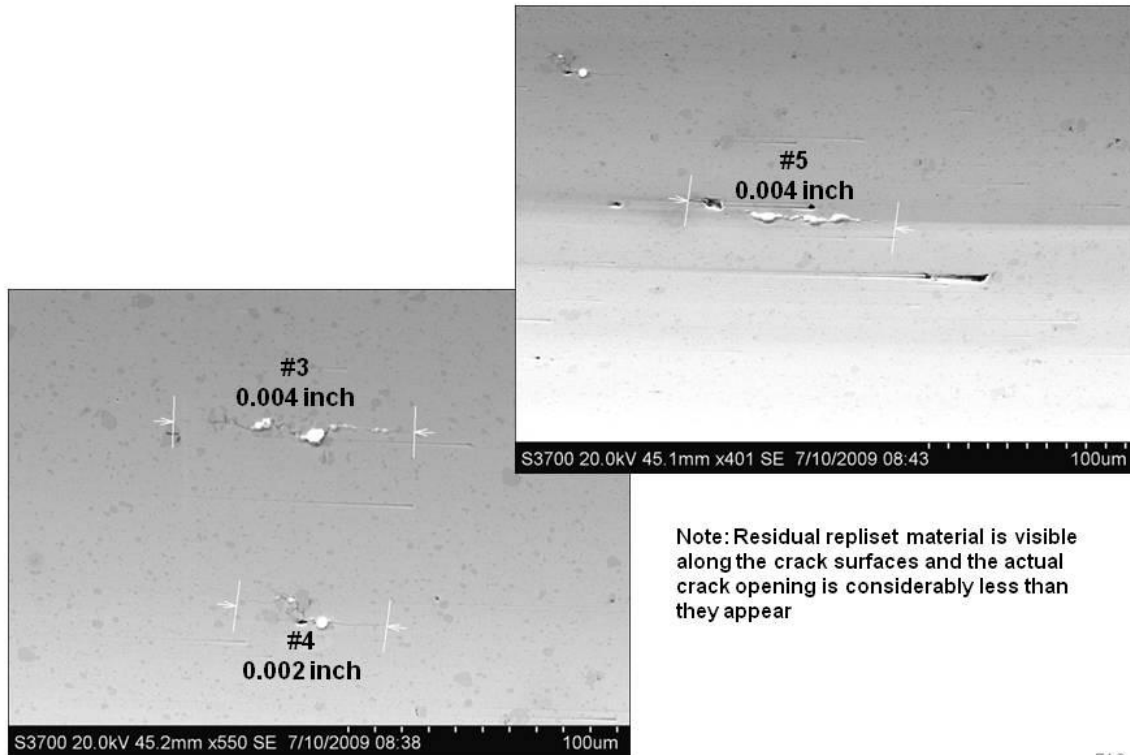
Location and size of Cracks #3-5

Note: Residual replet material is visible along the crack surfaces and the actual crack opening is considerably less than they appear

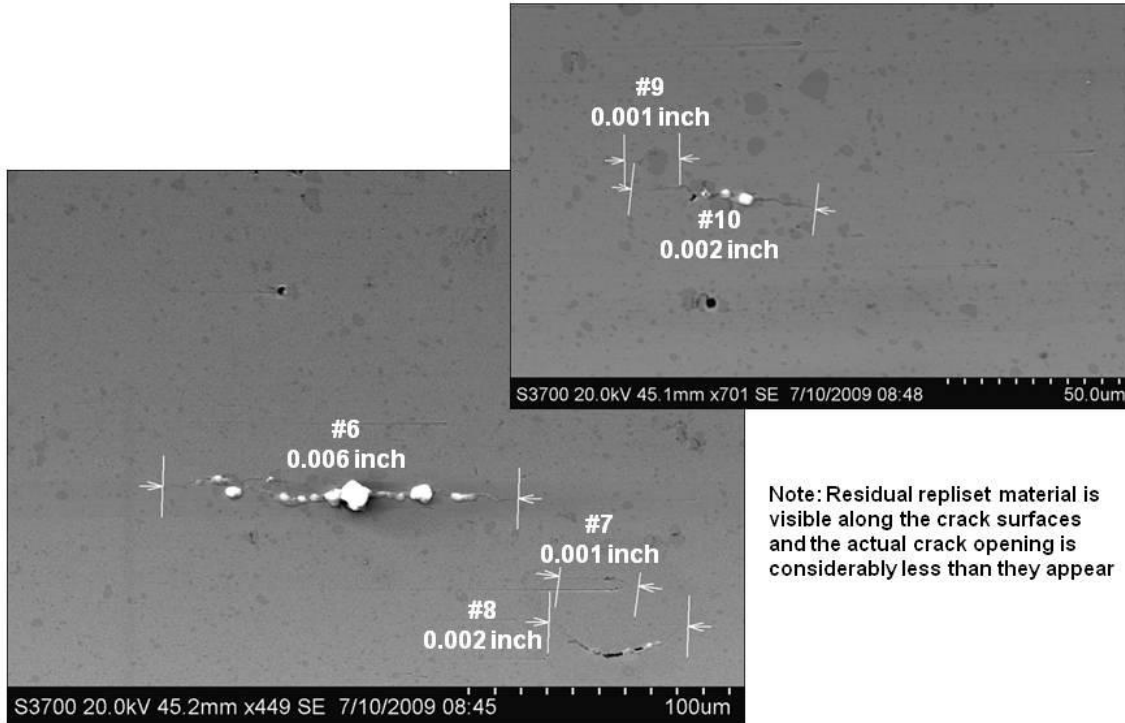
Location and size of Cracks #6-10

Note: Residual replet material is visible along the crack surfaces and the actual crack opening is considerably less than they appear
