Pressure Testing of a Minimum Gauge PRSEUS Panel

Andrew E. Lovejoy¹ and Marshall Rouse²
NASA Langley Research Center, Hampton, VA 23681

Kim A. Linton³ and Victor P. Li⁴
The Boeing Company, Seal Beach, CA 90740

Advanced aircraft configurations that have been developed to increase fuel efficiency require advanced, novel structural concepts capable of handling the unique load conditions that arise. One such concept is the Pultruded Rod Stitched Efficient Unitized Structure (PRSEUS) developed by the Boeing Company. The PRSEUS concept is being investigated by NASA's Environmentally Responsible Aviation (ERA) Program for use in a hybrid-wing body (HWB) aircraft. This paper summarizes the analysis and test of a PRSEUS panel subjected to internal pressure, the first such pressure test for this structural concept. The pressure panel used minimum gauge skin, with stringer and frame configurations consistent with previous PRSEUS tests. Analysis indicated that for the minimum gauge skin panel, the stringer locations exhibit fairly linear response, but the skin bays between the stringers exhibit nonlinear response. Excellent agreement was seen between nonlinear analysis and test results in t

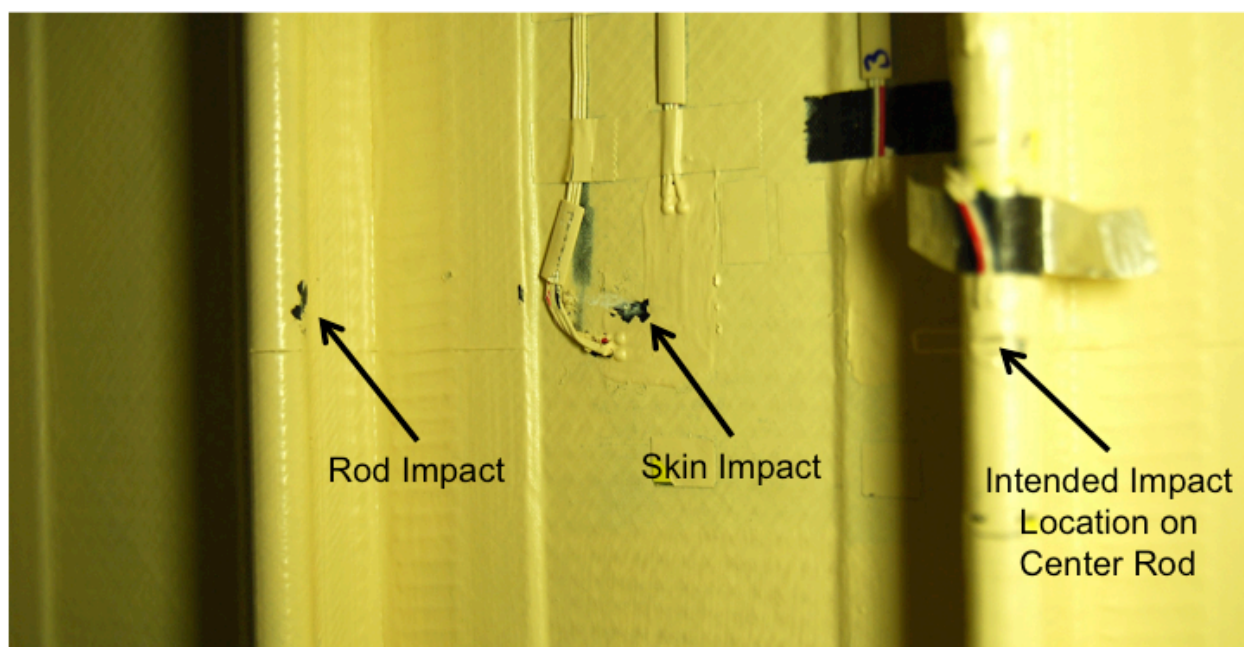
Prior to applying load level 3, the panel was impacted with barely visible impact damage (BVID) at an impact energy of 20 ft-lbs. This energy level is meant to represent the ultimate force that a tool drop or other such event would impart on the inside surface of an aircraft, and has been used on previous PRSEUS tests.¹⁴ A spring-loaded impactor was used with a 1-inch diameter impact tup. The impactor was positioned against the side of the center stringer to inflict an impact at an angle of approximately 40 degrees measured from the plane of the panel. However, during execution, the impact apparatus slipped, and the impactor had a glancing blow to the skin, and then impacted the side of the stringer adjacent to the center stringer. Figure 22 shows the impact locations. Since the angle of impact with the skin was very shallow, it is believed that the impact to the adjacent stringer was very close to the desired 20 ft-lb energy level. Previous testing has shown that little effect is seen to the response and failure load due to impacts at this energy level to either the top or side of the rod region.¹⁴ Also, since the strains in the stringers adjacent to the center stringer are almost the same as those in the center stringer, it was concluded that this impact was sufficient so no additional impact was imparted.

Fig. 22. Impact of panel skin and stringer.

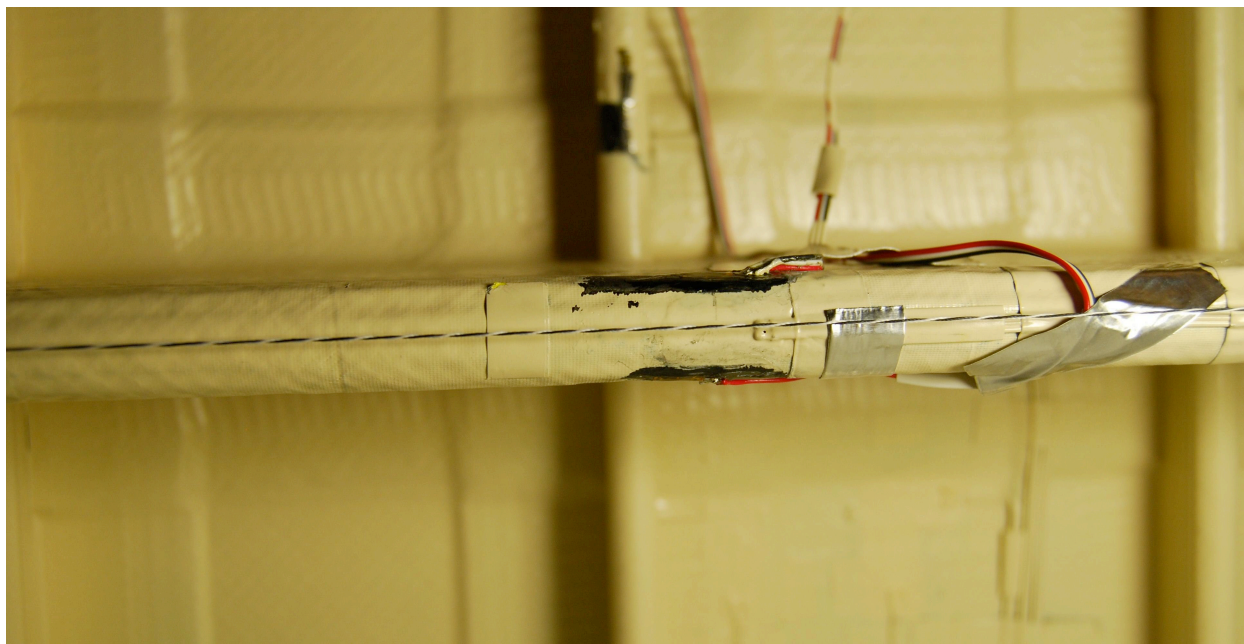
The VIC out-of-plane displacement plot from load level 2 (Fig. 15a) shows a slight offset in the displacement field. This offset suggested unsymmetric response of the frames during pressurization, and is a possible cause for the difference between analysis and load level 2 test response for some gages near the edge of the panel. Unsymmetric response of the frames could be due to initial geometric imperfections in the frames or boundary condition effects. Therefore, also prior to applying load level 3, the frames were checked for straightness using a twisted pair of white and black thread as shown in Fig. 23. This straightness check indicated that both frames appeared to be very straight, and therefore it is unlikely that initial imperfection of the frames caused this unexpected frame response. In order to monitor bending of the frames during load level 3, additional strain gages were added to either side of the frame tops at the center of the frame length, and were identified simply by numbers 42 – 45. Gages 42 and 43 are back-to-back on the frame top adjacent to the gages at the edge of the panel shown in Figs. 7 and 8, with gage 42 being located on the side of the frame toward the center of the panel. Gages 44 and 45 are back-to-back on the other frame top, with gage 44 being located on the side of the frame toward the center of the panel.

Fig. 23. Straightness of frame using twisted white and black thread.

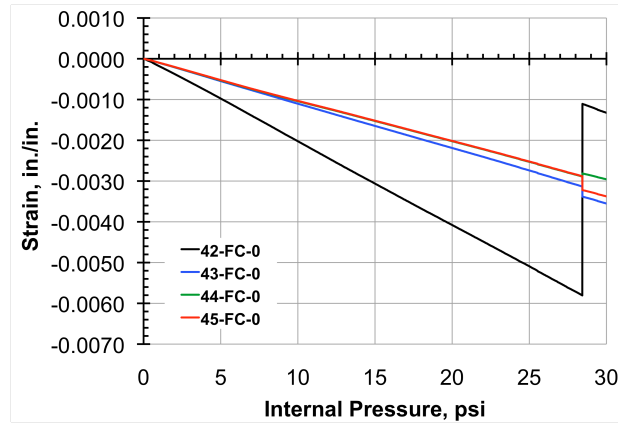
Fig. 30 shows the response for frame gages 42 – 45. Gages 42 and 43 clearly indicate bending of the frame. The lower strain value on gage 43 indicates that the frame is bending toward the edge of the panel until the center stringer fails, at which time the frame jumps to bending toward the center of the panel. Gages 44 and 45 show that the other frame does not exhibit any bending until after the center stringer fails, as the strain plots are coincident up to failure of the center stringer. After failure of the center stringer, this frame also bends towards the center of the panel. This unsymmetric response of the frames exhibited during the test is contrary to the finite element analysis, which predicts that both frames exhibit symmetric behavior and bend toward the center of the panel throughout the entire pressurization sequence.

Fig. 30. Frame 0-degree strain gage response at frame center tops for load level 3.

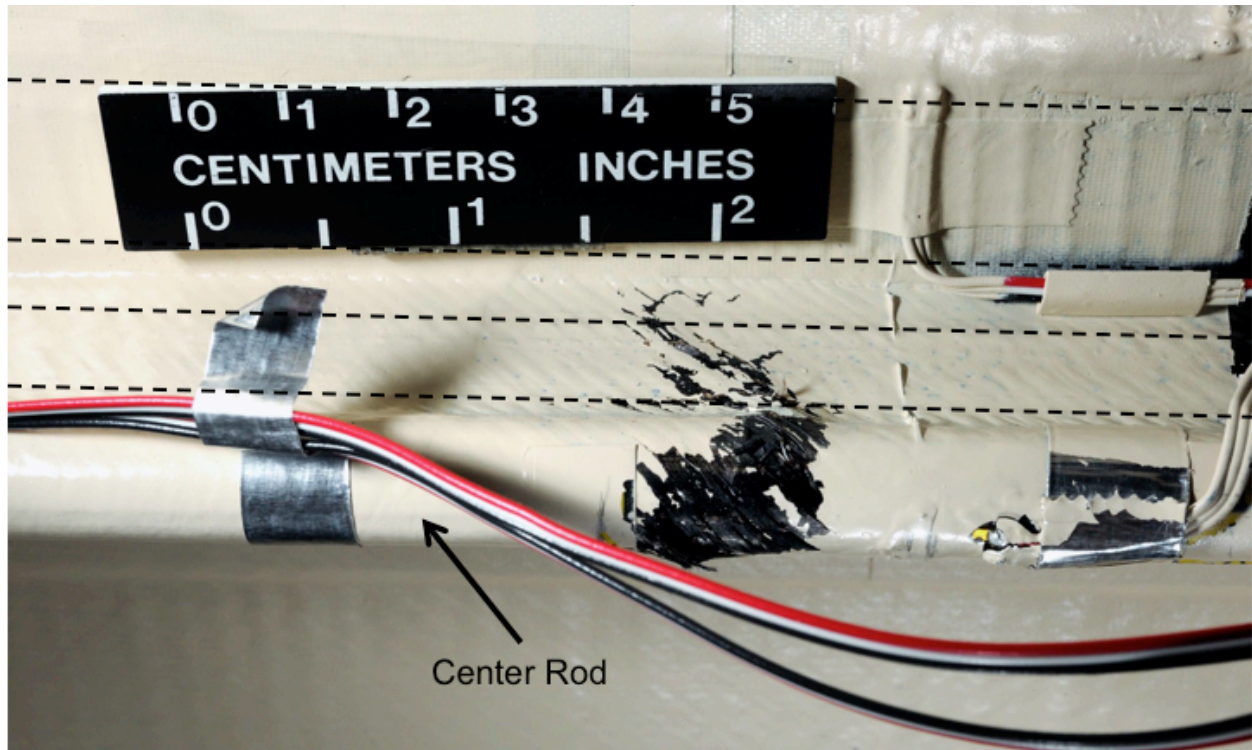
Post-test examination of the panel confirms that the load shift was associated with a failure of the center stringer. Figs. 31 and 32 show the two sides of the center stringer, where the locations of the stitching on the stringer web and flange are shown indicated by dashed lines. Failure is evident in the stringer wrap at the rod location, and damage progresses down the stringer web to the flange. The damage was arrested between the lower stringer web stitching and the stringer flange stitching while the panel was loaded beyond the 28.44 psi level. The pressure was increased to the maximum test pressure of 30 psi, and the damaged panel was able to withstand this increased loading without any indication of further damage. The initial failure at 28.44 psi was 3.0% above the analytically predicted value of 27.6 psi for the pristine panel. As has been mentioned, previous testing has shown little effect to the load carrying capability of the PRSEUS rod when impacted with the level of energy used, so it is not unexpected that the analysis of the pristine panel accurately predicts the response of the panel with BVID on the stringer.

Fig. 31. Center rod damage, side 1. Stitch locations indicated by dashed lines.

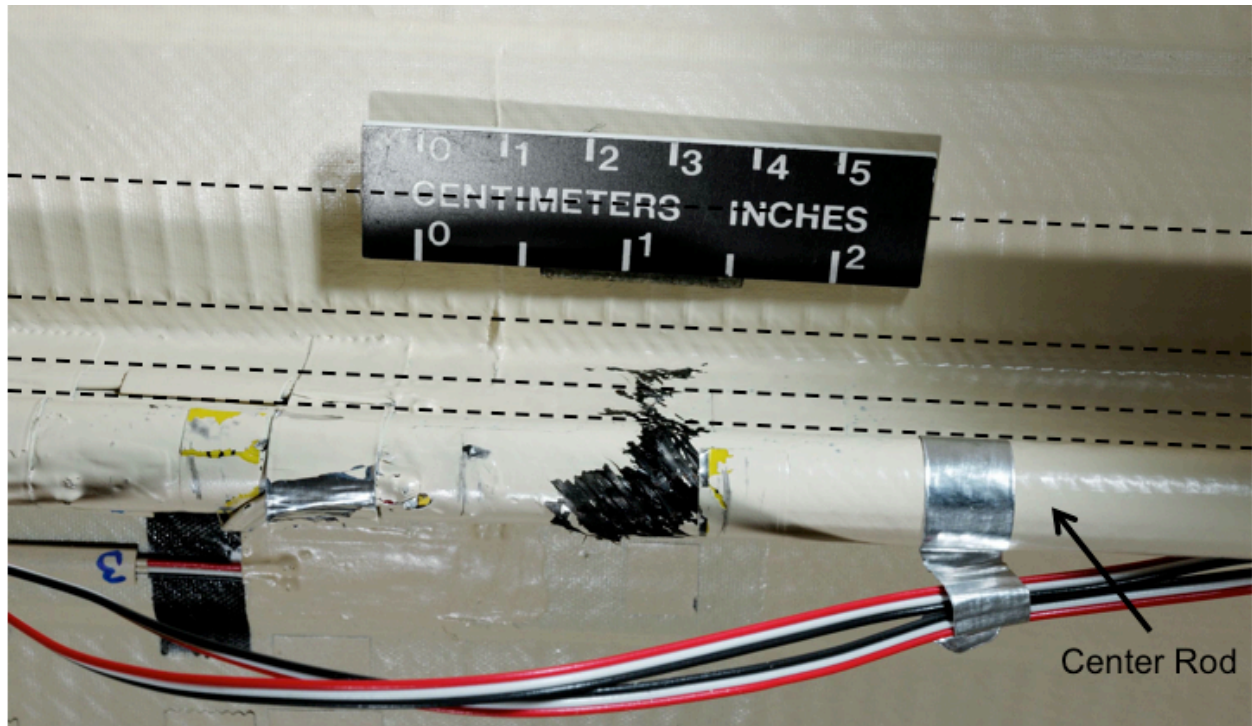
Fig. 32. Center rod damage, side 2. Stitch locations indicated by dashed lines.
