External Surface Changes Observed on the International Space Station (ISS) Through 2010

J. L. Golden, Ph.D.
Boeing Technical Fellow
ICPMSE-10J Okinawa, Japan
13 June 2011

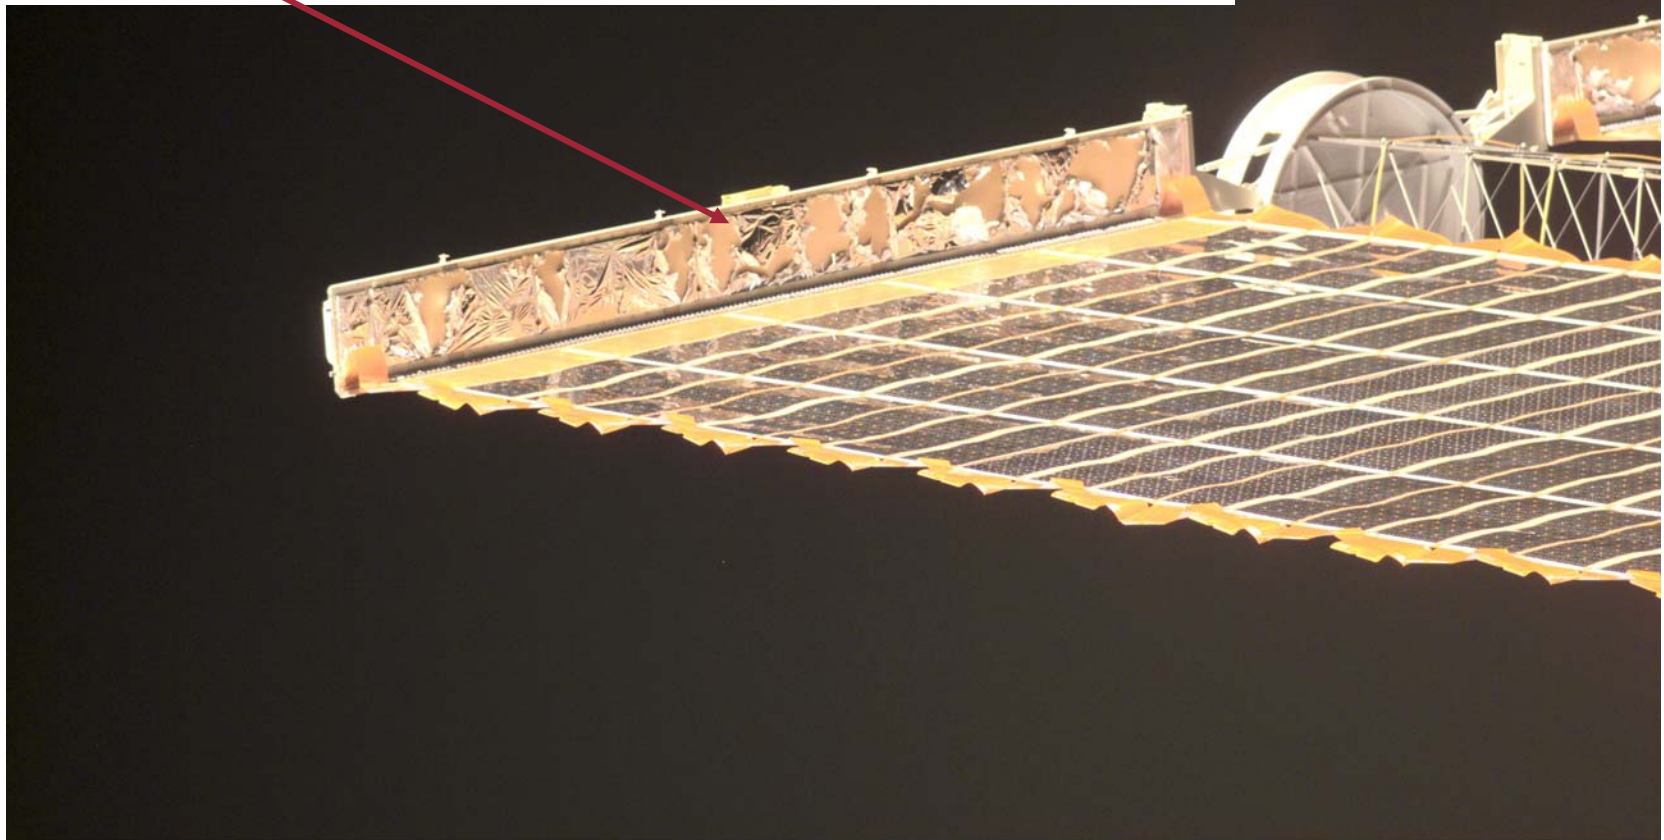
ISS003E5082 2001/08/04 03:40:57

Solar Array Wing (SAW) Blanket Box Assy

Polyimide Foam Covered by Aluminized Polyimide Film

Aluminized Film was severely degraded within months!

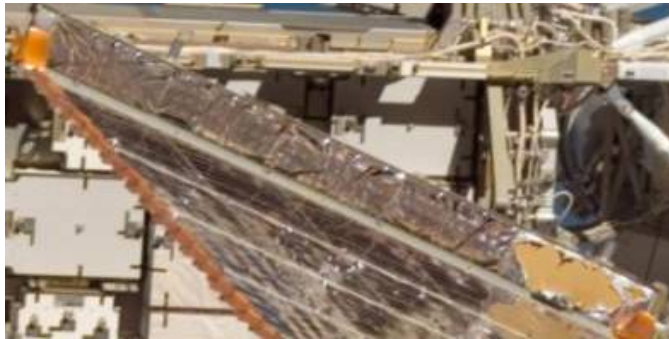
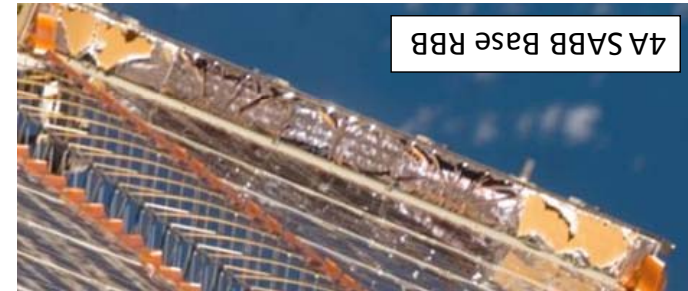
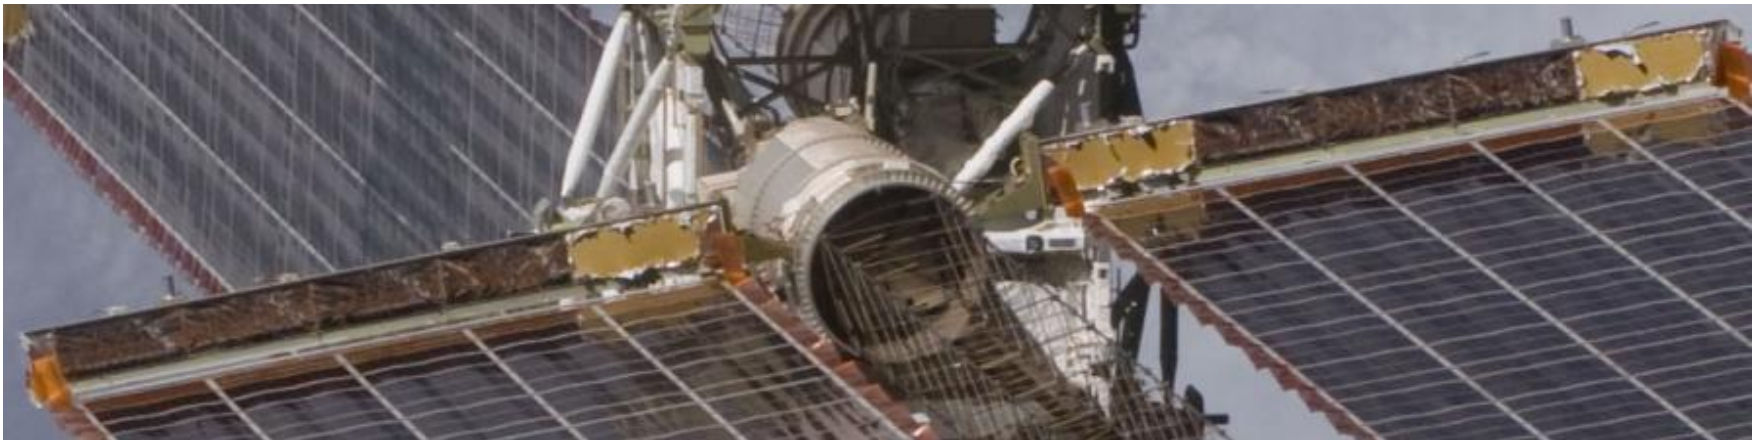
Not all SAWs were equally affected, plus the damaged occurred quickly and did not continue with time.

3 Months

38 Months

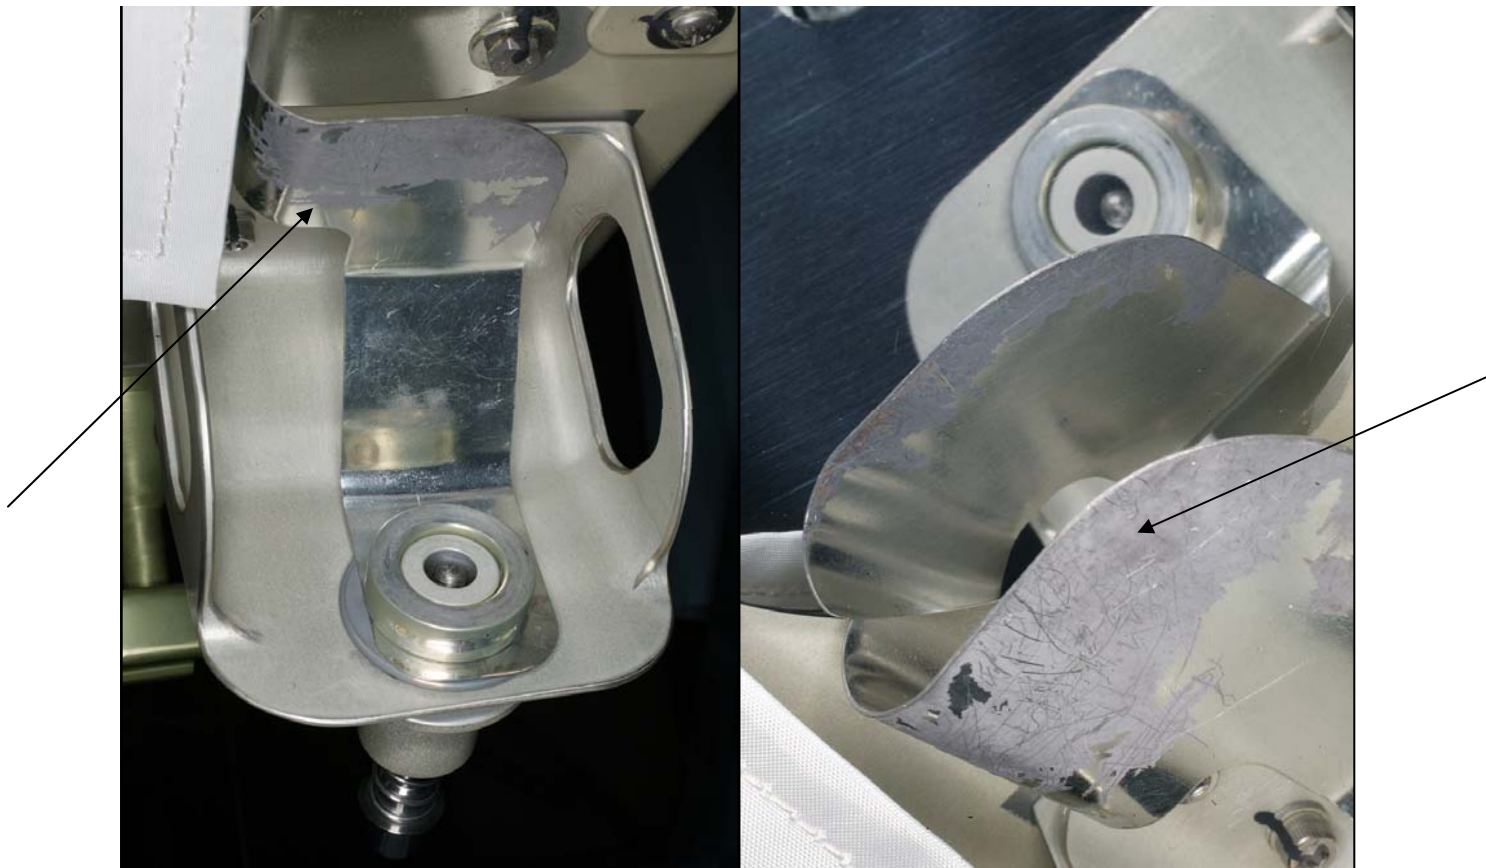
Trailing Umbilical System (TUS) Reel Grounding Strap (Tin-Plated)

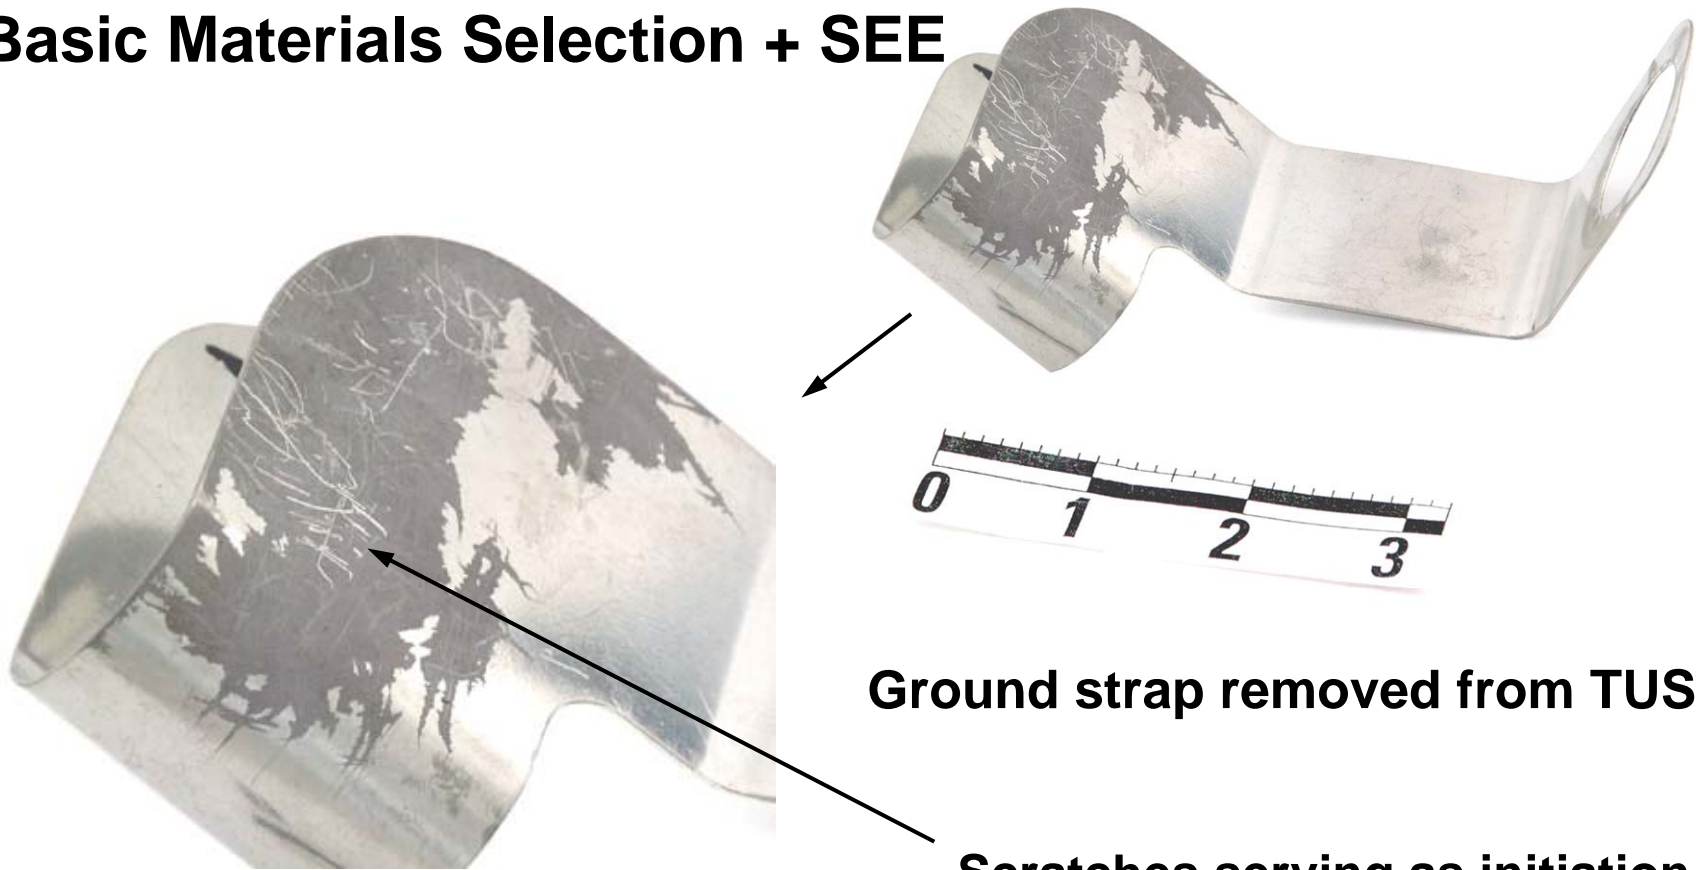
Detail of tin pest region

Ground strap removed from TUS

Scratches serving as initiation sites; low temperatures on-orbit accelerate phase transformation

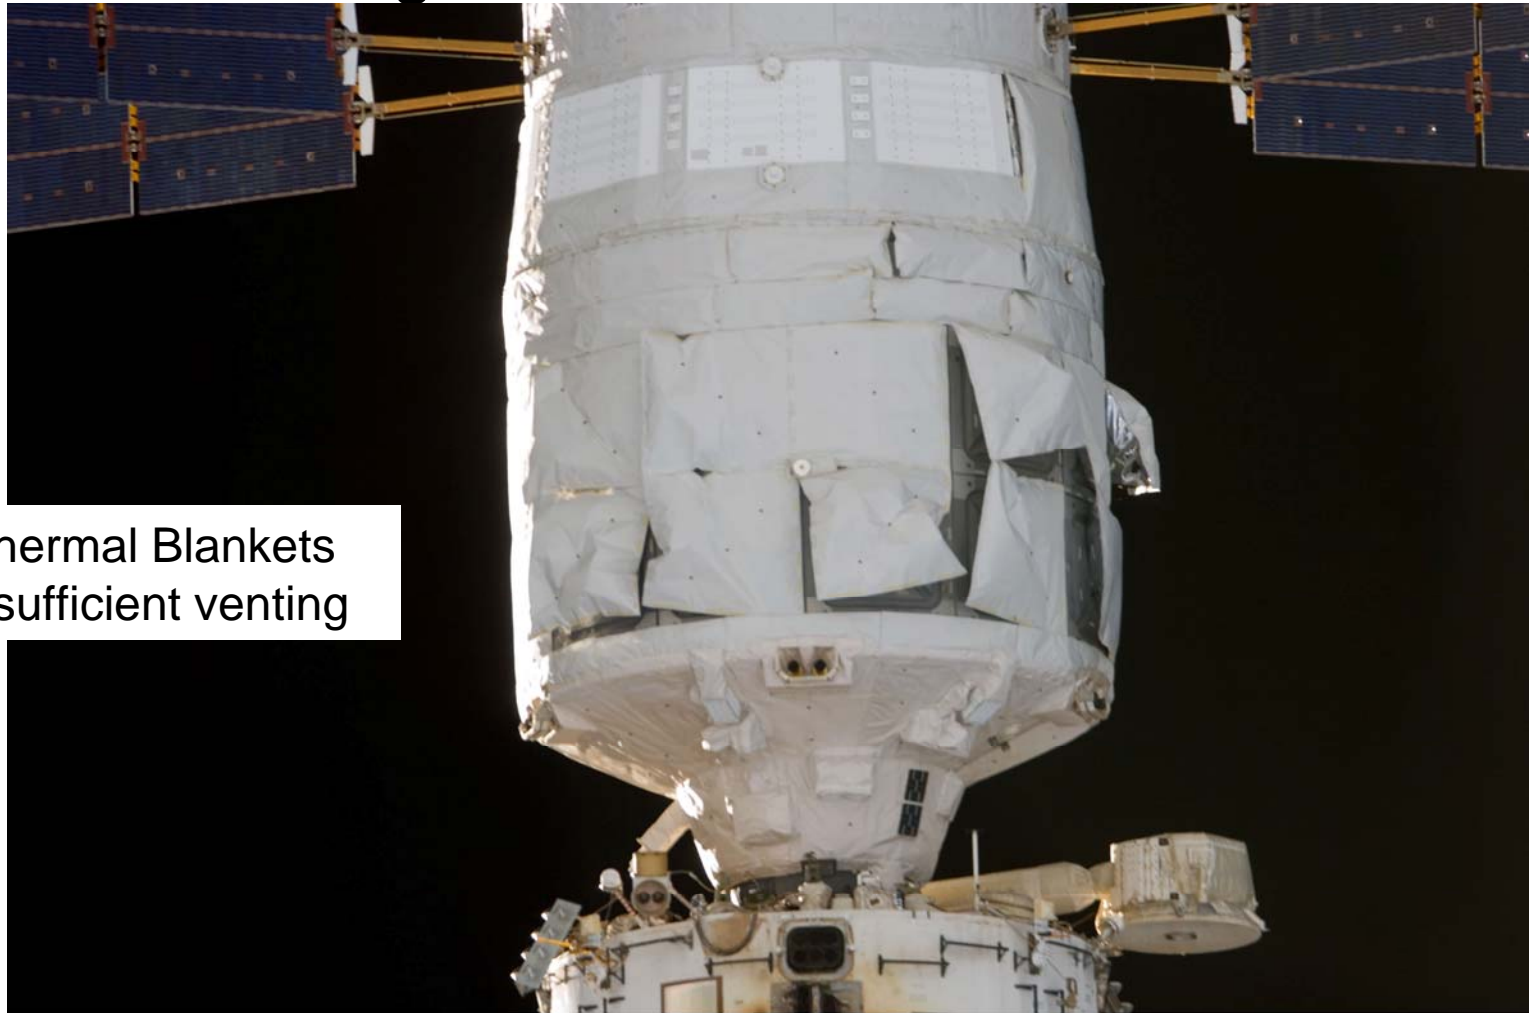
S124E005722

ATV1 Thermal Blankets
show insufficient venting

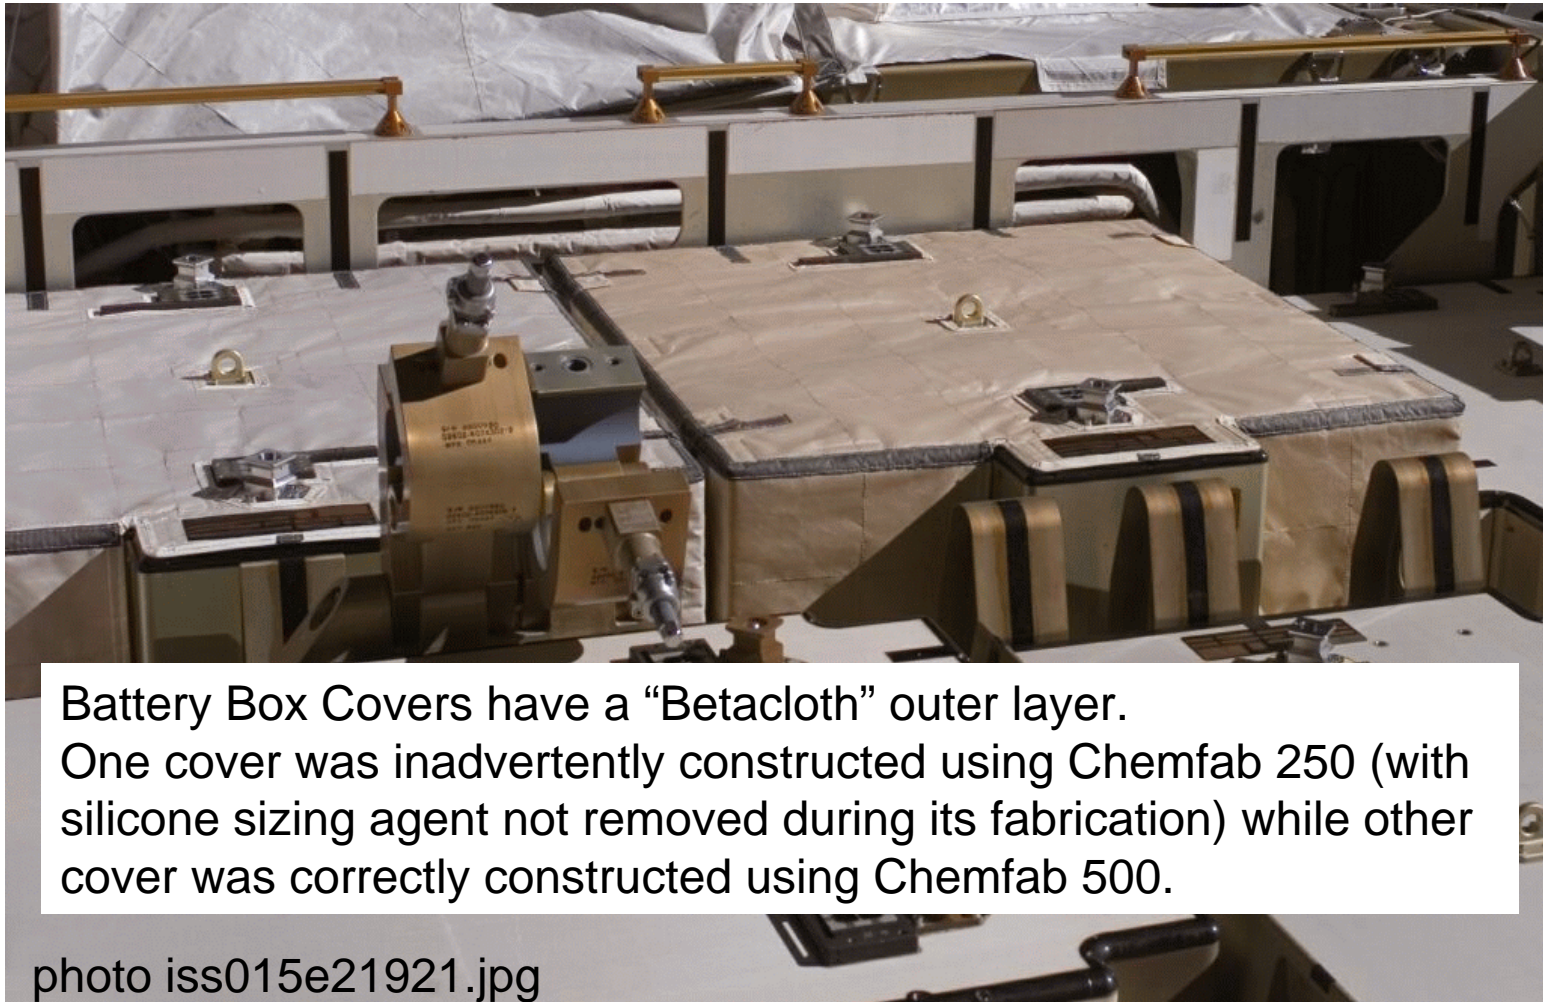
photo iss015e21921.jpg

Battery Box Covers have a “Beta cloth” outer layer. One cover was inadvertently constructed using Chemfab 250 (with silicone sizing agent not removed during its fabrication) while other cover was correctly constructed using Chemfab 500.

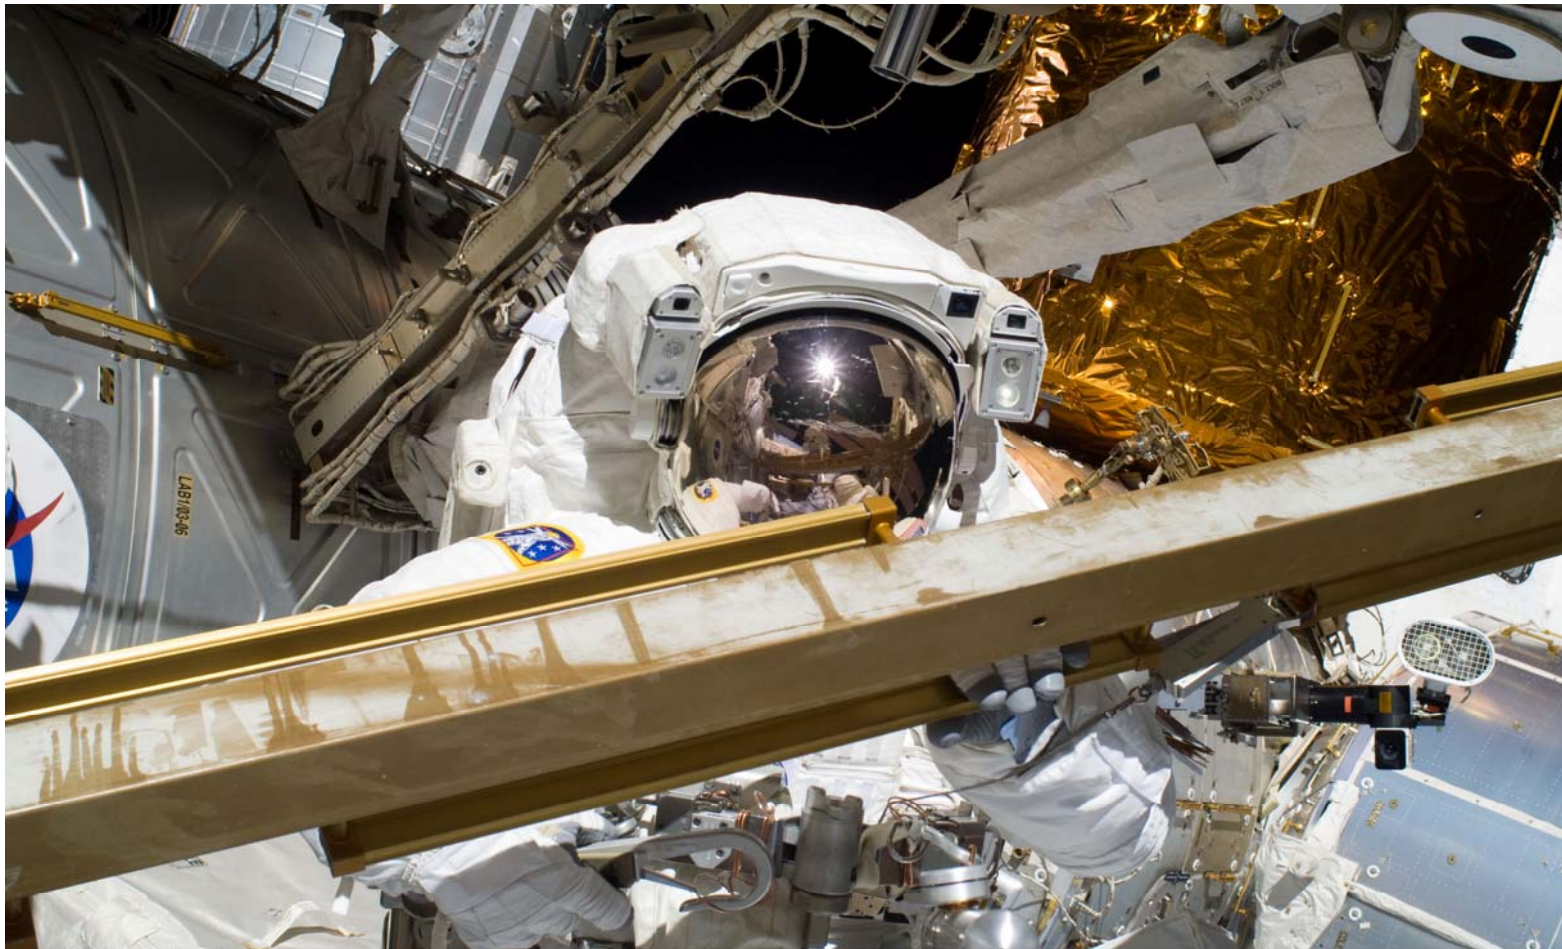
ISS026E030931

Materials Handling Issues (Ground Contamination)

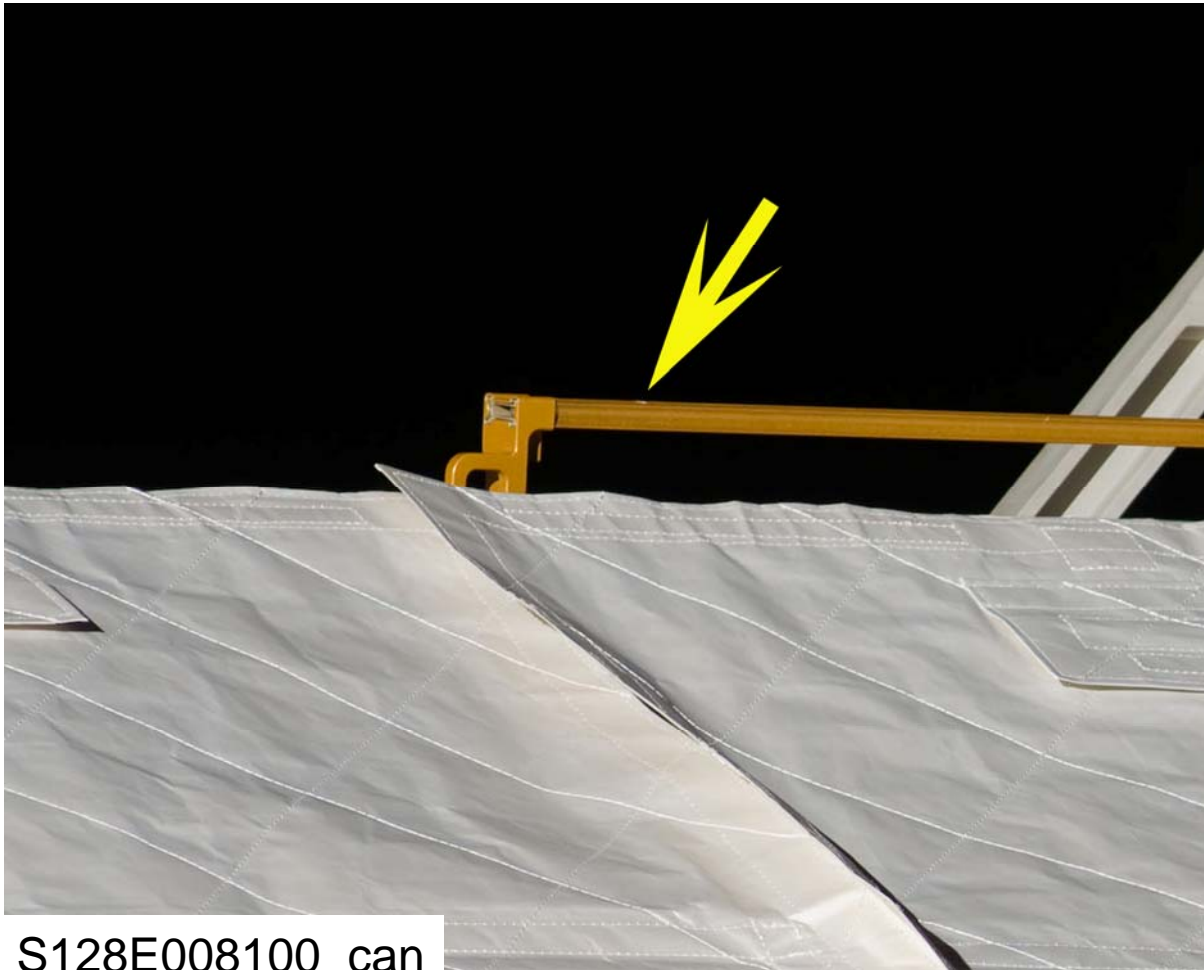
S128E008100_can

MMOD impacts on handrails are becoming increasingly troublesome, causing EVA glove damage

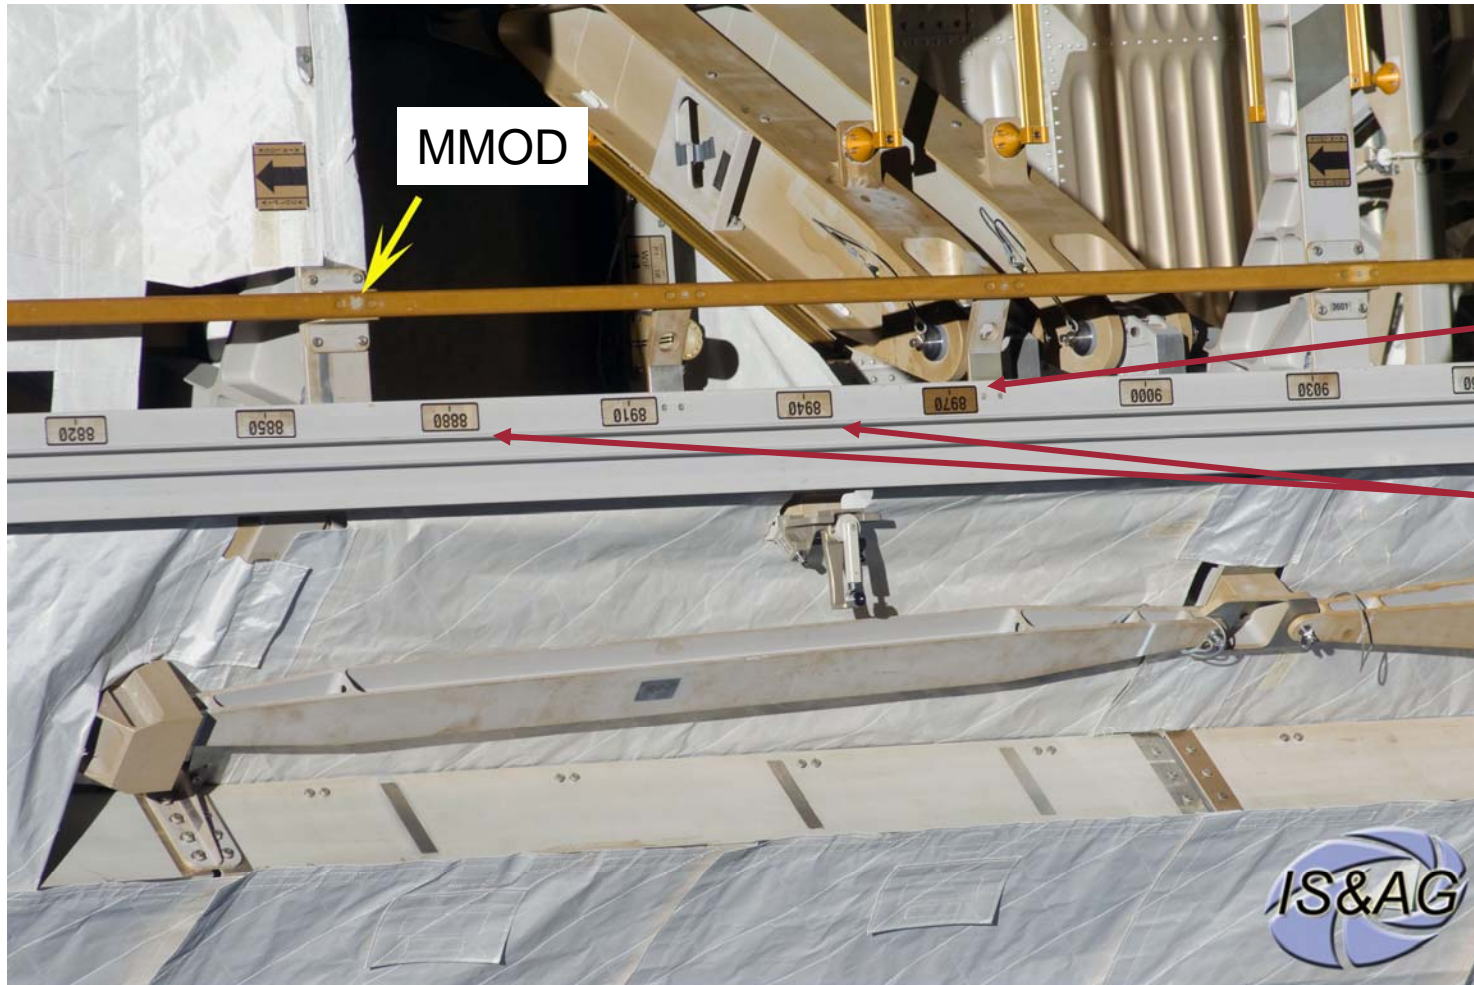
S128E008103

Anodized aluminum labels, which darkened quickly, have begun to recover their expected appearance with continued AO exposure!

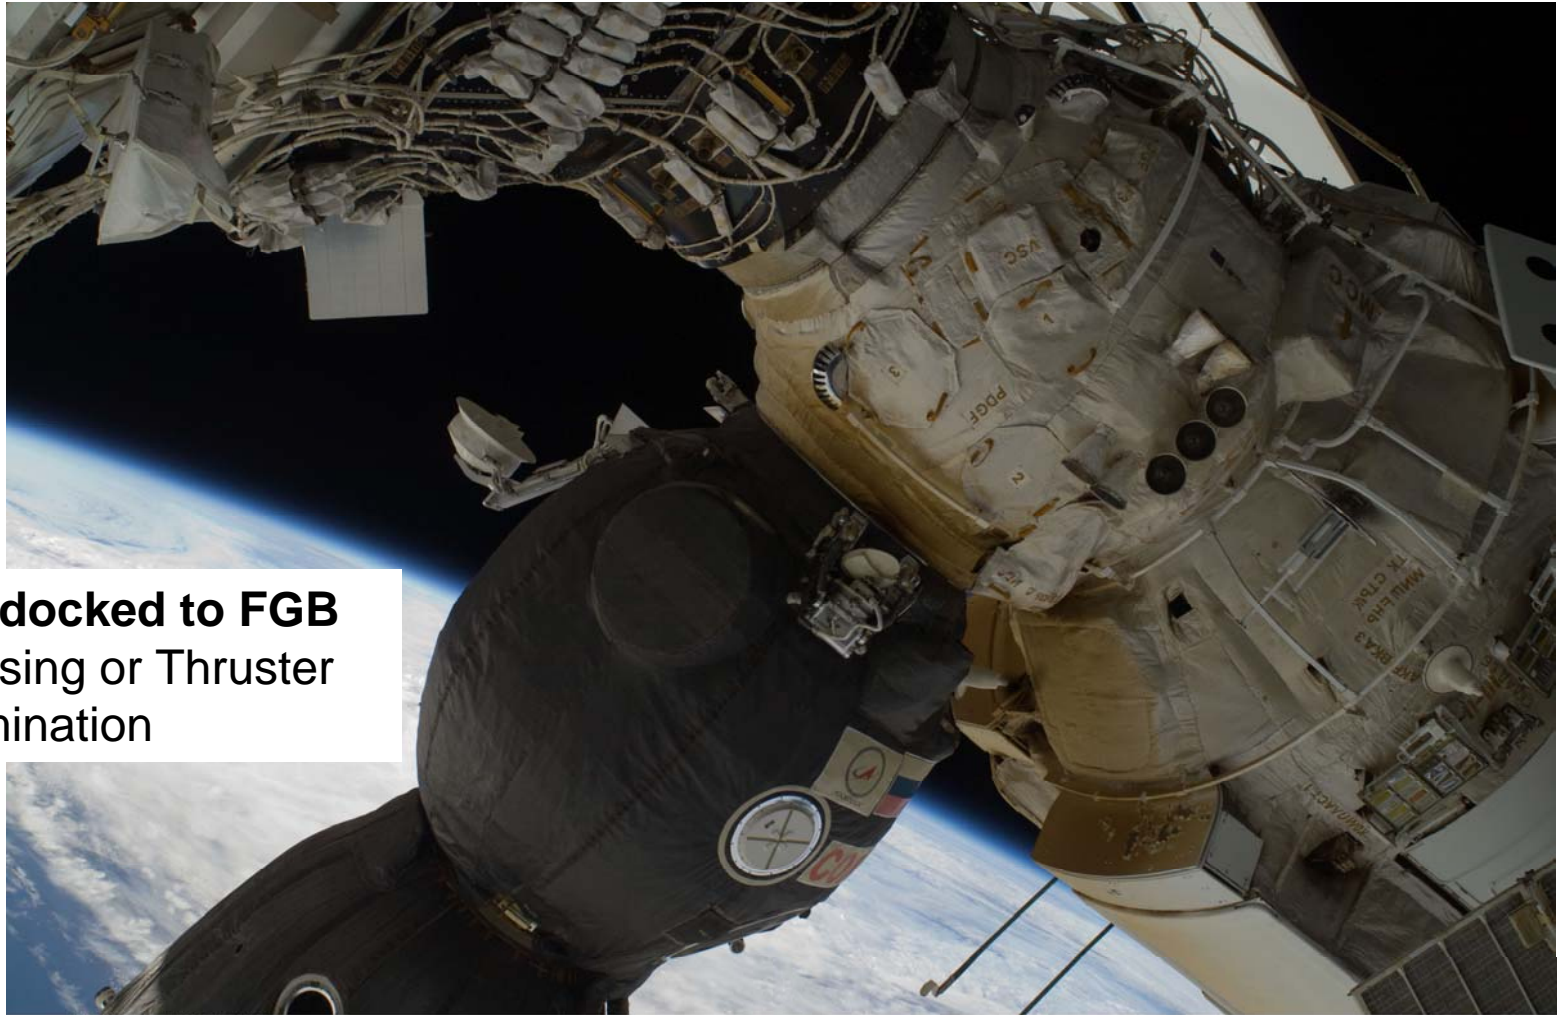
ISS022E067004

Soyuz docked to FGB
Outgassing or Thruster
Contamination

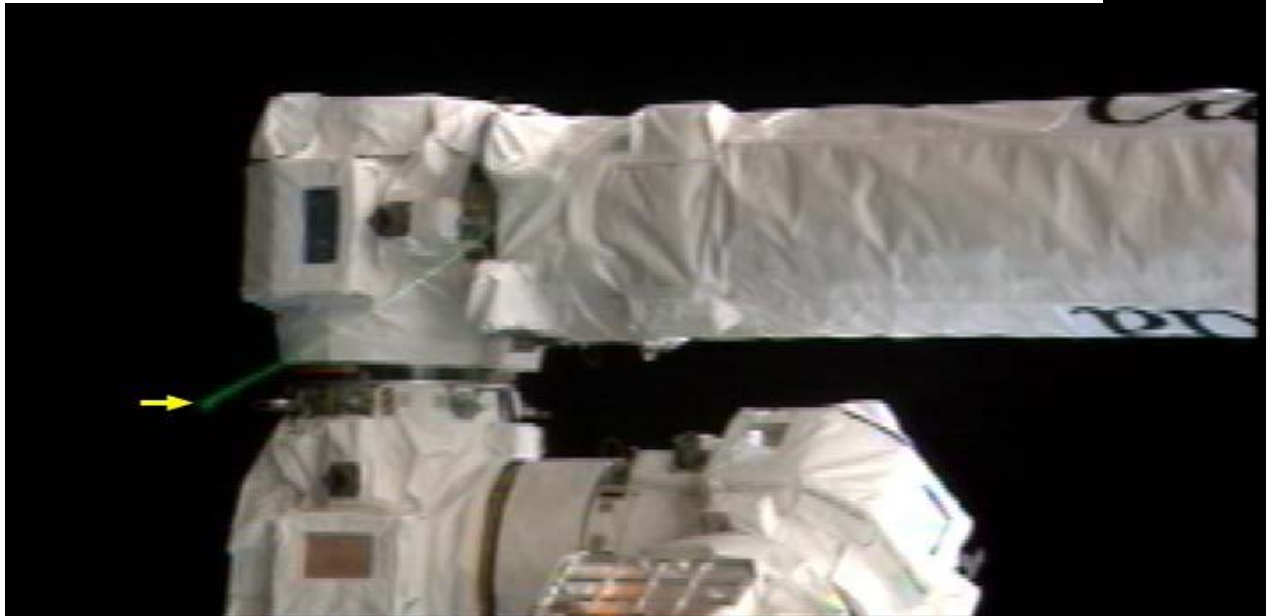
Charged Particle affecting Digital Video Camera Imaging

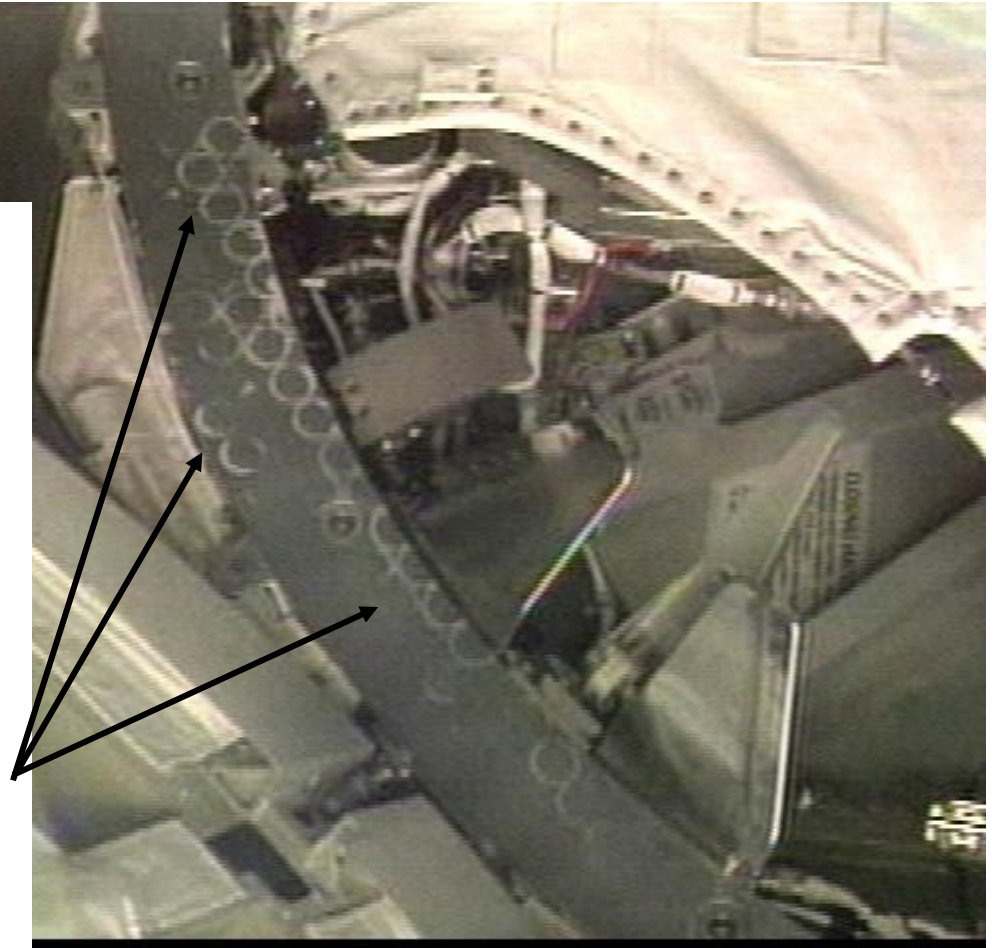
Pre-berthing inspection of a Node 1 sealing surface in 2001 identified these circular features as a concern. These features were later determined to be reflections of the camera's LED lighting system on the smooth, anodized aluminum sealing surface. No such feature actually exists.
