A Comparative Analysis of Two Full-Scale MD-500 Helicopter Crash Tests

Justin Littell

ATK Space Systems, NASA Langley Research Center MS 495, 12 W. Bush Rd, Hampton Virginia 23681

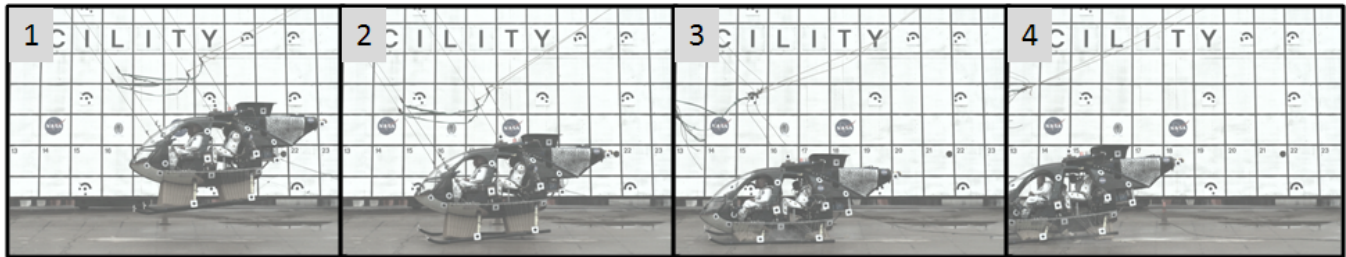
Fig. 6 MD-500 test which included the DEA - Image Sequence

In Figure 6, picture 1 (left) shows the helicopter approximately 30 ms before impact, pitched down and with some slight yaw. The yaw can be seen by noting the difference in horizontal position in the near and far skid gear. Picture 2 (left center) shows the helicopter at the point of right skid gear impact. Picture 3 (right center) shows the point of maximum DEA crushing stroke, and picture 4 (right) shows a post-impact rebound, again noting that the vehicle's nose has pitched down. At the point of maximum crush deflection (picture 3), the helicopter straightened out to show almost no pitch. After the point of maximum crush, the nose pitched forward on the rebound, presumably due to friction between the DEA and the impact surface. An analogous sequence is shown in Figure 7 for the MD-500 test which did not include the DEA.

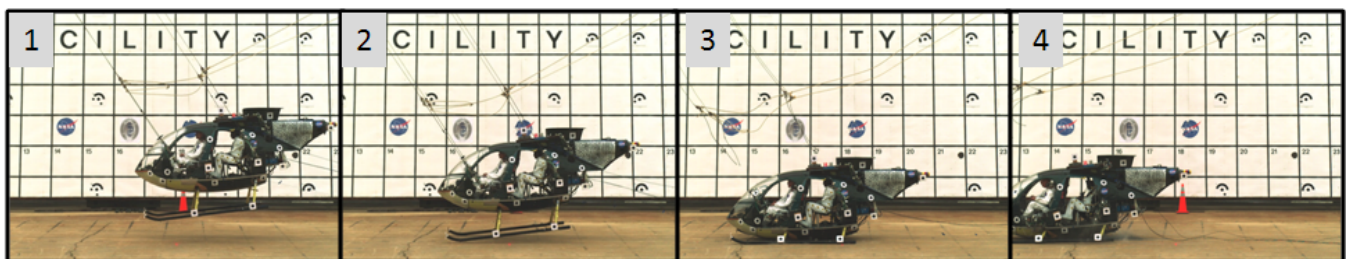
Fig. 7 MD-500 baseline test - Image Sequence

In Figure 7, picture 1 (left) shows the helicopter before impact. Note that due to the minimal roll and yaw present, the tips of the near and far skid gears were approximately at the same longitudinal position. Picture 2 (left center) shows the helicopter at the point of first skid gear impact. As before, for the MD-500 baseline test, the far (right) gear impacted the ground first which was due to the minor amount of yaw and roll present. Picture 3 (right center) shows the point of maximum vertical displacement, noting that the helicopter still had a down pitch orientation. Picture 4 (right) shows a post-impact rebound. After the point of maximum vertical deflection, the nose pitched forward on the rebound, presumably due to the downward pitch of the nose at impact. Post test photographs document some of the differences in the helicopter after the completion of each test, and are included to show the damage incurred. Figure 8 shows the post impact position of the helicopter immediately after each test.

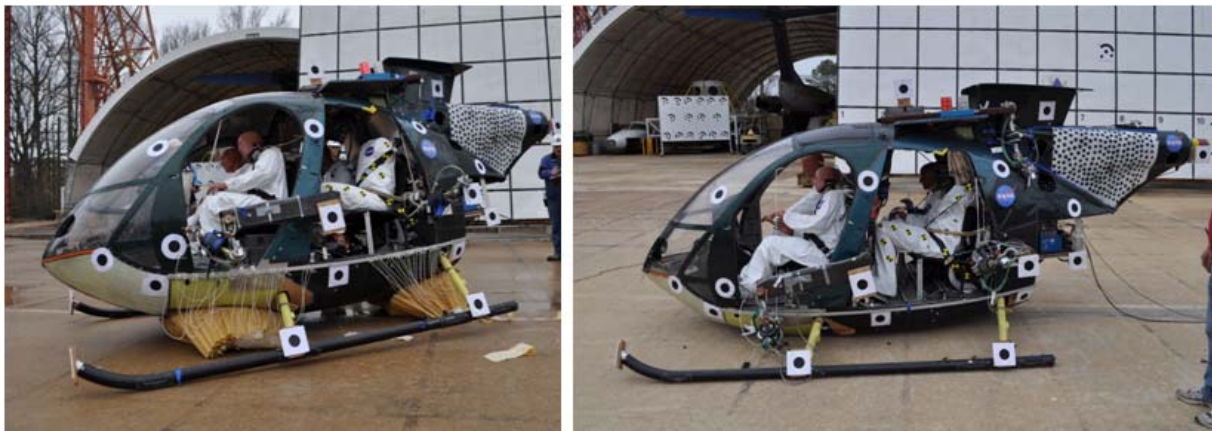
Fig. 8 Post test impact position of the MD-500 with DEA (left) and baseline (right)

Due to the presence of some yaw in both tests, the helicopter turned to the left during the post-impact slide out. The slide out distance for the test which included the DEA was 13.86 m (45 ft 6 in). The slide out distance for the baseline test was 15.57 m (51 ft 1 in). The slide out difference is attributed to the friction contact between the DEA and the impact surface. The MD-500 with DEA turned a greater distance, presumably due to the greater amount of yaw and yaw rate. Finally, it is noted that all of the onboard occupants for both tests are leaning to their right, presumably from the helicopter turning to the left.

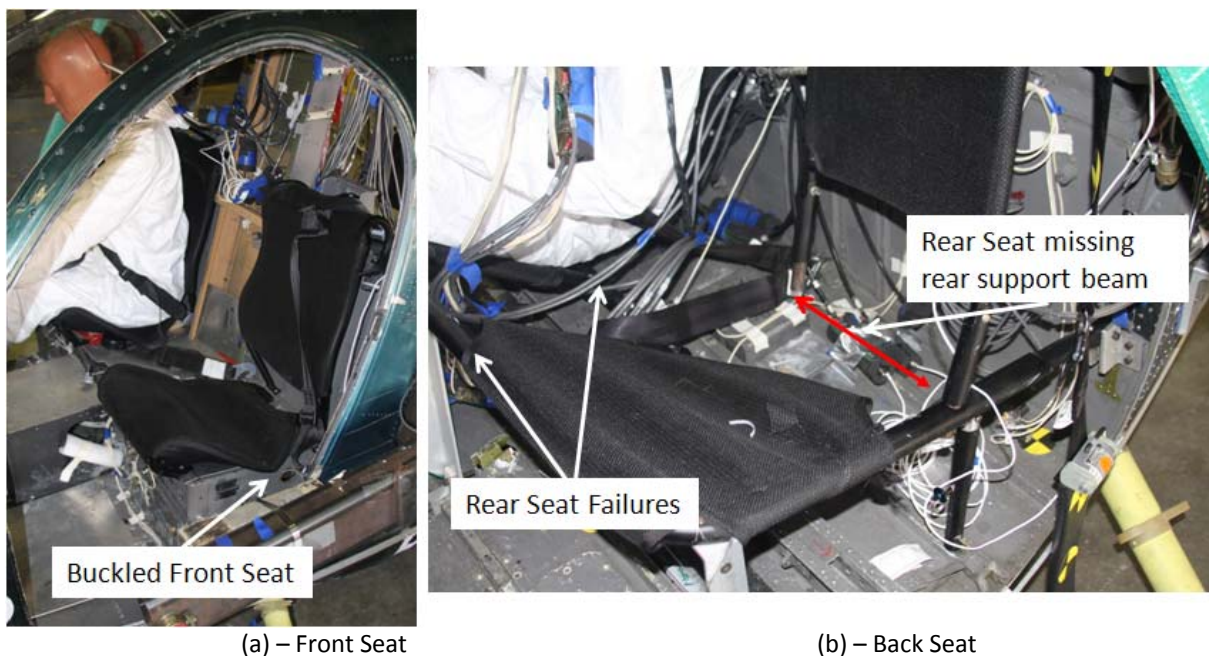
Fig. 9 Seat failures in MD-500 baseline test

Further inspections were completed after the helicopter was moved from the impact area. Figure 9 shows the condition of the front bucket and rear bench seats after the baseline test. Pictures of the test which included the DEA are not shown because the seats remained intact during that test. However, Figure 9 shows the front bucket seats buckled in multiple places, one of which is highlighted in Figure 9(a), while much of the rear seat failed, as shown in Figure 9(b). The rear support beam sheared from its connection points, while the front beam and the side beams have sheared and split at their attachment point junctions.

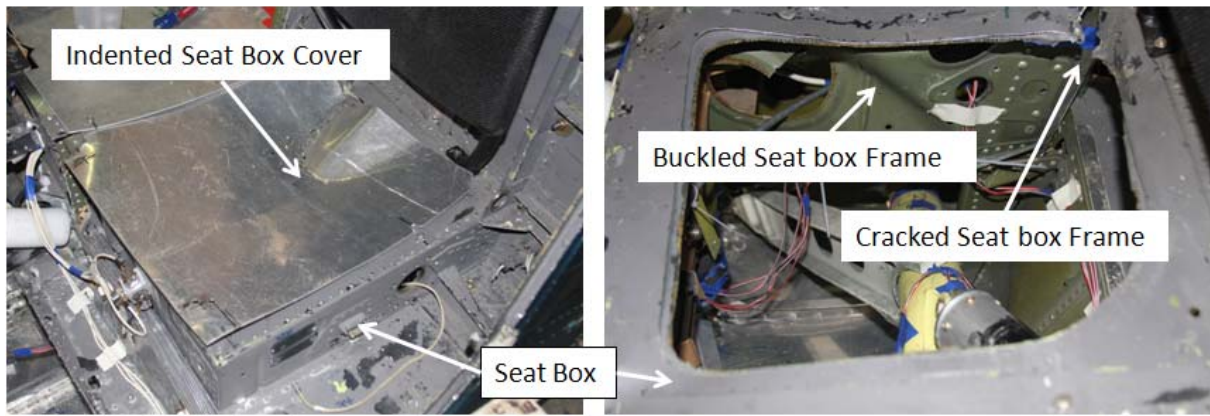
Fig. 10 Front seat box structural deformations

The seats and occupants were removed from the airframe and deformations of the supporting seat box structure were examined. Figure 10 shows the structure in the vicinity of the front seat box for the MD-500 baseline test. The post test photographs show extensive damage around the seat box area for the baseline test. The buckling of the front bucket seats caused the occupants to directly impact and dent the seat box cover. The seat box was cracked and the seat box support structure buckled. Figure 11 shows pictures looking further down below the seat box and into the subfloor.

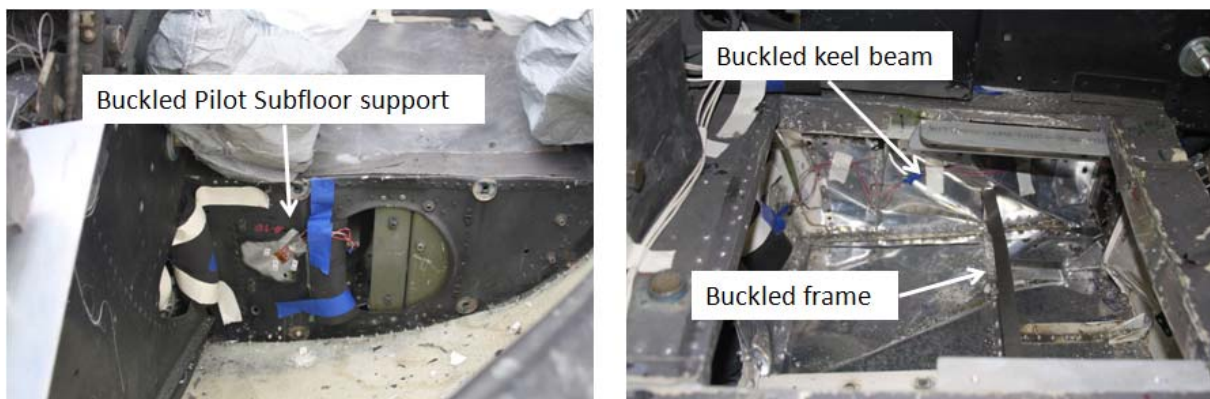
Fig. 11 Forward structural failures in MD-500 baseline test

Areas below the seat box under the pilot and copilot showed extensive buckling. The subfloor support showed signs of damage, while the middle keel beam and co-pilot frame also buckled. Figure 12 shows the damage from the keel beam under the rear occupants for the baseline test. As Figure 12 shows, major structural damage is seen in the rear keel beam. Cracks and buckled regions (not shown) were present under the rear floor, indicating major damage to the bottom section of the airframe. These failures are in contrast to the test which included the DEA, where the airframe did not show any signs of damage.

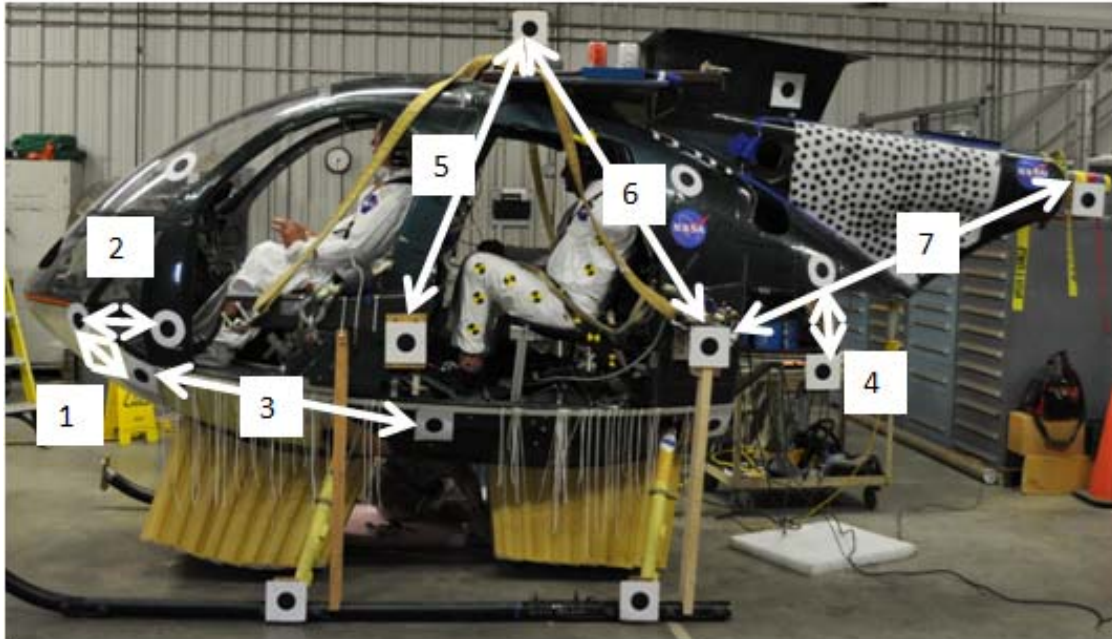
Fig. 19 MD-500 Photogrammetric Structural Deformation Locations

Table 3 shows that the highest relative displacements occurred in the front of the vehicle and near the rear at Position 4, for the test which included the DEA. The relative displacements in the front occurred when the nose impacted the surface first due to the pitched down orientation of the helicopter at impact. The large deformations from the DEA crushing upon impact pushed the front targets upward while the ballast mass in the nose continued downward. However, the photogrammetry results also showed that no permanent deflection occurred. The other area of high relative deflection was near the rear of the helicopter, under the tail support, in position 4. Position 4 measured the relative deflection on a

bar which connected the aircraft frame to a metal plate which held the onboard data acquisition system, acting as the ballast mass for the engine. The plate and data acquisition system weighed approximately 69 kg (150 lb) total, and was attached to brackets located on the tail. During impact, the inertial load into the tail due to the large amount of ballast mass in combination with the large amount of compliance in the tail caused the surrounding airframe to deform. However, the deformation was elastic in nature and the structure rebounded to its pre-impact position. All other areas examined exhibited low deflection, and confirmed the findings from the visual inspections that the airframe was relatively undamaged.

Large relative deformations were seen for the test which did not include the DEA, and confirmed the findings seen in Figures 8 through 12. The common trend in the photogrammetry data showed that the areas which had large amounts of ballast mass produced the areas of largest displacement. Ballast mass for the main rotor affected both Position 5 and 6, ballast mass for the engine affected position 4 and ballast mass for the tail rotor affected position 7. These inertial loads were not absorbed by the DEA structure since it was not included in the second crash test, which deformed the airframe the greatest amount. These photogrammetric results, along with acceleration profiles and visual inspections post-test showed that the airframe was unusable after the test.
