# 47th AIAA/ASME/SAE/ASEE Joint Propulsion Conference & Exhibit

## Lessons Learned from the Space Shuttle Engine Hydrogen Flow Control Valve Poppet Breakage

Abstract authored by Hugo E. Martinez, in collaboration with John Albright, Stephen Damico, and John Brewer of NASA's Johnson Space Center, Engineering (EP4)

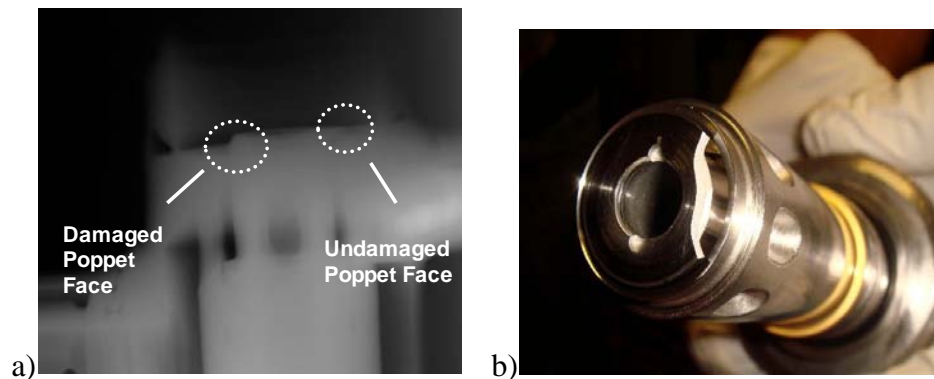
**Figure 1: a) Initial X-Ray of STS-126 failed poppet, b) Broken poppet flange.**

After STS-126 landing, an x-ray on the vehicle confirmed the cause as a broken poppet (Figure 1). The valve was removed from the system and sent to the vendor for teardown and evaluation, where a break of approximately 87 degrees of the poppet flange was documented (see Figure 1). The failure initiated in the flange radius (Figure X). The remainder of the valve's piece parts were inspected for clues as to the breakage, but no out of print condition, material non-conformance, or clear evidence of particle impact were found. In addition, vehicle inspections such as servicing of the upstream filter element and borescope inspections of the tubing, failed to uncover any evidence of particle impact as the cause. There was damage in the downstream 90-degree elbow, indicating that the particle had passed through on its way into the ET. Since the ET is not recovered post-launch, the broken piece was never found.

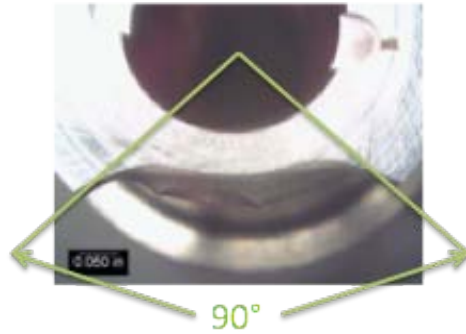
The ET pressure prediction model was used to determine the size of poppet circumference break needed to produce venting earlier than 120 seconds. This tool is used every flight to perform ET pressure predictions. STS-126 pressure profile after the poppet was broken was used to calculate the discharge coefficient ( $C_D$ ) of a broken poppet. That  $C_D$  was then used to calculate mass flow rate for any size poppet break. A parametric analysis was then run for one single poppet failure, varying the size of the poppet break and the time during flight that the poppet failed. From that data the chart in Figure X was developed showing the size of the poppet break as a function of mission elapsed time necessary to produce relief valve cracking prior to 120 seconds from lift-off. Fig. X shows that a poppet break of 150 to 180 degrees or larger would produce tank venting if it happened prior to 30 seconds into flight. After approximately 30 seconds single poppet breaks greater than 220 degrees would be required to produce venting.

**Figure X: STS-126 Failed Poppet cracked 90 deg circumference**

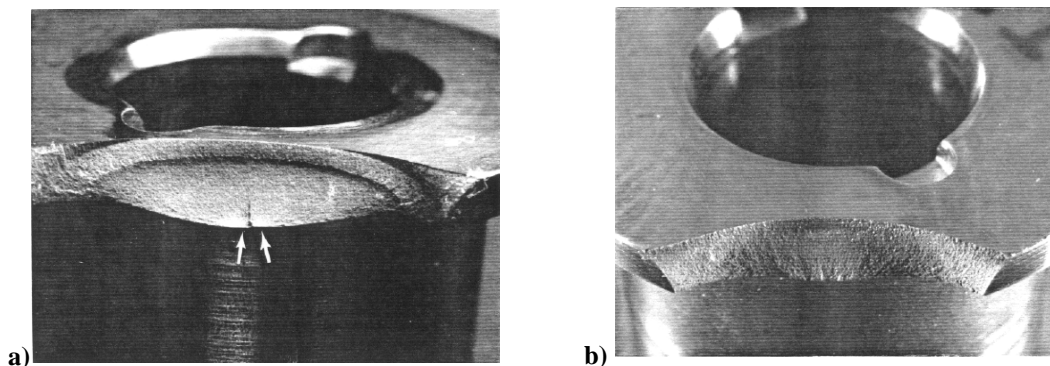
These new poppets were built from 440C, a very strong but brittle material. The drawing allows 440A or 440C, which have similar material properties, although 440C is slightly less ductile. Inspection of the poppets found no evidence of particle impact damage on any of the remaining surfaces. The first failure was originally blamed on particle impact due to facility contamination, although the morphology of the fracture surface showed some signs of fatigue. The test stand was inspected for the potential to generate contamination but no debris source was found. The upstream filter element was analyzed, the system was Freon flushed at a flow rate three times higher than the low flow rate, and 100A cleanliness was verified. The second failure, because it occurred after flushing and verification of the test stand, was blamed on fatigue entirely.

**Figure X. a) First ATP failure after 2 sec of stabilized GH2 flow time, ~72.5 deg crack. b) Second ATP Failure while pressure being brought up, ~58 deg crack**

Mitigation actions in response to the two ATP failures were minimal. A proposed change of material from 440C to Inconel 718 was disapproved by Configuration Control Board (CCB) due to cost. The program disallowed the use of 440C (replaced by 440A) for poppets because of the higher carbon content came at a cost of ductility. Additionally, all poppets made by that particular vendor were removed from inventory and post machining heat treatment was revised to improve material ductility and toughness. Dye pen inspections of poppet post manufacture and during refurbishment were implemented

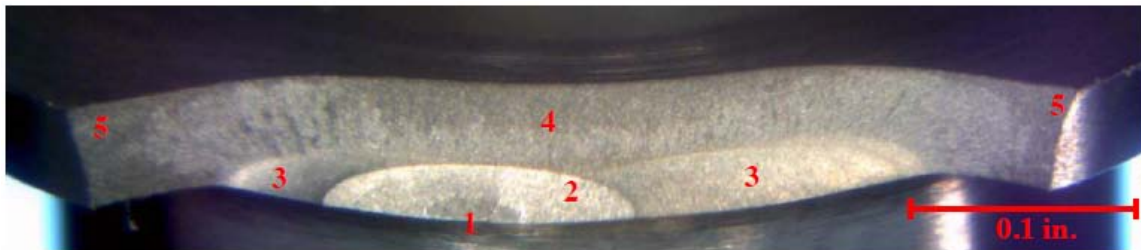
After STS-126 landing, the failed FCV was removed for inspection. Optical and Scanning Electron Microscope (SEM) fractography were conducted on the failed FCV poppet head. Preliminary results indicated the failure occurred by fatigue. The fracture exhibited several distinct “thumbnail” features, indicative of fatigue cracking, but the fracture morphology was not clear (e.g., no definite fatigue markings, striations, were present, and secondary cracking was considered “unusual”). Fracture by simple overload or impact was not evident. The crack was about 0.3 in. length before it went unstable and liberated material. Shown in Figure X, the five zones identified in the failed poppet head were 1) small initiation thumbnail crack (0.040” in length), 2) depth and circumferential expansion of zone 1 (0.138” in length), 3) asymmetric circumferential expansion of zone 2 (0.33” in length), 4) through-crack depth expansion of zones 2 and 3, and 5) final ligament at failure.

Figure X: STS-126 failed poppet fractography, detailed 5 zones of damage.

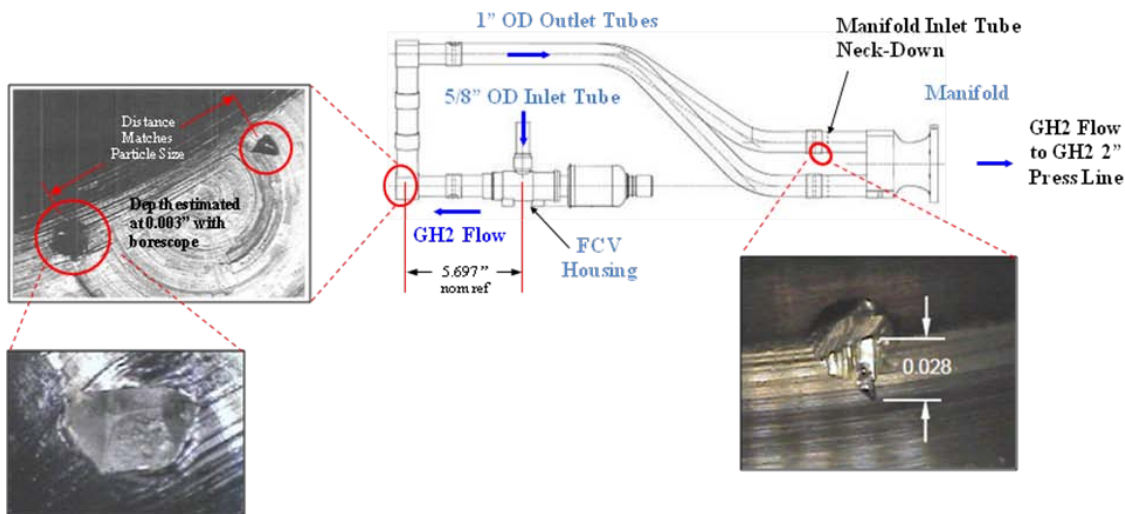
Borescope inspections were conducted of the OV-103 hardware post-landing after STS-126. In the first 90-deg elbow immediately downstream of the FCV, two dings were found, estimated to be 0.003 inches deep in the 304L stainless steel, with spacing that matched the approximate particle size missing from the failed poppet head. Further downstream, just prior to the 2 inch manifold, an additional mark was observed. Neither of these downstream indications revealed any data on the cause of the failure.

**Figure X:** Borecope inspection results of downstream GH2 pressurization system post-landing following the STS-126 failure.

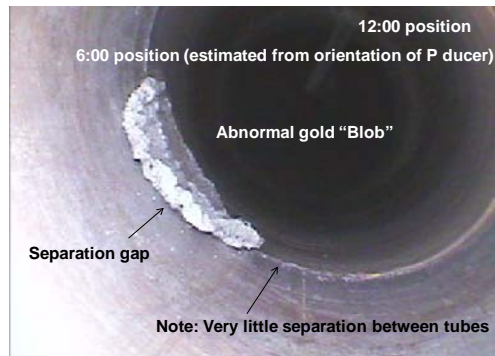
Borecope inspections were conducted upstream of the FCV also in an attempt to find possible cause for the failure. Inspections results found protruding gold braze slag in an upstream joint, but Materials and Processes (M&P) evaluation determined that the braze was intact (i.e., brazing material had not been released that could have impacted the FCV). It was concluded that the gold braze may have resulted from gold perform material run-out during line brazing during modification at the vendor, Palmdale, during OV-103 Flight 12 Orbiter Major Modification (OMM).

**Figure X:** Borecope inspection indication of gold brazing upstream of failed FCV.

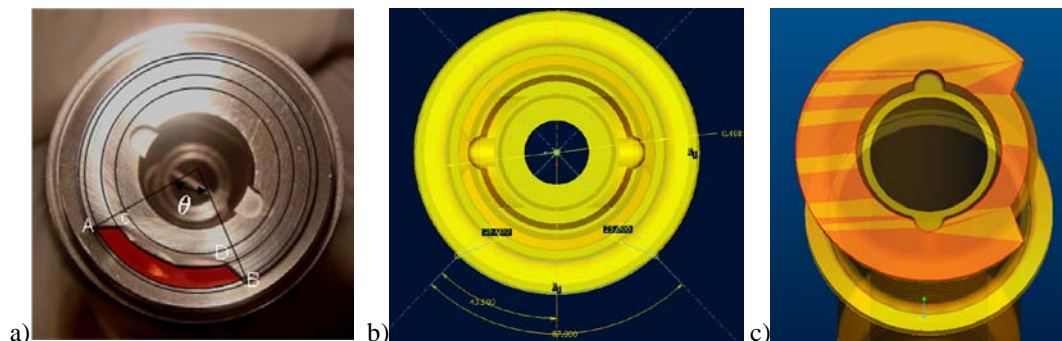
In order to support additional flight rationale questions for particle impact concerns, two different approaches were used to estimate the missing particle size and mass from the STS-126 failure: a CAD approach, and a “cloud map” inspection technique. In the latter approach, a Thermal Protection System (TPS) surface defect scanner was used to scan the surface of the failed poppet and generate the negative volume. A similar scan was made of the unbroken side of the poppet, and the negative volume was obtained by taking the difference and outputting to a CAD file. CAD results estimated a missing chip volume was 0.0013 cu. in., and mass was 0.141 gm. The resultant planar flow area exposed by the missing chip was calculated to be 0.031 sq. in.

**Figure X: a) Failed STS-126 poppet, b) crack size geometry modeling, c) resultant CAD model of failed poppet for particle size, mass estimations**

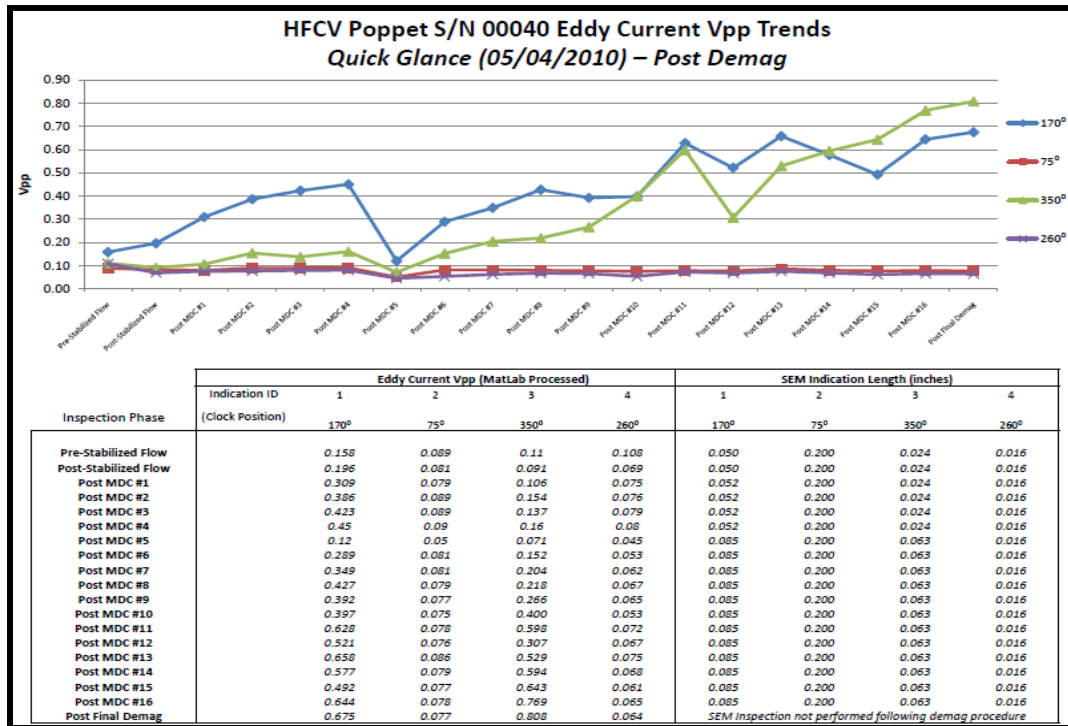
A similar drop in eddy current occurred on MDC #12, without a corresponding growth in crack size. This poppet completed 16 MDC without failure. This data did not indicate that a cracked poppet can fly safely. It did, however, did give insight to the NDE community on the limitations and abilities of the eddy current technique we were currently using.

**Figure X– 16 Mission Duty Cycles performed on poppet S/N 0040. Note: The 75° and the 260° indications were determined to be scratches rather than cracks.**

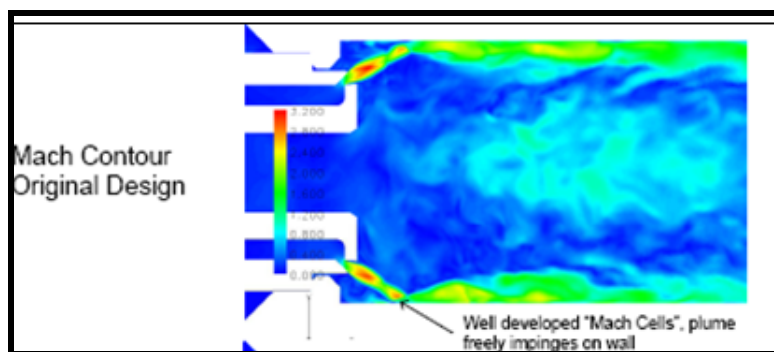
**Figure X– Discharge from the poppet flange impinges directly on the outlet tube wall. The plume contacted the exact location of the installed high frequency pressure transducers.**

The data for the first round of environmental testing revealed the environment just downstream of the poppet flange was so severe that the impinging GH2 flow damaged the high speed pressure transducers located there repeatedly (figure X). Testing showed that the pressure transducers further downstream captured clean usable data signatures. The acoustic emission sensors attached to the outside of the housing

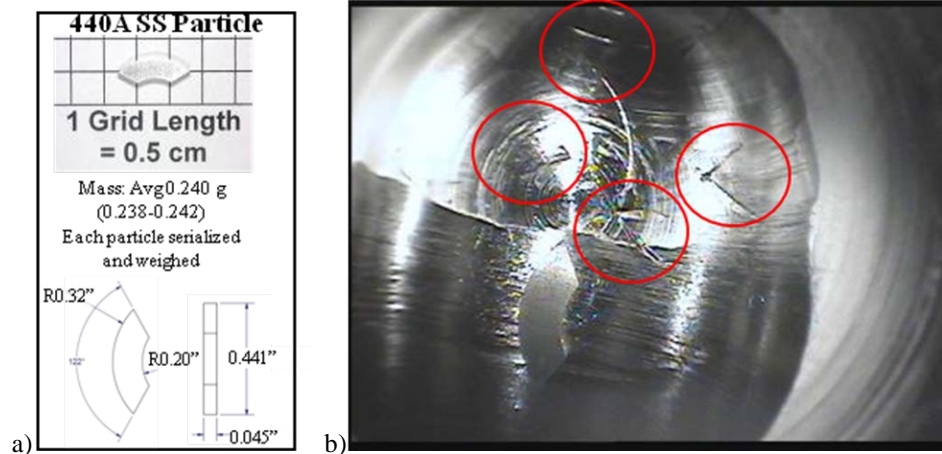
**Figure X:** a) WSTF Particle Injection test sample, b) WSTF Test results, First 90 deg elbow downstream of FCV. Impactor sample shown for comparison

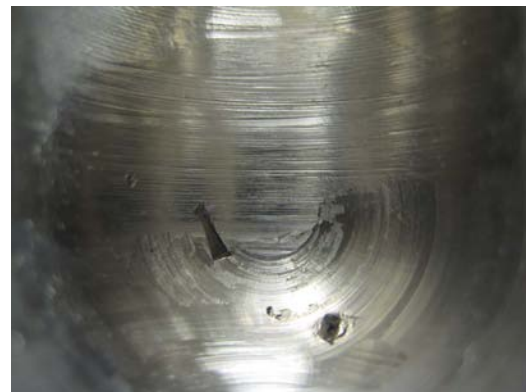
GRC testing was also conducted on the 80 deg bend just upstream of the 2” ET/orbiter disconnect. No perforation of tube observed even with worst-case “knife-edge” particle impact orientation and velocity 715-1,100 ft/sec

**Figure X: GRC testing impact feature at 0.022” depth on first 90deg elbow downstream of FCV**

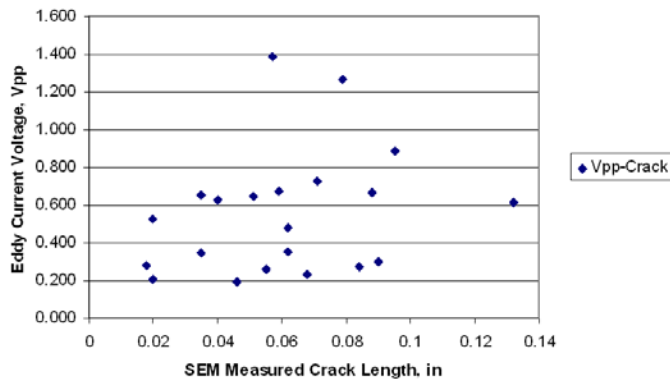
**Figure X: Eddy Current inspection results used for STS-119**
