Failure Investigation of an Intra-Manifold Explosion in a Horizontally-Mounted 870 lbf Reaction Control Thruster

Joseph G. Durning III¹ and Shayne C. Westover²
NASA Johnson Space Center, Houston, TX, 77058

Darren M. Cone³
NASA White Sands Test Facility, Las Cruces, NM, 88012

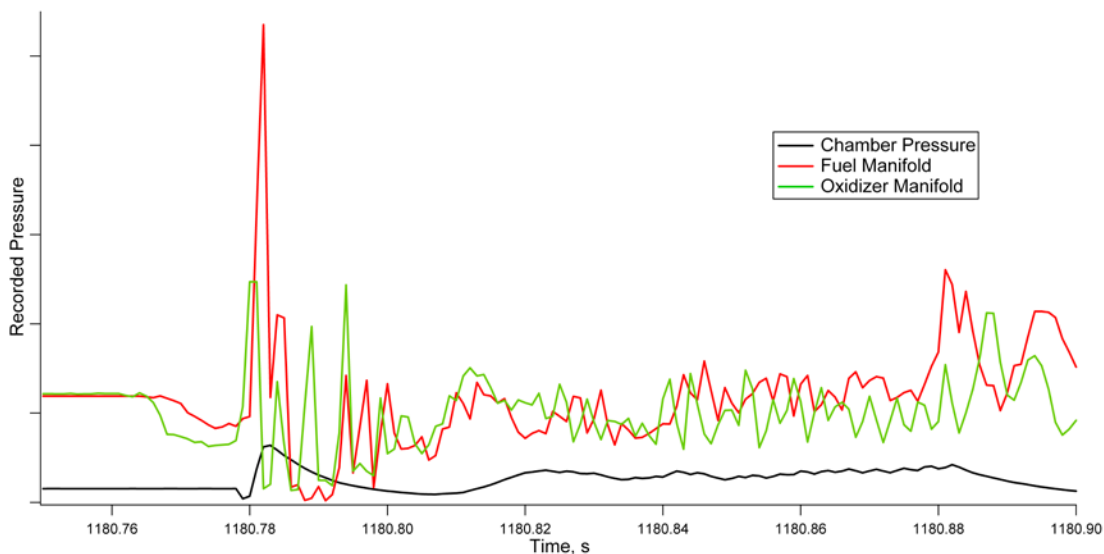
Figure 1 presents the thruster chamber pressure and the facility oxidizer and fuel manifold pressures during the explosive event. The “Chamber Pressure” measurement represents the pressure within the combustion chamber of the thruster as a result of the hypergolic propellant reaction. The “Fuel Manifold” and “Oxidizer Manifold” measurements represent the respective propellant fluid pressures in the distribution lines immediately upstream of the propellant isolation valves located on the thruster. The chamber pressure measurement is taken downstream of the thruster injector face while the fuel and oxidizer manifold pressure measurements are taken upstream of the thruster injector face. The thruster injector face provides a pressure boundary between the chamber and the propellant manifolds such that dynamic response of the system can be identified by interpreting the propellant pressure and chamber pressure responses.

Figure 1. Pressure Data Observed During Thruster L1L Failure.

By comparing the thruster chamber pressure and the facility oxidizer and fuel manifold pressures during the explosive event, it was clear that the energetic event occurred within the fuel manifold as evidenced by the significantly higher pressure spike. The oxidizer pressure does not appear anomalous, and the resultant chamber pressure is unusually low. Had the explosive event occurred within the thruster chamber, the chamber pressure measurement would have indicated the rapid increase. Likewise, the oxidizer manifold shows no indication of higher than expected pressure at startup which would be characteristic of a typical ZOT event.

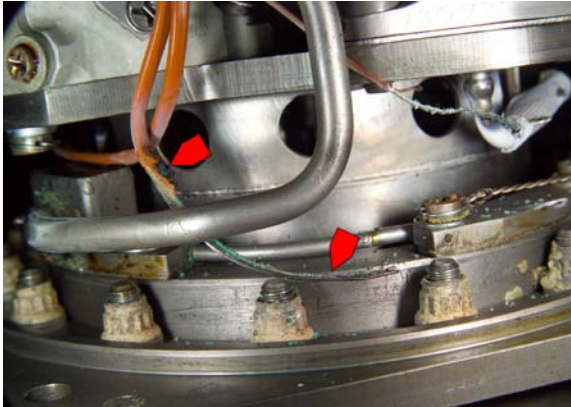
Figure 1 shows the facility thermocouple wires that were observed to have charring on the insulation housing, denuding of the leads, and wires disconnected from the thermal block. Figure 2 shows the white soot charring observed on some metal surfaces of the thruster and Fig. 3 shows the circumferential crack on the pressure transducer housing.

Figure 1. Charred, denuded, and disconnected wires noted on thruster L1L. (Photo ID WSTF0610E05896)

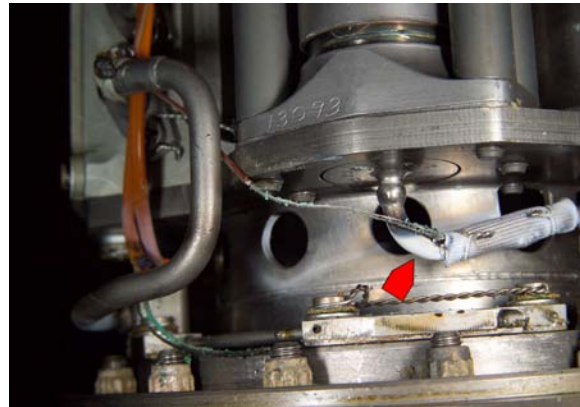
Figure 2. Charring noted on metal surfaces. (Photo ID WSTF0610E05892)

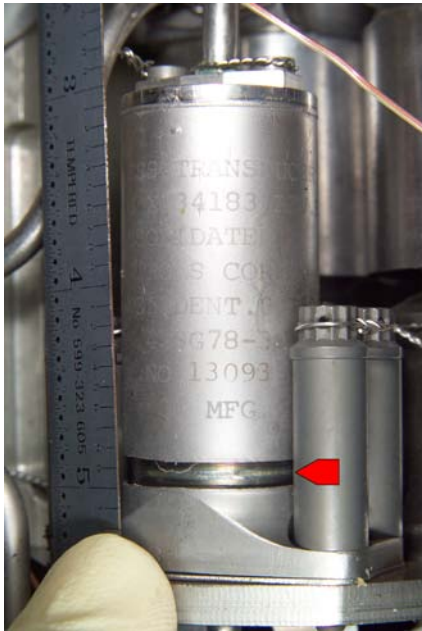
Figure 3. Broken pressure transducer housing. (Photo ID WSTF0610E05889)

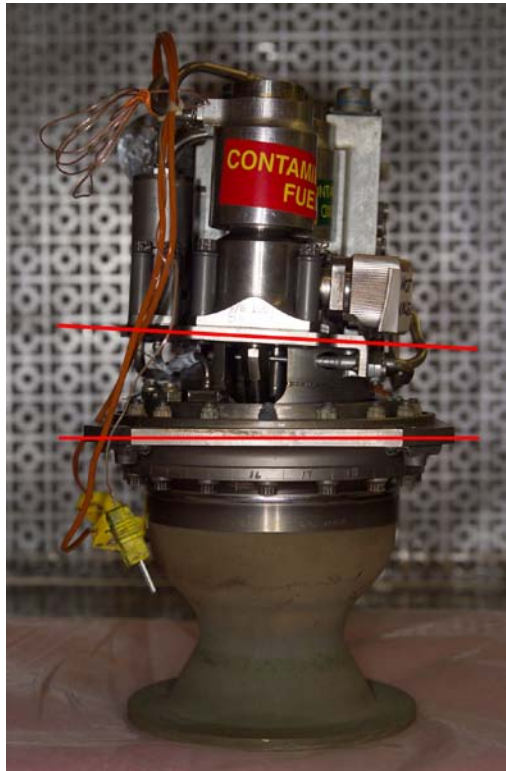
The valve standoff mounting plate, which is normally in a parallel plane to the thruster mounting flange, was found to be significantly misaligned. The misalignment indicated that the integrity of the injector may have been compromised during the test abort. A chamber weld leak test was performed to check the integrity of the thruster injector and audible leaking was observed. The blowing leak was too large to quantify and potentially masked any smaller cracks or leaks that might have been present. Further inspection of the chamber weld via borescope revealed significant cracking in the closeout weld channel. The crack extended circumferentially for approximately 180°.

Figure 4 shows the profile of thruster L1L with the misalignment of the valve mounting plate and thruster mounting flange highlighted.

Figure 4. Valve mounting plate misalignment relative to the thruster mounting flange. (Photo ID WSTF0610E05883)

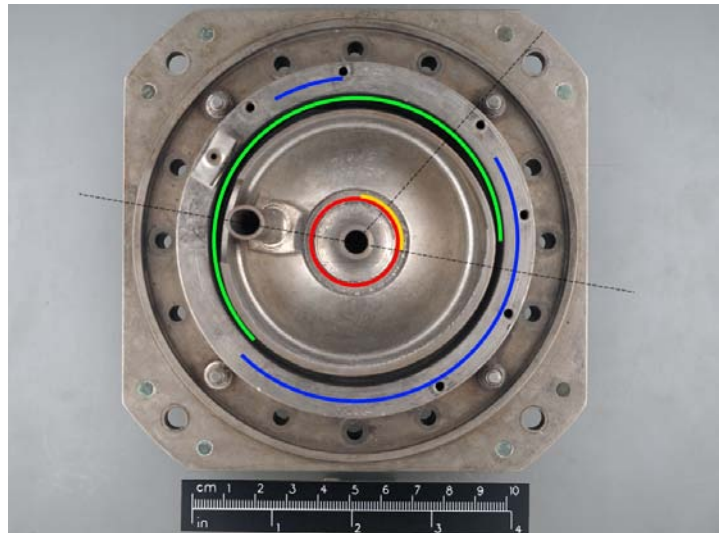
Figure 5 is a color coded map of the cracking found in the thruster during the failure investigation. Dashed black lines represent sectioning paths. Blue markings represent observed or potential cracking in the outer parent material of the thruster, external to the injector cavities. Green markings represent cracking that occurred in the closure weld of

Figure 5. Annotated locations of cracks observed in thruster L1L during destructive evaluation. (Photo ID WSTF0710E07140)

the fuel cavity when the explosive event occurred and over pressurized the cavity. The red and yellow markings represent cracks that occurred in the base material between the fuel and oxidizer cavities. The material damage represented by the red and yellow cracks caused much discussion within the failure analysis team because the void created by the cracks created a fluid path between the two manifolds. Ultimately, it was determined that the cracks occurred as a result of the explosion and were not the cause of the explosion.

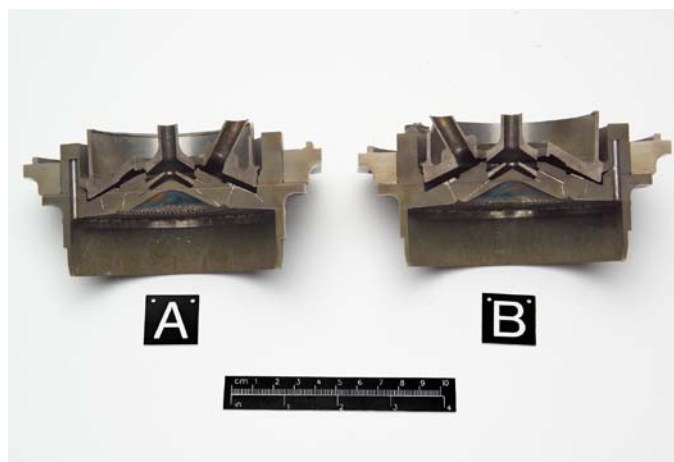
Figure 6. Further sectioning of thruster L1L to liberate the fuel enclosure. (Photo ID WSTF0810E07581)

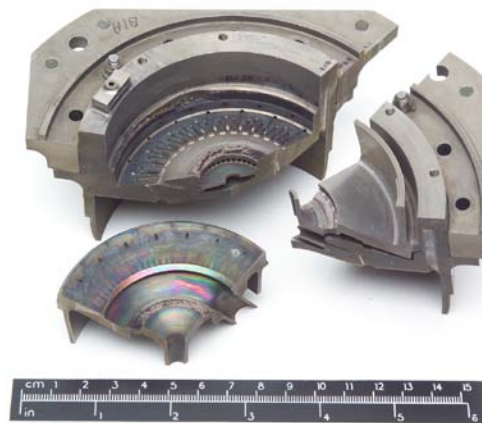
Figure 7. Thruster L1L sectioned by EDM. (Photo ID WSTF0810E07402)

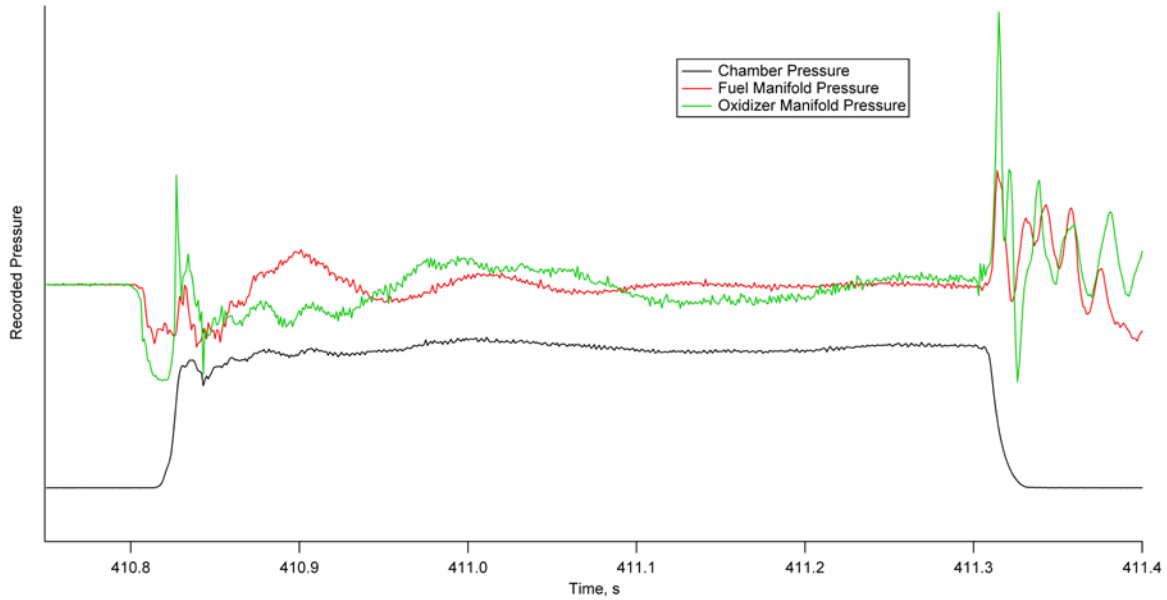
Figure 9 shows the recorded telemetry of the thruster chamber pressure transducer and the facility fuel and oxidizer transducers during the first pulse. At the initiation of the firing, the fuel and oxidizer pressures exhibit nominal response when the propellant isolation valves open. Chamber pressure response is nominal and reaches steady state levels indicative of a good thruster firing.

Figure 9. First pulse of thruster L1L, 0.5 s duration.

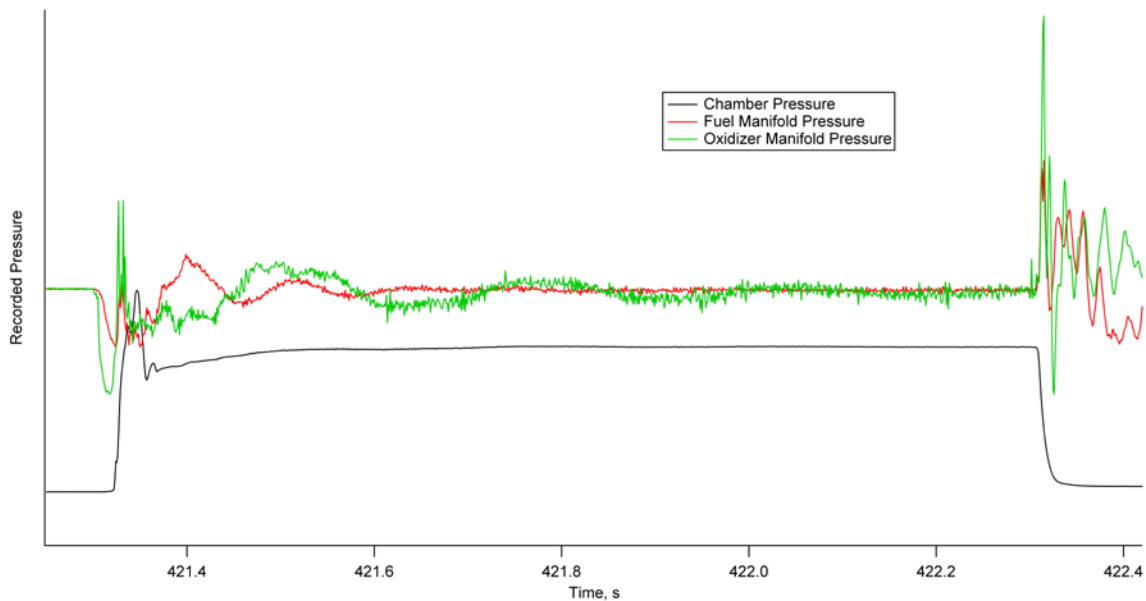
Figure 10 shows the recorded telemetry of the thruster chamber pressure transducer and the facility fuel and oxidizer transducers during the second pulse. At the initiation of the firing, the fuel and oxidizer pressures exhibit nominal response when the propellant isolation valves open. The chamber pressure shows a higher than nominal spike at the initiation of the pulse. This elevated pressure is indicative of a hard start where some excess propellant remained in the chamber after the previous firing. After the initial pressure spike, the chamber pressure recovers to a nominal level and maintains at a nominal steady state level through completion of the firing.

Figure 10. Second pulse of thruster L1L, 1.0 s duration.

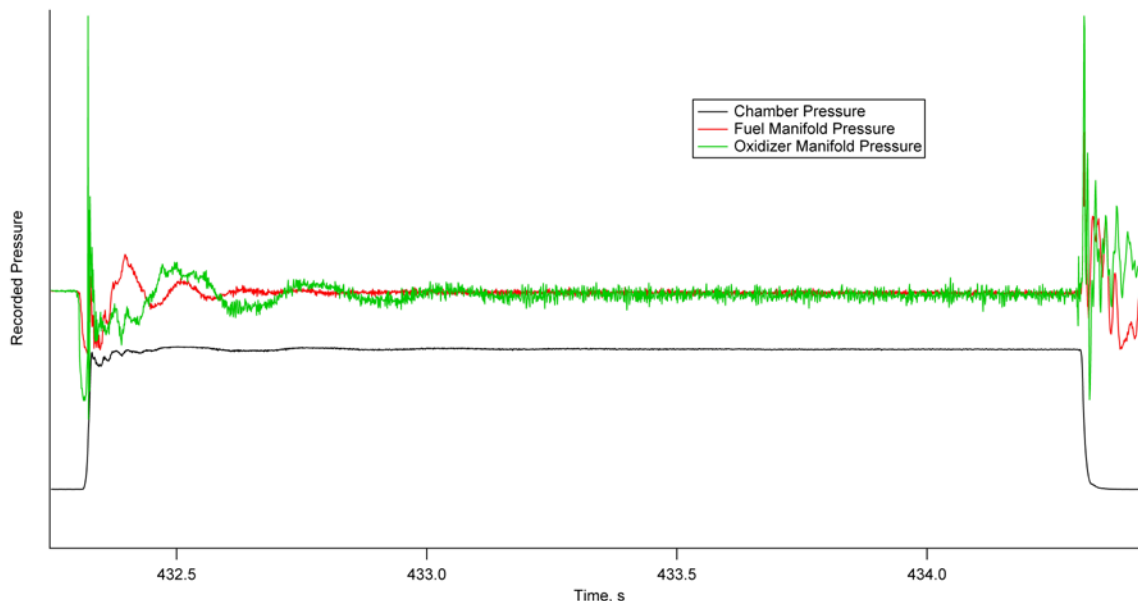
Figure 11 shows the recorded telemetry of the thruster chamber pressure transducer and the facility fuel and oxidizer transducers during the third pulse. At the initiation of the firing, the fuel and oxidizer pressures exhibit nominal response when the propellant isolation valves open. Some consideration was given to the oxidizer pressure

spike at the initiation of the pulse but after reviewing historical telemetry data, the pressure was determined to be in family. Chamber pressure response is nominal and reaches steady state levels indicative of a good thruster firing.

Figure 11. Third pulse of thruster L1L, 2.0 s duration.

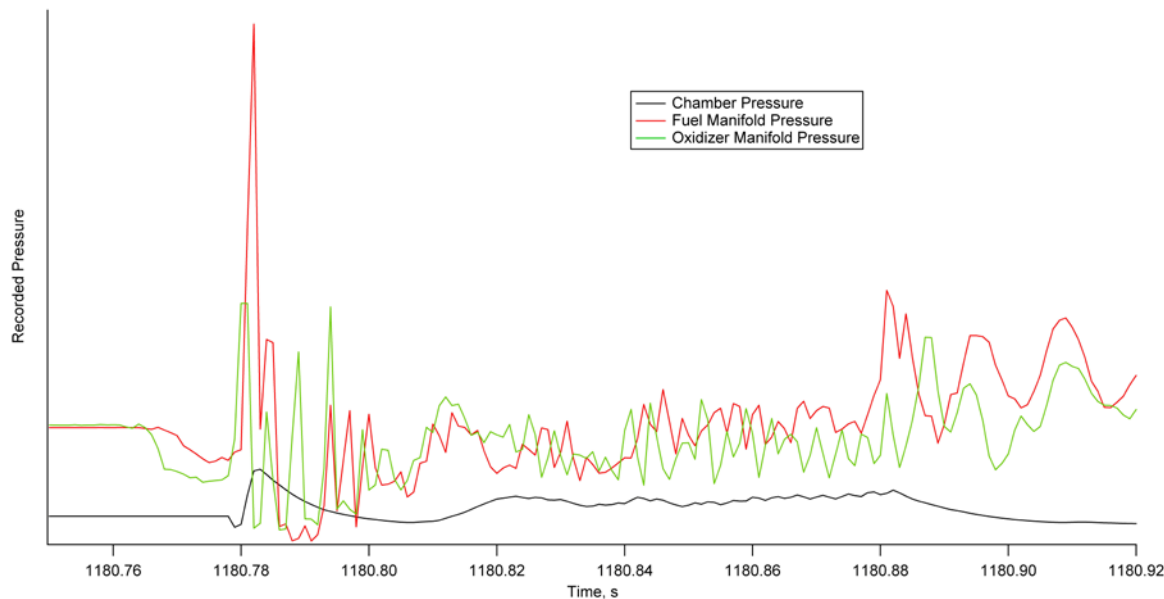
Figure 12 shows the recorded telemetry of the thruster chamber pressure transducer and the facility fuel and oxidizer transducers during the explosive failure event. At the initiation of the firing, the fuel and oxidizer pressures initially exhibit nominal response when the propellant isolation valves open. However, the fuel pressure then experiences an uncharacteristic spike corresponding to a drop-off of the chamber pressure. From that time onward, the chamber pressure fails to reach a nominal level, becomes erratic, and finally declines when the facility abort halted the firing profile. Ringing is seen in the fuel and oxidizer supply pressures from the explosive shock and resulting water hammer through the system.

Figure 12. Fourth pulse of thruster L1L; facility abort condition at approximately 0.1 s.

By comparing the thruster chamber pressure and the facility oxidizer and fuel manifold pressures during the explosive event, it was clear that the energetic event occurred within the fuel manifold as evidenced by the significantly higher pressure spike. The oxidizer pressure does not appear anomalous, and the resultant chamber pressure is unusually low. Had the explosive event occurred within the thruster chamber, the chamber pressure measurement would have indicated the rapid increase. Likewise, the oxidizer manifold shows no indication of higher than expected pressure at startup which would be characteristic of a typical ZOT event.
