Lessons Learned from the Space Shuttle Engine Cutoff System (ECO) Anomalies

The Space Shuttle Orbiter's main engine cutoff (ECO) system first failed ground checkout in April, 2005 during a first tanking test prior to Return-to-Flight. Despite significant troubleshooting and investigative efforts that followed, the root cause could not be found and intermittent anomalies continued to plague the Program. By implementing hardware upgrades, enhancing monitoring capability, and relaxing the launch rules, the Shuttle fleet was allowed to continue flying in spite of these unexplained failures. Root cause was finally determined following the launch attempts of STS-122 in December, 2007 when the anomalies repeated, which allowed drag-on instrumentation to pinpoint the fault (the ET feedthrough connector). The suspect hardware was removed and provided additional evidence towards root cause determination. Corrective action was implemented and the system has performed successfully since then.

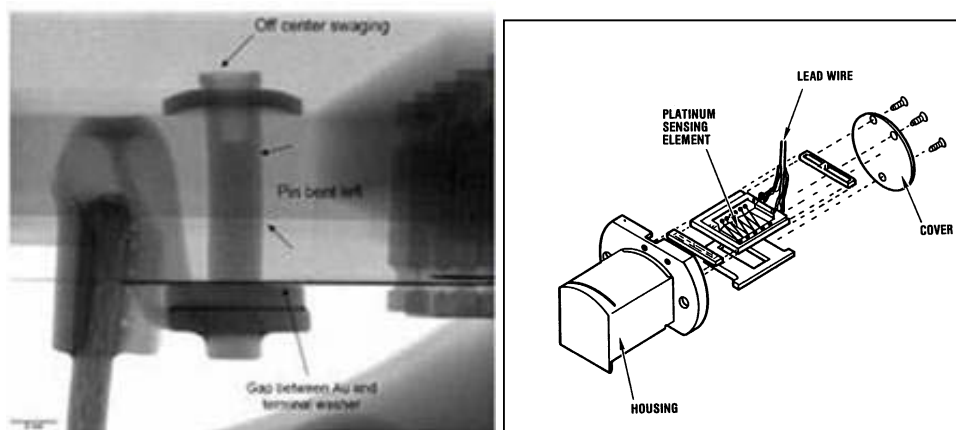
The sensor design uses a very fine platinum sensing element tensioned within a ceramic housing and brazed to gold plated contacts. To connect the sensor lead wires, the lead wires are brazed to terminal posts that are connected to the ceramic housing at the gold plating with swaged joints. Swaging of these tiny parts is a manual operation and subject to some variability. Loss of preload at this swaged connection was considered a potential cause of the intermittent open circuits observed, and will be discussed in more detail later. Figure 4 shows a highly magnified nanofocus X-ray image of a terminal post and swaged joint.

Figure 4. LH2 ECO Sensor in nano-focus view (left) and exploded view (right)

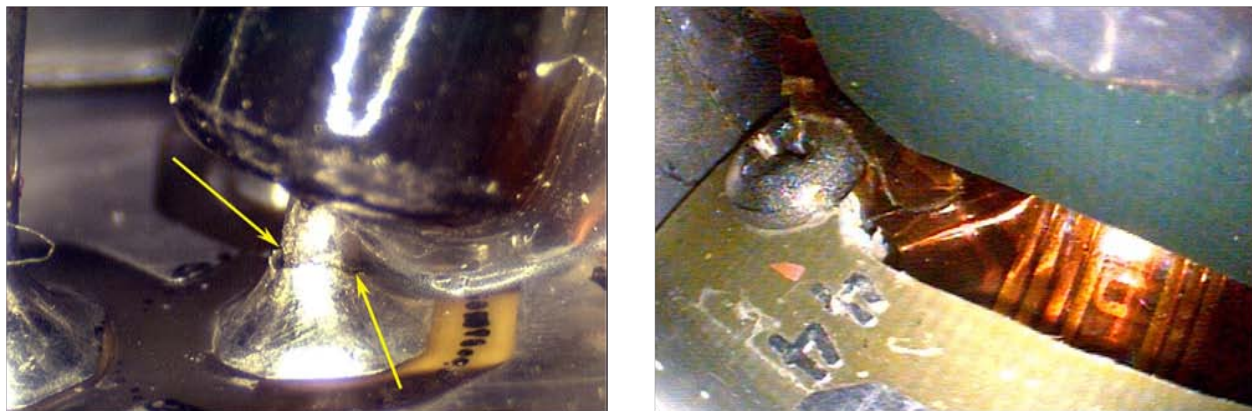
PSB s/n 108 and its mating 55P84 connector which had been previously removed were subjected to full acceptance tests, both of which were completed successfully. This test included thermal and vibration testing to levels above those seen on the vehicle during flight. The box was then torn down completely, and two discrepancies were found that appeared to be related to the two loading anomalies. A tear in the flexprint assembly, which is used to route signals from the box's motherboard to its connectors, was found in the LH2 ECO #3 circuit (see Figure 5). The tear was determined to extend only halfway through the path and did not compromise the integrity of the circuit. It was concluded that the tear was created during installation of the motherboard / flexprint assembly into the chassis, since trimming of the assembly was apparently required to make it fit. The other discrepancy found was a broken cold solder joint at a resistor in the LH2 ECO #4 circuit, but this electrical path was also verified to be good under vibration loads and other testing at the card level. Several other discrepancies (missing conformal coating, debonded card guides, a debonded capacitor, soldering issues, etc.) were also noted, but none could be traced to either of the original failures. In conclusion, no direct cause for the intermittent open circuit could be found within PSB s/n 108 used in the first tanking test.

Figure 5. PSB s/n 108 inspection found two discrepancies. On left is shown a defective solder joint in ECO channel #4 resistor R109. On right is shown a tear in the ECO #3 flexprint. Both were found to be only coincidentally related to the ECO #3 and #4 anomalies.

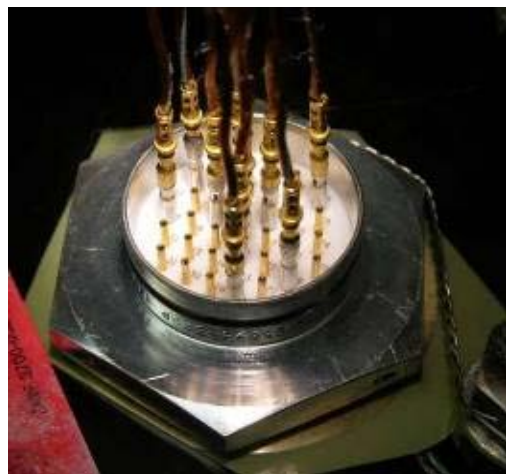
Figure 7. Soldered pins/sockets

The most reliable way to mitigate the failure mechanism was to create a solid connection at the external plug to feedthrough interface. This was done by soldering the sockets to the pins. (This is the same approach that was used on the Centaur upper stage following ECO anomalies in the 1990s.) Additionally the external plug was replaced with a different (internal) style that utilized a Teflon insert rather than the silicone grommet insert. The holes in the Teflon insert were enlarged to allow the soldered sockets to slip freely through this insert, so in effect the redesigned external plug just served to provide strain relief to the now soldered external harness. No changes were made to the internal connection, as this connection is not subject to all the causal factors and not considered suspect. Figure 7 shows a close-up of the external harness sockets soldered to the feedthrough pins (prior to installation of the external plug). The redesign was qualified through cryogenic cycle and cryogenic vibration testing, followed by destructive physical analyses. The redesigned connector was installed in ET-125 at the launch pad and performed successfully on STS-122. The installation was performed on ET-126 (for STS-123) in the Vehicle Assembly Building (VAB), and installations for remaining tanks are being done at MAF. Further corrective actions include stricter controls on the application of lubricants on connector assemblies and insuring cleanliness of the GSE that mates to these connectors.
