Swift BAT Loop Heat Pipe #0 Temperature Droop Problem and Solution after Its Primary Heater Controller Failure

Michael K. Choi*

NASA Goddard Space Flight Center, Greenbelt, MD 20771

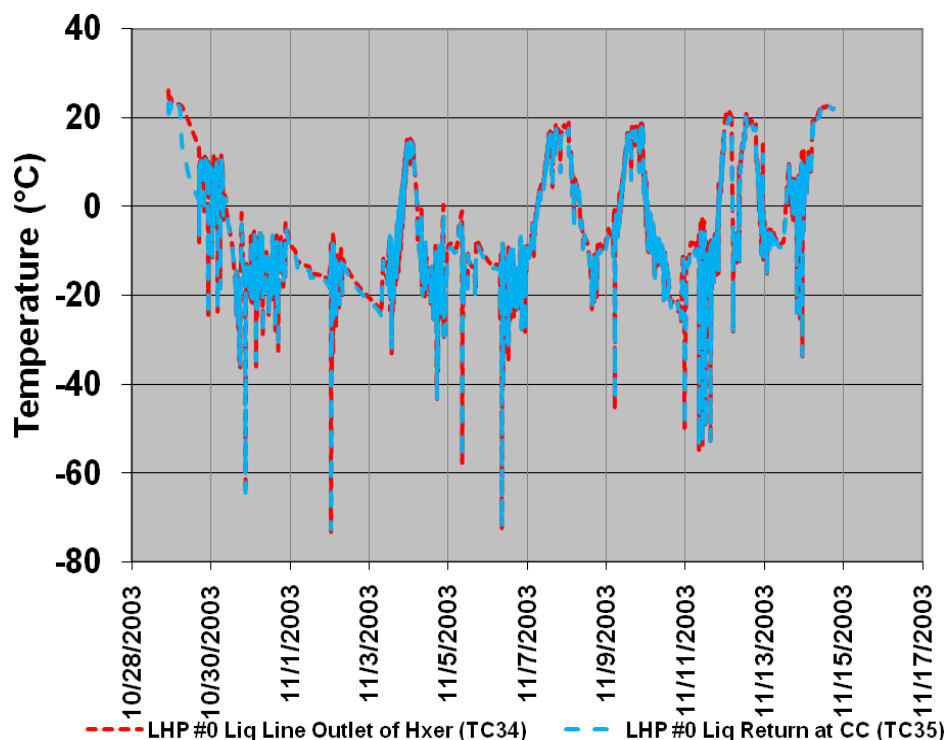
Figure 18. LHP #0 Liquid Return at CC Inlet Temperature in BAT T/V Test.

During the BAT integration and testing (I&T), the BPWHKLHPA5TEMP low alarm limits were set to -25°C for yellow and -30°C for red. These limits were intended to alarm non-nominal LHP operation. A thermocouple (TC35), adjacent to BPWHKLHPA5TEMP, was used in BAT instrument level thermal balance (T/B) and thermal vacuum (T/V) cycling tests. Also a thermocouple (TC34) was used to monitor temperature of liquid line outlet of VCHP heat exchanger. The test results show that TC34 and TC35 temperatures are nearly the same and the coldest temperature of TC34 or TC35 in tests is -70°C (Figure 18). On May 17, 2010, the BPWHKLHPA5TEMP alarm low limits for flight operation were changed to -35°C yellow and -40°C red. This change was intended to prevent alarms caused by temperature droop.
