# Selected Lessons Learned in Space Shuttle Orbiter Propulsion and Power Subsystems

NASA/Johnson Space Center, Houston, TX 77058

Over its 30 years of space flight history, plus the nearly 10 years of design, development test and evaluation, the Space Shuttle Orbiter is full of lessons learned in all of its numerous and complex subsystems. In the current paper, only selected lessons learned in the areas of the Orbiter propulsion and power subsystems will be described. The particular Orbiter subsystems include: Auxiliary Power Unit (APU), Hydraulics and Water Spray Boiler (WSB), Mechanical Flight Controls, Main Propulsion System (MPS), Fuel Cells and Power Reactant and Storage Devices (PRSD), Orbital Maneuvering System (OMS), Reaction Control System (RCS), Electrical Power Distribution (EPDC), electrical wiring and pyrotechnics. Given the complexity and extensive history of each of these subsystems, and the limited scope of this paper, it is impossible to include most of the lessons learned; instead the attempt will be to present a selected few or “key” lessons, in the judgment of the authors. Each subsystem is presented separate, beginning with an overview of the hardware and thei

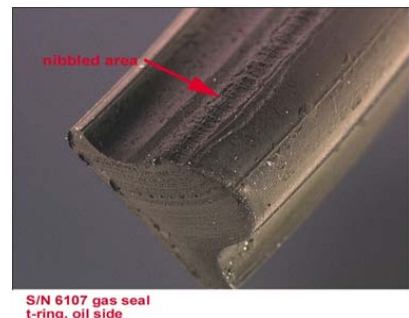
Hydraulic bootstrap pressure decay has occurred multiple times due to life and system contamination issues with the piston accumulators. The purpose of the bootstrap accumulator is to pressurize the hydraulic reservoir to maintain sufficient inlet pressure to the main pump for startup. On STS-50, an accumulator leaked on orbit due to nibbling of T-seal caused by extrusion of backup ring, resulting from long term exposure to pressure (Fig. 6). It resulted in continuous circulation pump

**Figure 6: Hydraulic piston accumulator seal damage**

operation on-orbit. The majority of piston accumulators inspected have shown minor backup ring extrusion. As a result of this, a 4-year flight limit was imposed on all piston accumulators. A welded bellows accumulator-type design replaced the piston type design in 1999. No gas leakage has ever occurred from Orbiter (or SRB) bellows accumulator units. The bellows accumulator requires no servicing for the life of the accumulator. The obvious lesson here is the preferred use of welded bellows hydraulic accumulators to prevent leakage and loss of function.

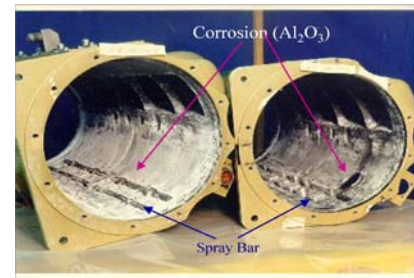
Since the beginning, the WSB aluminum heat exchanger containers have always had corrosion problems (Fig. 13). Nine WSB containers were removed during the Orbiter flight history due to severe corrosion and external leakage, primarily at the inlet/outlet stainless steel connections. The average useful life was 12.5 years, based on actual corrosion time of aluminum containers in the fleet. Post landing sampling/analysis of container water revealed presence of aluminum oxide (Al<sub>2</sub>O<sub>3</sub>) corrosion byproducts. Using an aluminum water tank in an open system makes the tank prone to aluminum-oxide corrosion and bi-metallic galvanic effects. A galvanic corrosion couple is formed from the dissimilar metals (aluminum and stainless steel) in the presence of conductive water. Adoption of higher water quality control in 1990 and PGME/Water in 2001 slowed the corrosion process but did not eliminate it completely. A preferred solution would be to change the container material to a non-galvanic material such as titanium.

**Figure 13: WSB heat exchanger containers showing evidence of galvanic corrosion**

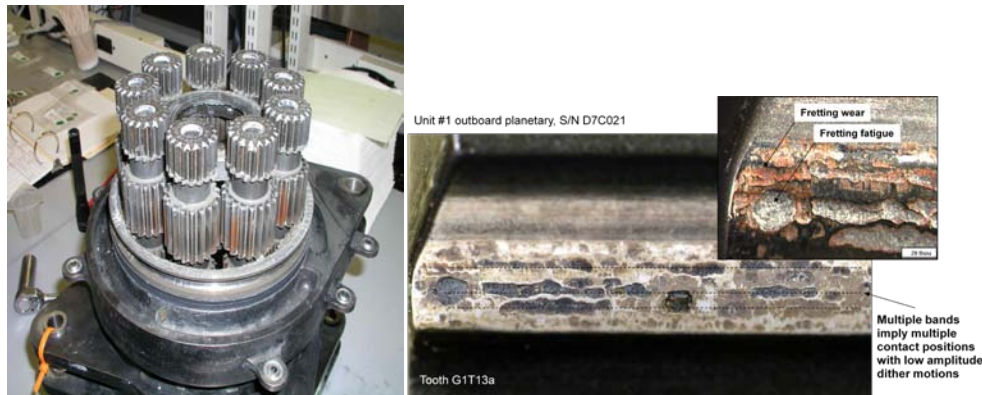
As part of a fleet leader inspection effort, the fleet lead RSB actuator was removed from OV-103 in 2003. To everyone’s surprise, considerable internal damage was found in the form of planetary gear and ring gear wear and fretting corrosion in addition to grease degradation (Fig. 15). The internal grease was yellow-colored and had decreased lubricity, with some physical oil separation and chemical breakdown. Some local gear teeth areas had reddish-brown grease, chemically-degraded from the fretting corrosion process. These findings had a considerable cost and schedule impact to the Program in that all fleet RSB actuators had to be inspected and most of them replaced, with all RSB actuators on OV-104 requiring the imposition of a limited life given that no available spares existed. These findings also led to Program-wide increased emphasis on corrosion and aging vehicle concerns. A lesson here is for future space applications to utilize greases with extreme pressure (EP) additives necessary for efficient boundary lubrication, better out-gassing qualities, corrosion-inhibitors and improved properties against physical separation and chemical breakdown.

**Figure 15: RSB actuator disassembly, showing the planetary gear set corrosion damage.**

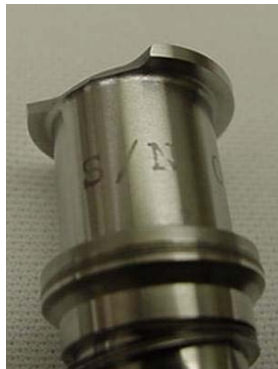
During STS-126 powered flight, the engine#2 Flow Control Valve (FCV) poppet broke across a portion of its flange (Fig. 20). This condition was detected via a change in inlet and outlet pressures though no command to change position had been sent. Since the poppet flange sees no impact loads, the cause was eventually deduced to be acoustic resonance caused by the high speed hydrogen gas exiting the valve. Special inspection methods were developed progressively as more was learned about the crack formation and propagation. Every flight valve tear downs and inspections were required to provide part of the continued flight rationale. It was learned that even structure with very high natural frequencies can be excited with acoustic inputs. Also learned was the fact that inspection methods need validation by complementary techniques, especially when cracks are very tight due to material properties and/or driving environment.

**Figure 20: STS-126 broken FCV poppet**

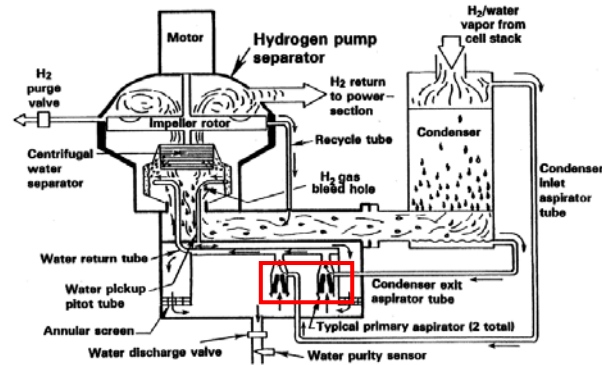
The first major in-flight fuel cell issue arose during STS-2 when FC1 had to be shut down less than five hours into the flight. At mission elapsed time (MET) +02:27, the crew reported that FC1 pH sensor reported off scale high; due to other pressing issues, the crew was unable to perform all of the contingency operations to confirm the pH level. Over the next two hours, FC1’s load-sharing decreased from a nominal 33% to 26%, indicating that the other fuel cells were picking up the load of the struggling fuel cell. At this point, flight controllers were concerned that possible KOH crossover might have occurred in the fuel cell and considered the fuel cell lost. The FC was then shut down and reactant valves were closed. Though the Orbiters are certified to land with only one working fuel cell, the failure of one results in a minimum duration flight (MDF). Once FC1 was shut down, the flight team became concerned that the isolated inter-cell potentials might be capable of water hydrolysis, producing free H<sub>2</sub> and O<sub>2</sub> and a potentially explosive situation; FC1 was restarted with the reactant valves still closed so that any remaining reactants in the stack would be consumed. This concern and safing procedure was new to the control team and had never been exercised during any mission simulations nor was it reflected in the onboard malfunction procedures for the crew. The team quickly learned that there should always be a plan to safely shut down and isolate any piece of hardware or even entire systems, particularly systems involving volatile reactants.

**Fig 26: H<sub>2</sub> Pump Separator schematic; aspirator tubes highlighted in red square**

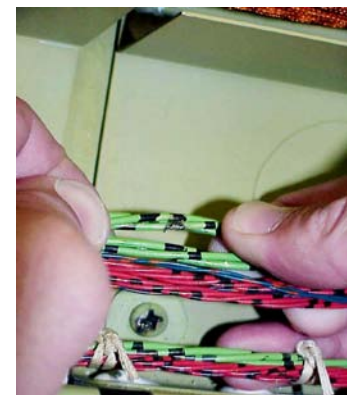
On STS-93, a short circuit occurred in the AC system during ascent that caused the loss of the primary controller on the center main engine and the secondary controller on the left main engine. Post-mission inspection found a damaged wire in one of the payload bay wire trays. The failure analysis revealed that the conductor was exposed because of mechanical impact; something striking the wire harness against a screw that had raised burrs on the head (Fig. 32). As a result of this failure, extensive vehicle wiring inspections were performed. As a result of the inspections, many other incidents were found of damaged wires and improperly protected wire harness.

**Figure 32: STS-93 wire short**

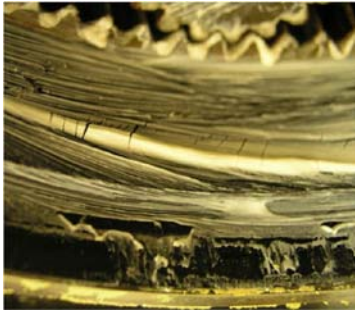
<ul style="list-style-type: none"> <li>☀ Utilize grease with extreme pressure (EP) additives necessary for efficient boundary lubrication, better out-gassing qualities, more stable base oil, corrosion-inhibitors and improved properties against physical separation and chemical breakdown.</li> </ul>
<p>Body Flap PDU internal leakage.</p>

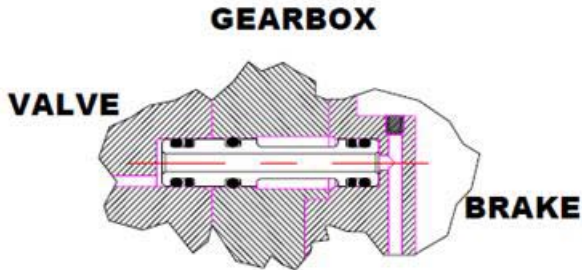
<p>Body Flap PDU transfer tube</p>	<ul style="list-style-type: none"> <li>☀ Assure correct alignment of interfacing seals and close-tolerance components to prevent leakage, e.g., transfer tubes. Build special alignment tooling if necessary.</li> <li>☀ Conduct post-assembly leakage tests, particularly of internal components with no available insight post- assembly.</li> <li>☀ Conduct periodic inspection of critical hardware cavities such as gearboxes.</li> </ul>

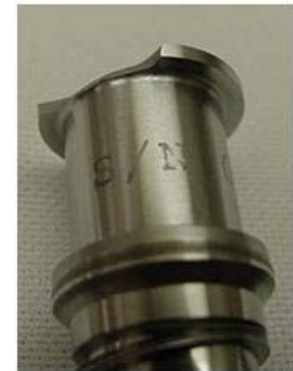
STS-126 broken FCV poppet

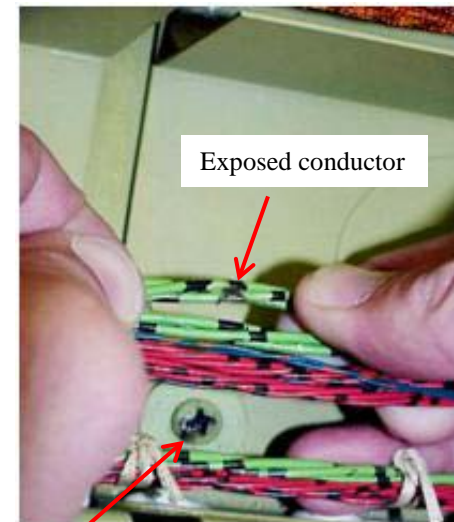
Burred screw

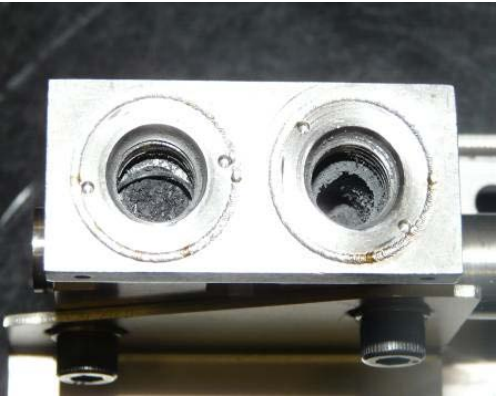
☼ Debris in bore and/or manufacturing dimensional variations can cause pyrovalve to not properly seal after firing/actuation. ☼ The NSI is an initiator and should not be used as a pressure cartridge, i.e., use NSI plus booster pressure cartridge.
