A Case Study of the Failure on Apollo 13

Based on TMX-65270, Report of Apollo 13 Review Board

Prepared by Brenda Lindley Anderson, QD34

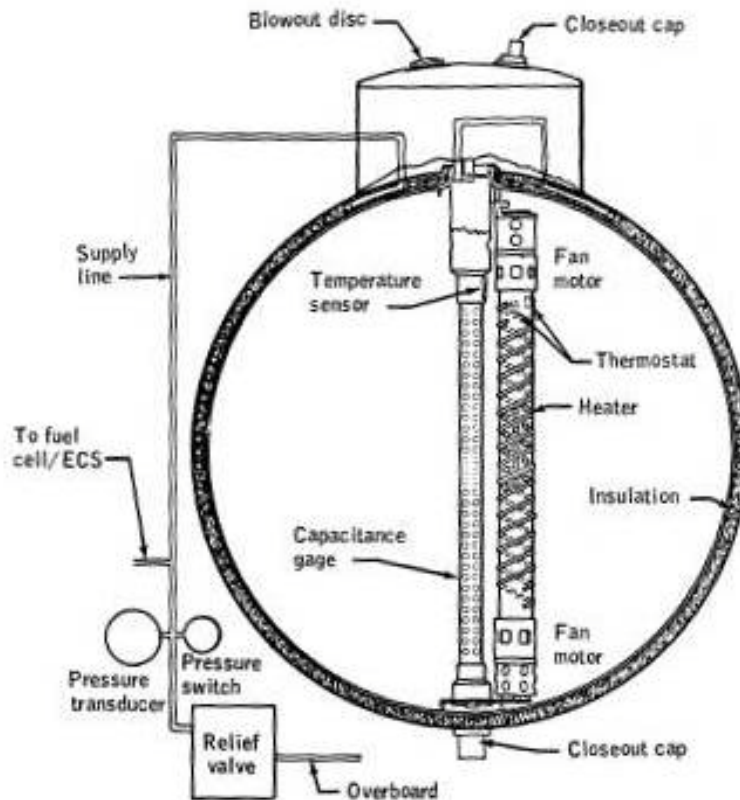
Figure 1 Service Module Oxygen Tank

The oxygen tank of the Apollo Service Module (SM) is constructed of concentric inner and outer shells, containing a vacuum between shells to reduce heat leak. A dome caps the tank providing containment for the fluid, electrical and signal paths into and out of the tank. See figure 1.

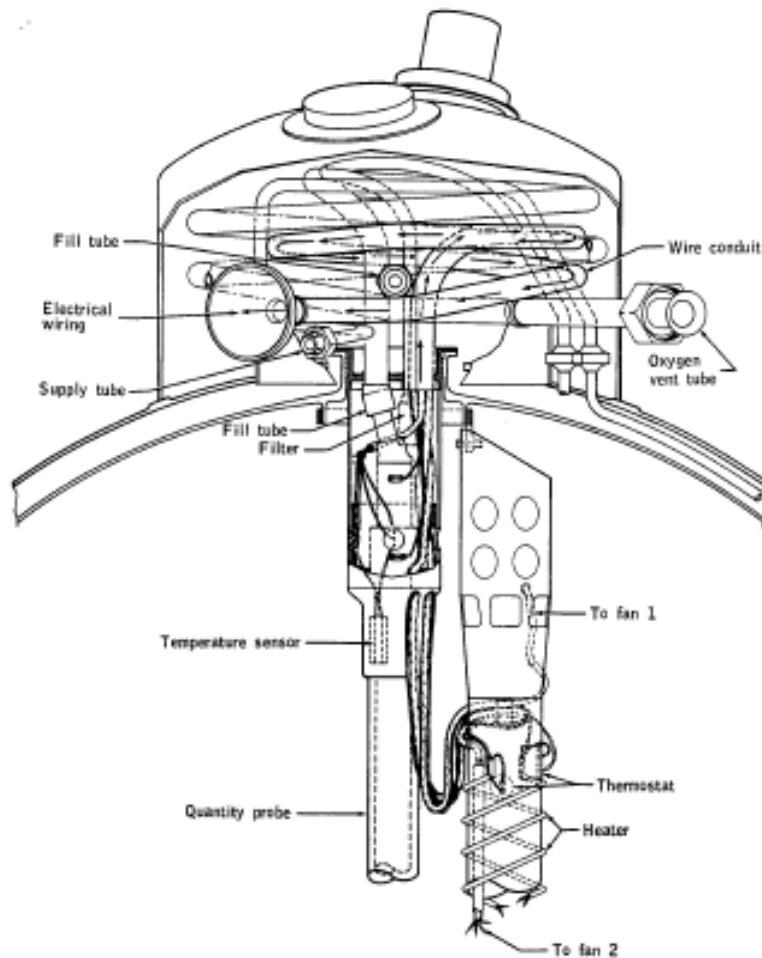
Figure 2 Wiring and Lines between Oxygen Tank and Dome

The routing of wiring and lines from the tank to the tank dome is shown in Figure 2.

was vented through the fill line. Now the quantity was 65%. Supplementary discussion among KSC, MSC, NA, and Beech personnel suggested that the de-tanking difficulty might be due to a leak in the line between quantity probe and fill line because of the loose fit between tube and sleeve. A leak in that line would allow gaseous oxygen to leak into the fill line, not driving lox from the tank. (Refer to Figure 2.) A discrepancy report was written for the oxygen subsystem.

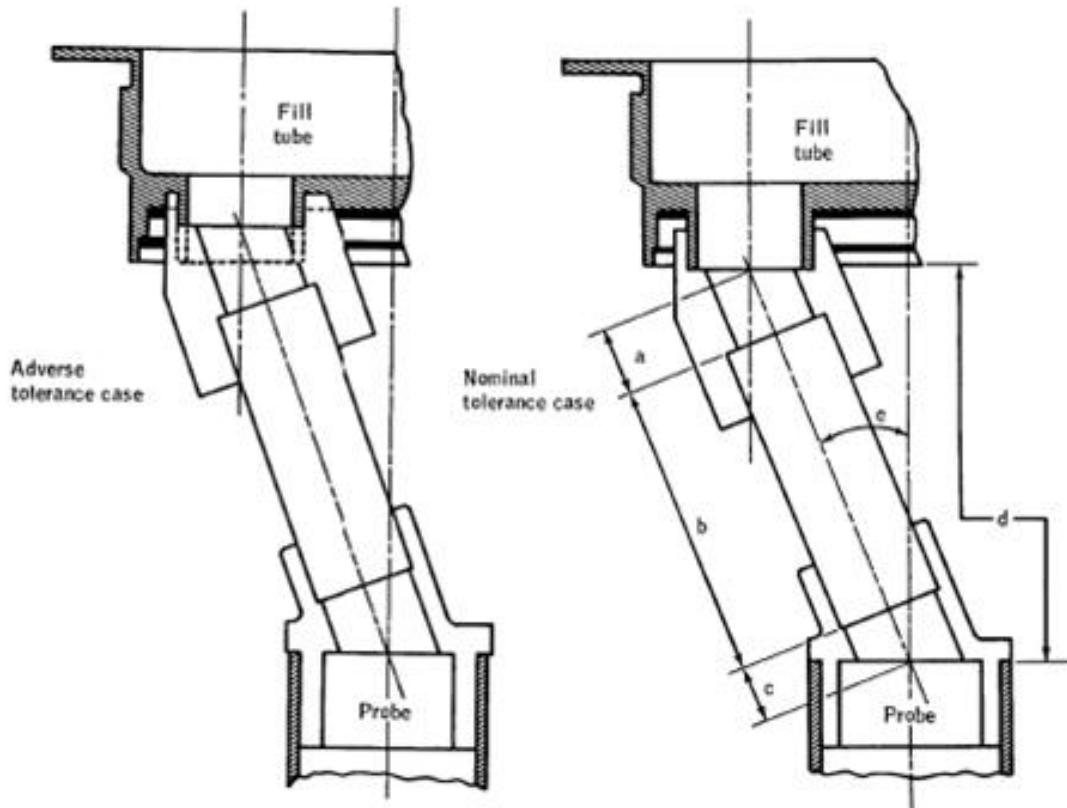
Figure 3 Nominal and Adverse Coupling Tolerance Cases

The fill line outside the oxygen tank enters, connecting to the inner cylinder of the capacitance gauge via a coupling comprised of Teflon adapters and Inconel tubing. The dimensions and tolerances for the assembly were chosen such that if worst case deviations occurred so the coupling didn't extend from fill line to gauge cylinder, a very loose fit would ensue. See Figure 3.

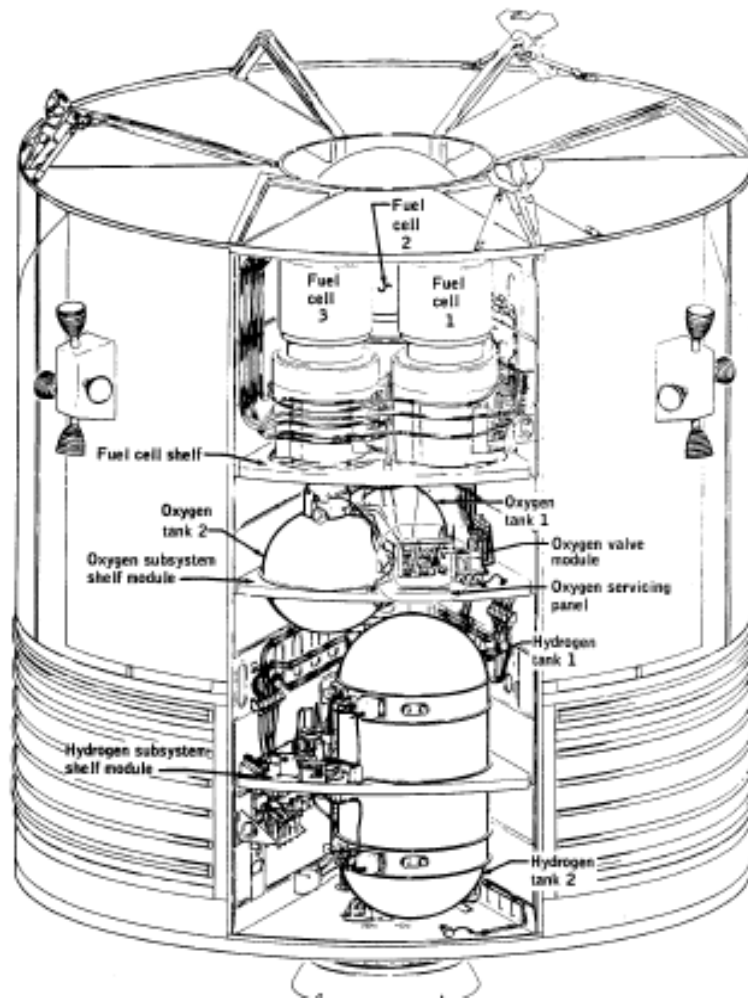
Figure 4 Arrangement of Cryogenic Systems and Fuel Cells in SM Bay 4

Oxygen tanks 1 and 2 are mounted on a shelf in bay 4 of the service module as show in Figure 4.

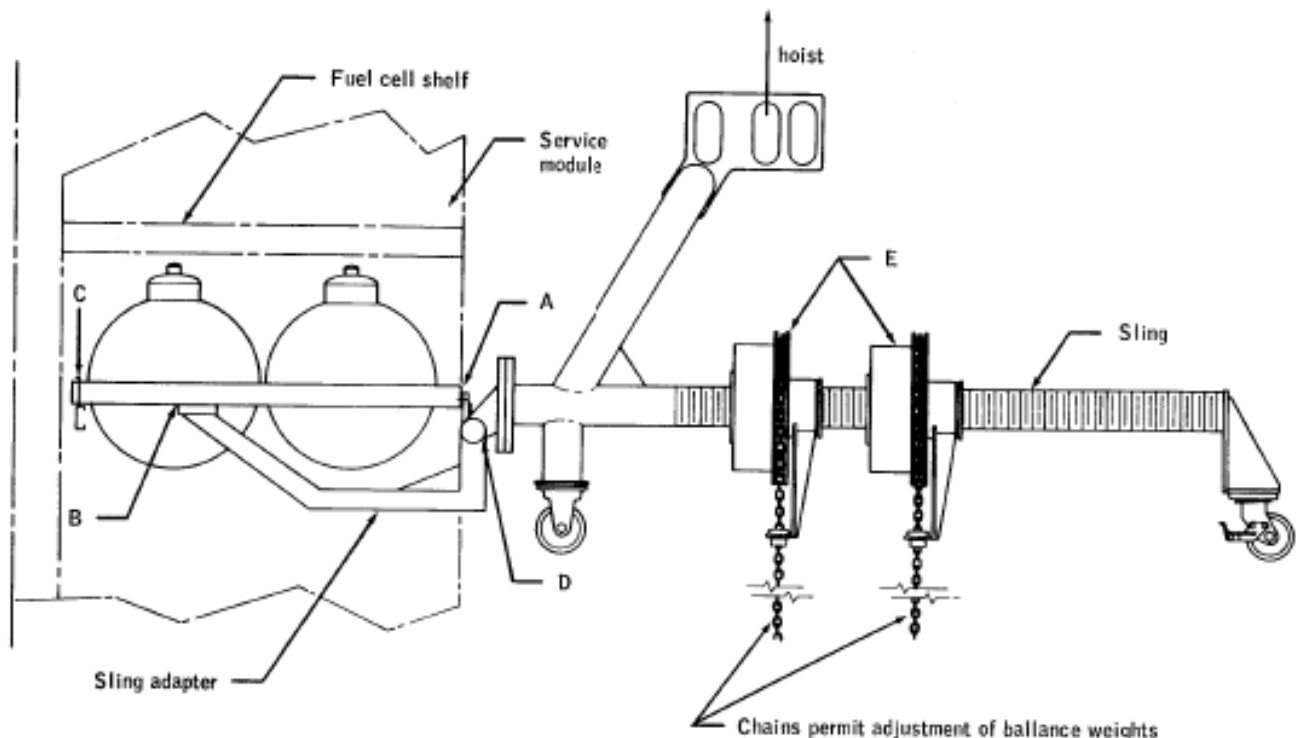
Figure 5 Hoist and Sling Arrangement for Shelf Assembly

The hoist and sling assembly shown in Figure 5 was used in removal of the oxygen shelf from SM 106. Disconnections were finished and a fitting from the crane was placed under the shelf to lift and remove it from the SM bay. A shelf bolt had been mistakenly left in the assembly. Consequently after the shelf was raised about two inches, the crane fixture broke and the shelf fell back into place. Photographs of the assembly following the mishap indicated that the close out cap of oxygen tank 2 might have struck the underneath side of the fuel cell shelf during the incident. At the time of the incident engineers thought that the shelf had simply dropped into place and they performed calculations to estimate the resultant force from the fall. After deliberation, the engineers decided that the shelf was initially accelerated upward before dropping which agreed with the photographic evidence.

The accident was recorded. The remaining bolt was removed and the shelf detached without additional problem. Because of this incident the oxygen shelf was re-tested for integrity, which including leak tests, proof-pressure test, and functional tests of pressure transducers, switches, thermal switches, and vacuum-ion pumps. No cryogenic testing was performed at this point. Additional visual inspection revealed no other problems. It should be noted that these tests would not have discovered any fill line leakage in oxygen tank 2. Additional tests and calculations performed during post-flight investigation concluded that the forces on the shelf during drop were likely close to those calculated at the time of the event. The investigating board determined the probability of tank damage from this accident was low, but it is possible that a loosely fitting fill tube might have become displaced by the drop.
