# A Case Study on the Failure on Apollo 13

Brenda Lindley Anderson

NASA Marshall Space Flight Center

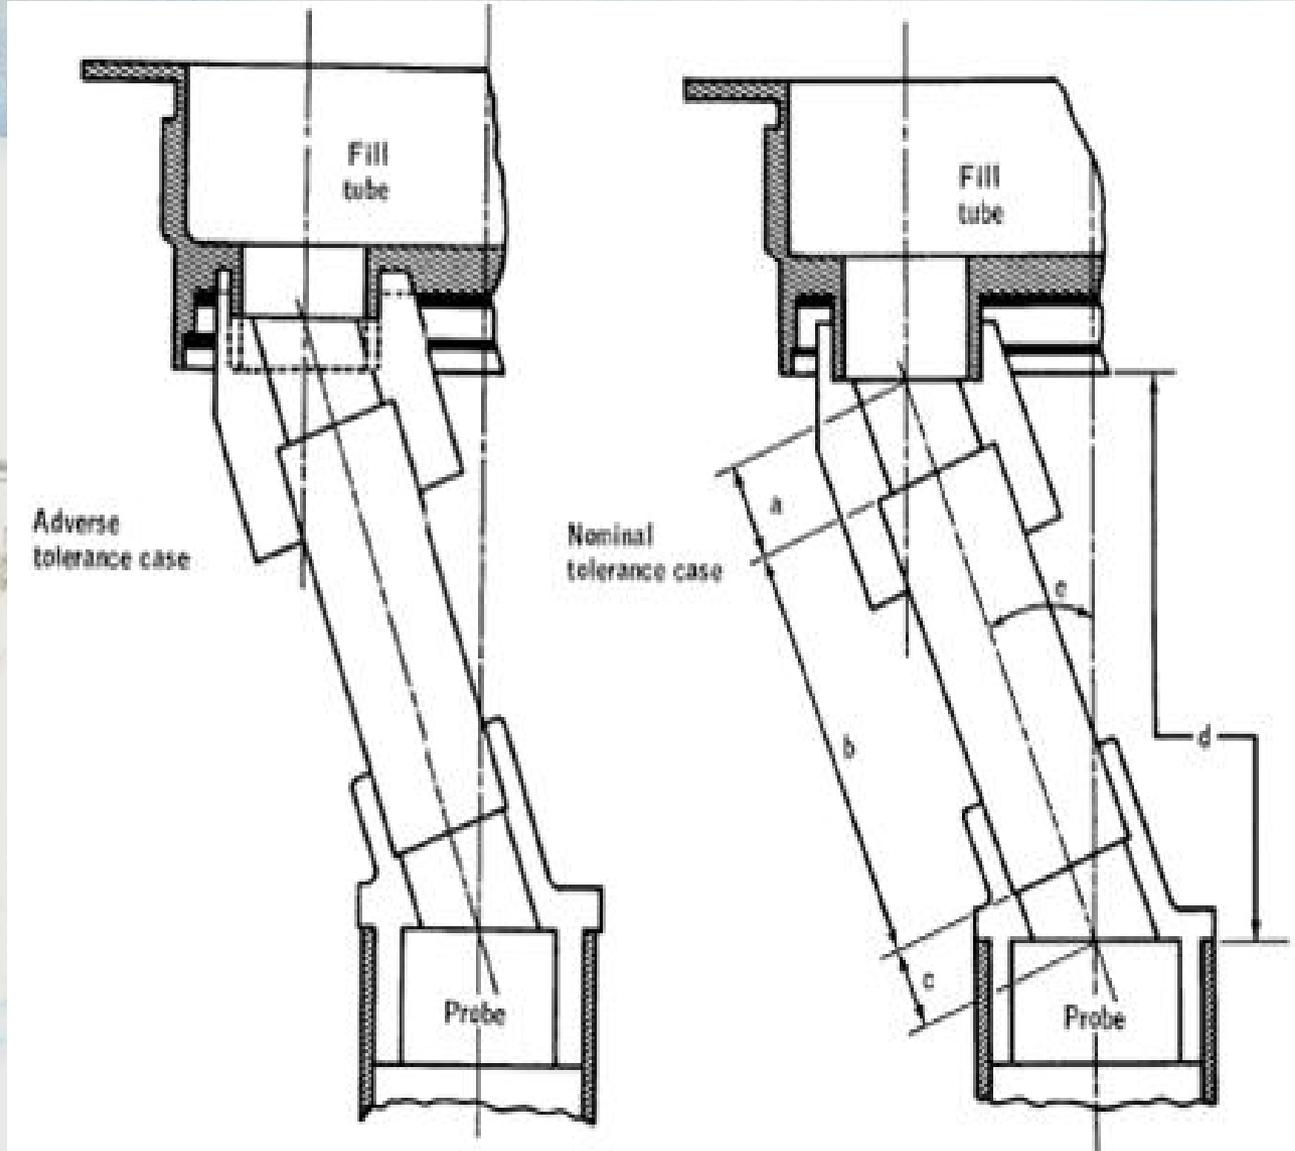
# Nominal and Adverse Coupling Tolerances

For worst case deviations, a loose fit is ensured for the coupling

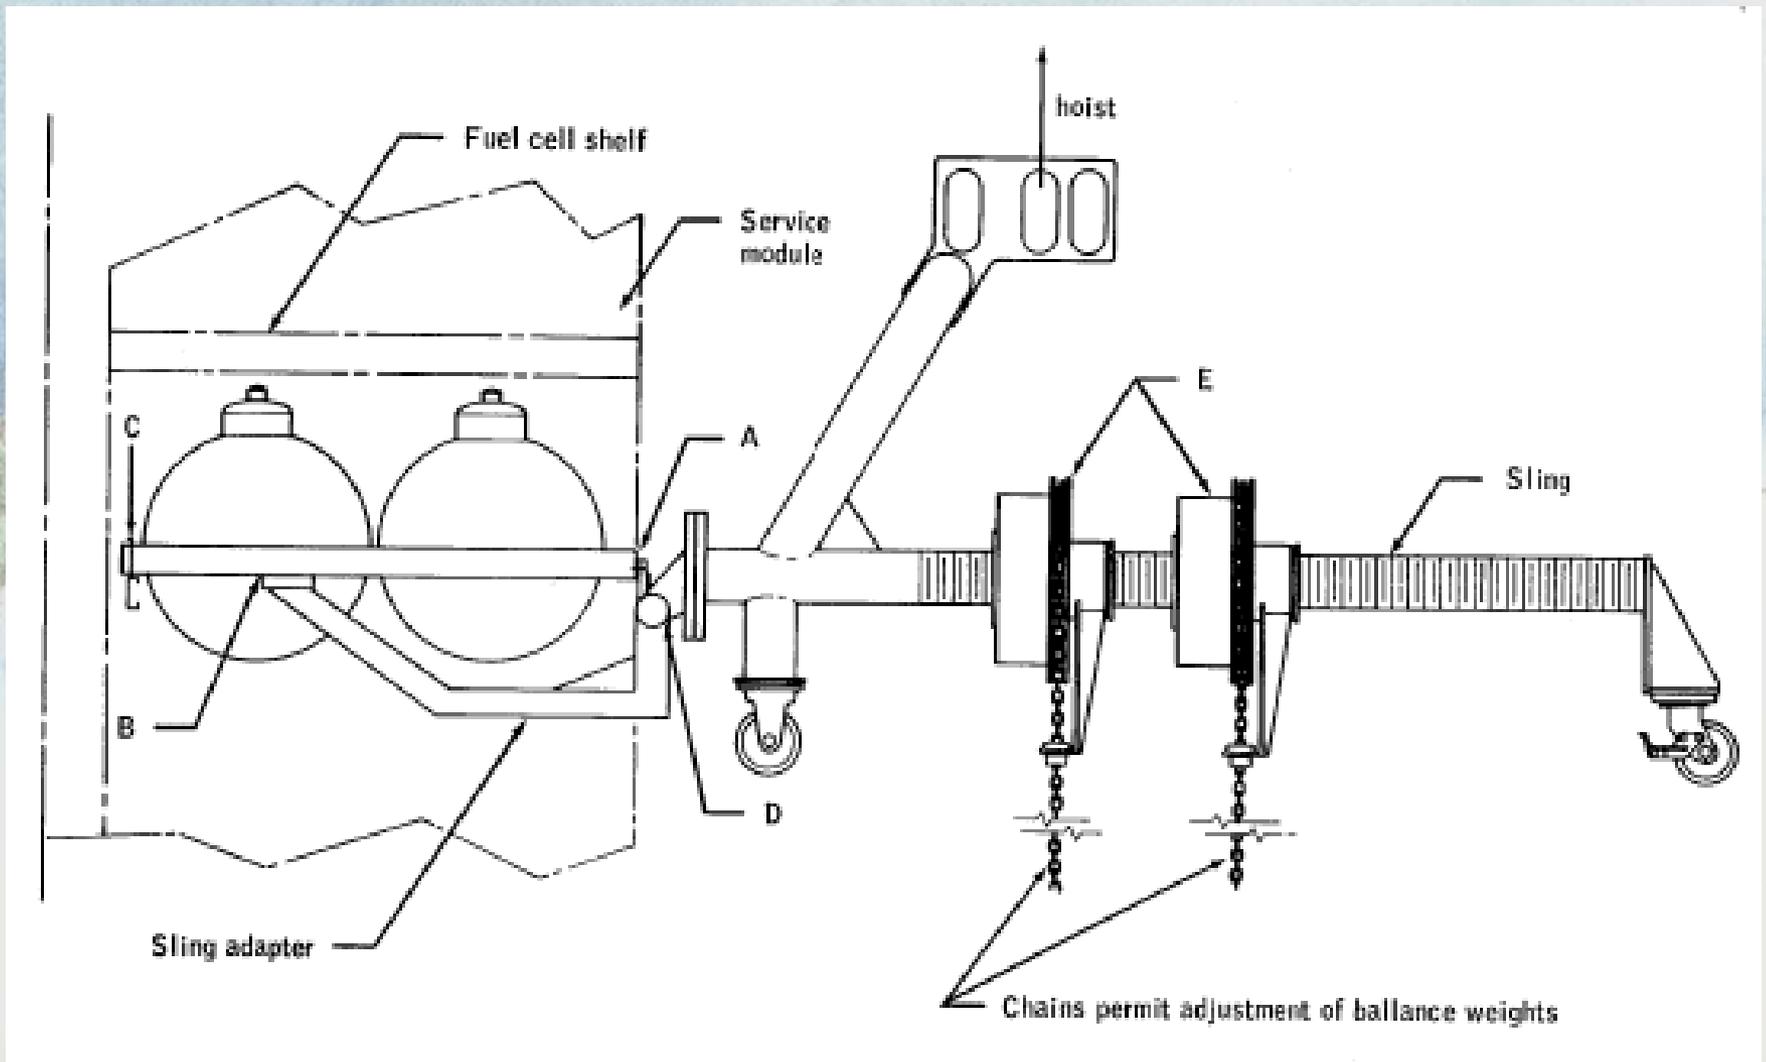
# Hoist and Sling for Shelf Assembly

- The tank shelf was disconnected from the SM and the crane placed under it to lift it from position. By mistake one bolt had been left in. The crane lifted approximately two feet, and then broke, dropping the shelf back into position.
- External photos were taken and calculations were performed to estimate the force from the fall. After the vacuum ion pump was replaced, no further anomalies were noted and no other work performed on the O2 tank.
