SHUTTLE HYPERVELOCITY IMPACT DATABASE

IAC-11.A6.3.7

62nd International
Astronautical Congress
Cape Town, South Africa
3 – 7 October 2011

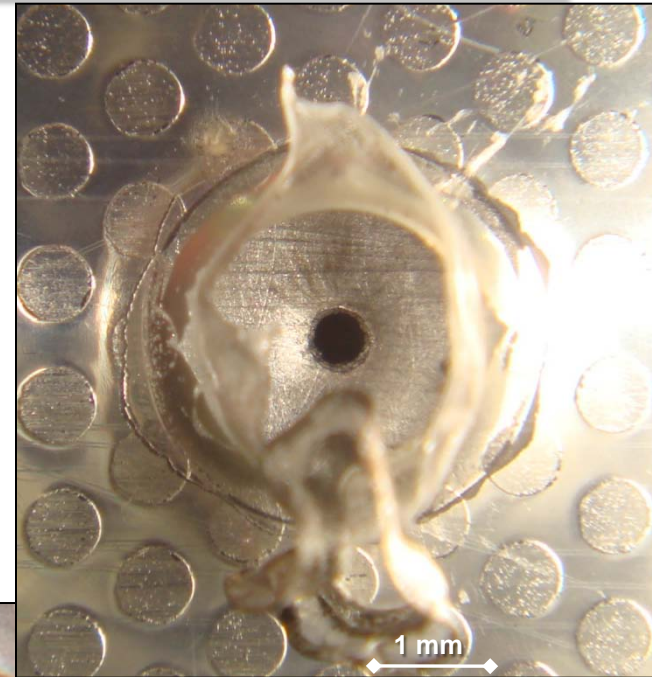
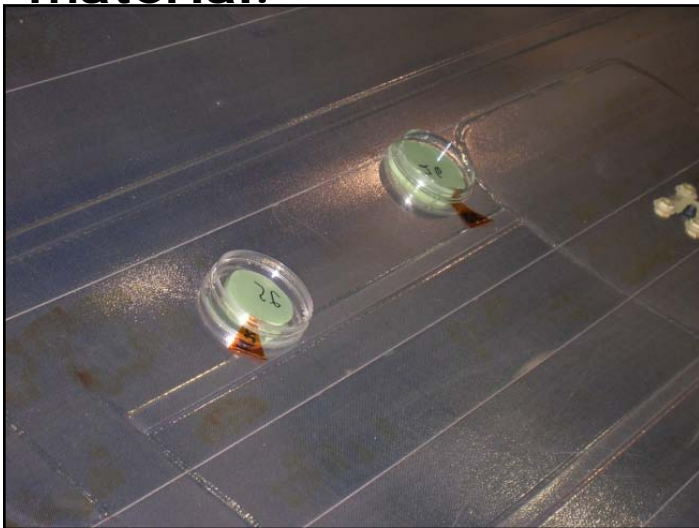
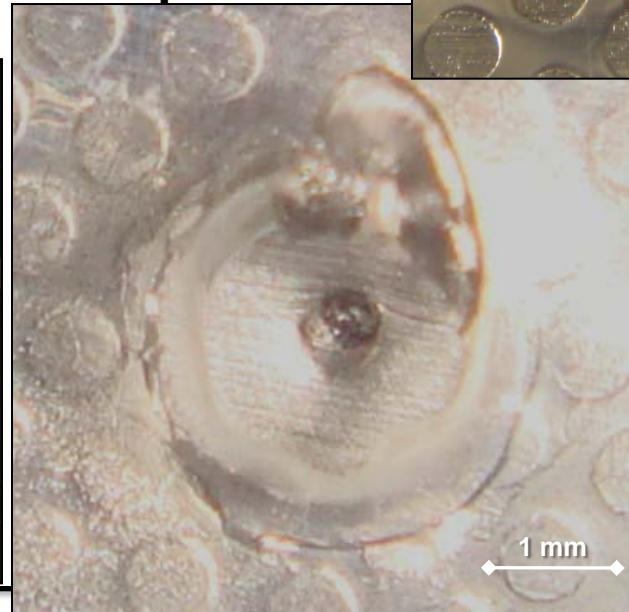
- ❑ 1 face sheet hole was observed (average) per mission. Thermal tape removed during repair is saved for SEM/EDS analysis. Material around face sheet hole was also recovered.
- ❑ Face sheet craters were the most commonly reported damage feature. Sampling was performed with Reprisil® vinyl polysiloxane impression material.

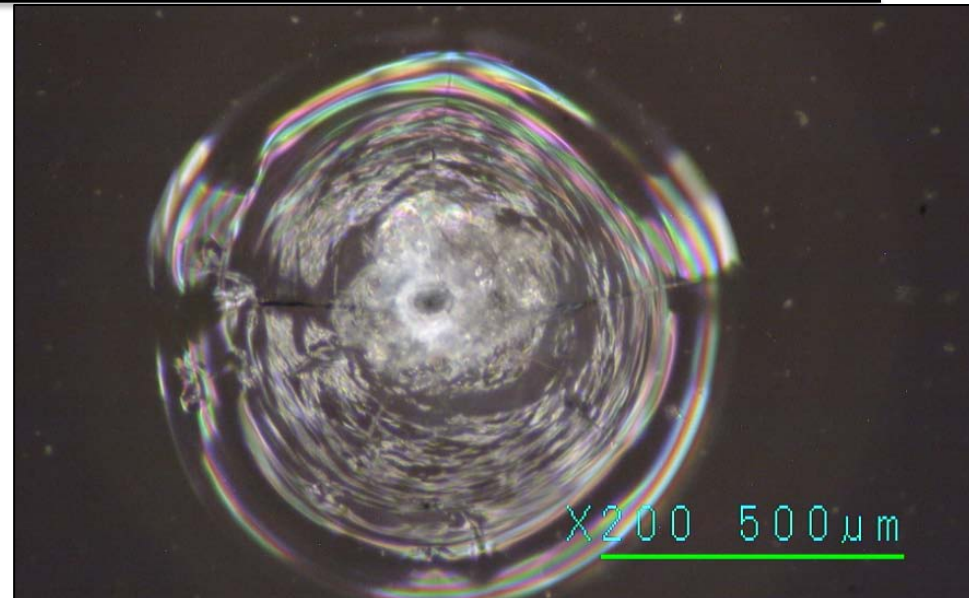
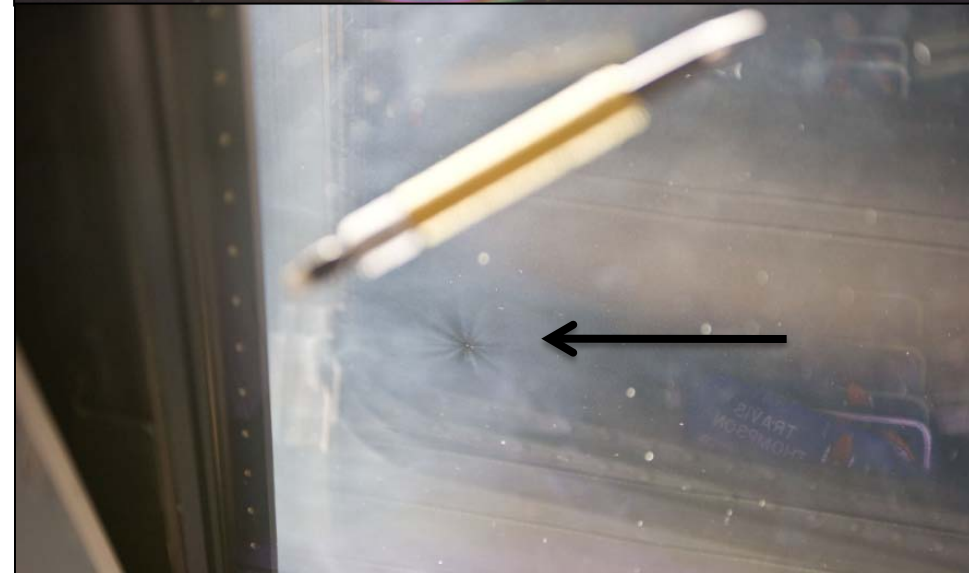
□ Impact features down to **100 μ m in diameter** were easy to detect on the vehicle with clean windows and good lighting.

□ New impacts on W1 and W6 (LH & RH sides) displace plume deposits from Solid Rocket Booster separation motor firings...distinctive radial pattern is easy to see.

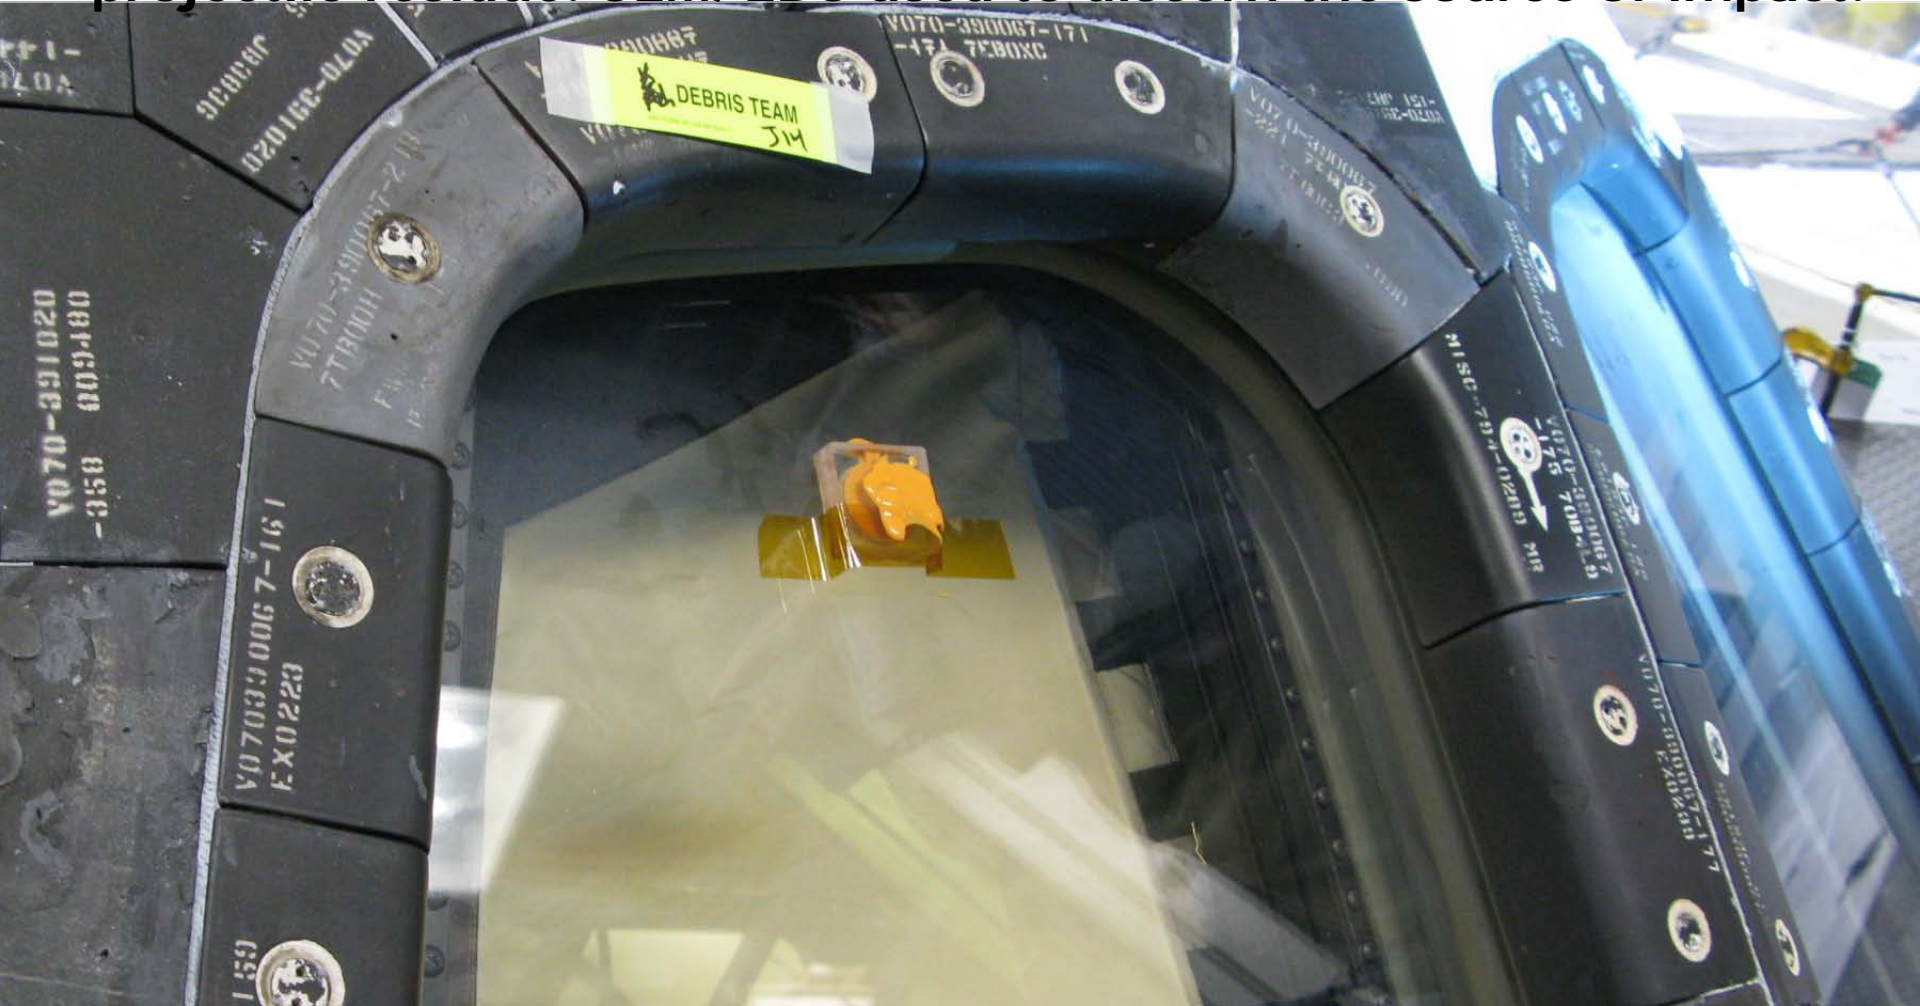
- Reprosil® vinyl polysiloxane impression material was used on suspected MMOD sites to measure crater features & extract projectile residue. SEM/EDS used to discern the source of impact.

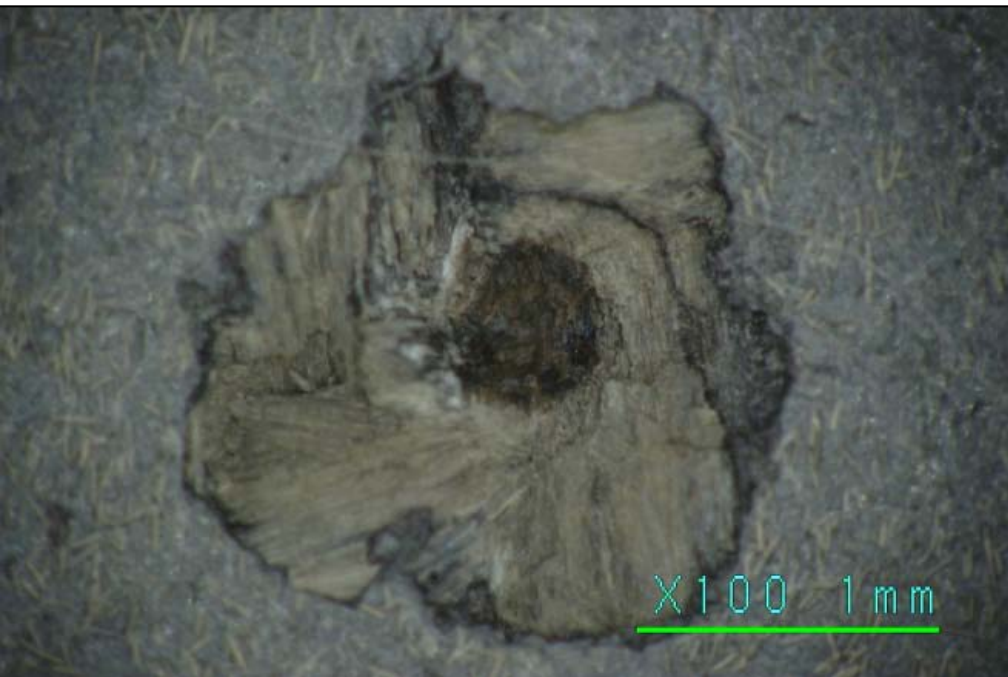
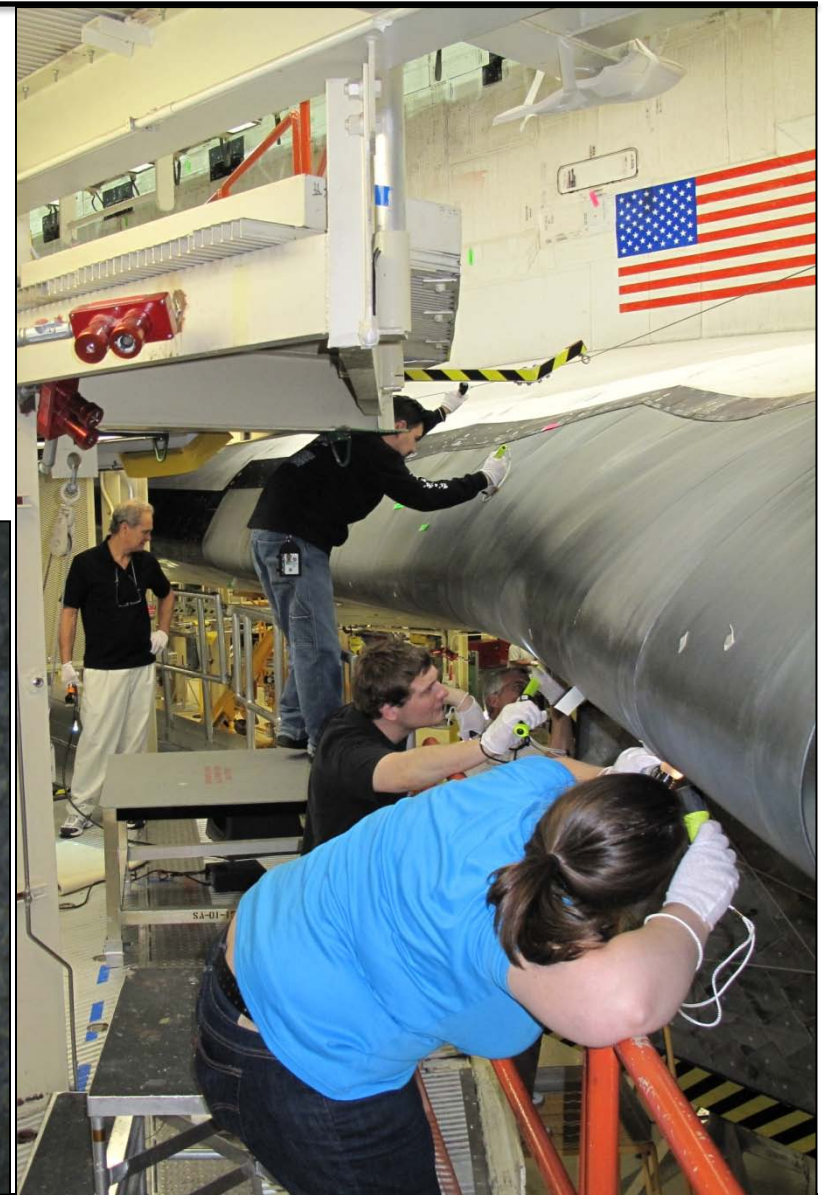
- ❑ Inspection access by platform. Overhead reaches necessary for complete inspection.
- ❑ MMOD impacts in RCC produce distinctive damage features.

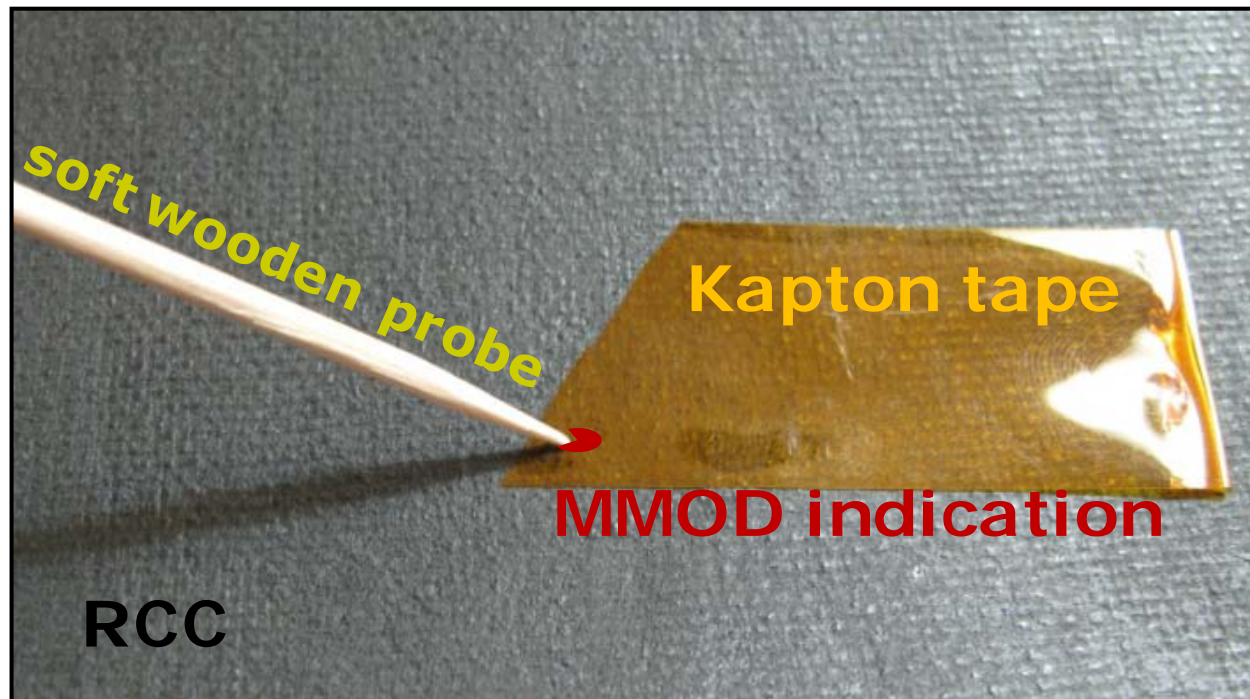
- ❑ Suspected MMOD impact sites were sampled with a tape pull technique. Projectile residue on tape was analyzed with SEM/EDS to discern the source.

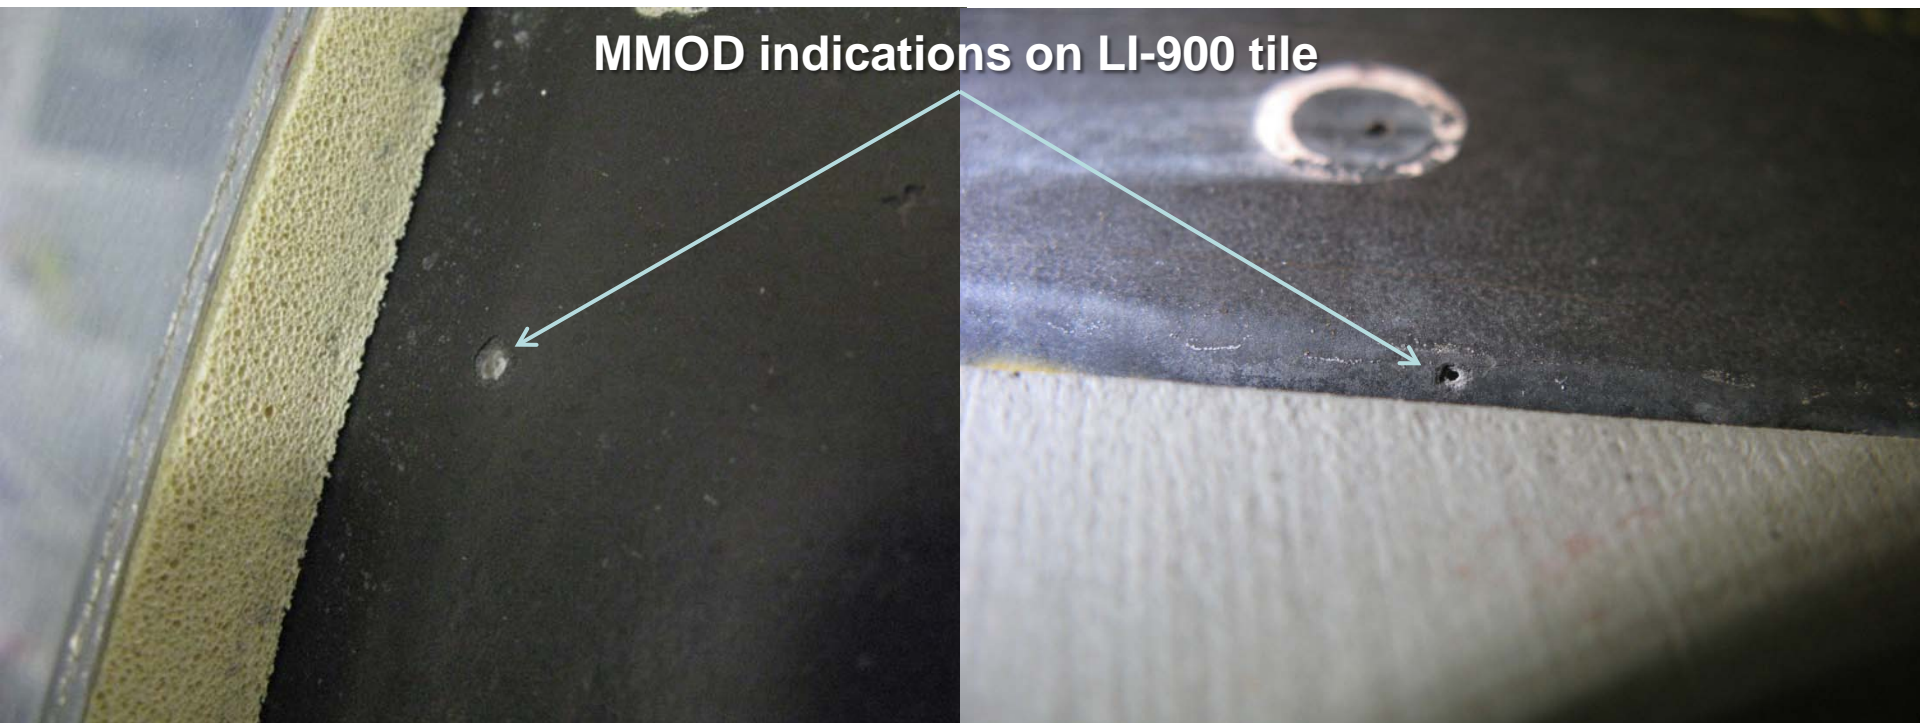
- ❑ Hypervelocity impact features in LI-900 TPS tend to have internal cavities that are larger than the entry hole.
- ❑ Difficult to sample on the vehicle. In a few instances scrapped tiles were removed and MMOD damage sites cored for direct analysis in the SEM/EDS

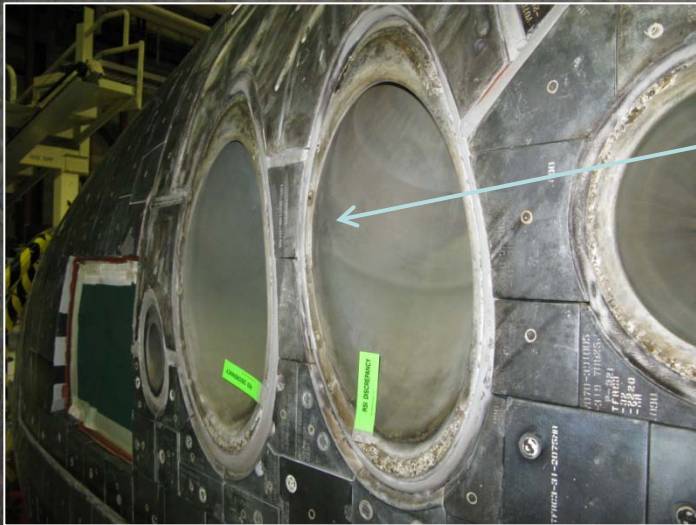
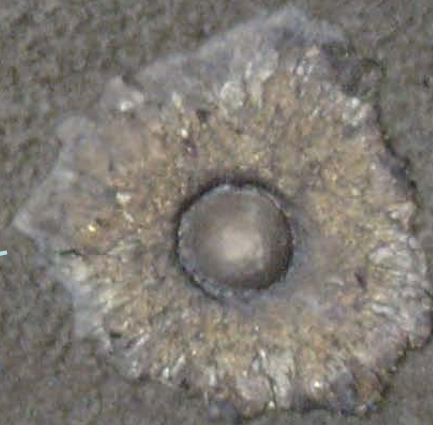
X25 4mm

- ❑ Crater in C103 Niobium alloy
- ❑ Distinctive coating loss and central crater

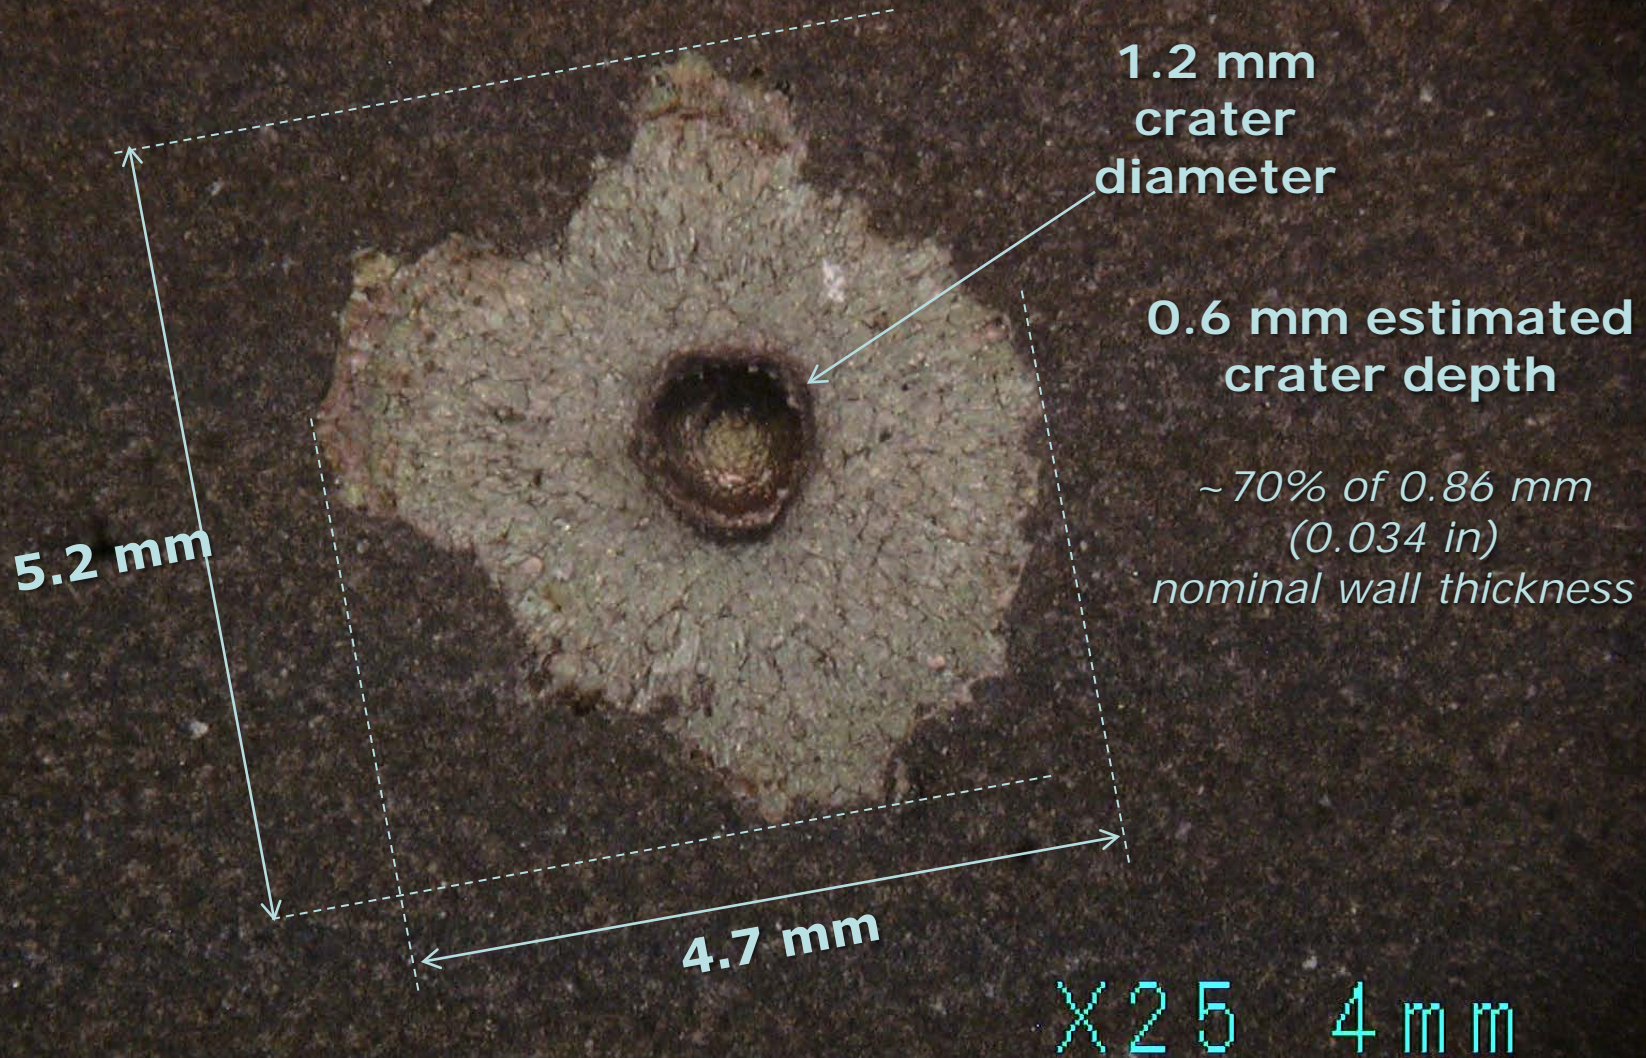
□ Impact in OMS main engine nozzle (entry crater)

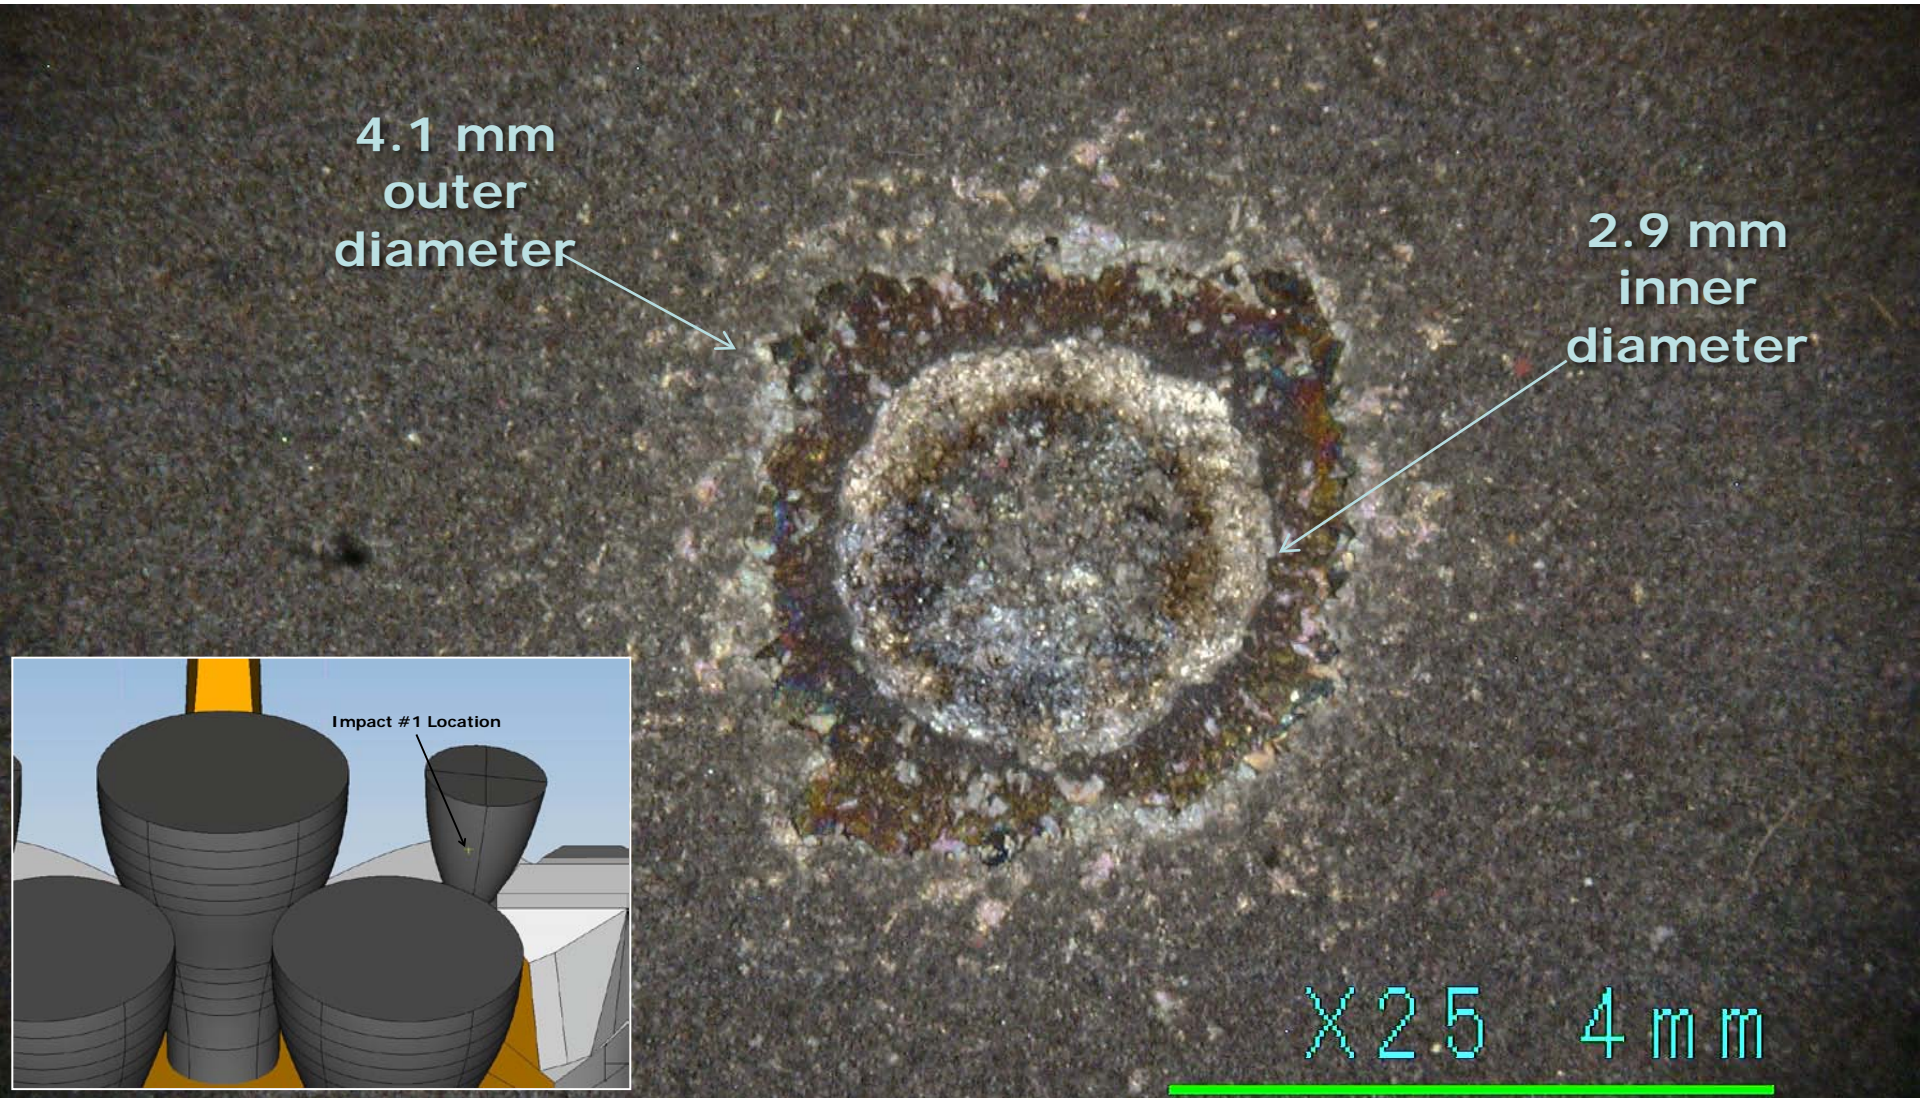
- Impact in OMS main engine nozzle (back side damage)

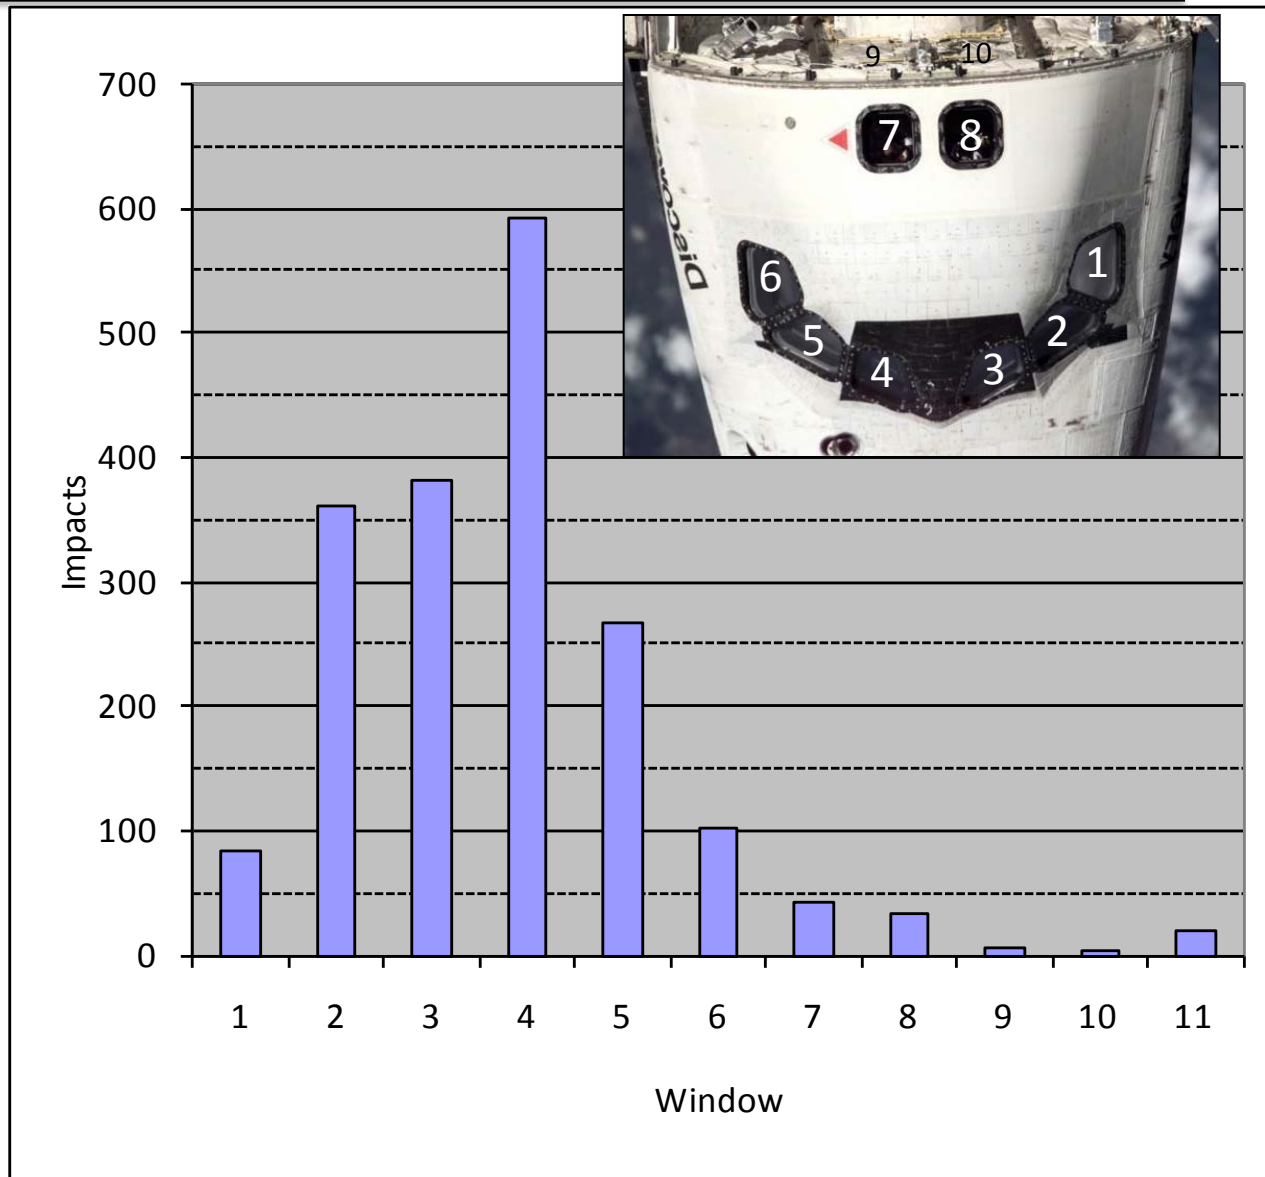
- Total observed impacts per window.
- Distribution at W4 was skewed by a large number of impacts on STS-85 thru STS-91.
