Geoscience Laser Altimetry System (GLAS) Loop Heat Pipe Anomaly and On Orbit Testing

The Geoscience Laser Altimetry System (GLAS) is the sole instrument on the ICESat Satellite. On day 230 of 2003, the GLAS Component Loop Heat Pipe (CLHP) entered a slow circulation mode that resulted in the main electronics box reaching its hot safing temperature, after which the entire instrument was turned off. The CLHP had a propylene working fluid and was actively temperature controlled via a heater on the compensation chamber. The slow circulation mode happened right after a planned propulsive yaw maneuver with the spacecraft. It took several days to recover the CLHP and ensure that it was still operational. The recovery occurred after the entire instrument was cooled to survival temperatures and the CLHP compensation chamber cycled on a survival heater. There are several theories as to why this slow circulation mode exhibited itself, including: accumulation of Non-Condensable Gas (NCG), the secondary wick being under designed or improperly implemented, or an expanded (post-launch) leak across the primary wick. Each of these is discussed in turn, and the secondary wick performance is identifi

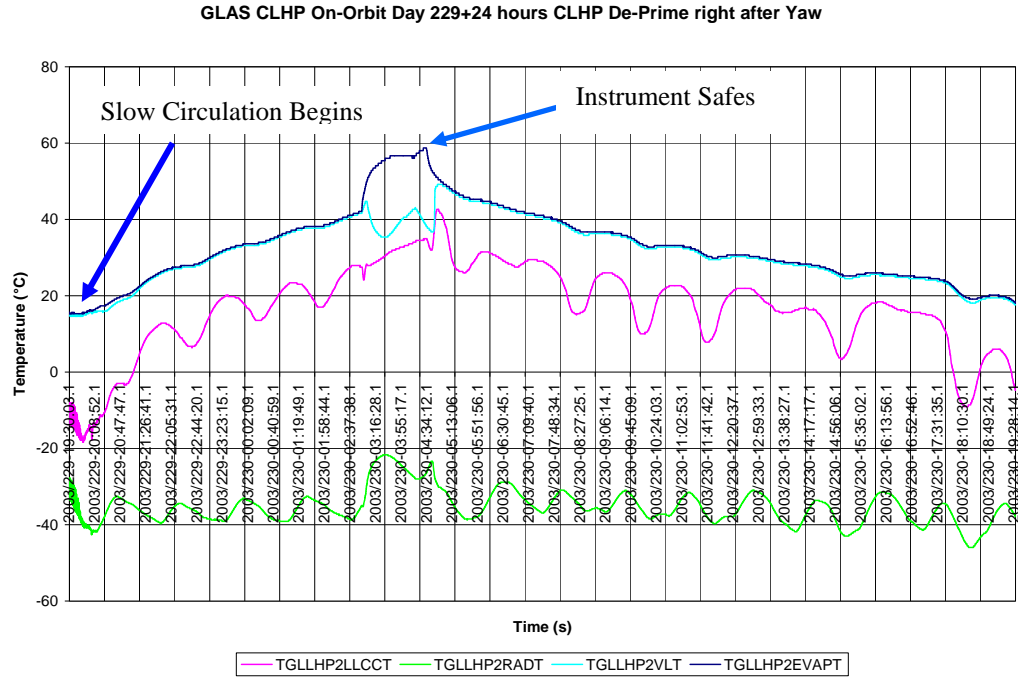
During the 6 year mission, only one significant thermal performance issue occurred. This happened in the fall of 2003 (the year ICESAT launched) when the GLAS Component Loop Heat Pipe (CLHP) did not provide adequate cooling to the Component thermal system (and therefore the GLAS electronics) following the Yaw maneuver at Beta 32° (which has the hottest and most transient sink.) The yaw maneuver produced around $5 \times 10^{-5} \text{ m/s}^2$ of acceleration. Though the CLHP appeared to continue to circulate fluid, the active control of the setpoint was lost. The week before the yaw maneuver, similar temperature excursions were observed, after which the CLHP recovered (or appeared to). Fig 2 shows the overall rise of the temperature, due to the slow circulation mode directly after an orbit maneuver of the ICESat Spacecraft. The increase continued until the instrument safed itself when the temperature limit on the MEB was reached. In the last several months before GLAS was decommissioned, tests were conducted with the instrument to try to reproduce the observed CLHP slow circulation from 2003. The test were unsuccessful with the exception of the last test, which included the yaw maneuver that was similar to the one linked to the original anomaly and followed by a setpoint increase which resulted in some precursor blips that will

Figure 2. Temperature rise due to slow circulation mode following Yaw Maneuver

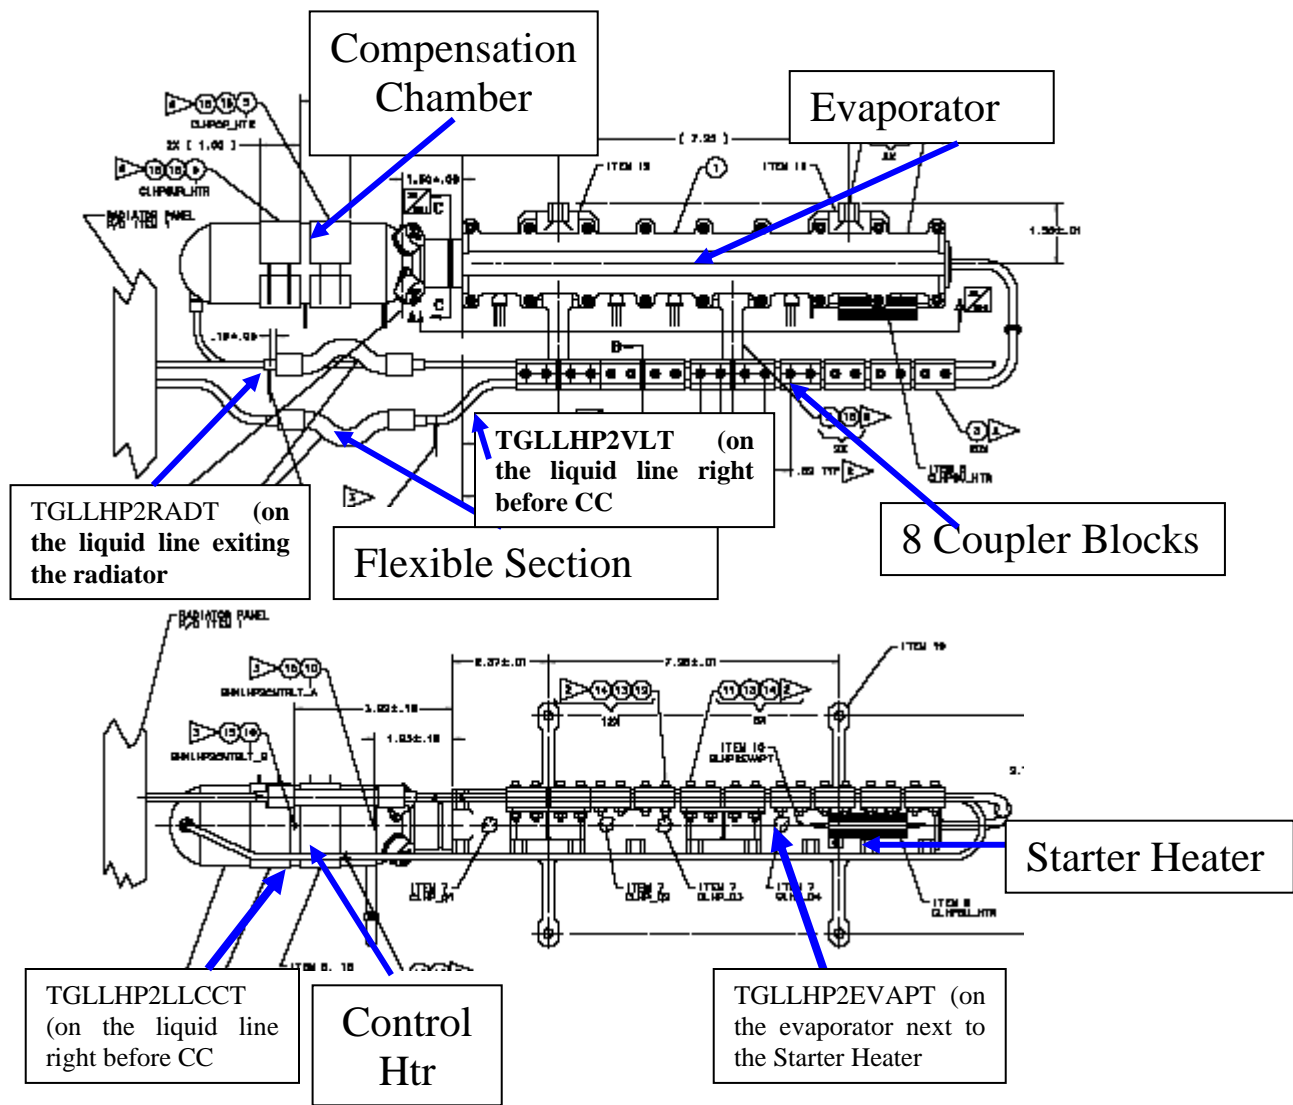
The available flight telemetry on the CLHP consists of 4 telemetry points: TGLLHP2EVAPT (Evaporator), TGLLHP2VLT (Vapor Line), TGLLHP2LLCCT (Liquid Line at CC entrance), TGLLHP2RADT (liquid line exit from condenser); respectively located on the LHP Evaporator near the starter heater, the vapor line after exiting the coupling blocks (which is the saturation vapor), the liquid line after the coupling blocks but before the compensation chamber, and the liquid line exit directly from the radiator (see Fig 3). The TGLLHP2EVAPT is used to measure the relative temperature of the component system (as the electronic components are coupled to the evaporator via constant conductance heat pipes (see Fig 1).

Figure 3. Component LHP Telemetry, Starter Heater and Operational Heater.

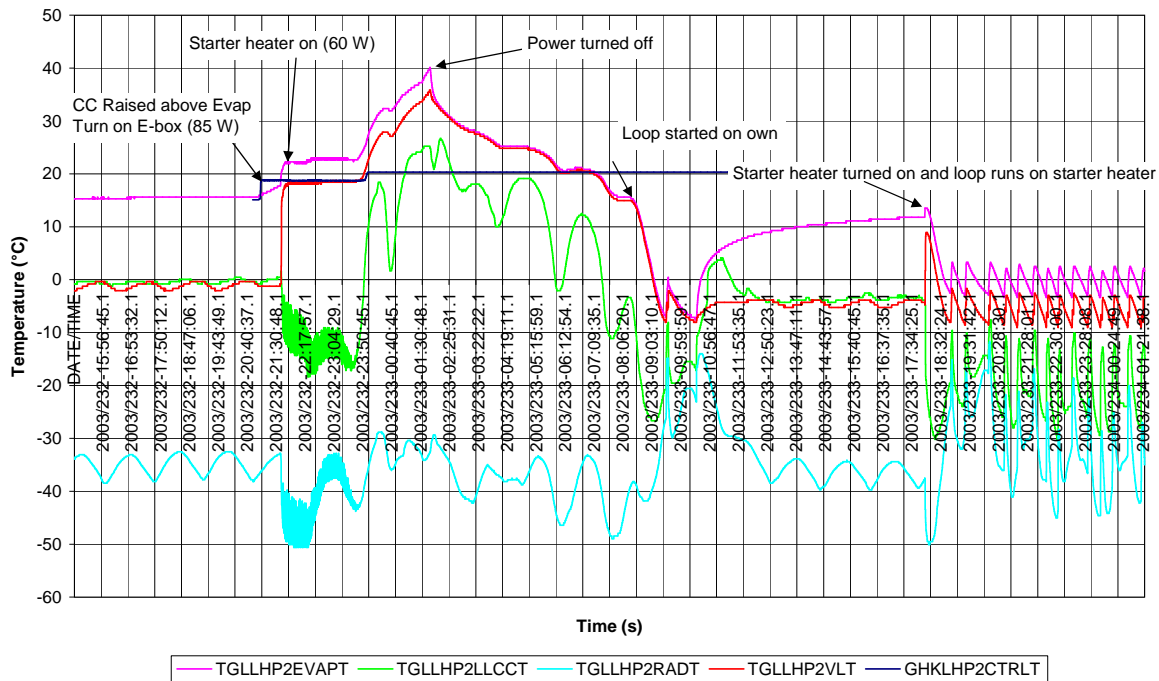
An attempt to quickly re-prime and pre-condition the LHP two days later resulted in the LHP starting quickly but failing soon after, as shown in Fig 4. After the LHP was operated cold on the survival heater for many hours, the LHP was slowly (decreasing the setpoint increase rate to 1/36 of the previous rate) raised back to operating range and operated with a full load plus a 60 W starter heater without entering the slow circulation mode for the remainder of the mission.

GLAS CLHP On-Orbit Day 232+30 hours 2nd attempt to reprime and restart (not successful)
Note: CC was raised 2°C above Evap for 15 minutes before restart

Figure 4. CLHP Second Start-up attempt pre-conditioning, failure, and recovery

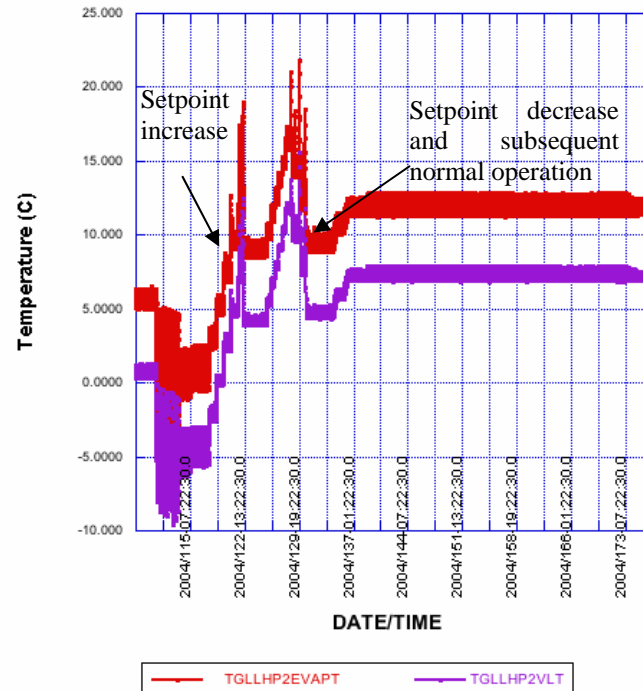
Nominal operations of the LHP resumed after flushing of the CLHP with the survival heater. After this slow circulation mode was experienced, there were observations of the slow circulation precursors during later flight operations, as shown below in Fig 5, however the slow circulation mode was averted by lowering the CLHP

operating temperature by a few degrees, which flushed the evaporator core with liquid. It was important to flush the evaporator after observing the blips on subsequent blip precursors. There had been blip precursors before the Fig 2 slow circulation run away 3 days prior to the Yaw maneuver. Whatever was affecting the LHP at that time must have remained and the perturbation of the Yaw maneuver must have exacerbated the problem to cause the slow circulation. In Fig 5, the temperature setpoint decrease is observable and then the precursor blips ceased.

Figure 5. Further observations of slow circulation precursors on-orbit

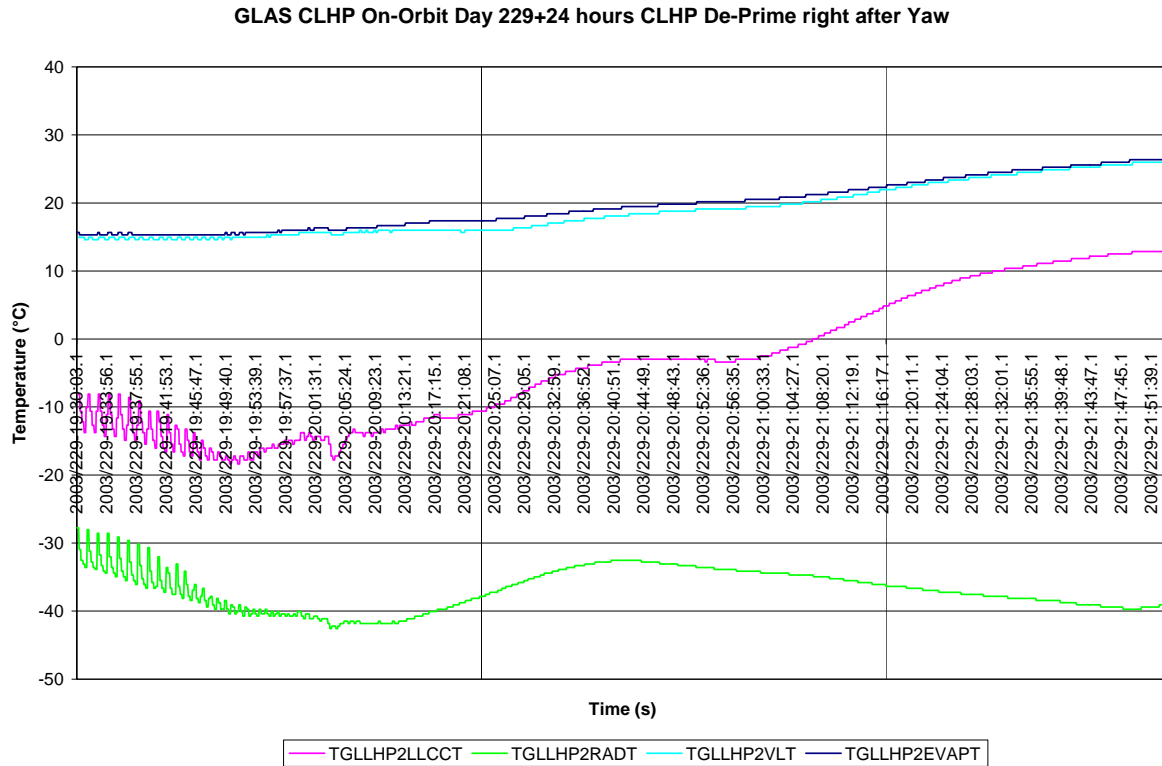
- Temperature excursions were seen on cold portion of orbit when the condenser cooling (due to a colder sink) results in a liquid transfer from the Compensation Chamber and Evaporator Core to the Condenser see Fig 6
- LHP Runs better at colder temperatures – more liquid fill in the compensation chamber due to density changes

Figure 6. Blow up of the original CLHP De-Prime showing the Liquid Line temperature drop and then slow circulation mode commence

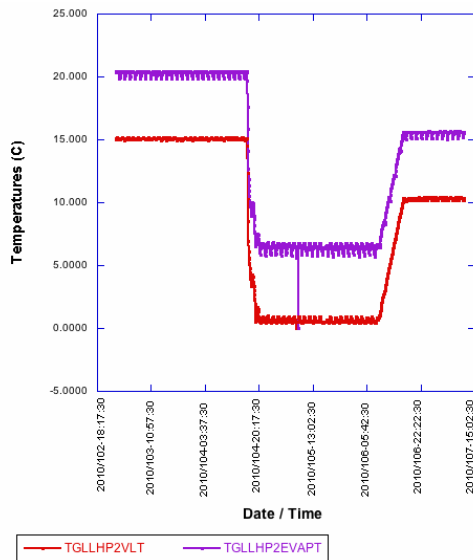
Following the end of the GLAS science campaign, a series of instrument tests were initiated to explore the causes of the slow circulation mode. The intention of the test was to reproduce the flight failure. The Test program is shown in Table 1. A sink change test is shown in Fig 7 and a setpoint change test. This test did not result in any precursor blips.

Figure 7. Sink Change Test (at 0°C) and Setpoint Change Test.

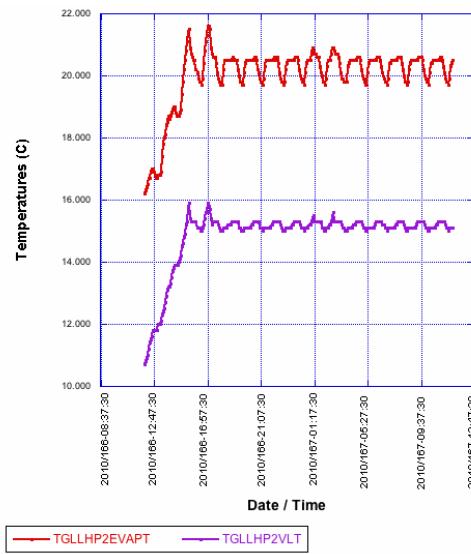
Figure 8. EVAPT Blips (slow circulation precursors) resulting from combination of setpoint changes and high control points

As is seen, neither sink transients (rotating the CLHP radiator to face the Earth versus deep space), nor setpoint changes were successful in forcing the CLHP to start to show precursors for slow circulation mode. Only by combining setpoint changes and high control points after the yaw maneuver, were the precursor blips observed (Fig 8). As was noted earlier, these pre-cursor blips may be indications of a susceptibility to future sustained slow circulation mode. Fig 8 shows the only precursors for slow circulation that occurred during the testing a few days after the Yaw maneuver and when the LHP setpoint was well above its nominal setting (this graph has a setpoint of 20 C.) The previous precursor blips during the baseline mission occurred when the CLHP was set at 15 C in the original slow circulation runaway and at 7.5 C during the Fig 5 blips. Note also that after the setpoint was dropped 5°C that the precursor blips stopped (which Fig 5 shows.) The effect of dropping the setpoint transfers fluid from the condenser into the evaporator core rapidly potentially re-wetting the dried out wick section.
