Moisture-Induced TBC Spallation on Turbine Blade Samples

James L. Smialek

NASA Glenn Research Center

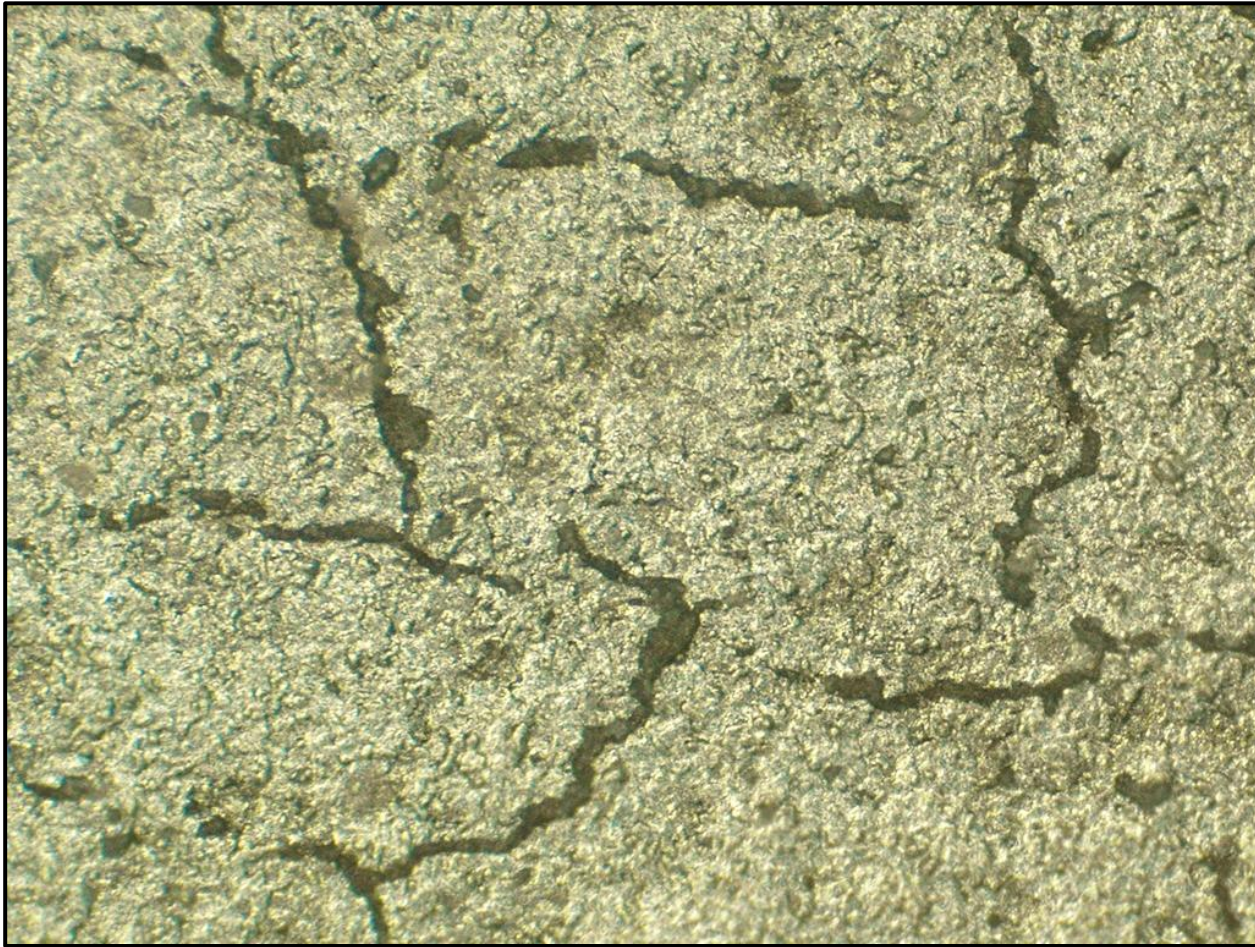
Figure 13

While the overall exposed bond coat appearance is that of clean reflective metal, closer examination reveals additional detail. **Figure 13** is an optical surface micrograph of sample C2, oxidized at 1200°C for 5 hr. before failing by water immersion. It shows a series of entrained scale in more or less a grid like network of stringers.

Figure 13. Optical macrograph of Sample C2 after TBC delamination resulting from a 2 minute water drop test following 5 hr intermittent oxidation at 1200°C. Reflective bare metal bond coat and network of retained oxide.

C2, 1200°C, 5 hr; 2 min. H₂O failure; 100x

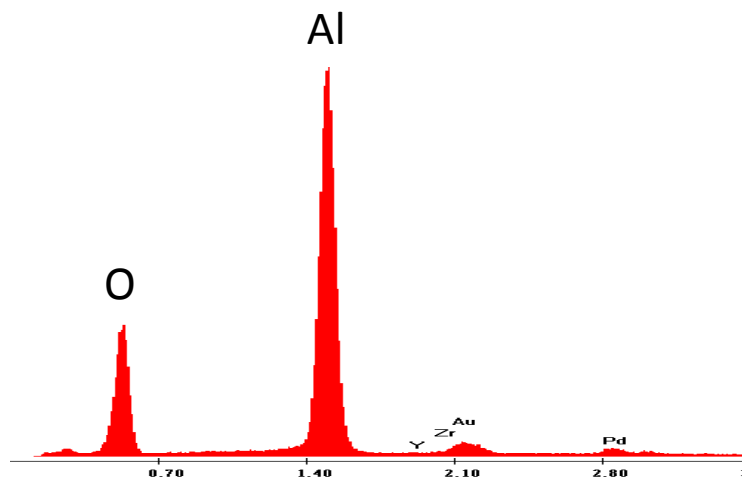
Figure 14

The surfaces exposed by TBC delamination were examined by SEM/EDS. **Figure 14** shows a typical area of the underside of a spalled fragment of coating. For the most part, the TBC fragment retained the thermally grown alumina scale which exhibited an undulating or rumpled morphology (**1a**). The scale underside grain morphology is apparent (**1b**) with most grains being in a 1-2 μm range. Some highlighted areas in backscatter imaging were shown by EDS to be Ni,Ta- rich oxide or Ni metal alloy. Attempts were made to examine the attached alumina scale in fracture sections of spalled TBC fragments, **Figure 15**. Unfortunately, no good section views of the scale were found, even though EDS identified the alumina scale away from the fracture section. It is seen that the TBC layer was about 140 μm thick here.

Figure 14. Backscatter SEM image and EDS spectra of exposed alumina grain surfaces attached to the underside of the spalled TBC. Sample B4, 35 hr intermittent oxidation at 1150°C.

Spalled Oxide Underside: B4, 1150°, 35 hr
Scale Undulations and Grains
