Examination of Surface Residuals Obtained during Re-Lubrication of the International Space Station (ISS) Solar Alpha Rotary Joint (SARJ)

J. L. Golden* and J. E. Martinez**

M&M 2012 / P-06 Failure Analysis of Structural Materials
Phoenix, AZ 31 August 2012

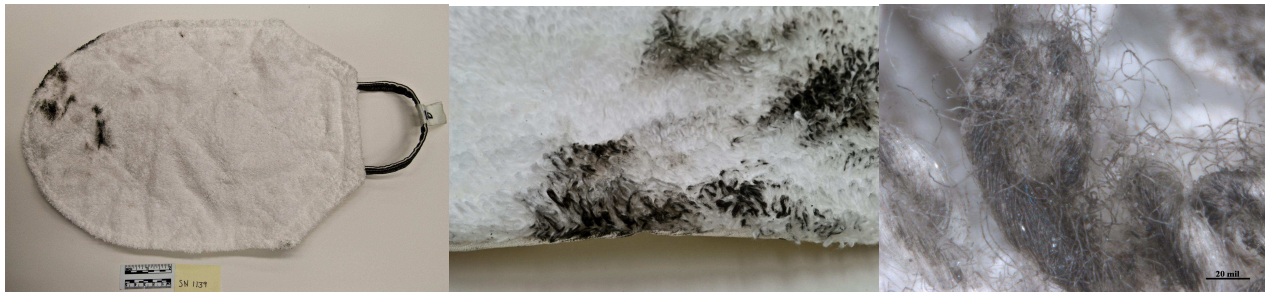
FIG. 1. EVA mitt containing grease sample from the outer canted surface of the SARJ race ring, showing increasing levels of magnification used to for initial evaluation.

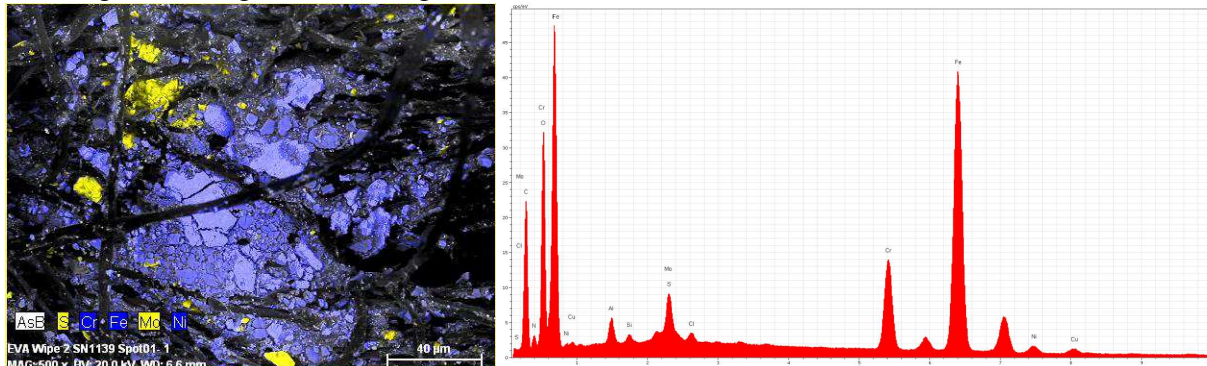
Obviously, evidence of molybdenum disulfide (MoS_2), a major component in the grease applied, was prevalent in the analysis conducted. But a small amount of mechanism wear debris was observed. Figure 2 shows an example of a region of concentrated wear debris. Although some MoS_2 is observed, most of the contaminant in this location is nitrided 15-5PH steel, as verified by the associated chemical analysis. High oxygen content was also observed which, when associated with the apparent friable nature of the steel material, suggests that this contaminant could be quite old, perhaps even associated with the mechanism’s original manufacture and acceptance testing.

FIG. 2. SEM and elemental analysis of a typical region of contaminant sample from the SARJ outer canted surface. A mixture of MoS_2 (grease) and nitrided 15-5PH steel (wear debris) is indicated.

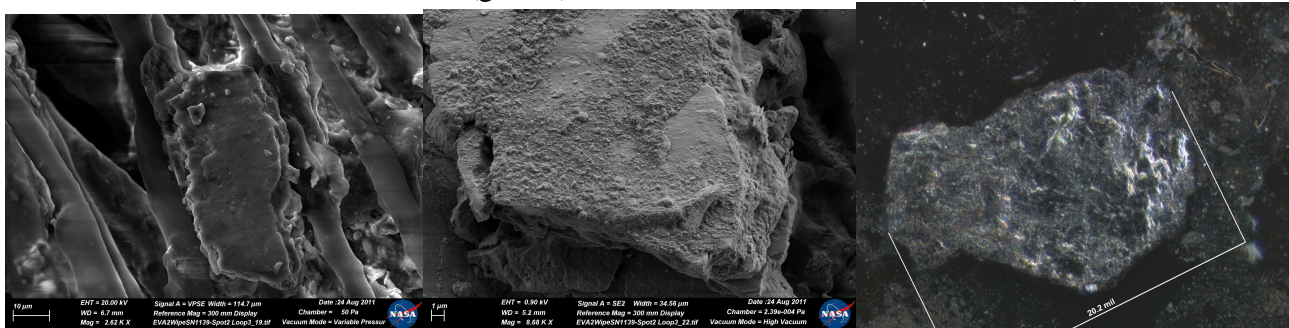
Additional microscopic analysis is shown in Figure 3, for two additional debris particles examined. The first particle is shown in two images: the first using variable pressure SEM imaging and showing the nitrided 15-5PH steel particle trapped among the sampling-mitt cotton fibers; and the second using secondary back-scatter imaging and a slightly higher magnification, which shows residuals of grease contamination on the steel particle and evidence of oxidation. The second of the particles shown in Figure 3 was the largest of the metallic debris particles observed in the investigation. In other particulate analyses, evidence of gold from the original mechanism lubrication system was observed, but very few such indications were found.

FIG 3. Examples of two wear debris particles. The first two images are of the same particle, shown using the SEM in variable pressure mode, followed by a secondary backscatter image. The third SEM shows the largest race-ring debris particle observed during this investigation.

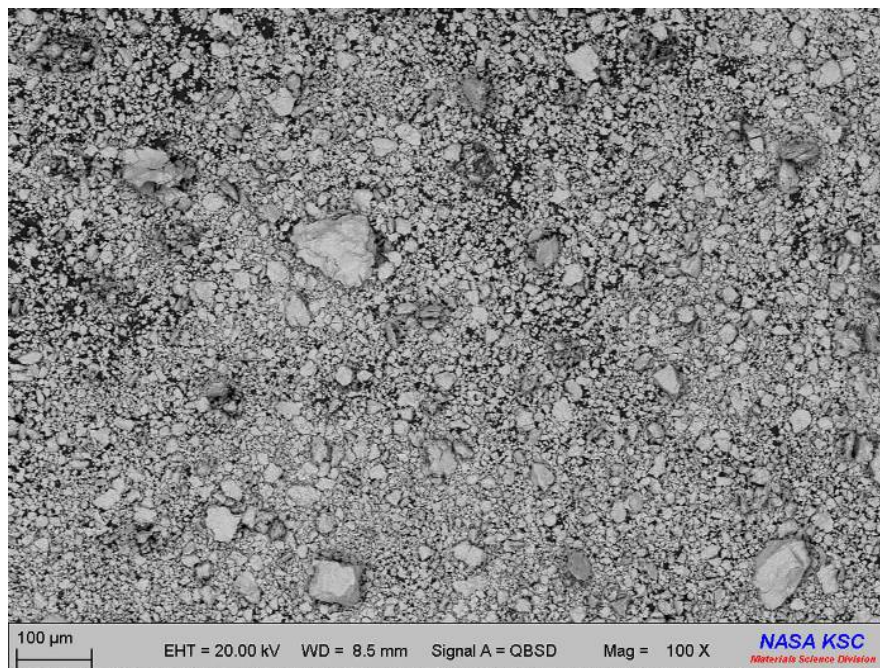
Representative area of
“fine” debris (< 100 μm)

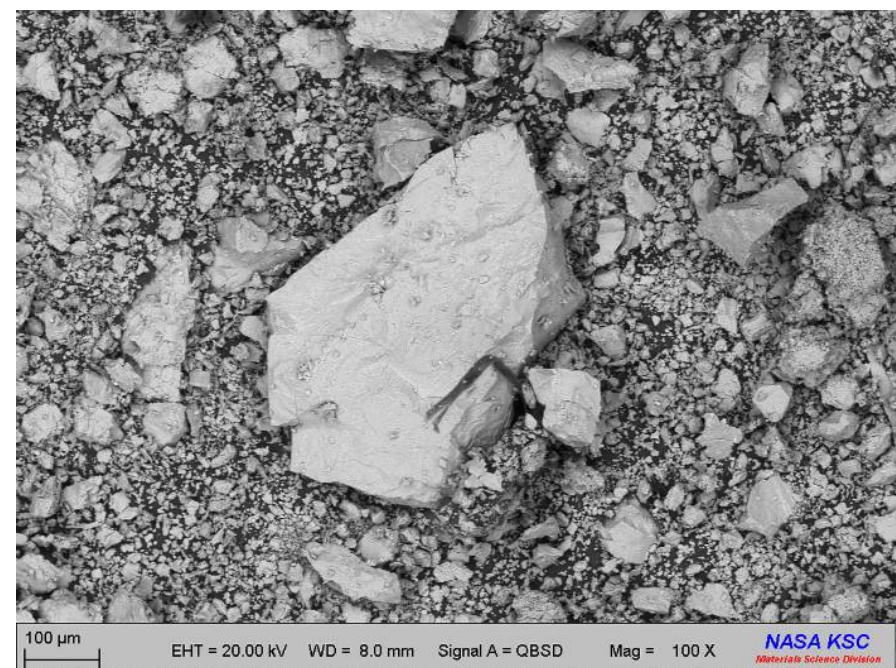
Representative area of all debris;
broad particle size distribution

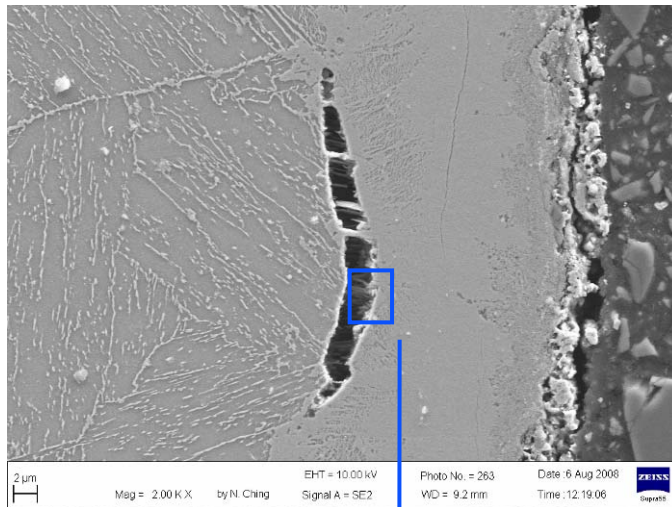
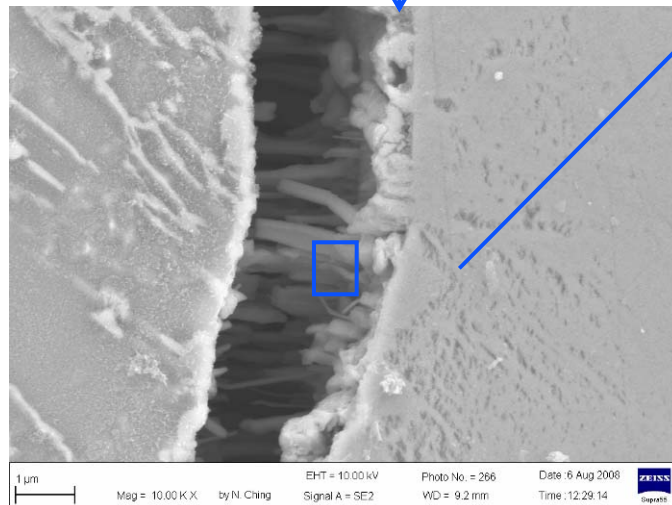
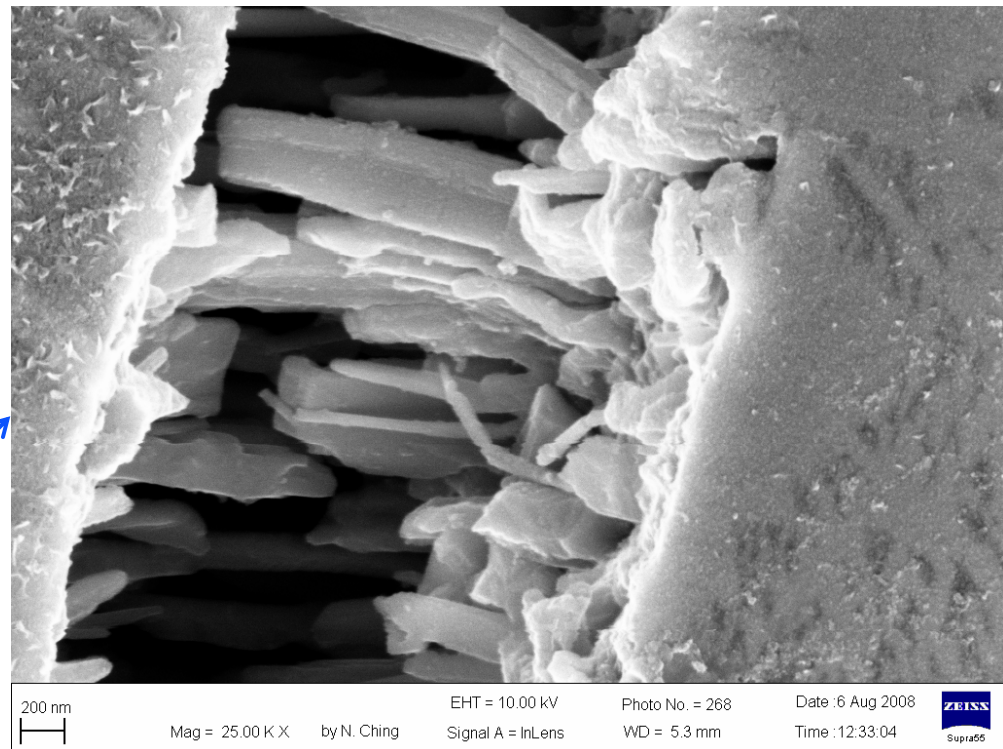
Polished metallographic sample showing discontinuous intergranular separation (DIGS). The degree of porosity and the type scaffolding structure inside each DIGS varies, and at times appears as a nanostructure.

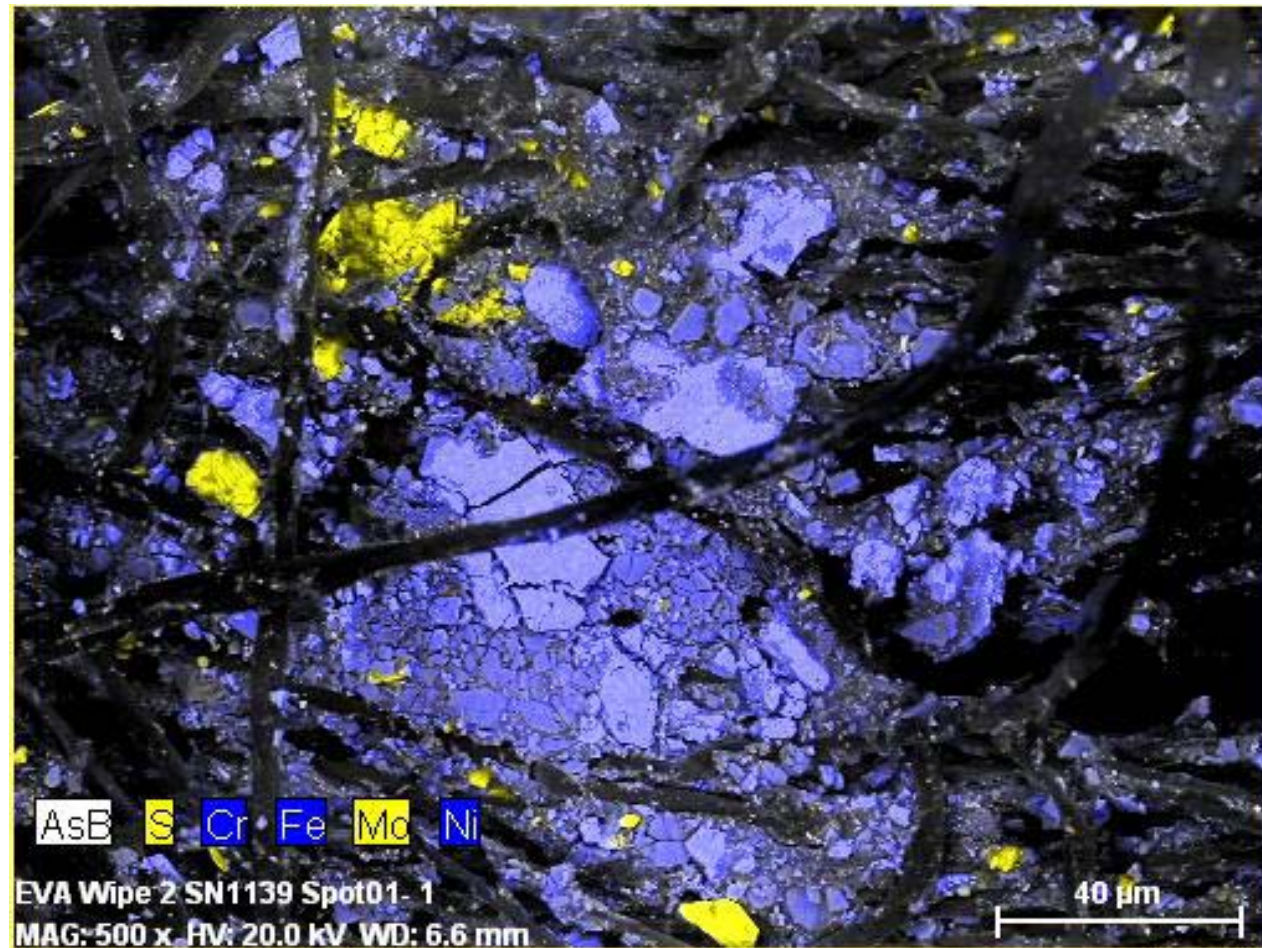
Backscatter Image, showing 15-5PH steel debris and MoS₂ (from lubricant)

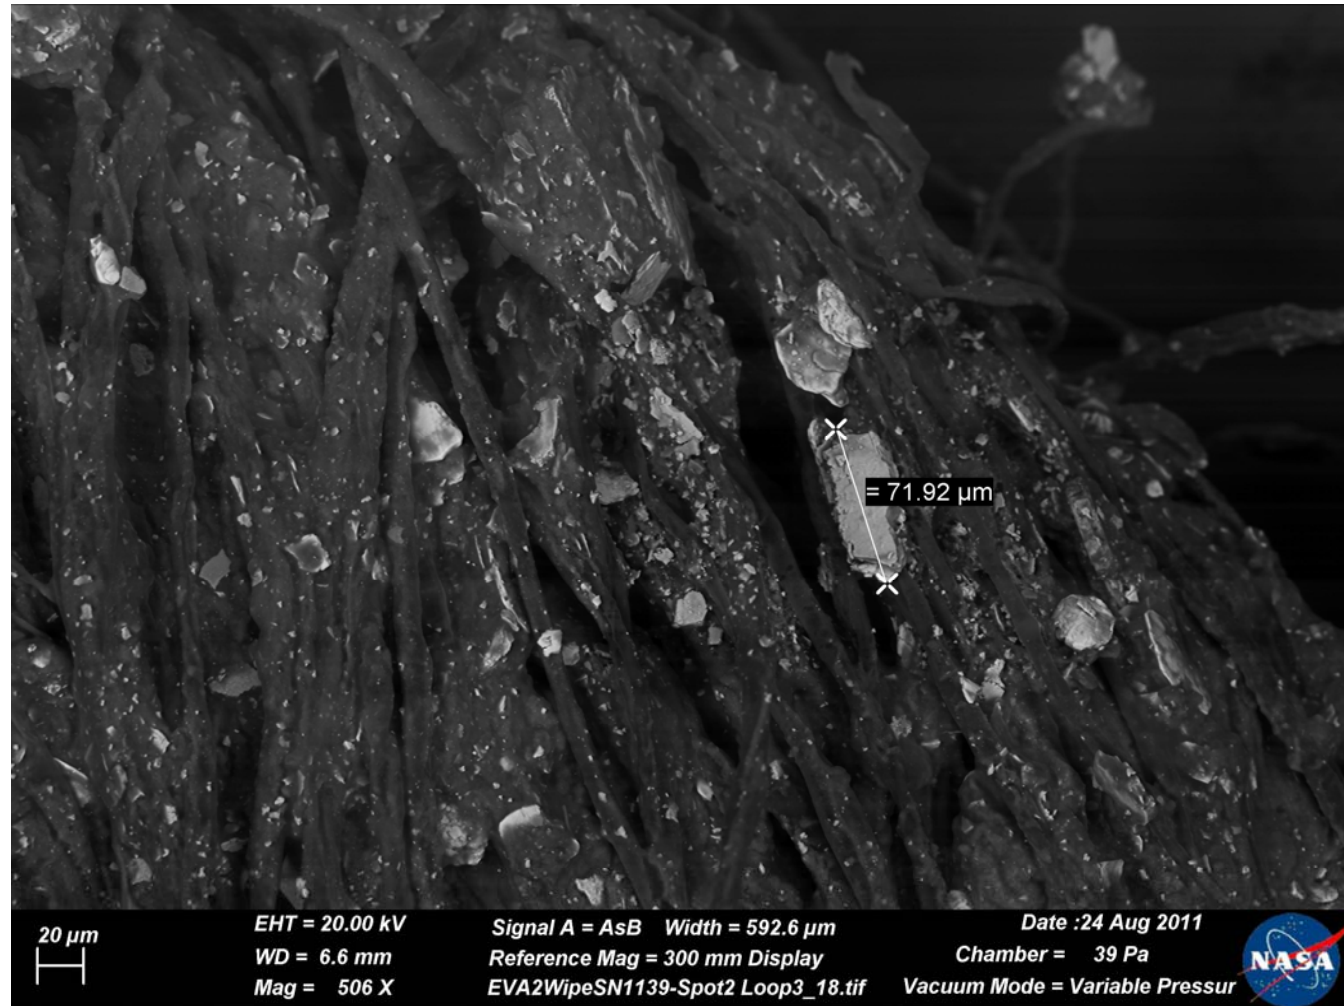
Backscatter Image in Variable Pressure mode. Most particles are MoS_2 , but one looked interesting.

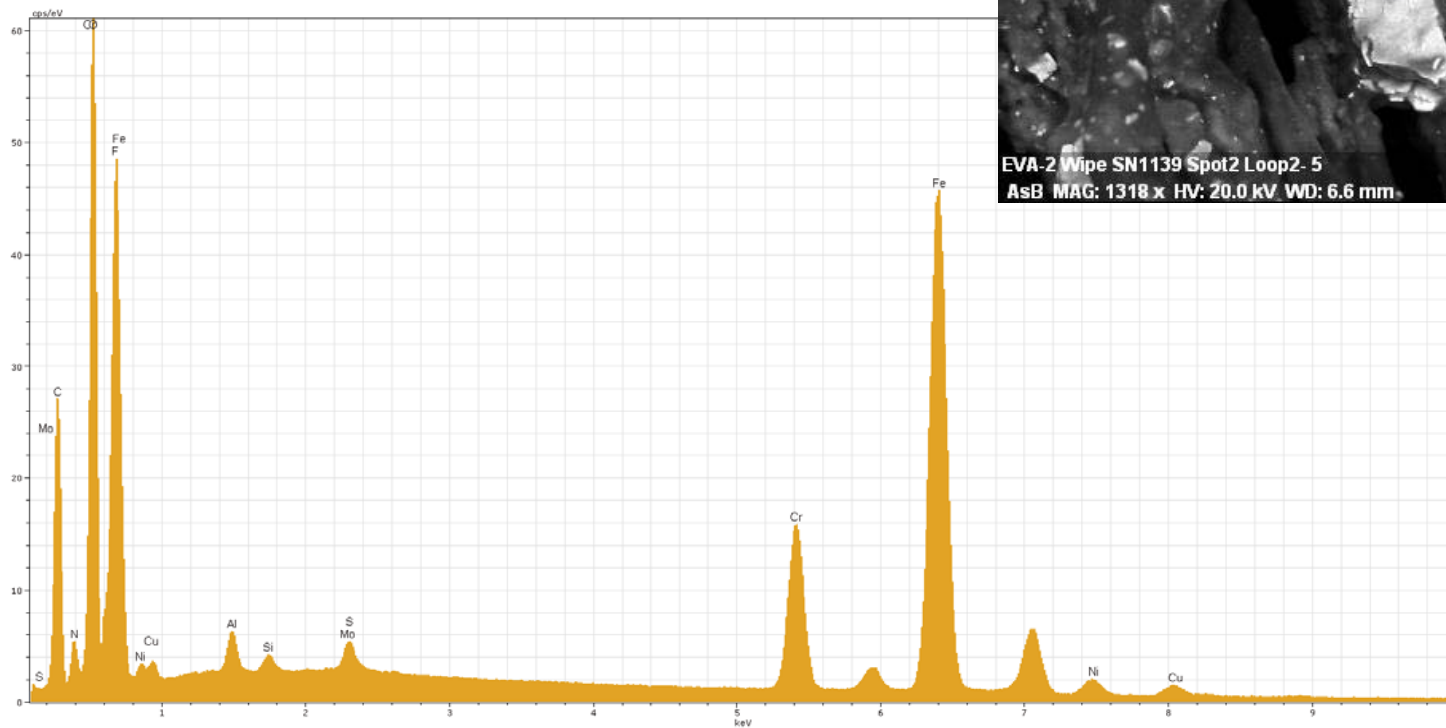
EDS analysis of particle is consistent with nitrided 15-5PH with a strong oxide signature.

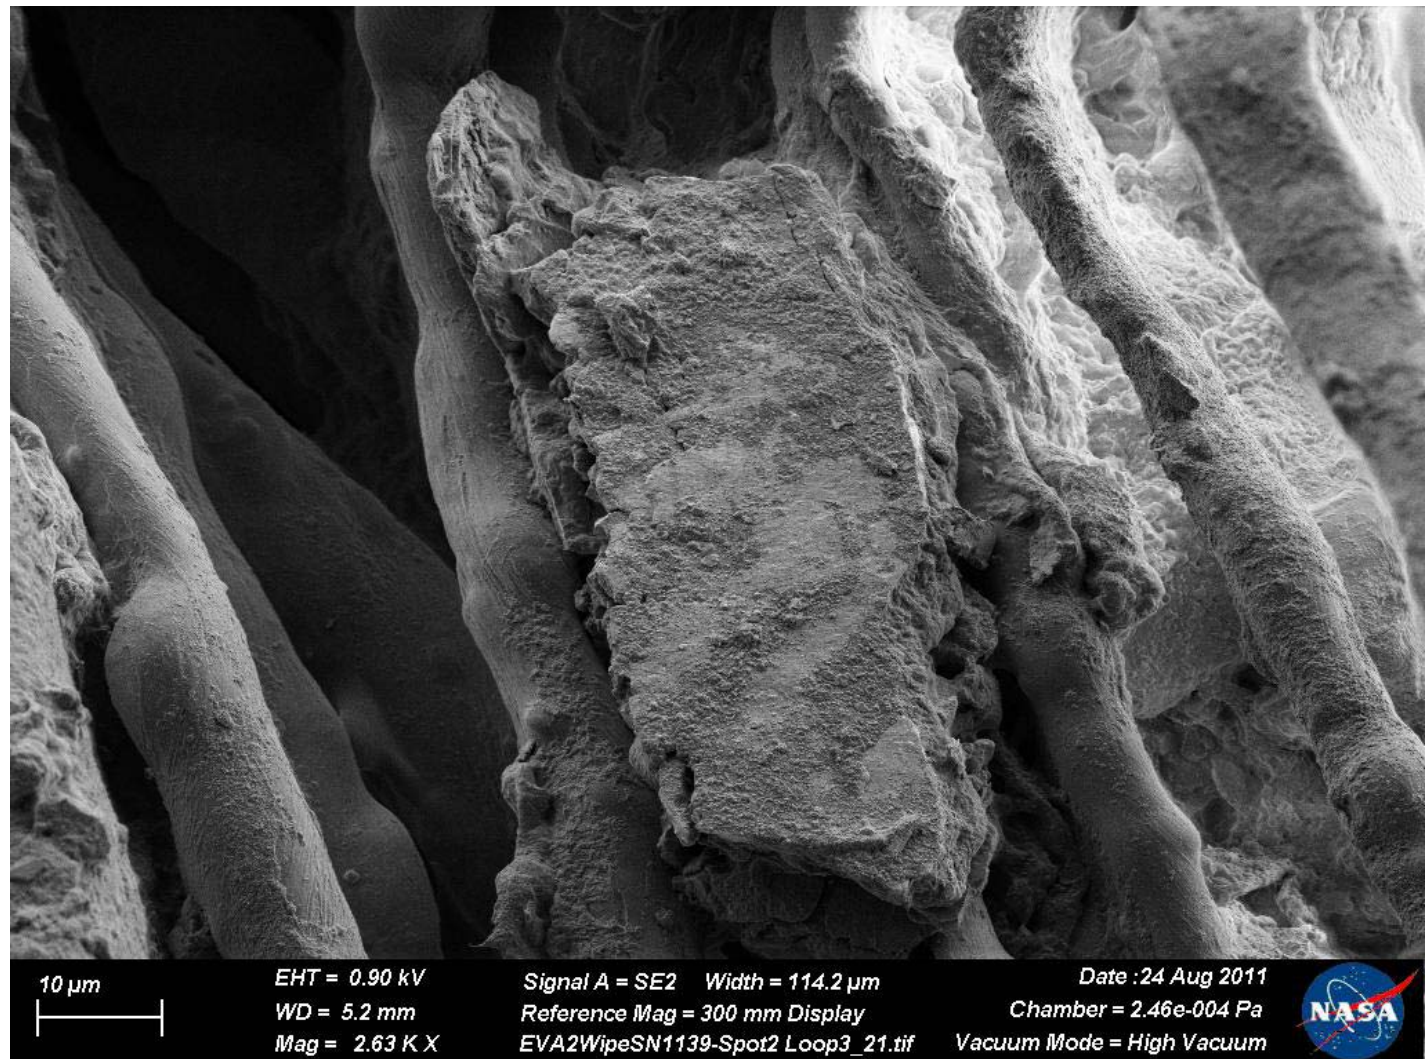
High-resolution Secondary Electron (SE2) image of Nitrided 15-5PH debris.

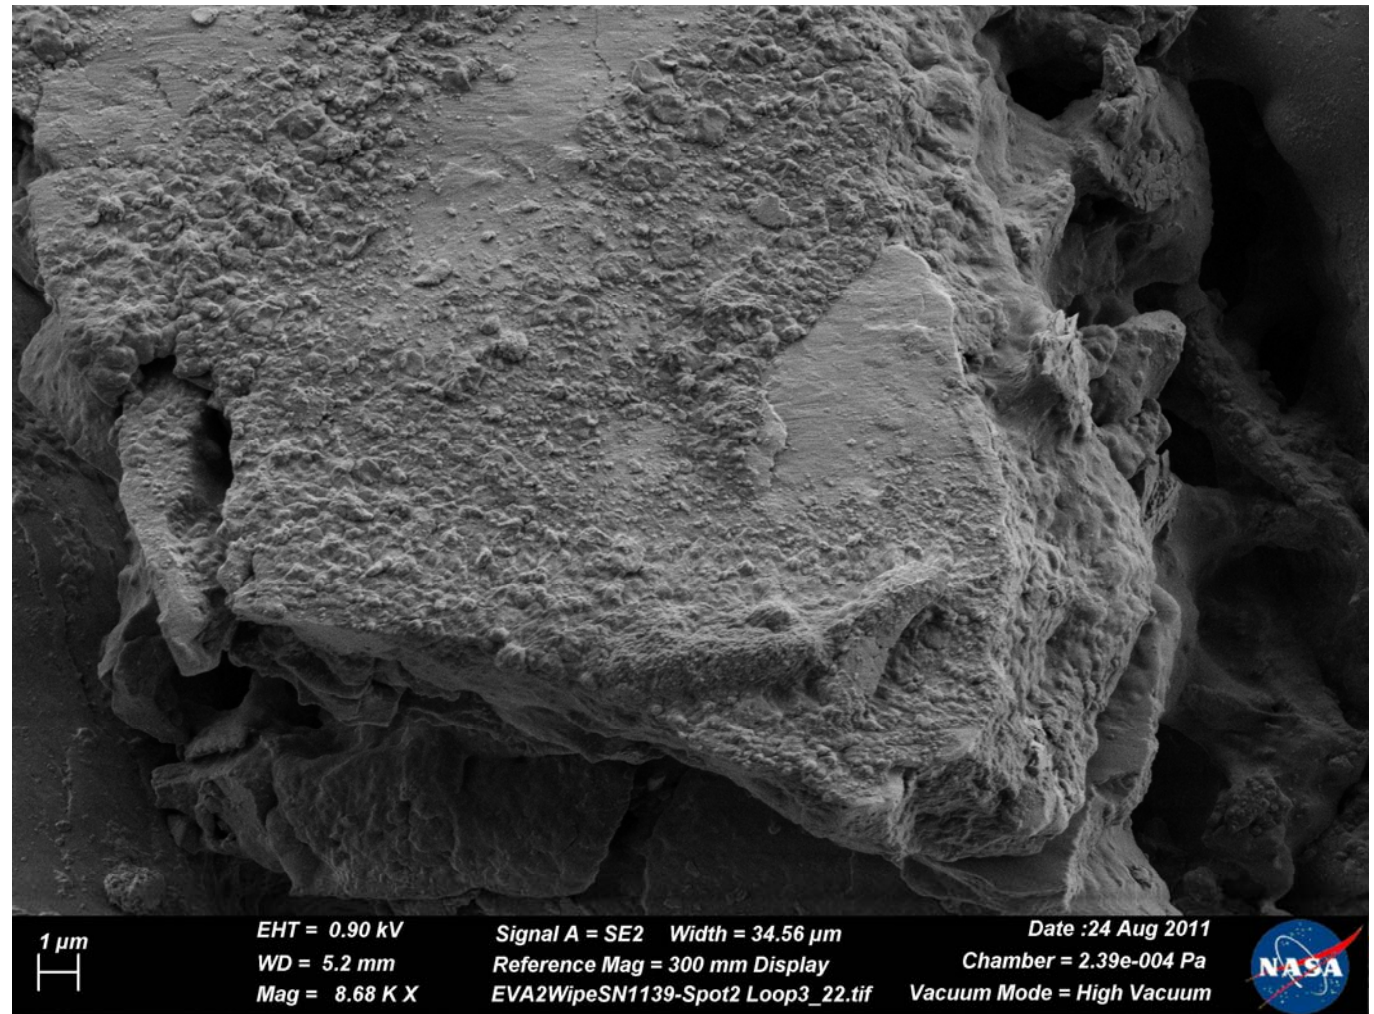
Higher magnification
High-resolution
Secondary Electron (SE2)
image of
Nitrided 15-5PH debris.

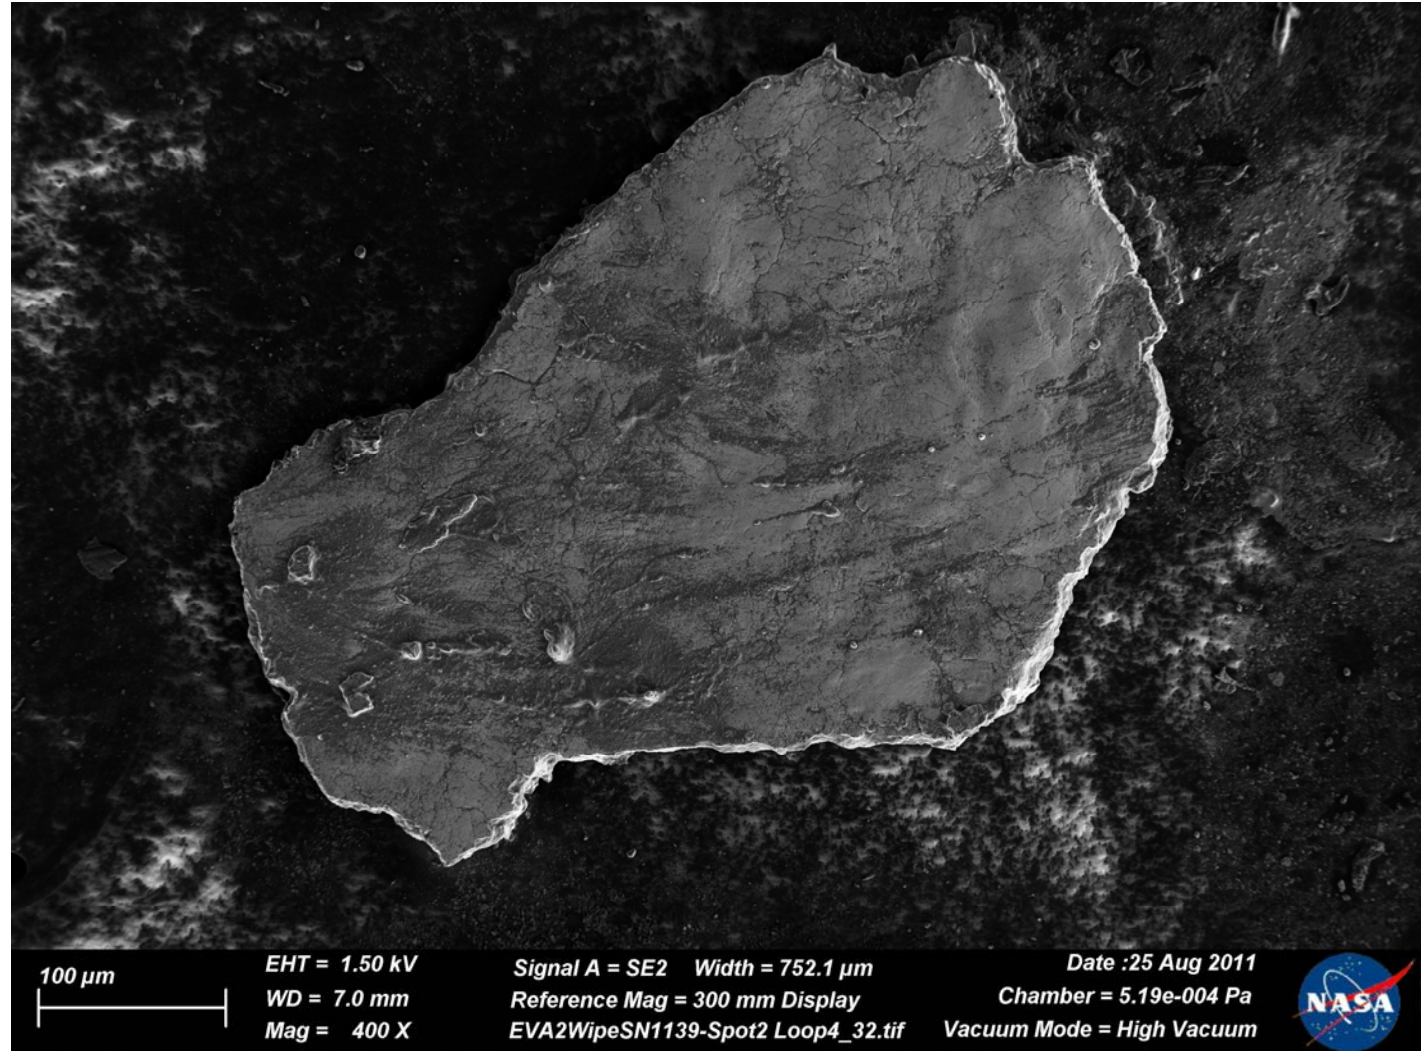
Largest particle was found during prep for GC_MS; it measured 500 μm in greatest chord length, was very thin and flat. Confirmed as nitrided 15-5PH but with a high oxygen peak.

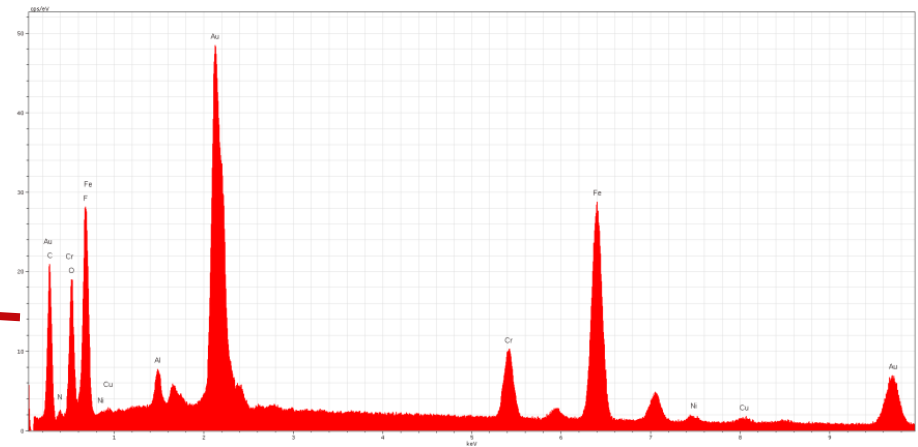
Bright areas are gold, from the original mechanism lubrication system

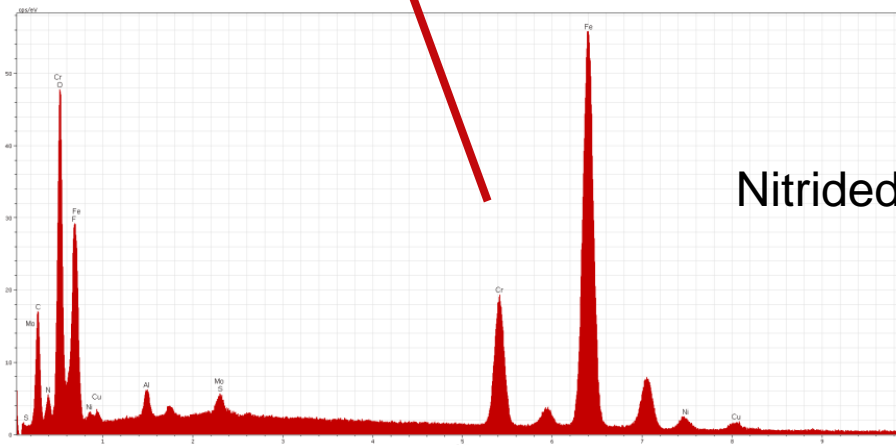
Nitrided 15-5PH Steel
