DRAFT: FEDSM2005-77052

A CFD ANALYSIS OF EASTERLY WIND FLOW IMPACTING THE VEHICLE ASSEMBLY BUILDING

ABSTRACT

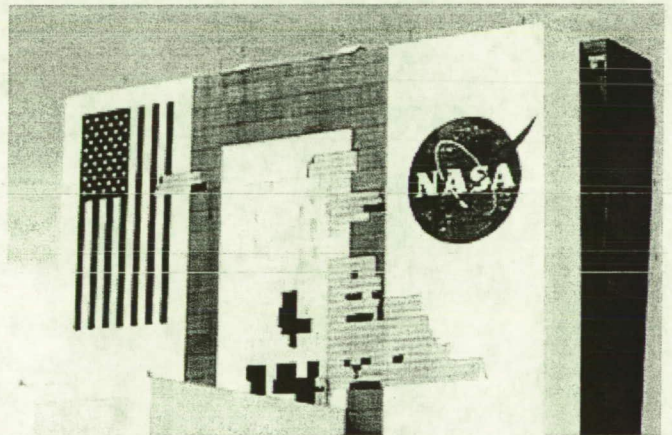
Figure 1. Panel loss from Hurricane Frances on the south face of the VAB

Though the low-level surface winds at KSC never reached hurricane strength (74 mph) during Hurricane Frances, extensive panel failure occurred at wind speeds far below the 118- to 125-mph wind load limit reported in the literature. The maximum sustained winds measured at a nearby wind tower were 53 mph at a height of 54 ft and 80 mph at 492 ft. with such low-velocity winds actually seen along the similar 525-ft vertical extent of the VAB, we need to turn to the results of the CFD analysis to help explain the inordinate loss of panels from the south face. The final panel loss count was approximately 825 panels, or 20 percent of the total VAB side-surface area, with the majority of the damage occurring on the south face, above and toward the right of the low bay.

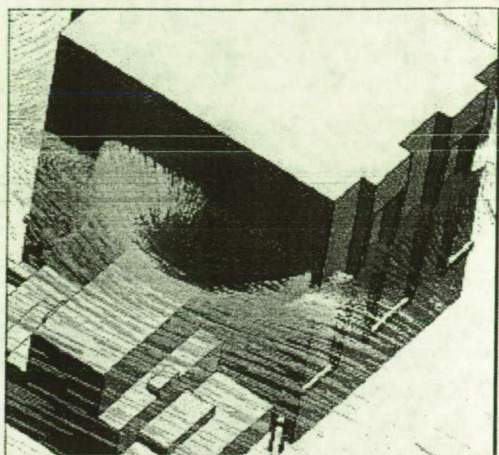
Figure 15. Flow separation around VAB ($V=10$ knots)

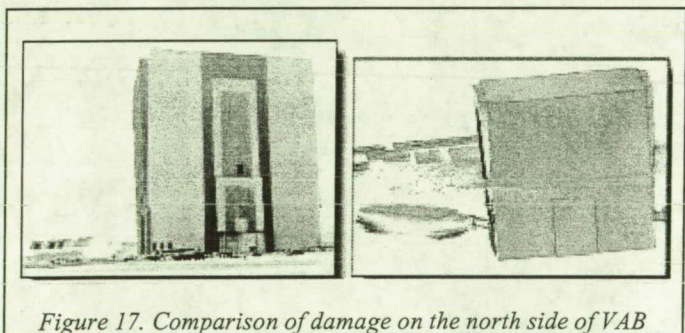
Figures 6 through 12 graphically show the CFD pressure distributions on the VAB for various wind intensities from the east. Figures 9 and 10 show the results when the wind is biased $\pm 10^\circ$ about the East face. The predicted streamlines in Figure 13 indicate strong vortices in the region between the low and high bays of the VAB. This indication is consistent with the fact that the most damage was confined to the south face. In addition, photographs taken after Hurricane Frances indicate that the panels in this region were peeled off the wall in two directions (i.e., either toward the upper left corner of the south face or toward the upper right corner). This two-directional flow phenomenon (Figure 14) is also predicted by the velocity vectors of the computational simulation (Figure 15), indicating a strong recirculation zone near the region where the panels were stripped off the surface. The CFD analysis also predicted flow separation around the top of the building, which again is consistent with the actual damage seen on the roof (Figure 16). The north side of the building only suffered minimal damage, as shown in Figure 17.

Figure 17. Comparison of damage on the north side of VAB
