**External Surface Changes Observed on the International Space Station (ISS)
Through 2012**

Dr. Johnny L. Golden, Boeing Research & Technology
13100 Space Center Blvd., MC HB3-20, Houston, TX 77059 USA
johnny.l.golden@boeing.com 281-226-6710 / 281-226-6582(fax)

J. L. Golden, Ph.D.
Boeing Technical Fellow
ISMSE-12

ESA/ESTEC, Noordwijk, The Netherlands
25 September 2012

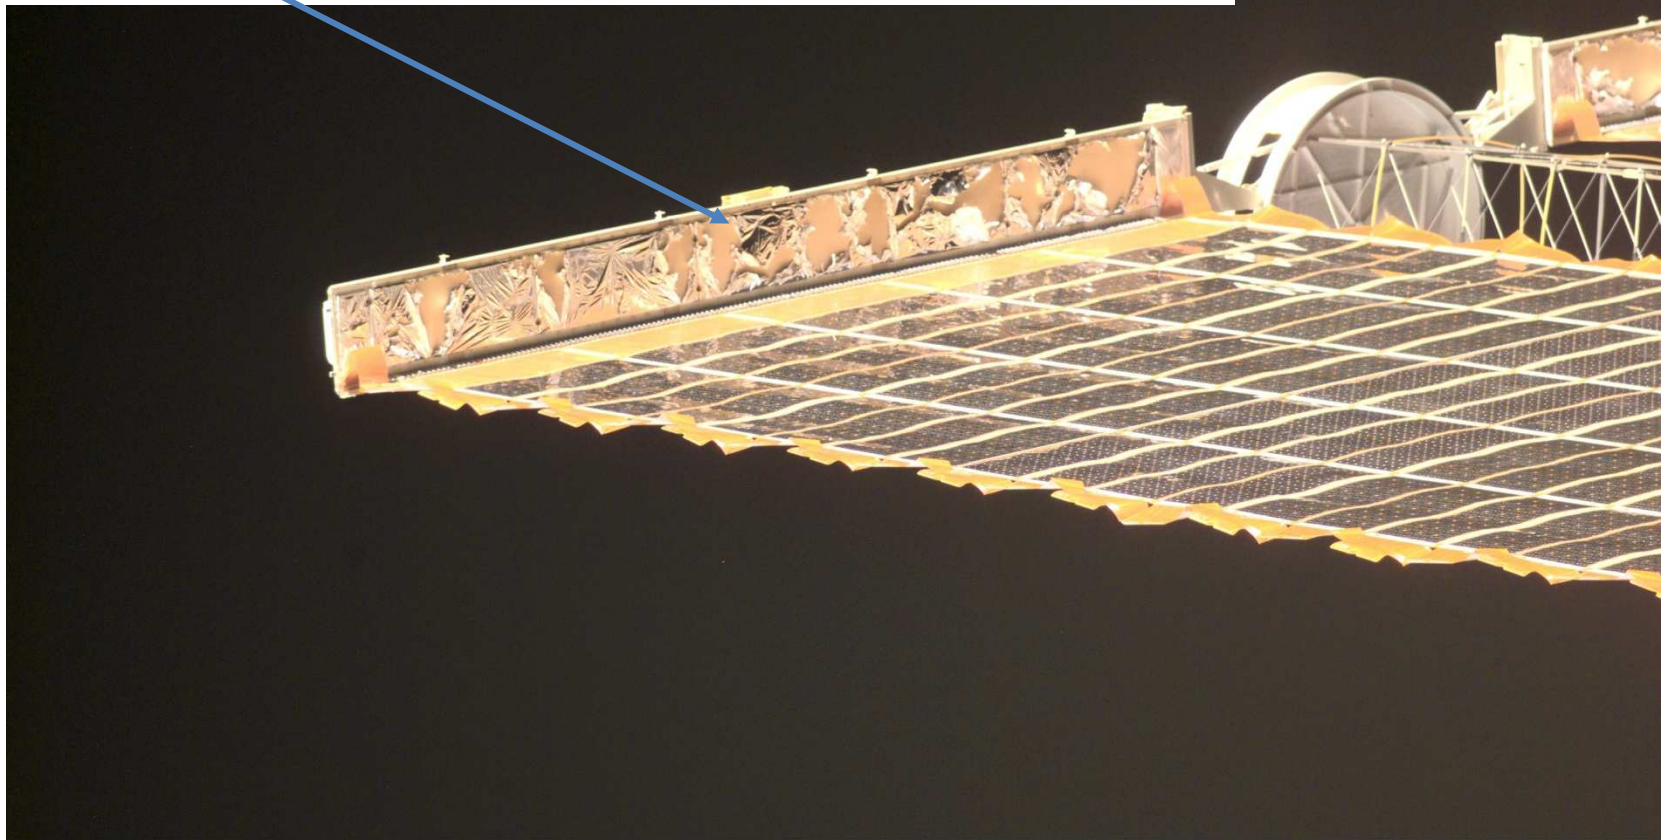
ISS003E5082 2001/08/04 03:40:57

Solar Array Wing (SAW) Blanket Box Assy.

Polyimide Foam Covered by Aluminized Polyimide Film.

Aluminized Film was severely degraded within months!

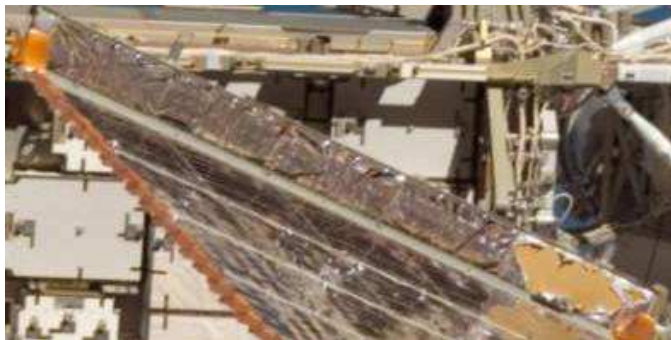
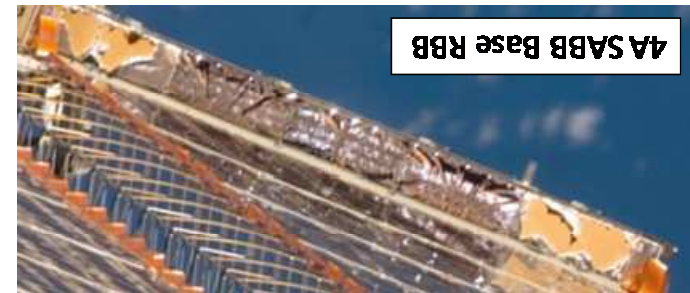
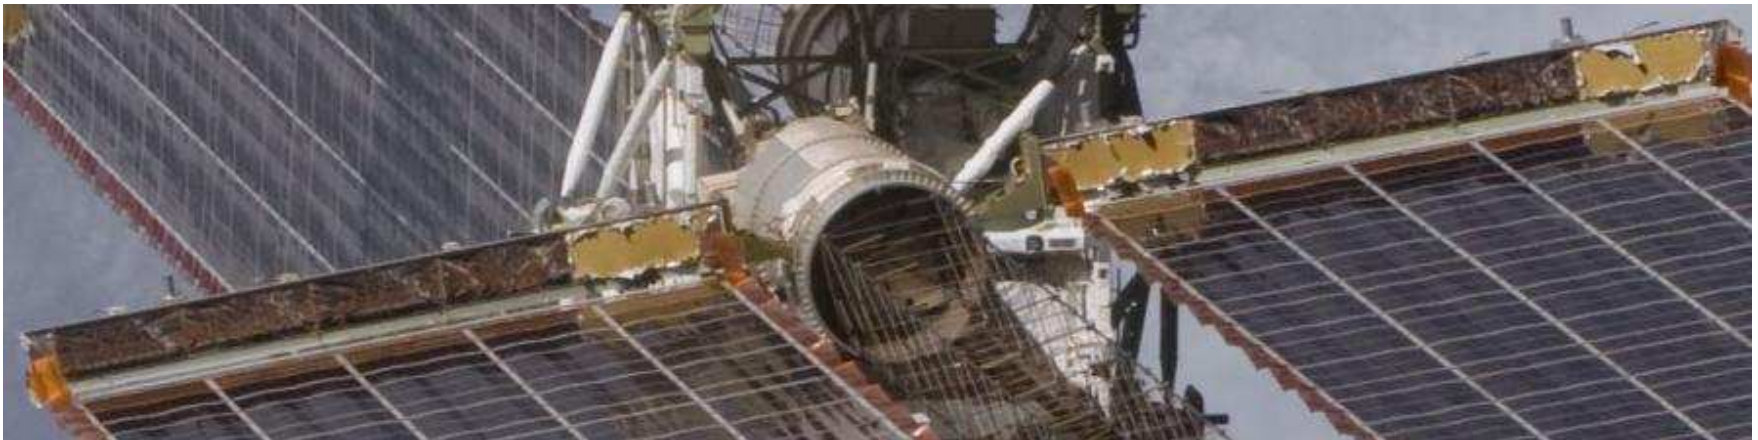
Solar Array Wing (SAW) Blanket Box Assy

Not all SAWs were equally affected, plus the damaged occurred quickly and did not continue with time.

3 Months

38 Months

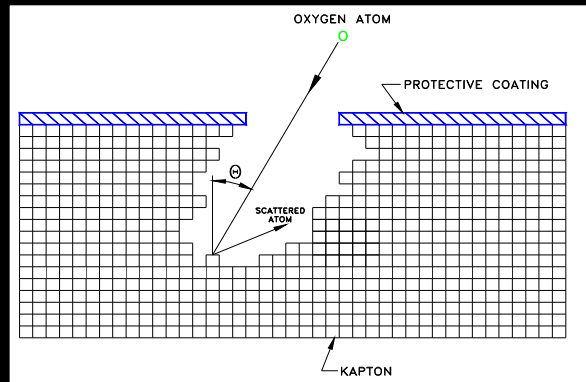
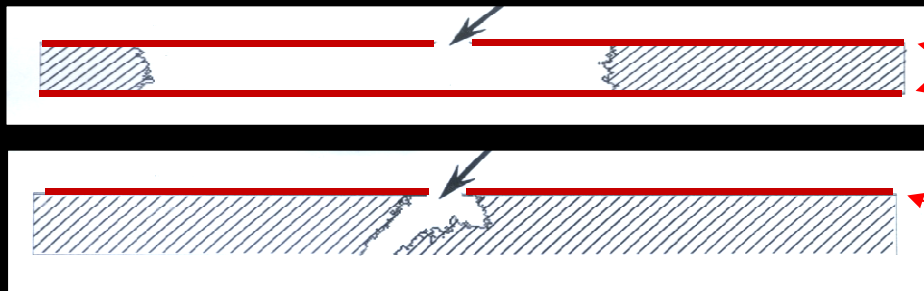
ISS Solar Array Blanket Box Cover Erosion Computational Predictions

Aluminized on
both sides of Kapton
(ISS configuration)

Aluminized only on
exposed side of Kapton

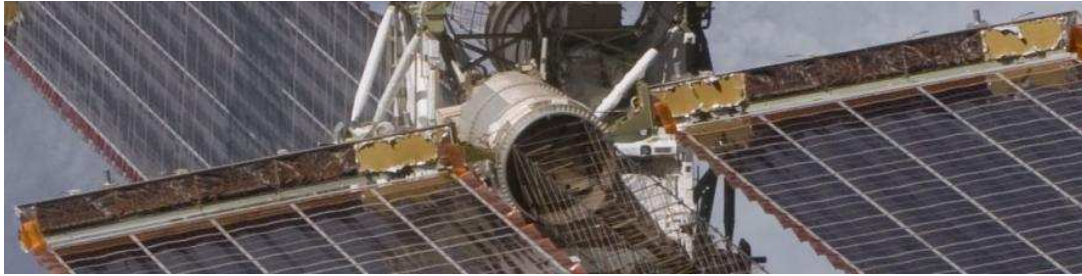
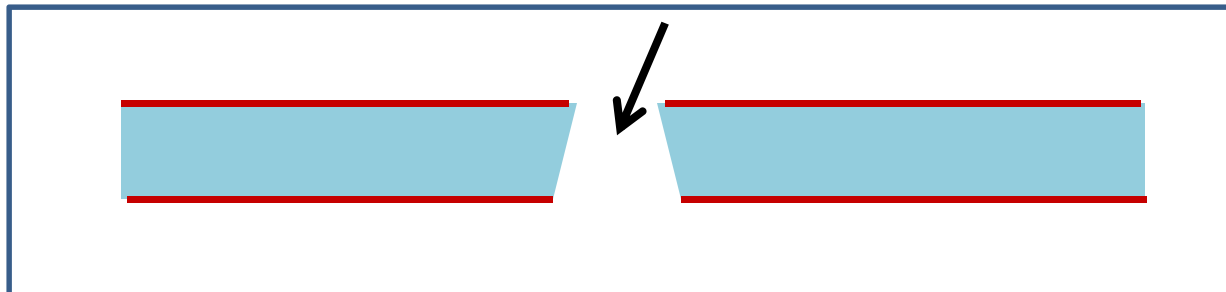
- That some areas of the SAW blanket boxes remain intact for years after the initial rapid failures further suggests that MMOD impacts are slow to initiate the damage observed from defects/damage in the surface metallization layer.

Aluminized on both sides
25 μm Kapton

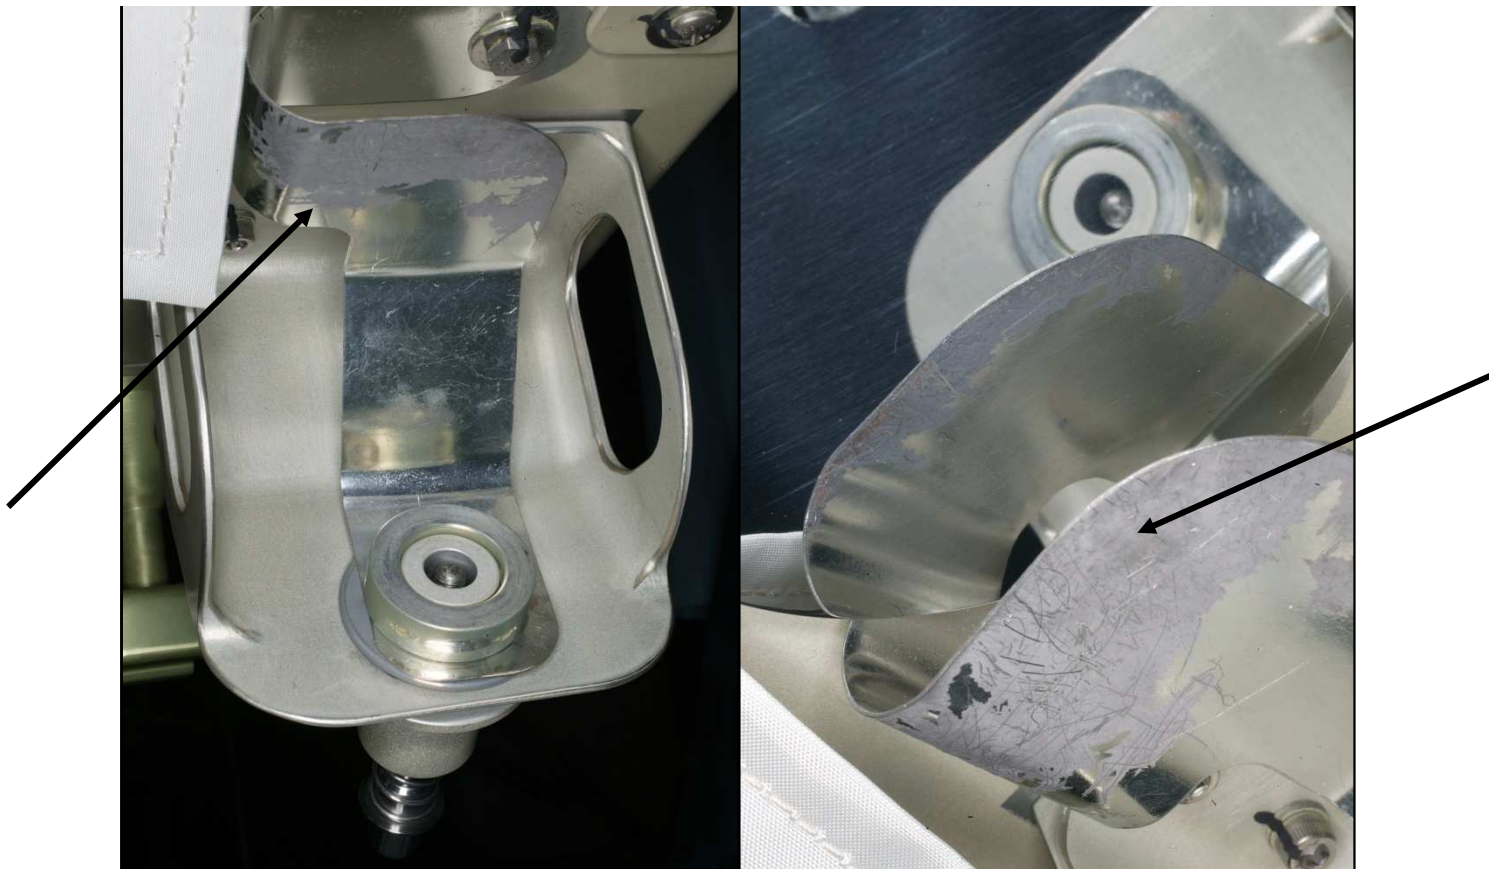
Trailing Umbilical System (TUS) Reel Grounding Strap (Tin-Plated)

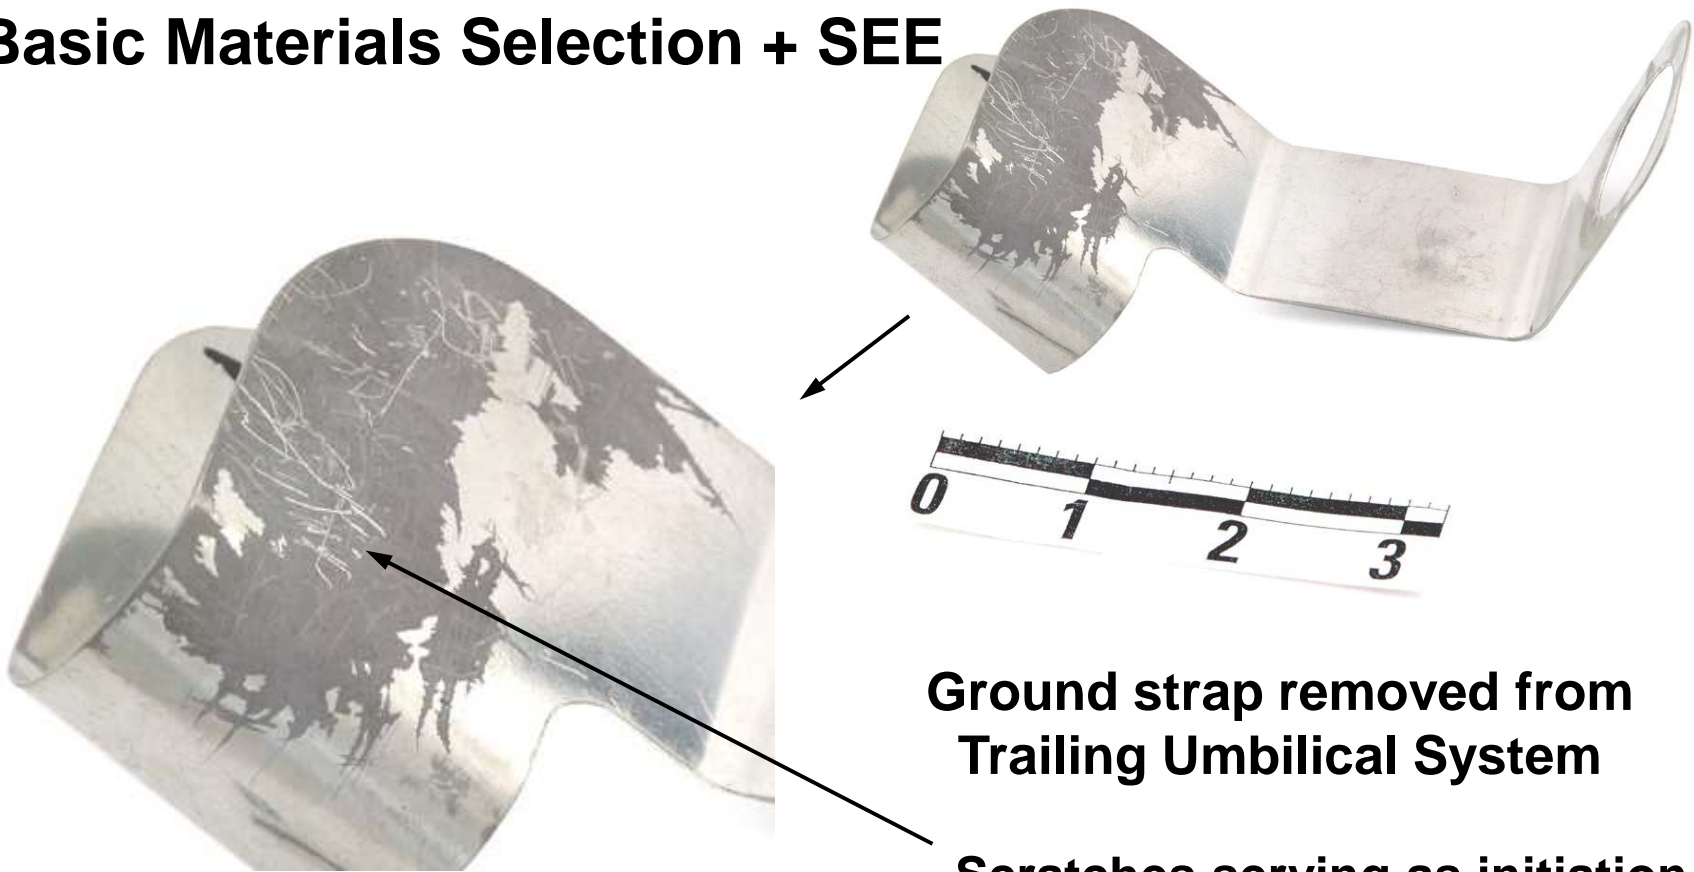
Detail of tin pest region

**Ground strap removed from
Trailing Umbilical System**

**Scratches serving as initiation
sites; low temperatures on-orbit
accelerate phase transformation**

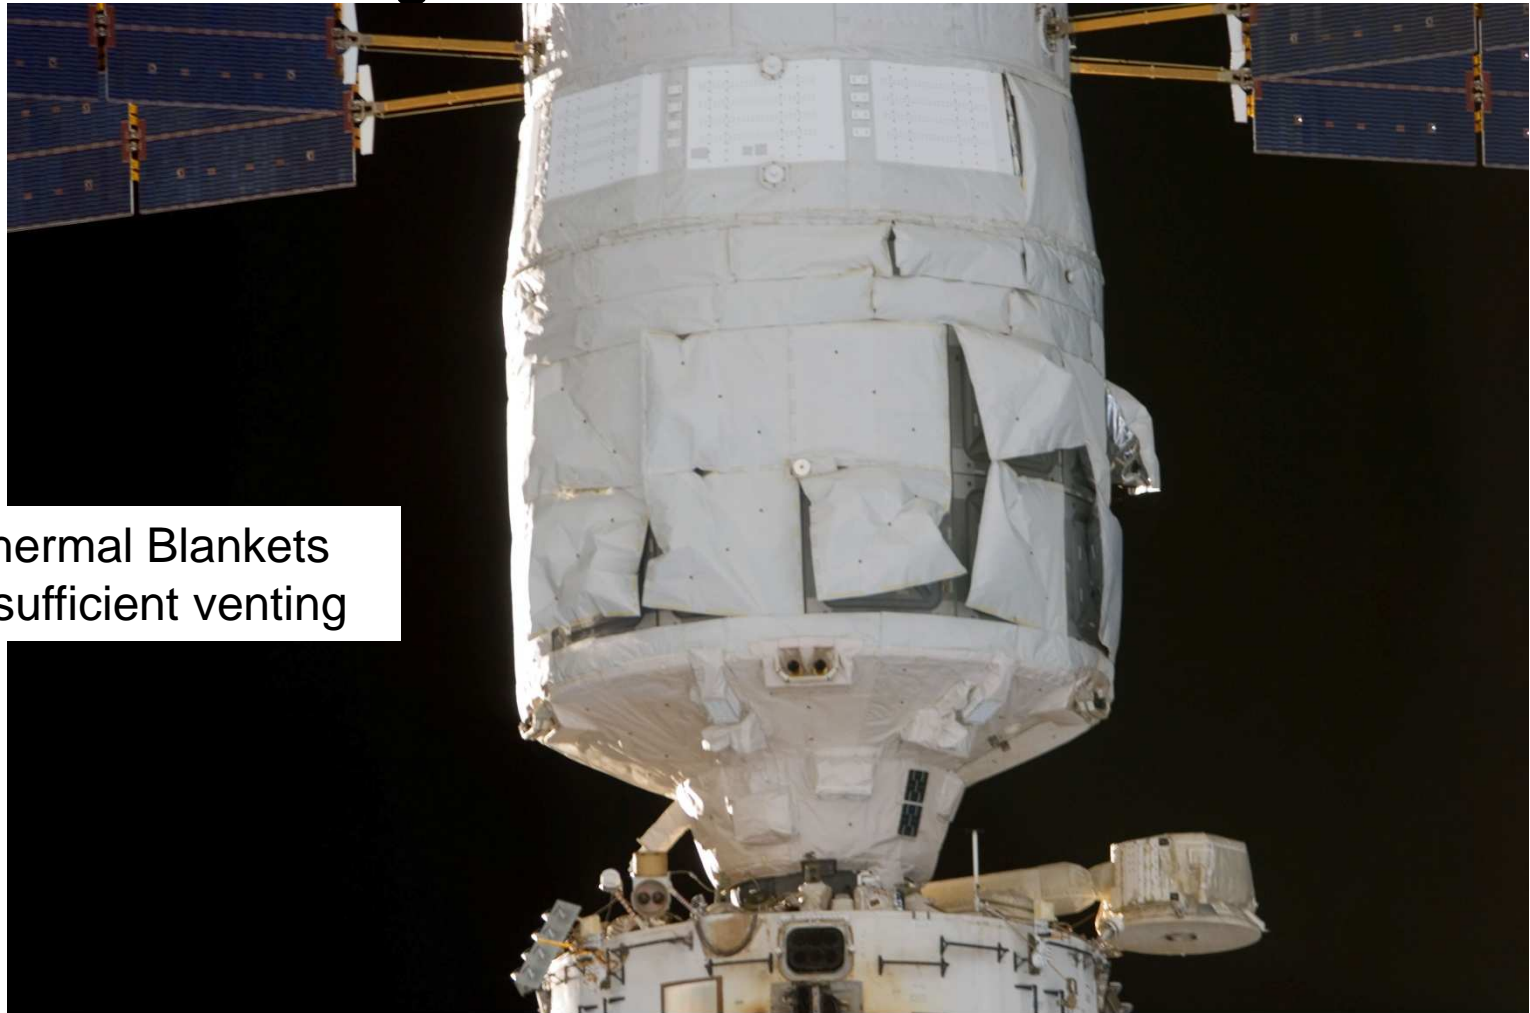
S124E005722

ATV1 Thermal Blankets
show insufficient venting

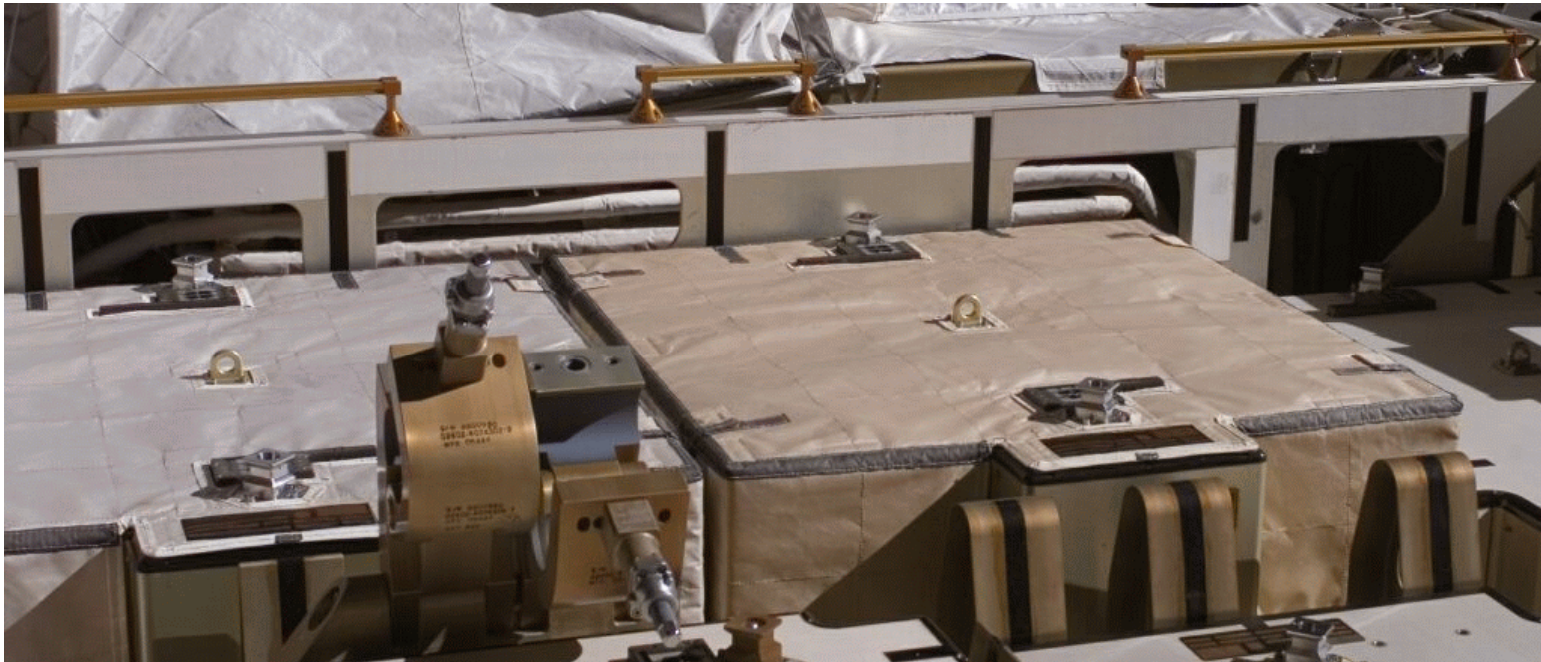
photo iss015e21921.jpg

Battery Box Covers have a “Betalcloth” outer layer. One cover was inadvertently constructed using Chemfab 250 (in which silicone sizing agent is not removed during fabrication) while other cover was correctly constructed using Chemfab 500.

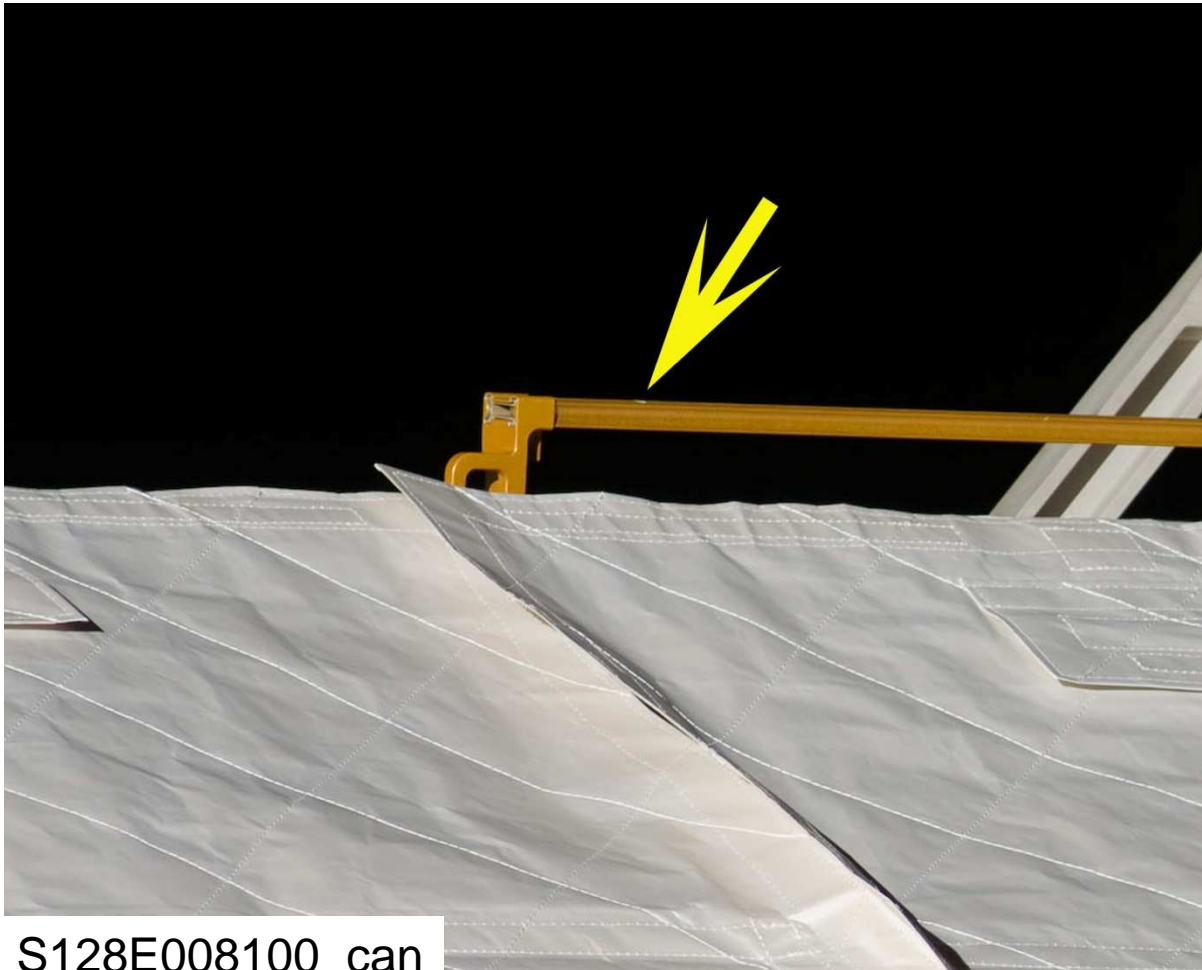
MMOD impacts on handrails are becoming increasingly troublesome, causing EVA glove damage

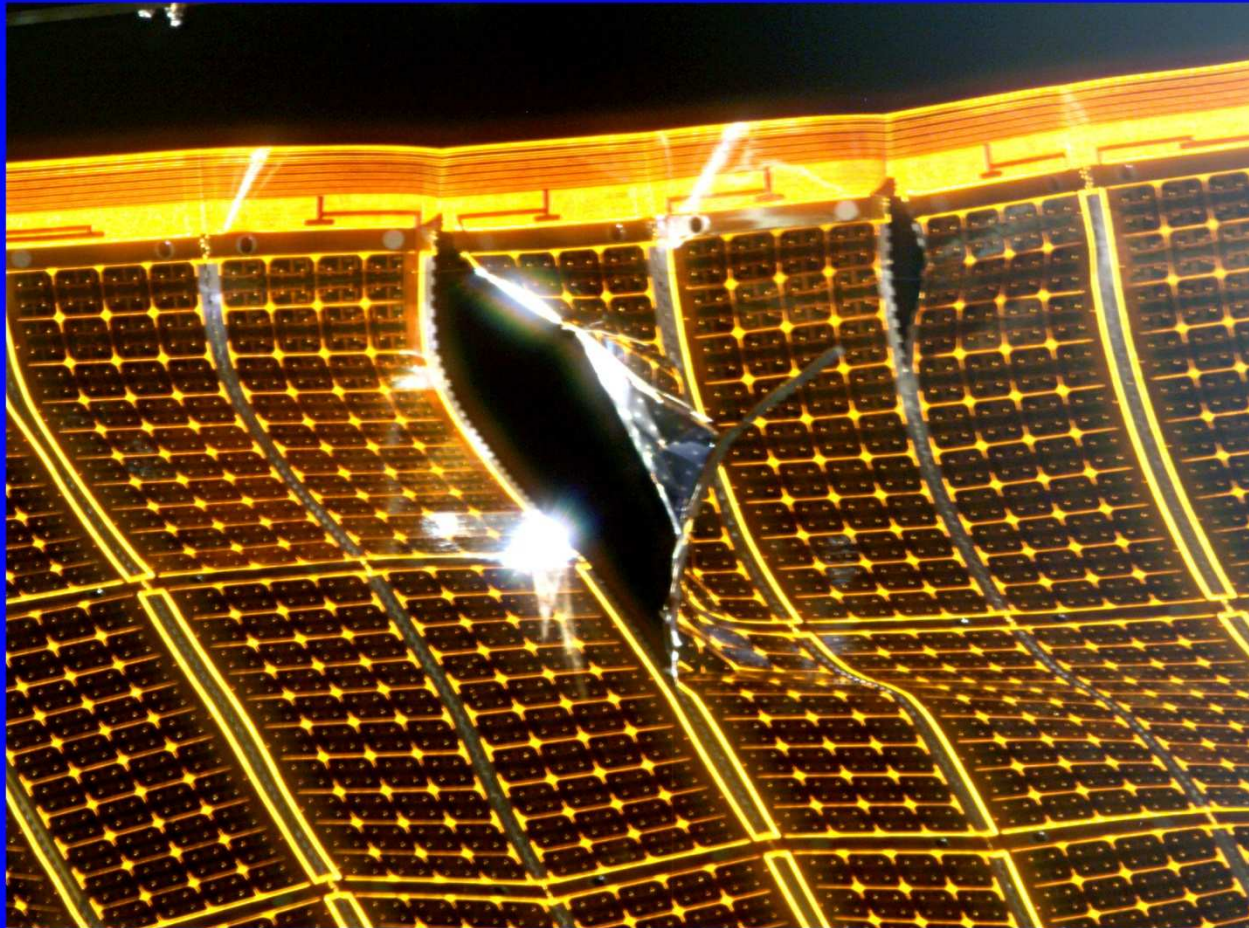
Second Rip in P6 SAW Damage During Re-Deploy 10/30/07

- P6 Guidewire sample observations
 - SEM images reveal abundant evidence of melting and melt mobility on several strands in the guidewire.
 - Several areas of unusual chemical composition were observed in the melt region.
 - Bismuth and Gold/Copper particles.
 - The Fe/Cr/Ni composition of the wire make it difficult to discern some types of micrometeoroids.
 - The evidence suggests that orbital debris impact of sufficient energy damaged wire(s) in the wire bundle.
 - Individual wire(s) breaking would cause the wire bundle to unravel, leading to additional mechanical damages, which lead to eventual complete failure of the guidewire.
 - The failed guidewire snagged into the solar array wing, leading to the damage observed during redeploy.

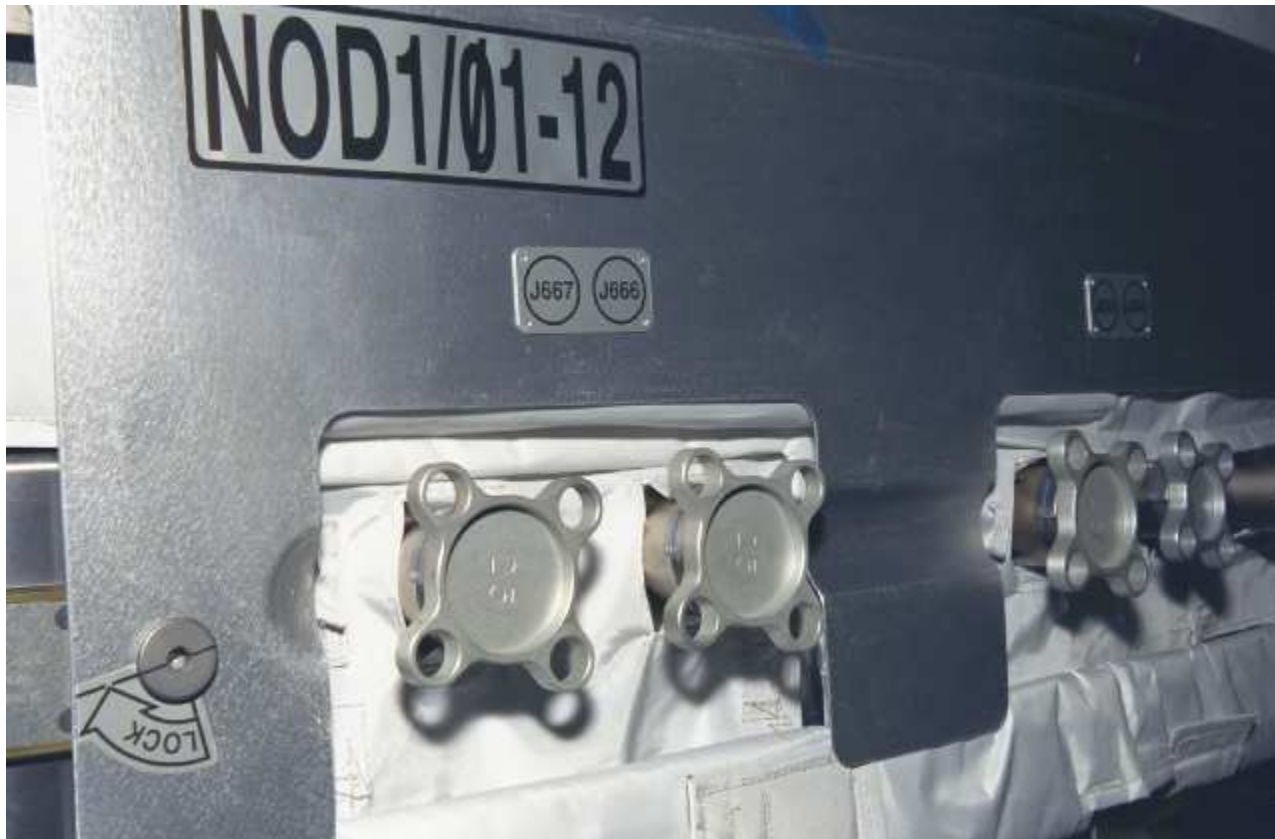
Preflight (closeout) Photo showing anodized foil labels

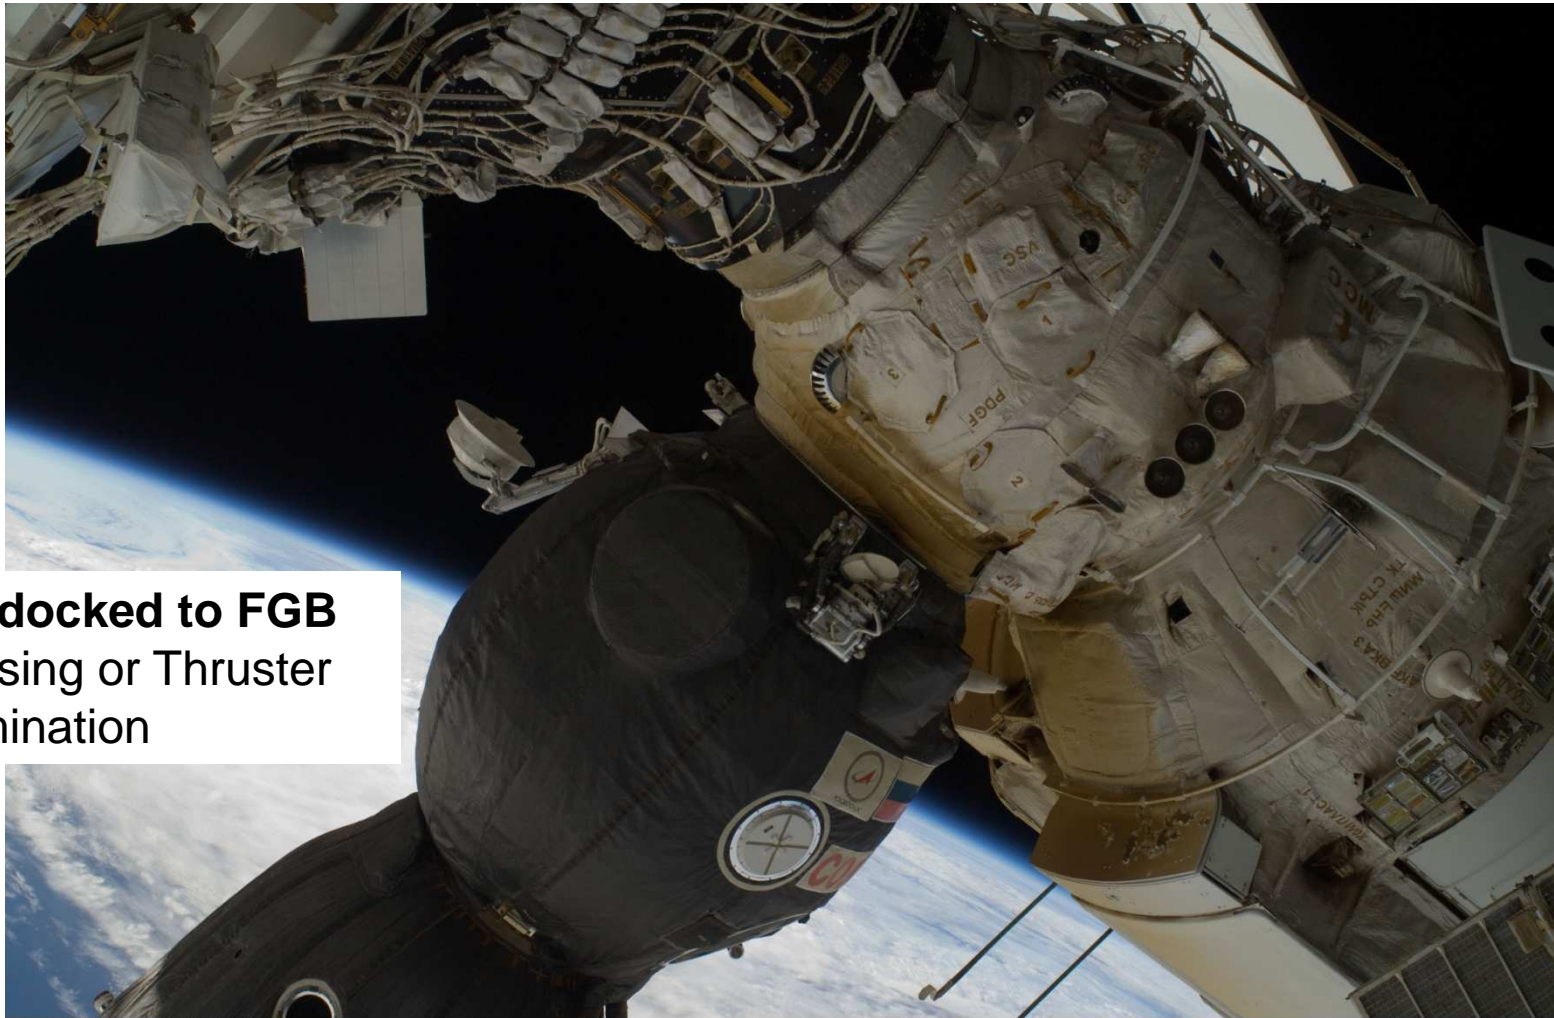
ISS022E067004

Soyuz docked to FGB
Outgassing or Thruster
Contamination

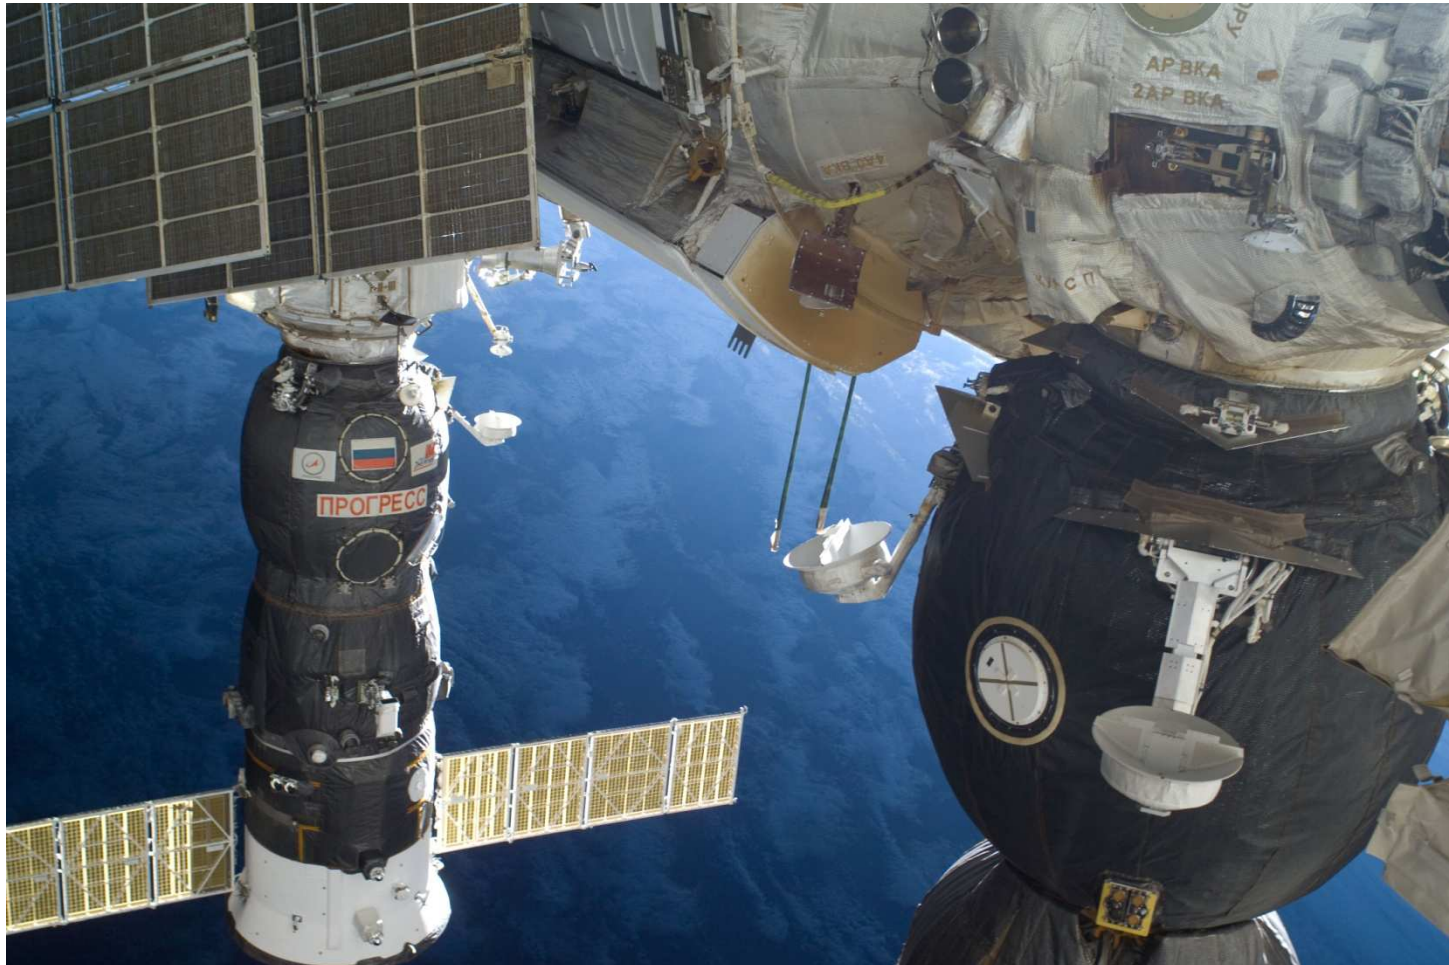
ISS021E031911

Opposite
direction
from
previous
photo

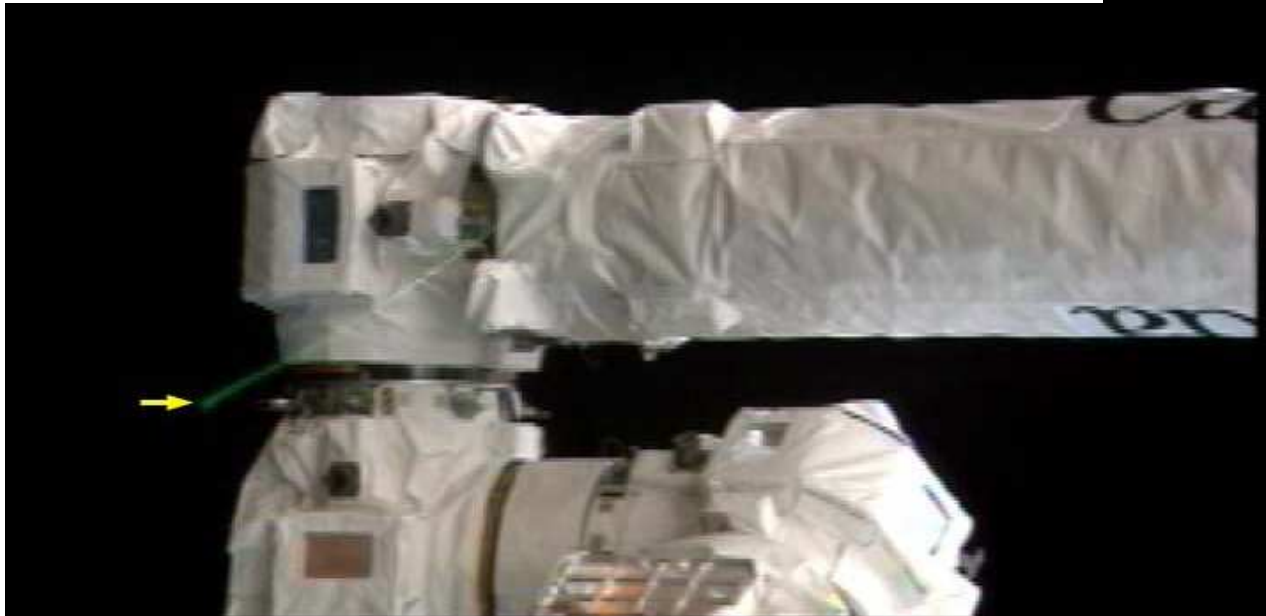
Charged Particle affecting Digital Video Camera Imaging

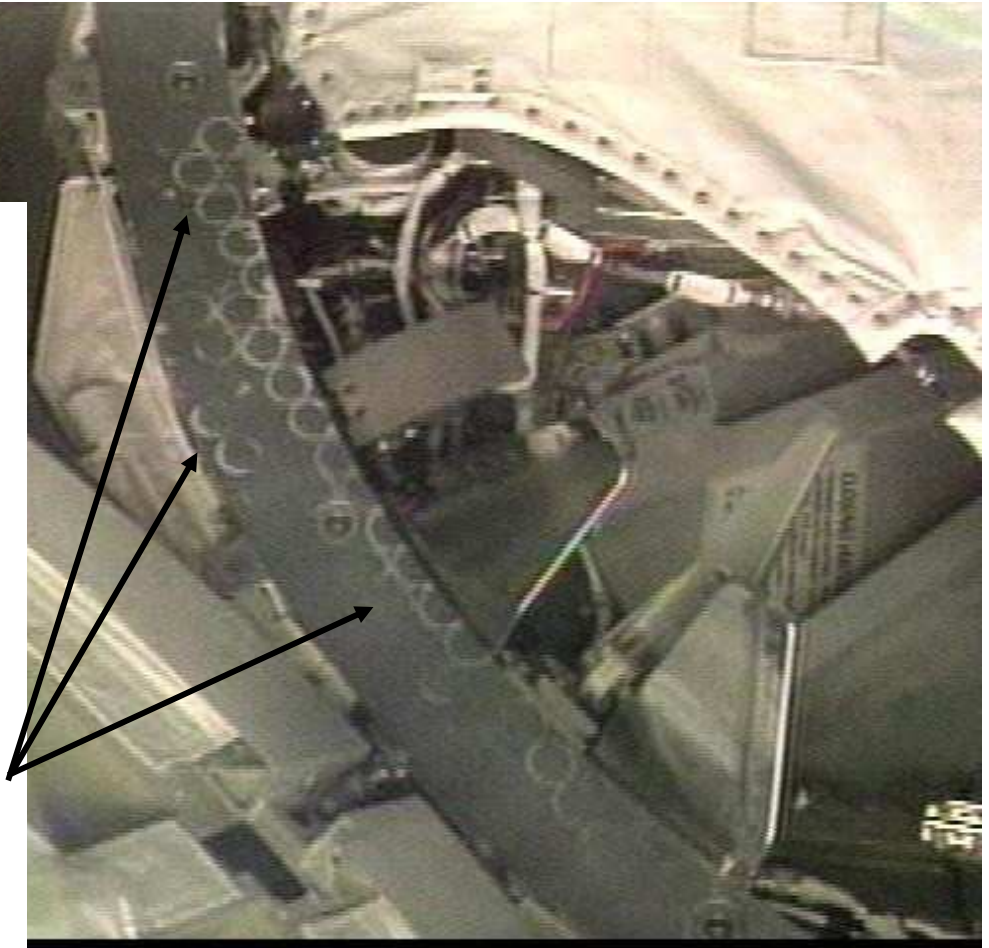
Pre-berthing inspection of a Node 1 sealing surface in 2001 identified these circular features as a concern. These features were later determined to be reflections of the camera's LED lighting system on the smooth, anodized aluminum sealing surface. No such feature actually exists.
