SPACE SHUTTLE COLUMBIA POST-ACCIDENT ANALYSIS AND INVESTIGATION

Steve McDanel

NASA

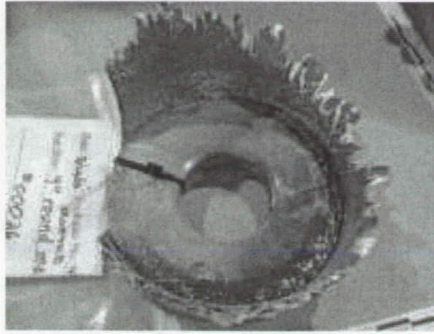
Fractographic and metallographic analyses of several pieces of debris, Fig. 2, were performed to characterize such fracture characteristics as broomstrawing and feathering of aluminum alloys; suspected stress-assisted grain boundary oxidation (SAGBO) of Inconel components; and intergranular high temperature fracture features observed on several A286 stainless steel spar fittings.

FIGURE 2. Interior view of aluminum drag chute canister. Parker [2]
