Investigation into the High-Voltage Shutdown of the Oxygen Generation System Aboard the International Space Station

The Oxygen Generation System (OGS) Hydrogen Dome Assembly Orbital Replacement Unit (ORU) serial number 00001 suffered a cell high-voltage shutdown on July 5, 2010. The Hydrogen Dome Assembly ORU was removed and replaced with the on-board spare ORU serial number 00002 to maintain OGS operation. The Hydrogen Dome Assembly ORU was returned from ISS on STS-133/ULF-5 in March 2011 with test, teardown and evaluation (TT&E) and failure analysis to follow. The purpose of this paper is to summarize the results of the failure analysis.

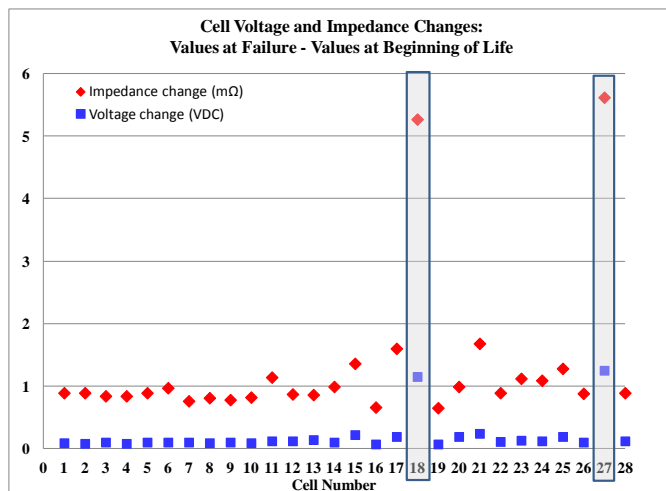
There was significant evidence supporting cationic contamination of the membrane adversely impacting the cell resistance. As can be seen in Figure 6, the resistance of all the cells in the cell stack assembly increased, with the largest gains observed in Cell 27, which had triggered the fast shutdown of the Hydrogen ORU, and Cell 18, which exhibited the next highest voltage in the cell stack.

Figure 6. Changes in Cell Impedance and Voltage.

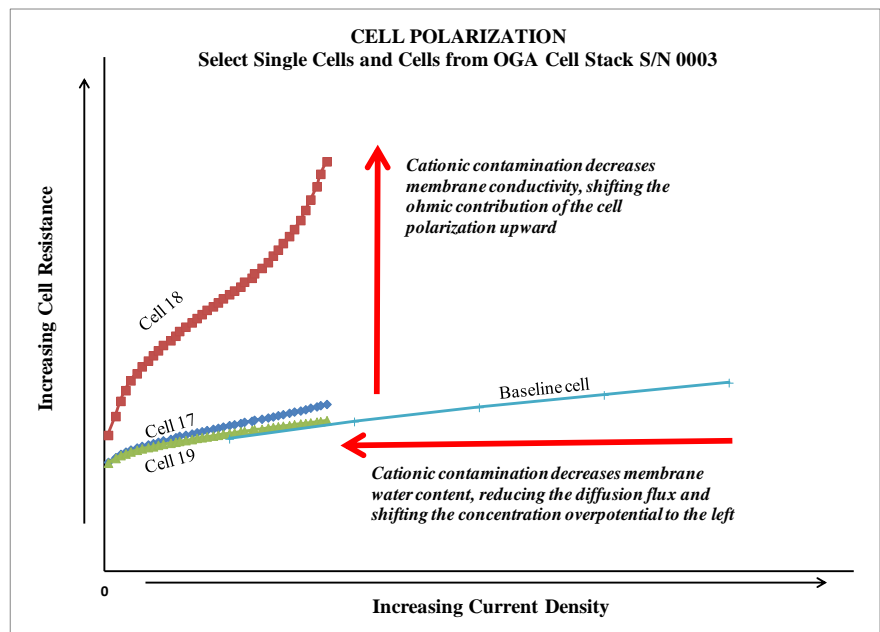
Testing of Cells 17, 18 and 19 in the laboratory showed stable operation at low oxygen production rates (25%); however, as the production rate was increased to 50% or 100%, Cell 18 triggered an automatic shutdown of the test article and test system due to rapid voltage rise. The polarization curves for the triplet of Cells 17, 18 and 19 is included in Figures 9, and provides evidence of reduced membrane water content and its adverse impact on the concentration overpotential and limiting current density of an operational water electrolysis cell.

Figure 9. Polarization Curve – Cells 17, 18, 19 from Hydrogen ORU and Baseline MEA.
