# Full-Scale Test and Analysis Results of a PRSEUS Fuselage Panel to Assess Damage Containment Features

## I. ABSTRACT

Integrally stitched composite technology is an area that shows promise in enhancing the structural integrity of aircraft and aerospace structures. The most recent generation of this technology is the Pultruded Rod Stitched Efficient Unitized Structure (PRSEUS) concept. The goal of the PRSEUS concept relevant to this test is to provide damage containment capability for composite structures while reducing overall structural weight. The National Aeronautics and Space Administration (NASA), the Federal Aviation Administration (FAA), and The Boeing Company have partnered in an effort to assess the damage containment features of a full-scale curved PRSEUS panel using the FAA Full-Scale Aircraft Structural Test Evaluation and Research (FASTER) facility. A single PRSEUS test panel was subjected to axial tension, internal pressure, and combined axial tension and internal pressure loads. The test results showed excellent performance of the PRSEUS concept. No growth of Barely Visible Impact Damage (BVID) was observed after ultimate loads were applied. With a two-bay notch s

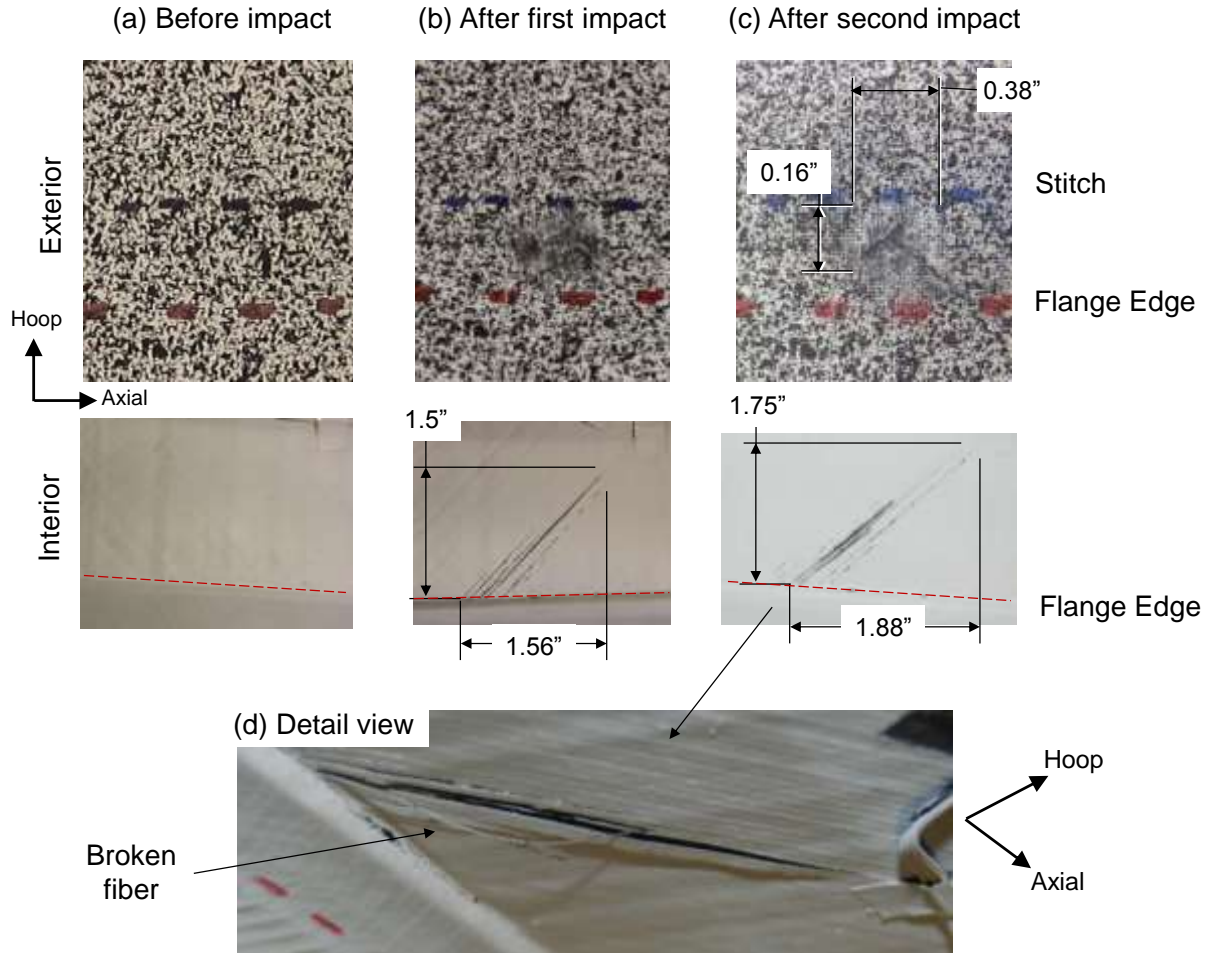
Figure 3. Photographs of the BVID, as Seen From the Exterior and Interior, Before and After Impact

Photographs of the impact site are shown in Figure 3. The baseline condition is shown in Figure 3(a). After impact, visual inspection showed little indication of fiber breakage or a dent on the exterior surface, as shown in Figure 3(b), which are criteria indicating a severe BVID [7]. The panel was impacted a second time in the same location with the same impact energy, which created clearly visible fiber breaks over an area of 0.16 by 0.38 inch on the exterior surface and visible fiber breaks and delamination on the interior surface, as shown in Figure 3(c) and (d), respectively. Therefore, this damage was classified as very severe BVID that was deemed acceptable for the purpose of this test. The impact depth was 0.015 in. The impact region was inspected using visual, ultrasound, and flash thermography techniques before impact (baseline), after impact, and after each case. Three limit load conditions were applied, followed by three ultimate load conditions: (1) pressure overload of 18.4 psi (2P), (2) ultimate axial load (150% DLL), and (3) ultimate combined load conditions (1.5P + 150% DLL).

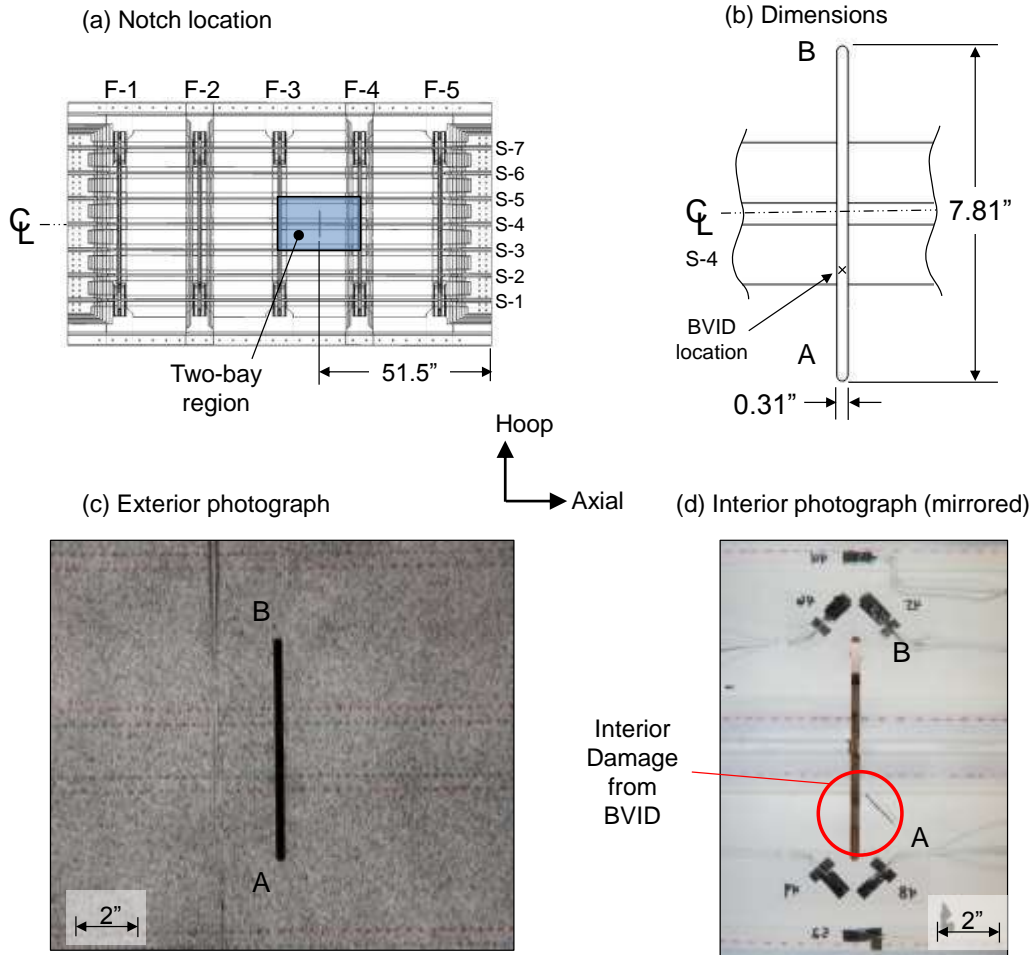
Figure 4. The Two-Bay Notch

The purpose of Phase III was to demonstrate compliance with 14 CFR 25.571 by showing that the panel could support limit loads with a two-bay notch severing the central stringer, and then to monitor the failure process while increasing the axial load until catastrophic failure occurred. The notch was machined over the BVID at the location shown in Figure 4(a) using a 5/16-inch router bit and a machining template. The impact damage site was partially removed during the notch machining to minimize the effects on Phase III results, as shown in Figure 4(b). The notch was 7.8-inch long by 0.31-inch wide and was placed symmetrically across stringer S-4, as shown in Figure 4(b). The notch was through the thickness and severed both the skin and the central stringer, as shown in Figure 4(c) and (d), respectively.

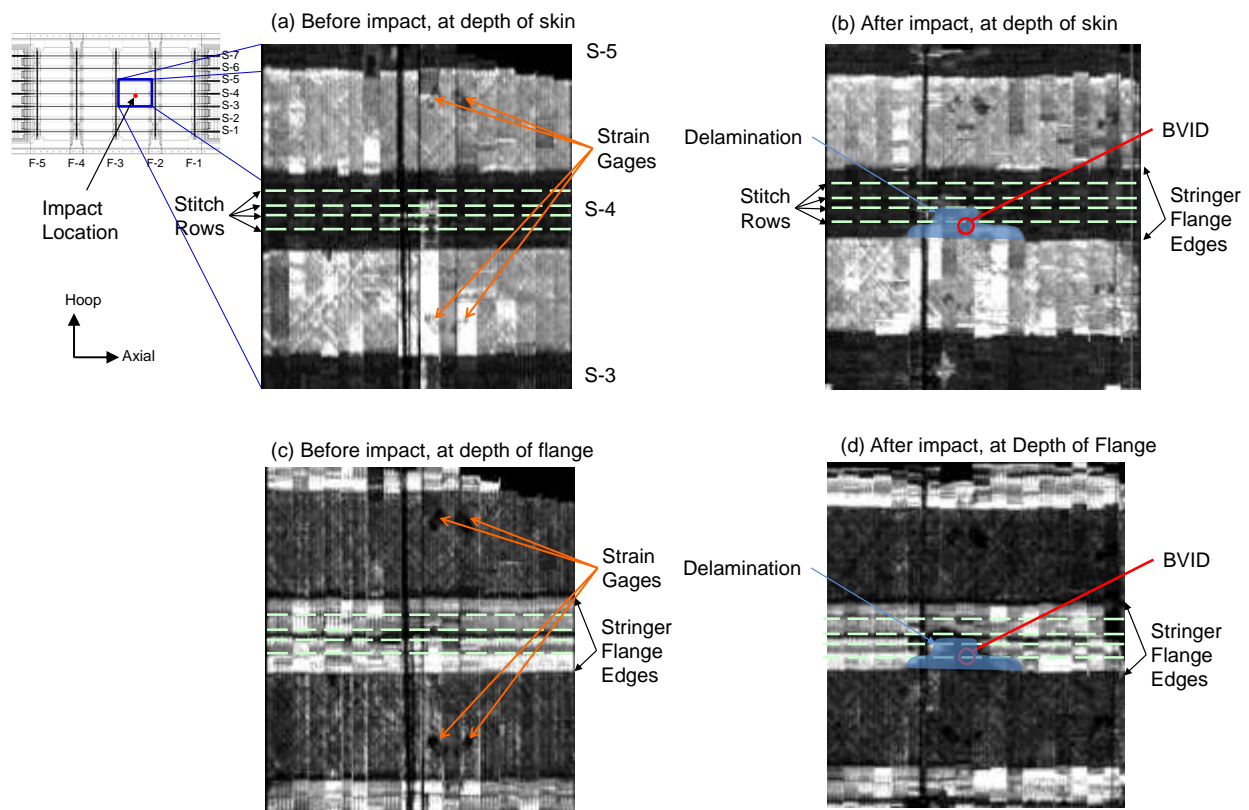
Figure 14. C-Scan for Impact Region

The C-Scan was performed in the region around the impact location. Figure 14(a) and (c) show the preimpact C-Scan, and Figure 14(b) and (d) show the postimpact C-Scan. The C-Scans are shown at two depths: the depth of the skin and the depth of the flange. The location of the BVID and the delamination that resulted from the impact are identified in Figure 14(b) and (d). Note that between the edge of the stringer flange and the first stitch row, the delamination is significantly longer than the part of the delamination contained between the first and second stitch rows (first and second are relative to the stringer flange edge). Also note that the delamination is completely arrested by the second stitch row. C-Scans were performed after each load condition was applied during Phase II, and no growth of the delamination associated with the BVID was observed, which indicated that the stitch rows arrested any further delamination growth throughout the loading sequences of Phase II.

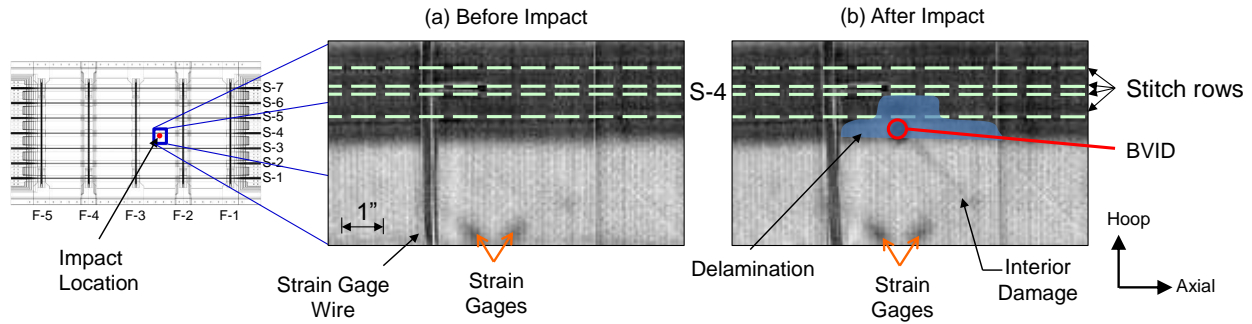
Figure 15. Flash Thermography Results Showing the Second Derivative (2D) of  $t-T$  at 2.0 Seconds for the Impact Region

The flash thermography system was able to identify the damage resulting from the impact, showing a delamination size similar to that found using the C-Scan, as shown in Figure 15. The

presence of the lighter regions immediately to the left and right of the dark circular damage indicate delamination between the stringer flange and skin, highlighted in blue.

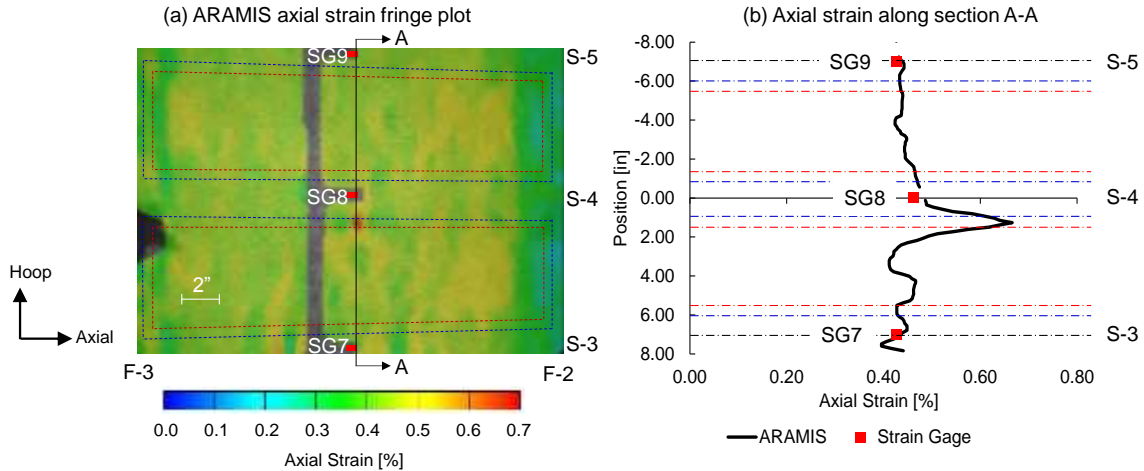
Figure 17. The ARAMIS and Strain Gage Results for Postimpact Loading at 150% DLL, Tension Only

A significant local strain concentration was detected using the ARAMIS system. The axial strain in the vicinity of the BVID and along cross section A-A, is shown in Figure 17 for 150% DLL. The maximum magnitude of axial strain in the vicinity of the BVID remained well below the anticipated material failure strain of 0.9% for the skin [4], which is consistent with the visual observations of no damage growth.

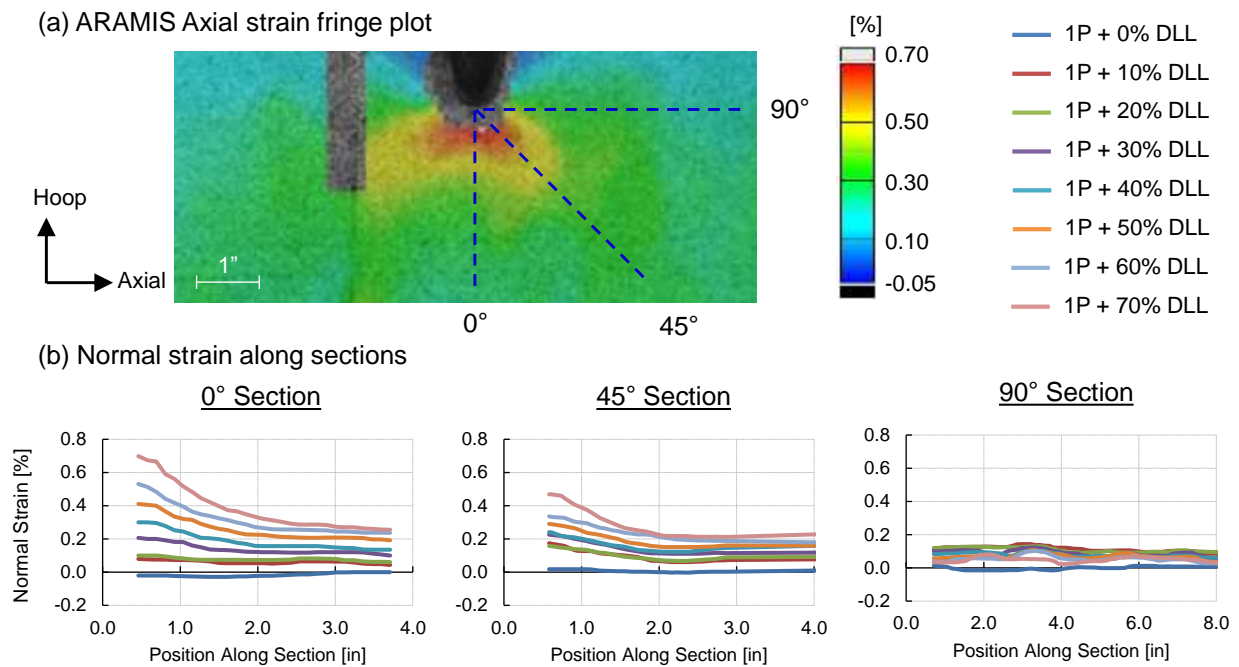
Figure 20. The ARAMIS Axial Strain Distribution at the Notch Tip for 1P + 70% DLL and Section Plots Showing Normal Strain Along 0°, 45°, and 90° Sections.

Normal strains along 0-, 45-, and 90-degree sections from notch tip A at the same load level (shown in Figure 20) indicate that notch tip strains are approaching the material failure strain, which is in agreement with the observed visual damage initiation at this load level.

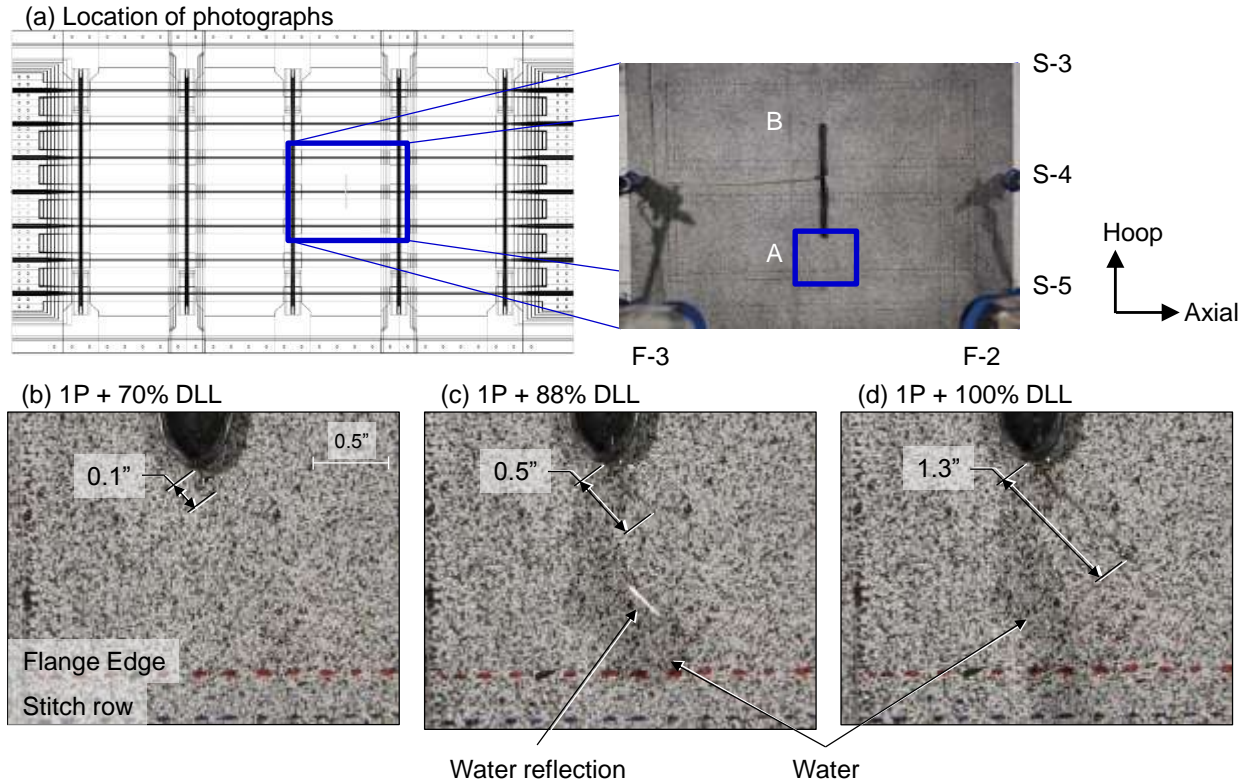
Figure 21. Photographs of Damage Propagation From Damage Event A During Load Step 2, Showing the External Surface of Notch Tip A

Figure 21 shows photographs of the damage propagation sequence on the exterior surface during load step two. The gray area progressing out from the notch tip is the water leakage path. Figure 21(b) shows visible damage formation measuring about 0.1 inch at a combined load of 1P + 70% DLL.

Throughout the remainder of load step two (beyond damage event A), exterior damage propagation continued in the 45° orientation, parallel to the surface ply fiber direction, indicating a matrix cracking damage mode. Figure 21(c) shows an intermediate load level where damage is clearly visible and measures 0.5 inch. Figure 21(d) shows the extent of damage at the end of load step two, where the visible crack had propagated 1.3 inch from the notch tip.

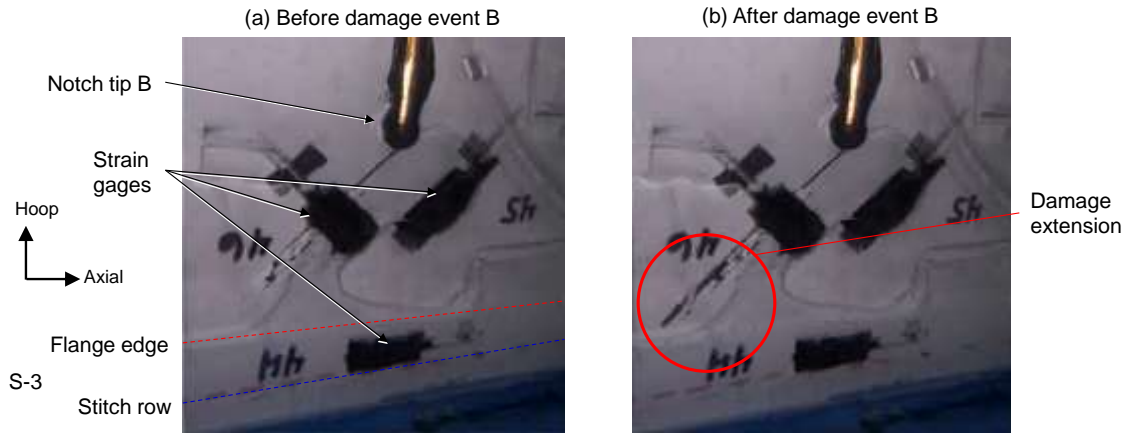
Figure 22. Photographs of the Interior Surface Showing Damage Propagation From Notch Tip B

In load step 3, the pressure load was reduced to zero while maintaining 100% DLL. During load step 3, damage propagation was observed on the interior surface only, denoted as damage event B. Figure 22 shows before and after photographs of the damage event, where damage propagates to the adjacent stringer flange.

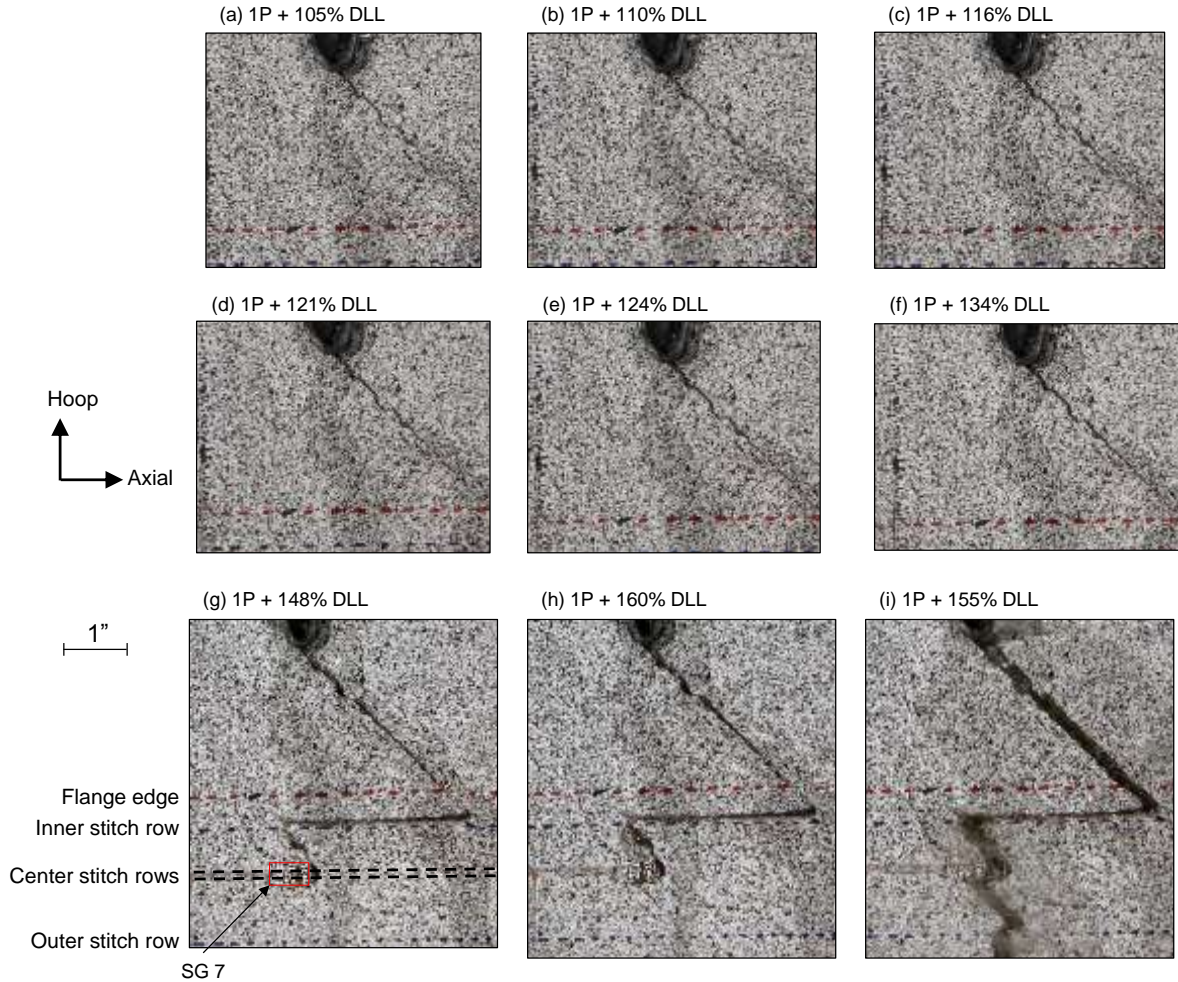
Figure 23. Exterior Surface Damage Propagation From Damage Event C to D at Notch Tip A

Photographs of the damage propagation on the exterior surface from damage event C to D (axial load increased from 100% to 160% DLL) at notch tip A are shown in Figure 23, with the same orientation and scale as Figure 21.

Visual damage propagation was slow, stable, and in a 45° orientation from the notch tip up to 1P + 134% DLL and was arrested by the inner row of stitching, as shown in Figure 23(a) through (f). As the load reached 1P + 140% DLL, damage at notch tip A propagated instantaneously from the stringer flange, to the center stitch row and was once again arrested, as shown in Figure 23(f) and (g), respectively. Additional axial load was required to propagate the damage beyond the stringer. The load reached 1P + 160% DLL, as shown in Figure 23(h), at which point damage propagated instantaneously beyond the two-bay region (damage event D) and out of the exterior surface field of view, as shown in Figure 23(i). This damage propagation created a 5% axial load drop, indicating a reduction in the stiffness of the panel.

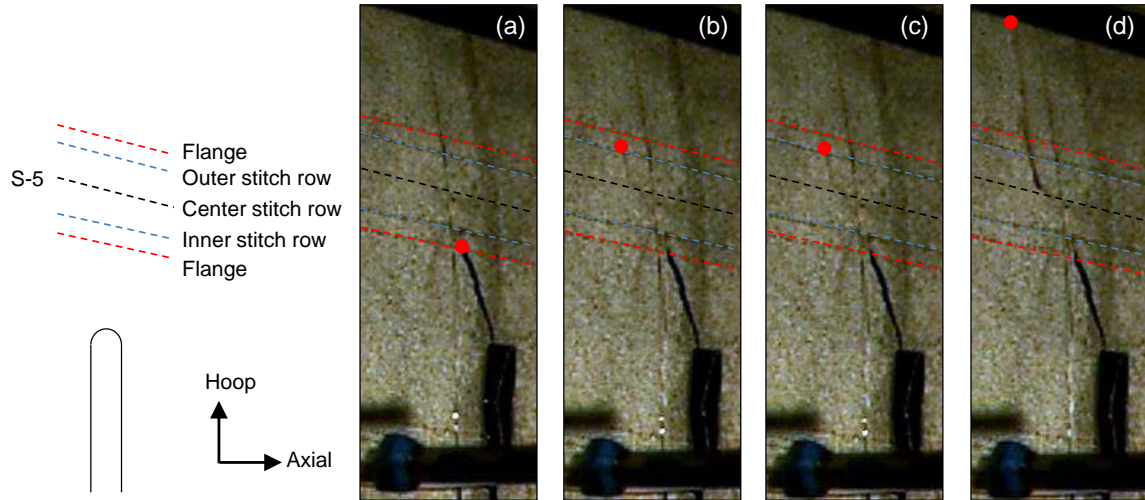
Figure 24. Sequential Frames Captured Using a High-Speed Camera Showing Damage Propagation Beyond the Two-Bay Region

The high-speed camera was used to capture damage event D at the opposite notch tip (notch tip B), where damage propagated beyond the two-bay region. The damage propagation was analogous to the notch tip A results shown in Figure 23(h) and (i), however the damage behaved slightly differently. The damage had been arrested by the inner stitch row up to 1P + 160% DLL and then propagated past the other stitch rows nearly instantaneously. The four high-speed camera frames that captured this event, which are 0.2 milliseconds apart, are shown in Figure 24. The images are marked with a red dot to indicate the extent of visual damage propagation observed in images (a) through (c). In image (d), the red dot indicates that damage extended at least to the edge of the field of view. The damage was briefly arrested (duration was approximately 0.4 ms) at the outer stitch row, as shown in Figure 24(b) and (c).

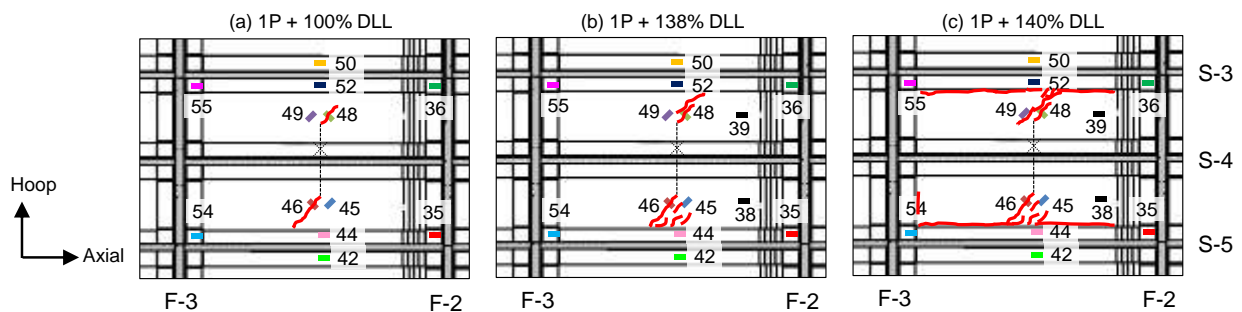
Figure 25. Observed Visual Damage Accumulation on the Interior Surface (a) After Damage Event B and (b) Before and (c) After Delamination Formation

Damage visible on the interior surface was much more widespread than on the exterior surface. As the load was increased from damage event C, visual observations on the interior surface showed slow, stable damage accumulation ahead of both notch tips, which propagated to the adjacent stringer flange edges, as shown schematically in Figure 25(a) and (b). At 1P + 140% DLL, cracks formed instantaneously along both adjacent stringer flanges indicating a delamination between the free edge of the stringer and the skin, as shown in Figure 25(c). The interior damage was subsequently arrested by the stitching in the frame flanges as load was increased leading up to damage event D. Prior to damage event D, all the damage had been completely contained within the two-bay region by the stitching through the flanges of the surrounding stiffeners.

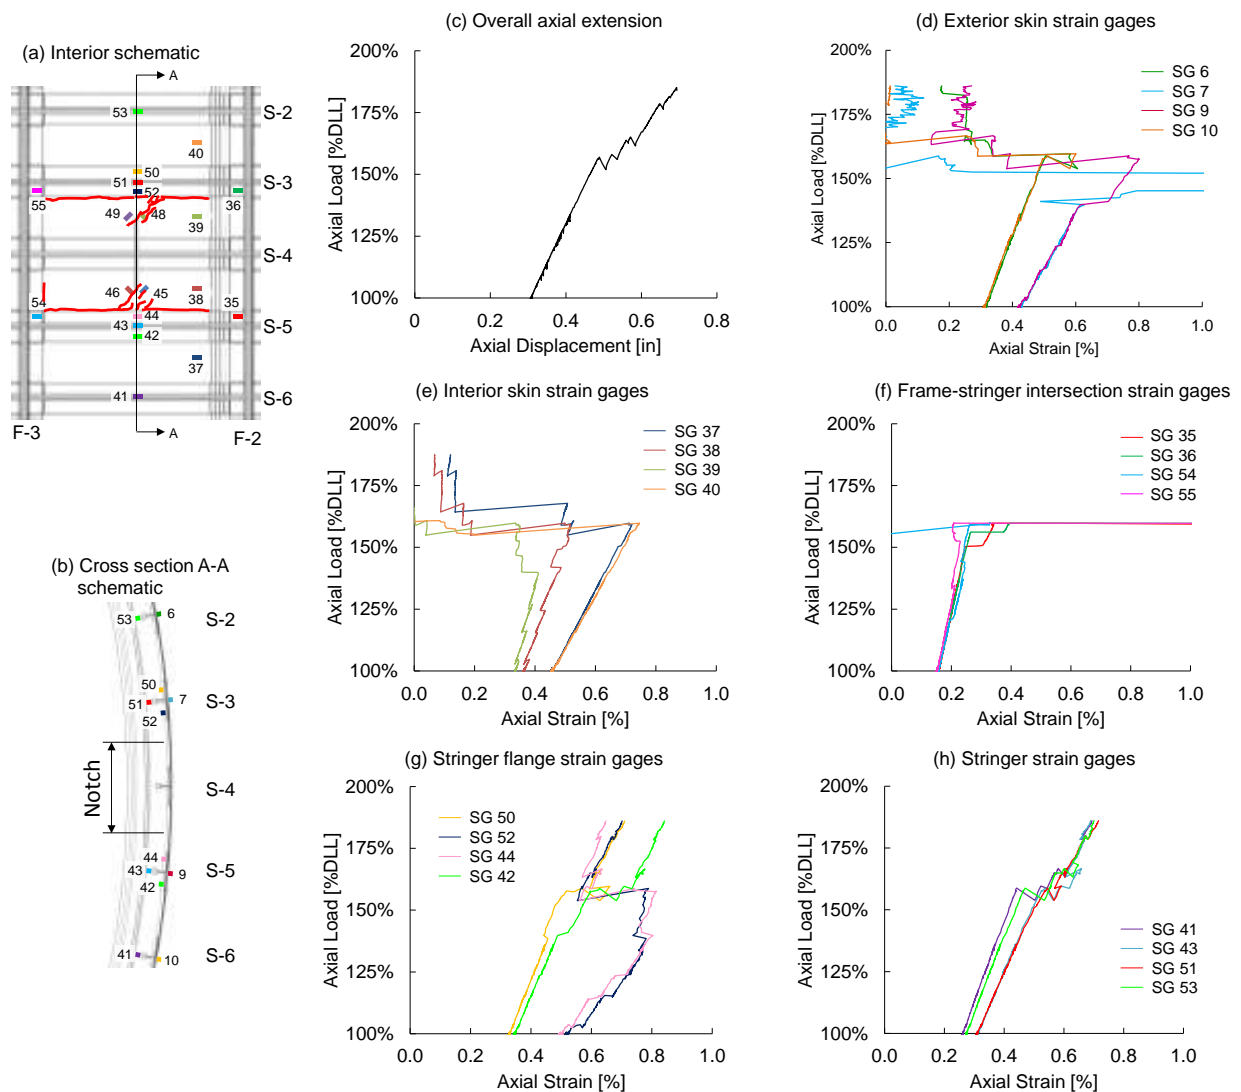
Figure 26. Selected Strain and Displacement Results and Locations Between Load Steps 4 and 5

Damage propagation was also evident through several strain redistributions as axial load was increased beyond damage event C, as shown in Figure 26. Detailed strain gage locations are

The first evidence of strain redistribution occurred at 1P + 140% DLL as damage propagated instantaneously to the adjacent stringer's center stitch row (refer to Figure 23(f) and (g)). This strain redistribution was observed in the exterior skin strain gages above the adjacent stringers (SG 7 and 9), as shown in Figure 26(d). Strain gage 7 showed a particularly large discontinuity as damage propagated directly next to the gage (see Figure 23(g)). A small strain reduction discontinuity in the interior skin gages (SG 38 and 39) in the two-bay region, as shown in Figure 26(e), and in the stringer flange gages (SG 44 and 52) in the two-bay region, as shown in Figure 26(g), indicated load carried by the skin was slightly reduced due to the damage event. This small strain redistribution had very little effect on the overall load carrying capability.

Shortly after, as the load was increased beyond  $1P + 140\%$  DLL, the damage propagated parallel to the adjacent stringers delaminating the unstitched edge of the stringer flanges to the stringer frame intersections and was arrested by the stitching in the frame flanges. This damage growth is evidenced by the strain discontinuities of the strain gages located at the frame and stringer intersections, (SG 35, 36, 54, and 55) shown in Figure 26(f) near  $1P + 150\%$  DLL applied load.

At damage event D ( $1P + 160\%$  DLL), several strain discontinuities occurred, indicating significant load redistribution from the skin to the stringers. Strain on the internal surface of the skin in the vicinity of the damage (SG 38 and 39) dropped to near zero, indicating the failure of the skin in this region. Strains on the stringer flanges closest to the notch (SG 44 and 52) reduced by 0.25%, while strains on the stringer's other flanges (SG 42 and 54) increased, indicating load transfer to the stringers and suggesting failure of the first stitch row as damage delaminated the stringer flange from the skin. A discontinuity in axial displacement also occurred, as shown in Figure 26(c).

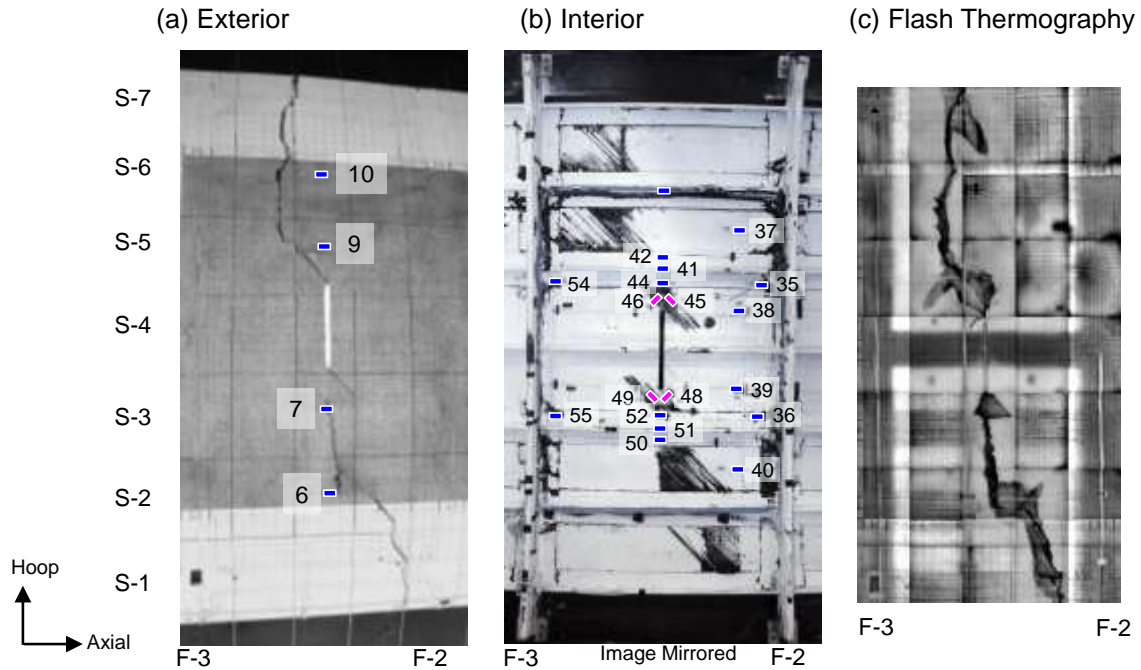
Figure 27. Postfailure (a) Exterior Surface Photo, (b) Internal Surface Photo (mirrored for direct comparison), and (c) Flash Thermography Results (1D, t = 5s)

Postfailure inspection was used to identify failure mechanisms. Visual and thermography inspections were conducted. Visually damage was observed to be more widespread on the interior than the exterior. The damage followed a tortuous path, which was not self-similar or symmetrical. Figure 27 shows a side-by-side comparison of an exterior surface photograph, an interior surface photograph, and flash thermography results. The through-the-thickness damage was contained within frame F-2 and F-3. The damage path was altered at several of the locations where it crossed the stitching rows, demonstrating the ability of the stitch rows to turn and contain damage.

Visual inspection showed stitch and stringer failures. Stitch failures were widespread, resulting in delamination of the frame and stringer flanges from the skin. A majority of the stitch failure occurred during the sudden release of energy at catastrophic failure.

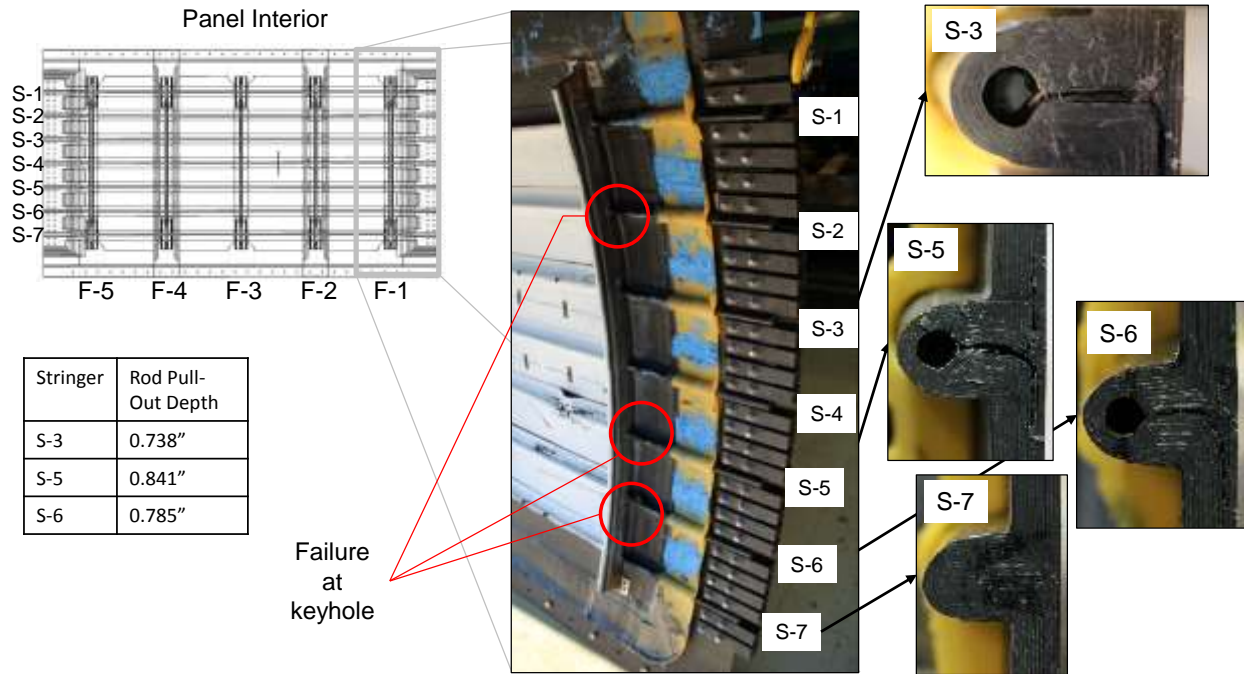
Figure 28. Evidence of Stringer Rod, Web, and Flange Pullout in Stringers S-3, S-5, and S-6

Stringer rod, web, and flange pullout occurred in three of the stringers, S-3, S-5, and S-6, as shown in Figure 28. Visual evidence suggests that the stringer wrap plies, webs, and flanges delaminated from the surrounding load introduction buildup and skin plies. Failure at the stringer and frame intersections (keyhole), circled in red in Figure 28, indicates that the stringers displaced axially, relative to the frame.
