# Photogrammetry Measurements During a Tanking Test on the Space Shuttle External Tank, ET-137

## ABSTRACT

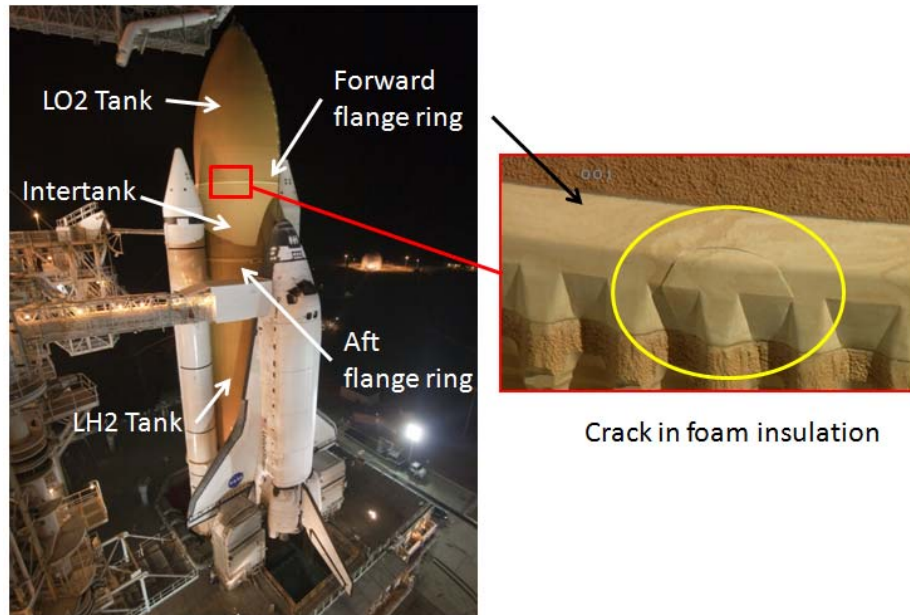
Launch Pad 39-A, on September 16, 2010. A series of scrubs pushed the launch back to November 5, 2010. On November 5, 2010, the launch was scrubbed because of leaks in the ground umbilical carrier plate (GUCP), which occurred during the filling process of the external tank (ET), ET-137. During the post-scrub walk down inspection, cracks were discovered in the thermal protection system (TPS) foam insulating the flange connecting the liquid oxygen (LO2) tank and the intertank near the top of the ET on Panel 2. These cracks were unrelated to the GUCP leak issue.

**Fig. 1** Cracks in the ET foam at the LO2 flange on Panel 2 due to stringer cracking

Closer inspections indicated that the TPS cracks initiated from an area where the riveted hat stiffeners (stringers) mounted to the ET Intertank, providing additional structural support to the Intertank near the LO2/intertank interface. Inspections of the stringers necessitated cutting the TPS foam away and revealed that cracks were present in more of the aluminum stringers in regions outside the one highlighted in Figure 1. The issue was mitigated by removing the cracked portions of the original stringers and replacing with new stringers and z-doublers. The remaining un-cracked stringers received a small reinforcement on their feet [2]. New TPS foam was reapplied to the repaired region to provide insulation for the ET. Figure 2 shows a final repaired Panel 2 region.

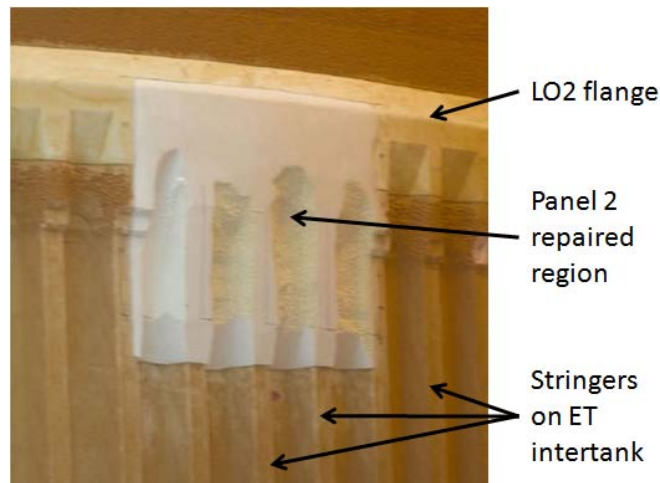
**Fig. 2** A repaired region of the LO2 Flange on ET Panel 2

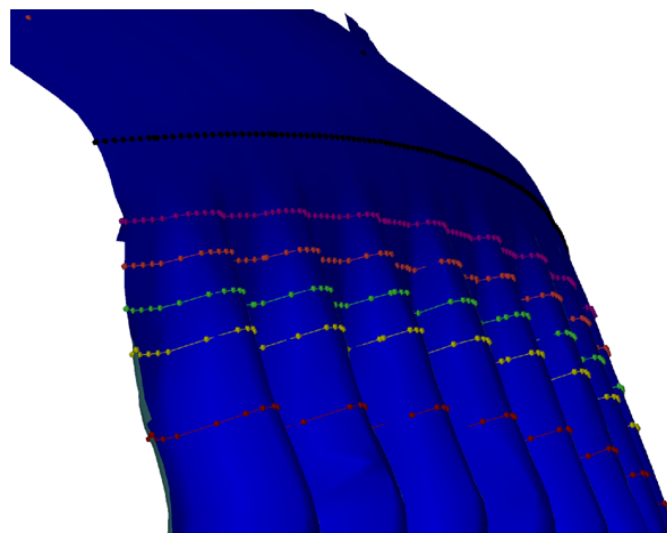
The data were first used in a qualitative surface analysis examination. The surface analysis was a three dimensional surface visualization feature. It was used as a quick look to determine whether any anomalies (i.e., stringer cracks) occurred on the ET surface. All nominal conditions were detected from the surface analysis. Several features including the radial curvature of the ET, the peaks and valleys of the stringers, and the LO2 flange were highly noticeable. Figure 9 shows the surface analysis of the ET, visualized in blue. The horizontal lines seen in Figure 9 will be addressed later in this section.

**Fig. 9** Surface analysis visualization

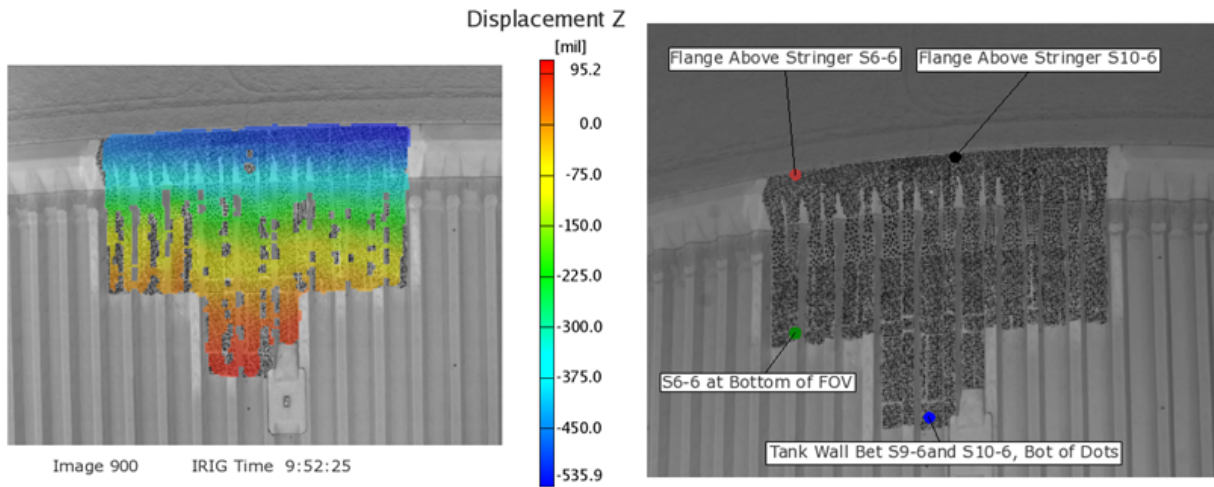
Figure 10 shows two ways of extracting the data from the full field measurements. The left image shows a fringe plot of the unmodified full field radial (z) displacement just at the completion of fill (image 900). The change in radial displacement is very noticeable and indicates significant movement in the ET, with an inward motion of more than 0.5 inches at the top of the flange. Gaps or holes in the data indicate portions of the pattern that were not tracked and were mainly due to the discontinuity of the dot pattern resulting from the abrupt change in direction between the stringer tops and valleys. From the fringe plots, particular places of interest were identified for further time history analysis. Figure 10, right, shows locations of four discrete points identified for further analysis.

**Fig. 10** Full Field fringe plot (left) extracted points for time history analysis (right)

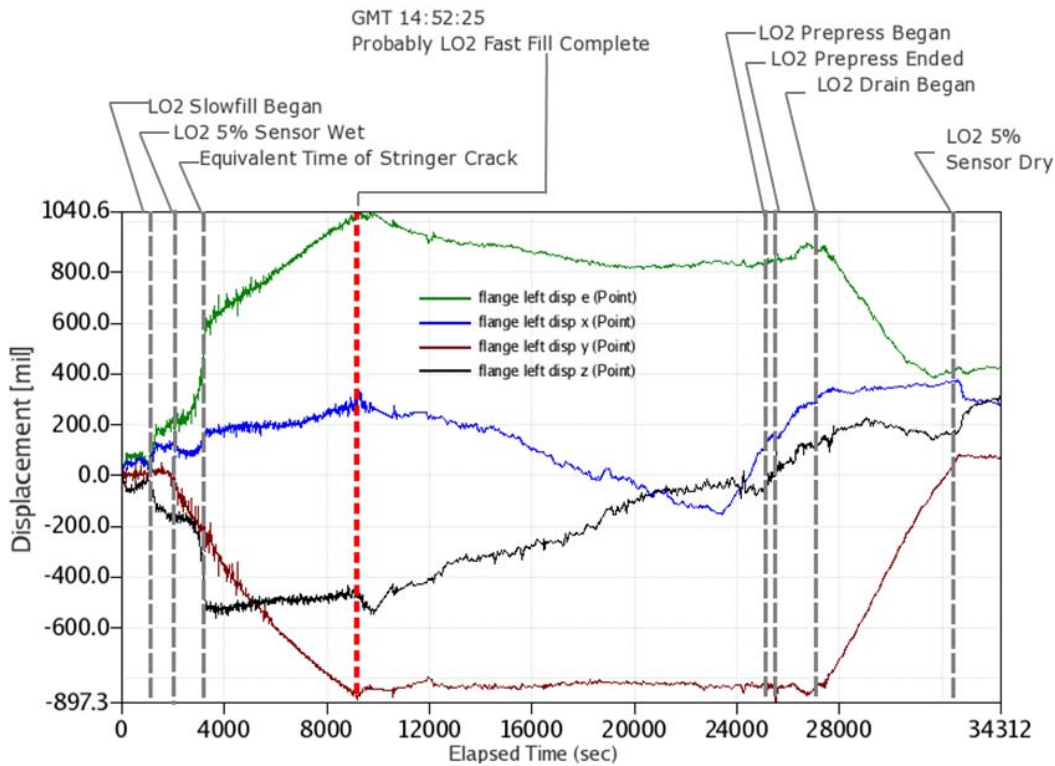
**Fig. 11** Time history of displacements at a point on the left flange

The time history shows that between the LO2 slow-fill milestone and the completed LO2 fast-fill milestone, the point on the left flange exhibited almost 900 mils of vertical displacement in the  $-y$  (downward) direction, which is represented by the plateau in this line in Figure 11. This displacement disappears at the milestone when the LO2 drain began, and the point reaches almost the starting position after the LO2 sensor dry milestone. This finding is due to the sag in the ET from the weight of the propellants. Also, the radial displacement, which is represented by the black line in Figure 11, is negative, indicating contraction due to the super-cooled liquid inside the ET. Finally, the horizontal displacement, represented by the blue line in Figure 11, is positive, indicating displacement toward the right of the image.

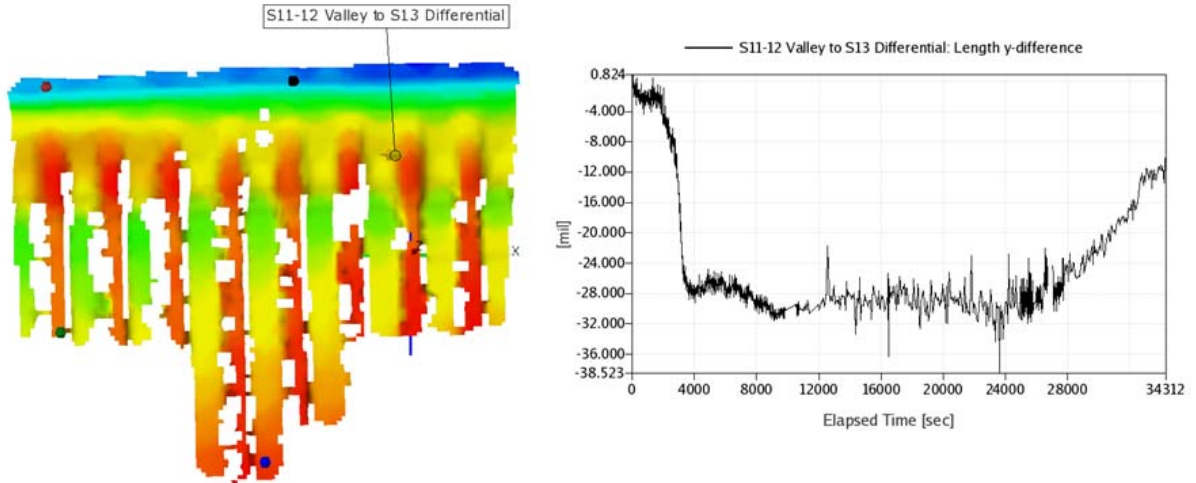
**Fig. 12** Analysis for stringer crack determination

The plot in Figure 12, right, shows the vertical difference between the stringer peak and valley. A large abrupt spike represented by a discontinuity in the data would indicate a possible crack formation, as a crack would show significant shearing motion between the peak and the valley. In contrast, the gradual changes seen over the course of the first 4000 seconds of the test were determined to be normal ET motion. Similar analyses were conducted for the other stringer locations. The analysis of this data did not show evidence of any newly developed cracks that might have occurred during the tanking test.

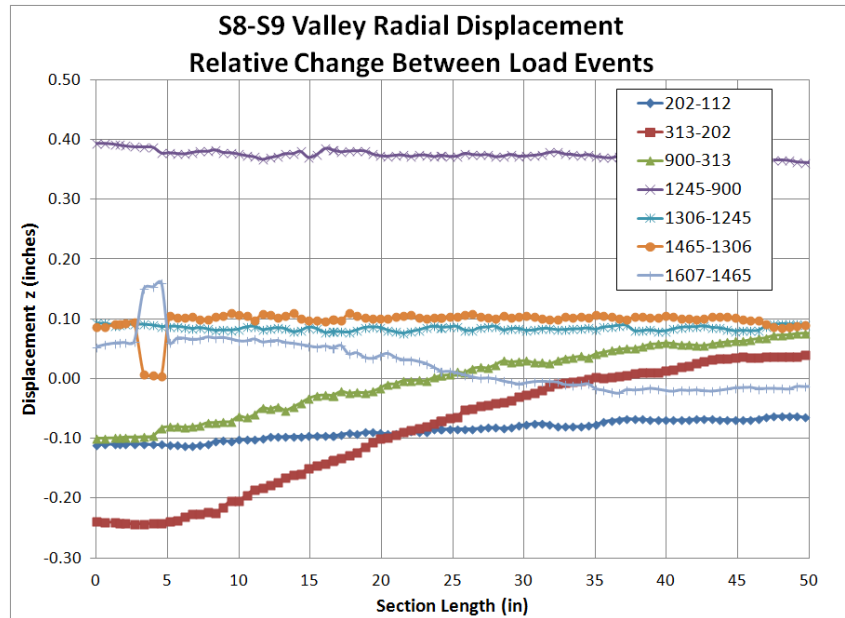
**Fig. 14** Relative change between significant events for the S8-S9 valley section line

Figure 14 suggests that all events up through the filling of the ET (image 900) cause actual deformation, which is noted by the slope increase in the three data sets leading up to image 900. Data set “202-112” shown in blue in Figure 14, starts off as a flat line indicating rigid body motion. However data set “313-202” shown in maroon in Figure 14, shows a significant change in radial (z) displacement throughout the section length, indicating relative motion. Data set “900-313”, shown in light green in Figure 14, shows a similar trend. The difference between LO2 fast fill and LO2 pre-pressurization (images 1245 and 900, or time 25559 sec and 9590 sec) seems to cause rigid body motion only. Similar phenomena can be seen between the difference of the LO2 drain (image 1465) and the end of the LO2 prepress (image 1306). The remaining curves show some form of sloped line and most likely indicate structural deformations of the ET. The minor plateau around the 5 inch mark in the data represents a false reading in the image 1465 data due to data dropout.

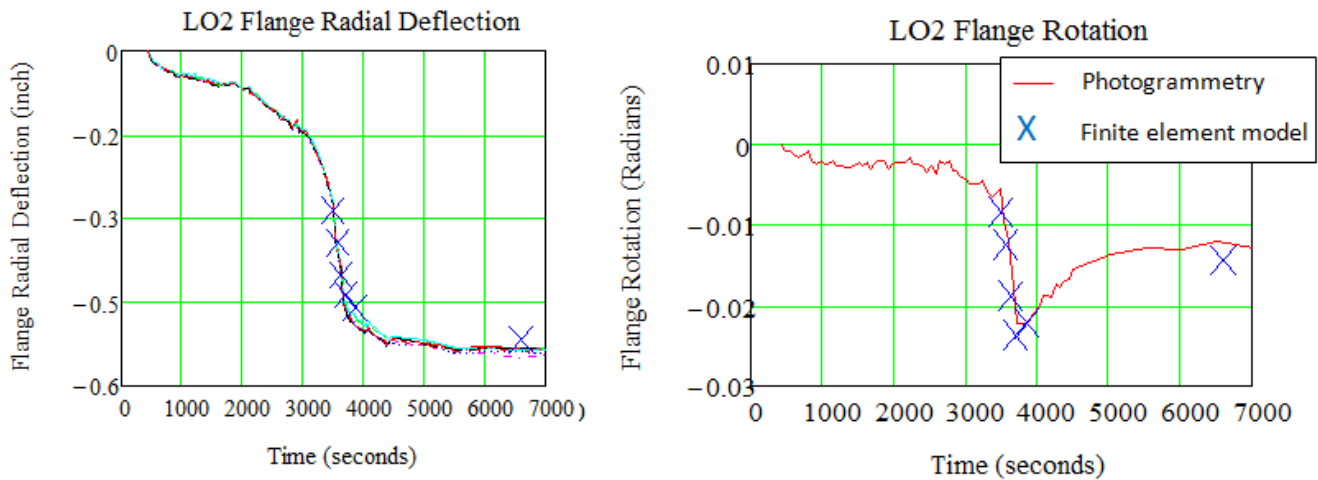
A complete analysis which includes further section line extraction and data analysis was performed by NASA Marshall Space Flight Center (MSFC). Because stringer cracks were not seen in the Panel 6 data, the majority of the data was used to compare and validate computer modeling efforts on the ET performance. Figure 15 shows a comparison of photogrammetry data, shown in solid lines, to finite element analysis predictions for flange radial deflection and rotation angle. For a complete analysis on the test-simulation correlation, refer to reference 17.

**Fig. 15** Comparison of photogrammetry data to finite element analysis
