## **Boiling eXperiment Facility (BXF)**

# **Fluid Toxicity Technical Interchange Meeting (TIM) with the Payload Safety Review Panel (PSRP)**

June 14, 2012

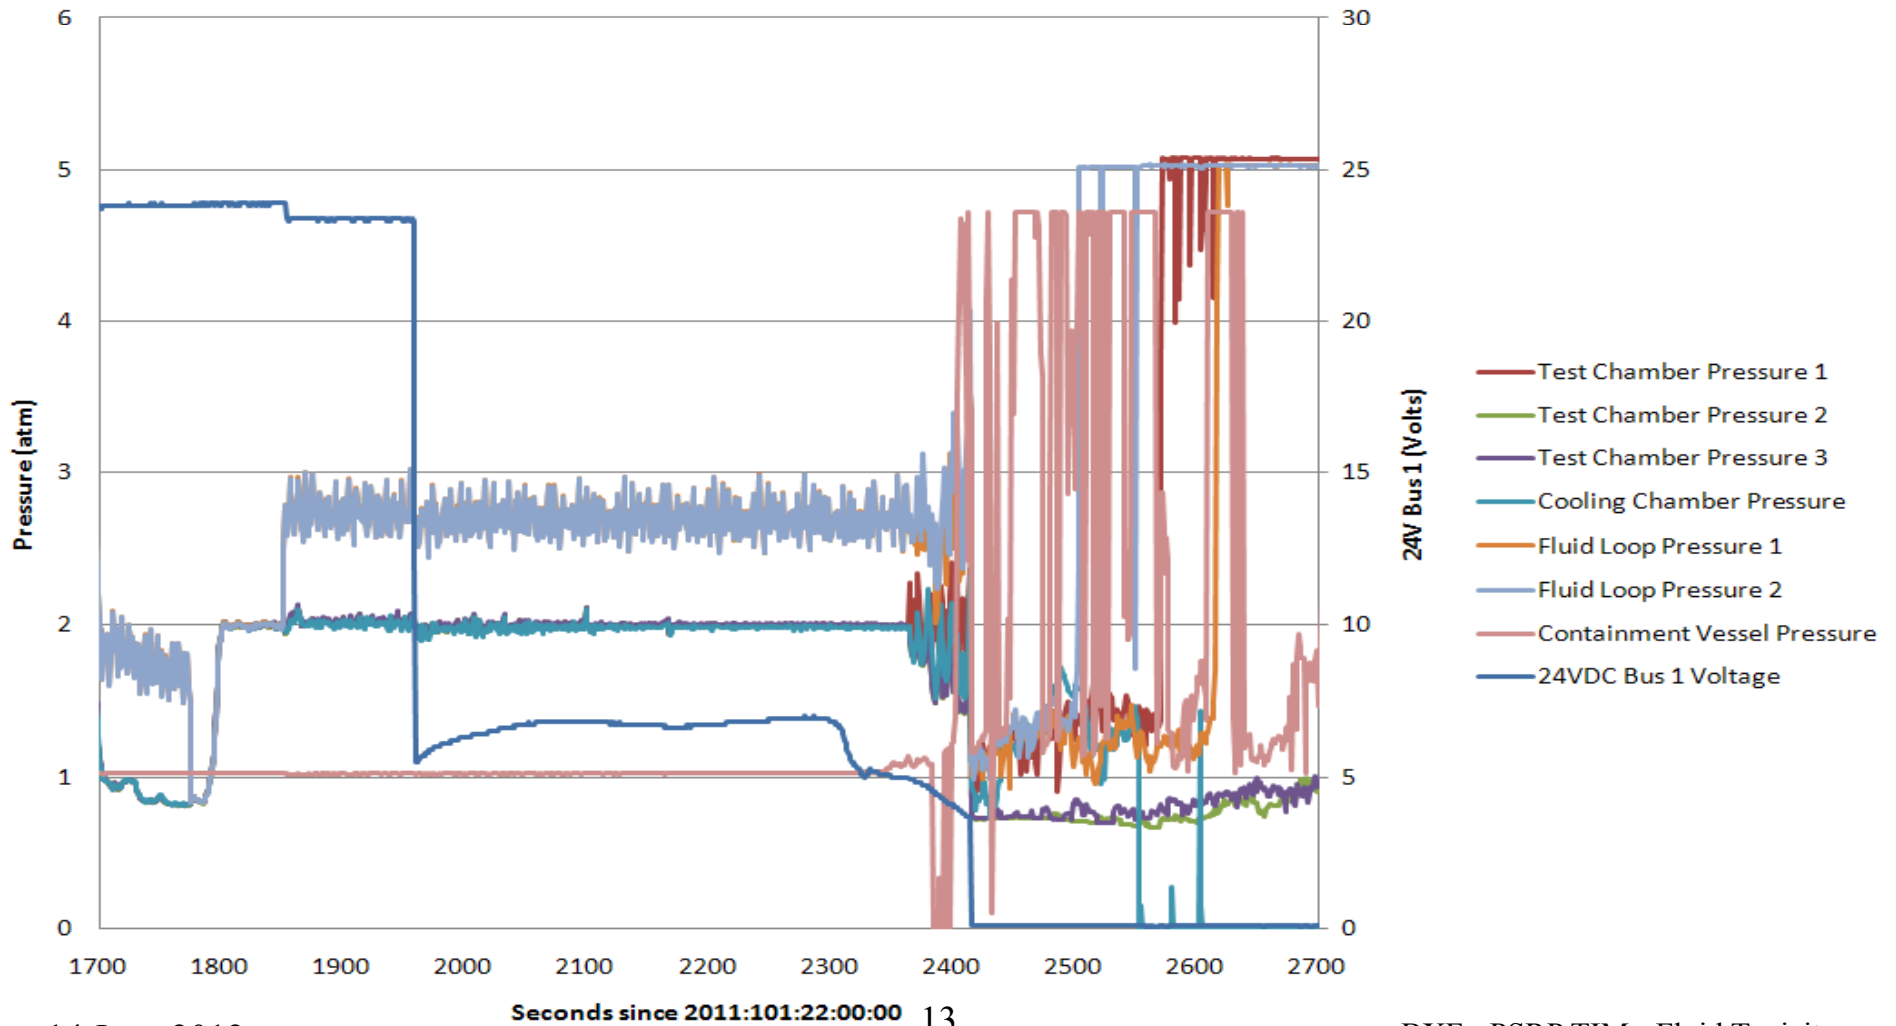
### 24V Bus 1 and Pressures at time of anomaly

- The Safety Circuit initially tripped when a system pressure reading exceeded its limit. Erratic pressure readings at the time of the anomaly and immediately afterwards are not deemed to be entirely credible. It is believed that a complex interaction between the shorted cartridge heater and the electronics inside the Containment Vessel (CV) is the cause of these readings.

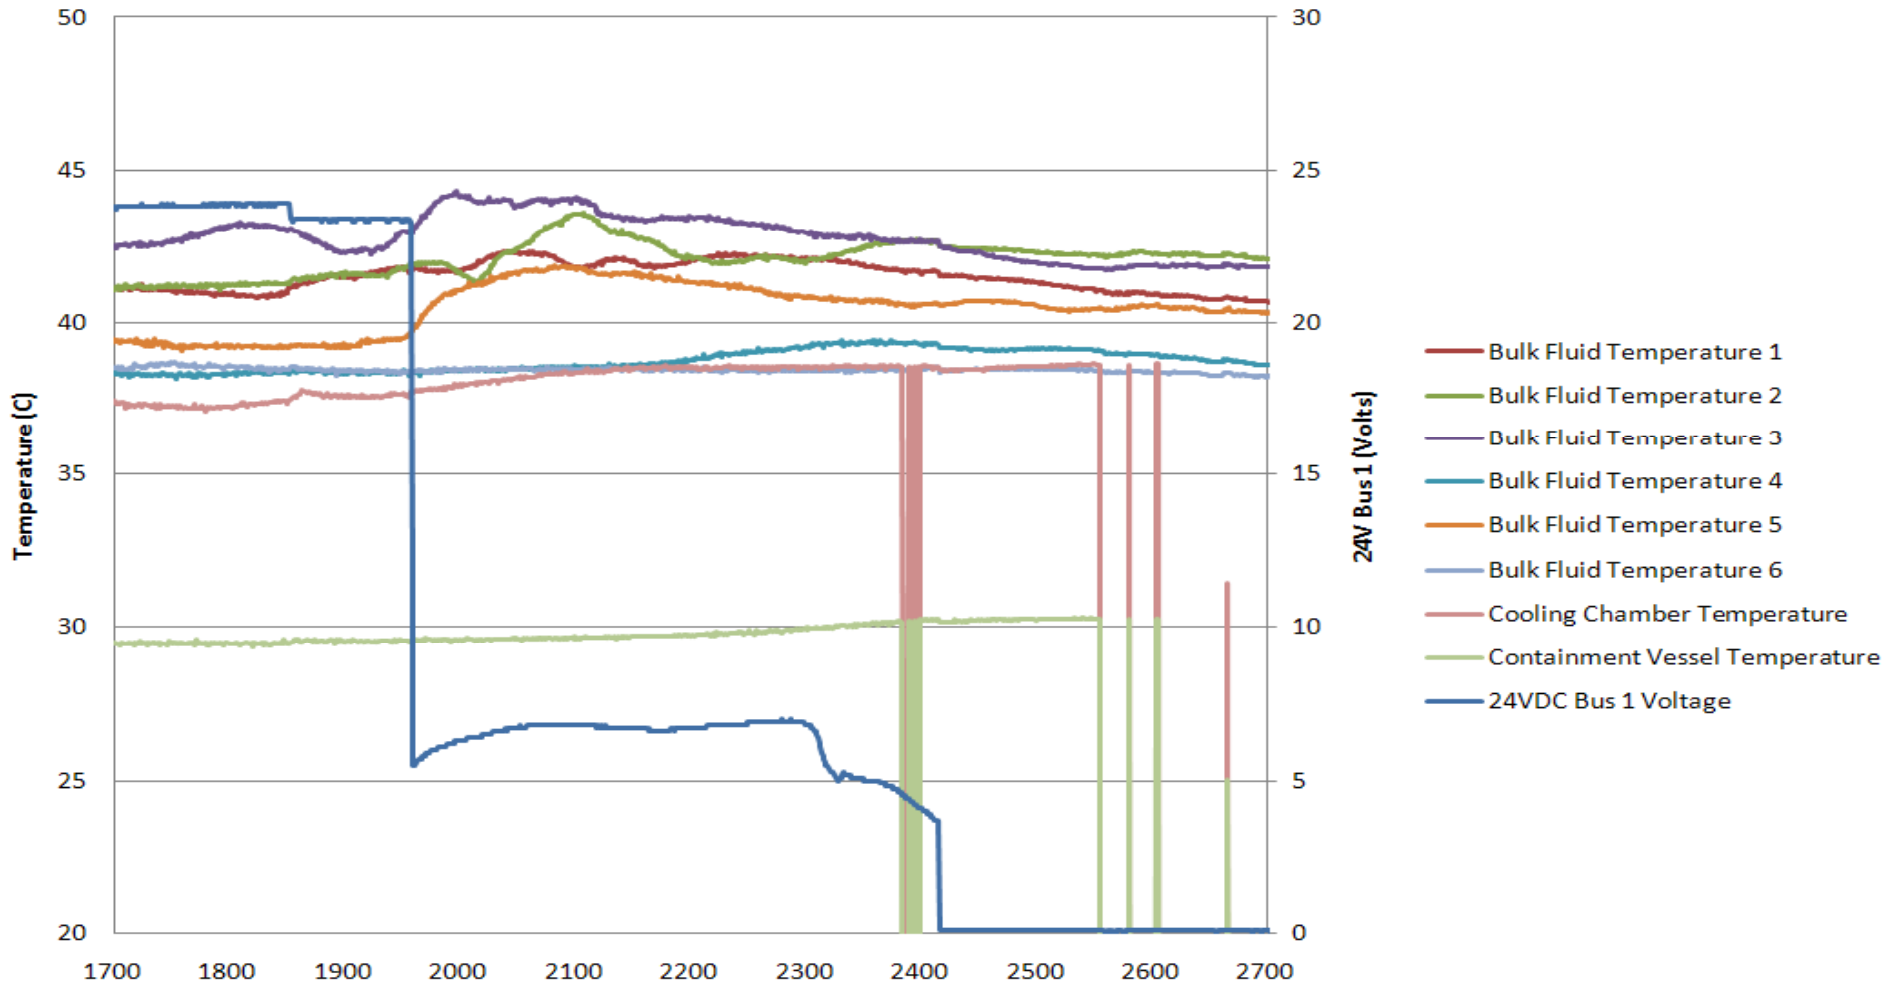
## 24V Bus 1 and Temperatures at time of anomaly

- Bulk fluid temperatures did not rise significantly at the time of the anomaly and remained within limits of the Safety Circuit; the overheating that occurred was a localized.

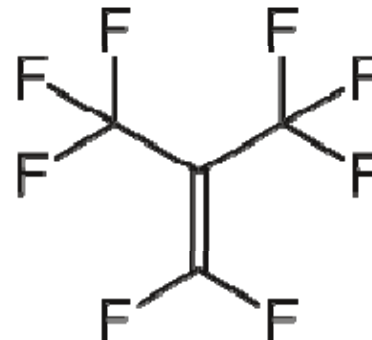
- Plan Change: Fluid Sampling & Analysis added
  - Rationale: Stronger evidence of an overheat condition, increasing concern that PFIB was produced.
- Two samples taken of BXF Fluid, 1 sample analyzed for PFIB
- **CONFIRMED!!!** 90 ppm of PFIB detected in BXF Fluid; Acceptable Exposure Level (AEL) is 10 ppb TWA
- CV reassembled to reestablish 3 levels of containment
- PFA Activities halted to determine how to proceed

Generation of PFIB in the fluid is indicative that the BXF Fluid (PFNH) was exposed to excessive temperatures long enough to cause molecular decomposition.  
14 June 2012

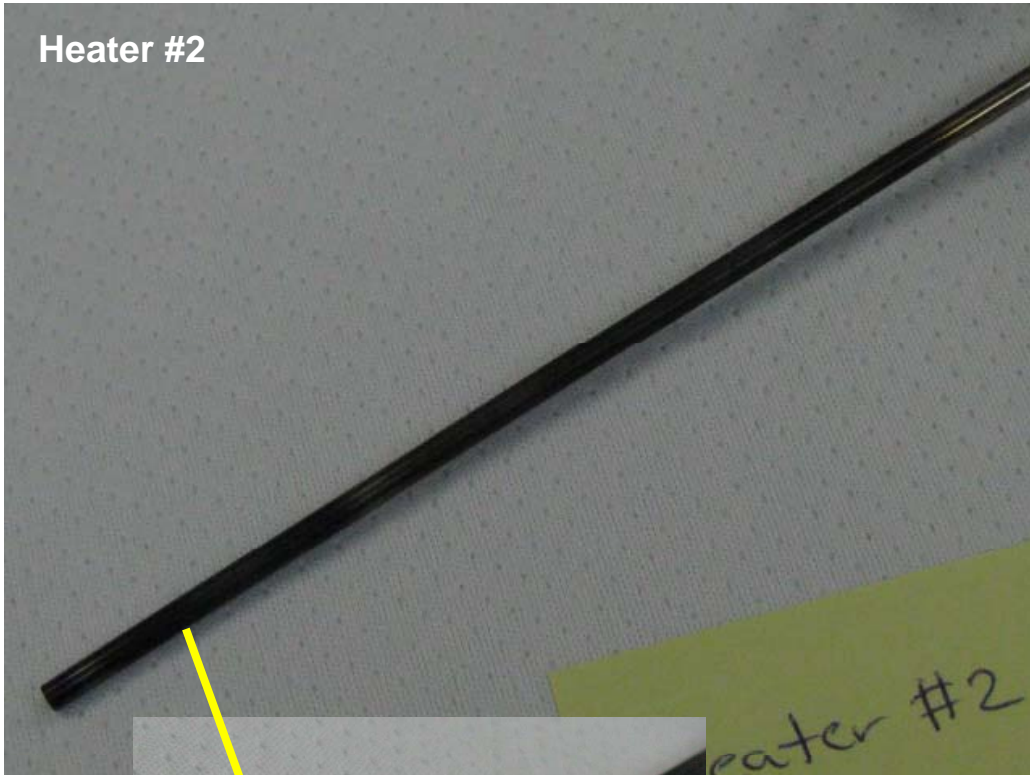
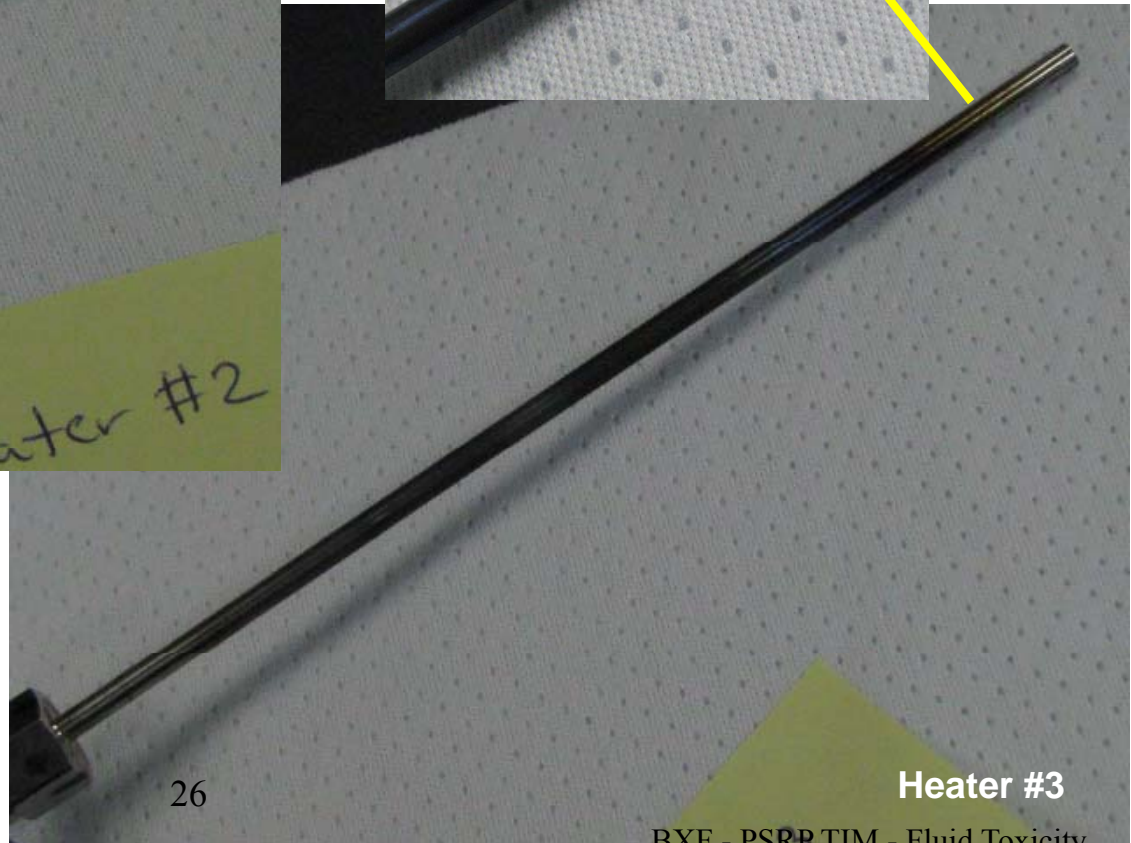
- Bulk Fluid Heaters #2 & #3 (Cartridge Heater S/Ns 012 & 009, respectively)
  - Discolored and blackened
  - Heater #2 more blackened than Heater #3
  - Aside from discoloration, no other damage observed
- Bulk Fluid Heater #1 (Cartridge Heater S/N 010)
  - Unable to extract through port fitting, so entire port fitting removed to extract heater
  - Extreme damage in two locations on heater sheath
  - Incoloy 800 melted in both locations
  - Brownish Magnesium Oxide and greenish Nickel-Chromium wiring visible

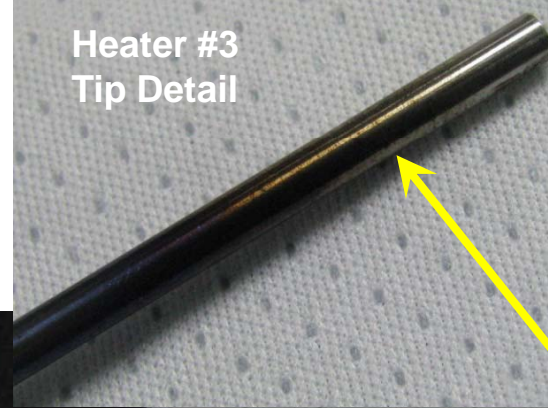
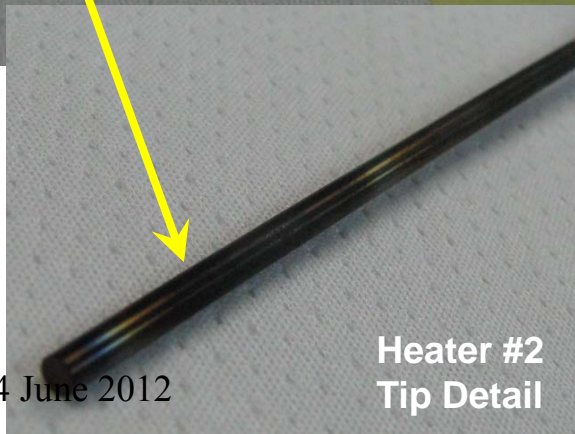
Heater #3  
Tip Detail

The damage of Bulk Fluid Heater #1 proves excessive temperatures were achieved on-orbit.

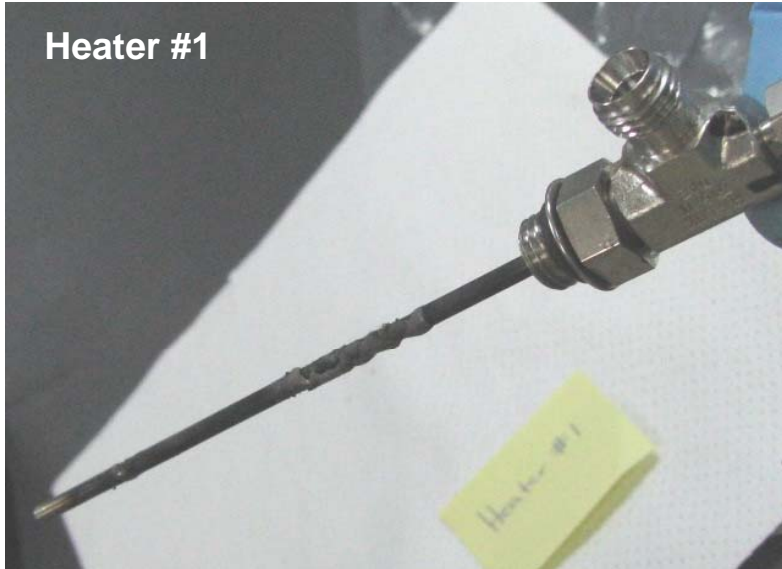
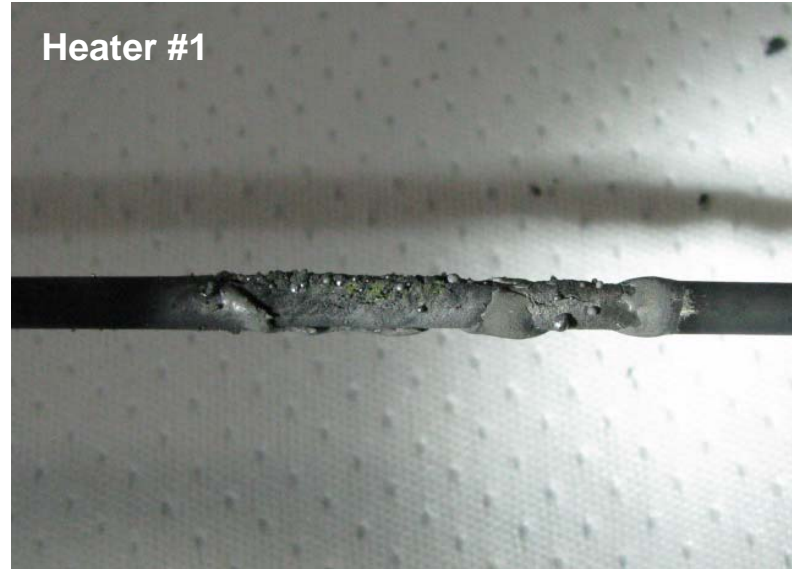
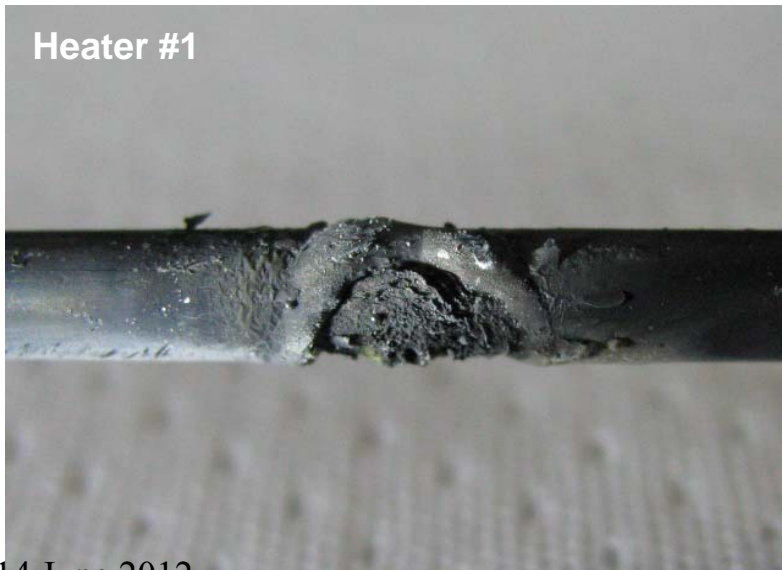
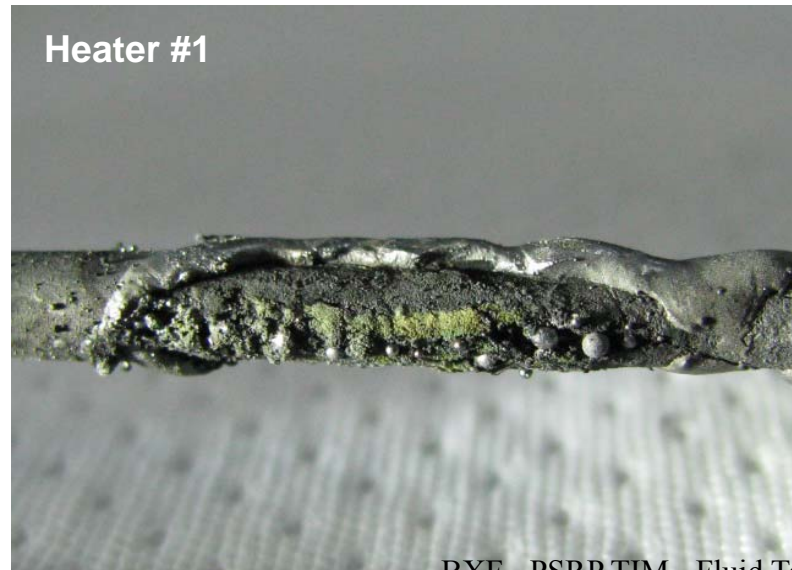
- Heater manufacturer Watlow examined discoloration and damage of heaters
  - “All signs of failures appear to be from exposure to high temperature.”
  - Heater #1: “Melting of sheath (insulation breakdown due to high temperature causing an arc...)”
  - Heater #2: “Discoloration and oxidation with a shorted internal winding due to high temperature.”
  - Possible causes: “Watt density too high” and “Material flow issues - low flow, no flow, or pattern of flow not taking heat away.”
  - Recommendation: “Suggest you monitor the heater temperature and use a high-limit controller to shut the heater down to avoid overtemperature.”

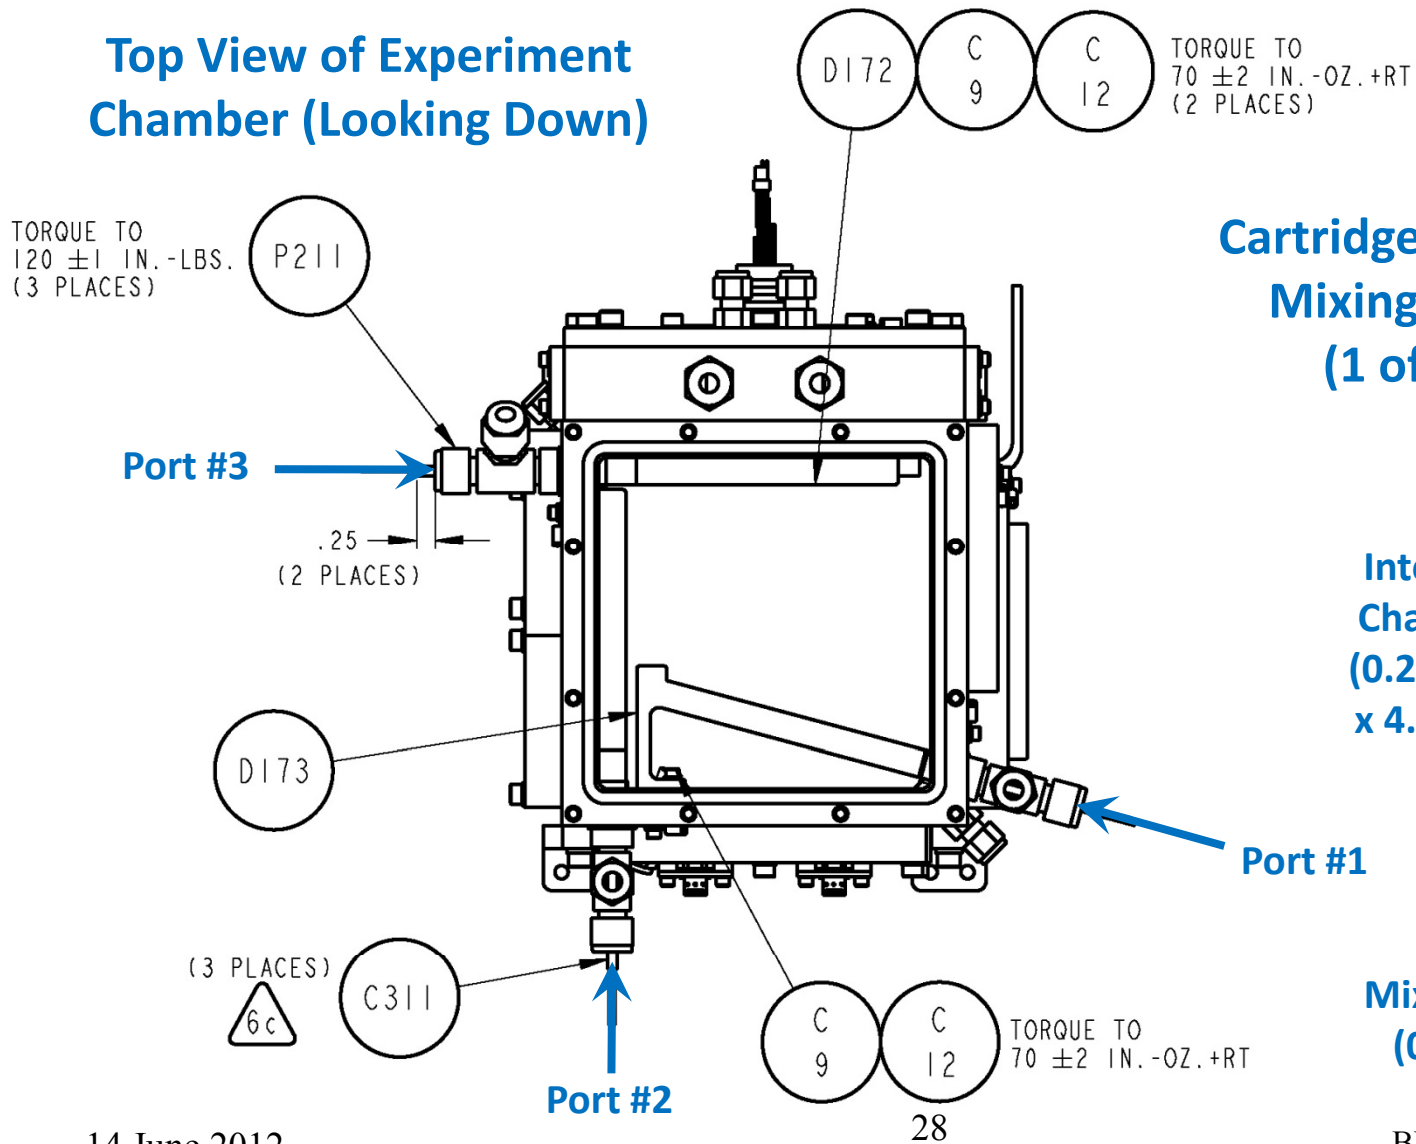
## Top View of Experiment Chamber (Looking Down)

The Experiment Chamber drawing seems to show a tight fit between the heater and the bored hole, but I'm not sure how Heater #1 could have blown apart if it was tightly nestled in a hole. Heaters #2 & #3 may not have burned up due to having a tighter hole and being able to transfer the heat more efficiently away from the heater.

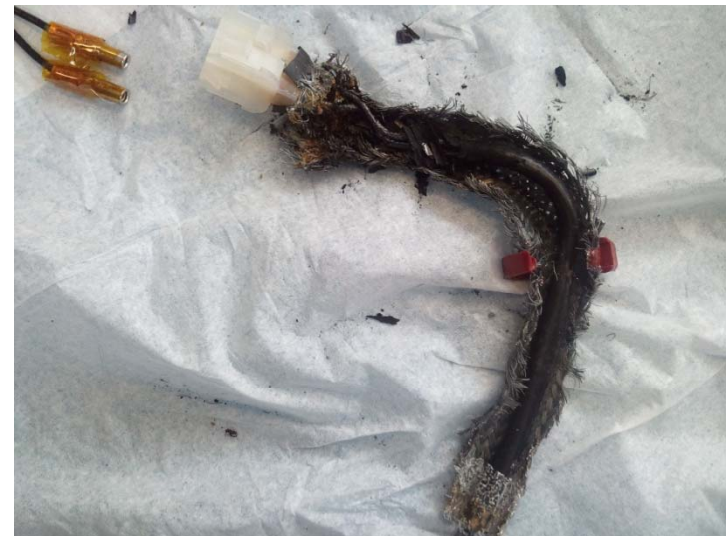
- Partial shorts to heater sheath found:  $\approx 40 \text{ k}\Omega$ , consistent with prior investigation results
- Bulk Fluid Heater 1 (Cartridge Heater S/N 010)

- Shield fused to inner insulation sleeving at connector, could not pull shield back from connector
  - Shield hardened, very tough and difficult to cut open

- Inner insulation sleeving carbonized near connector, crumbled apart
  - Internal wire insulation blackened overall, but whitened over crimped area; Exposed wire near connector.

- Connector melted, contacts completely encased, unable to extract
  - Wiring separated from heater on its own (no cutting needed)
  - Heater sheath bent at weakened damaged area due to handling

- Heater Resistance not stable, varied greatly during dissection
  - Heater Resistance at heater sheath =  $7.08 \Omega$ , stable
  - Shorts found to heater sheath  $\approx 8 \Omega$

- Wiring failed continuity measurements
