Stress Analysis and Testing at the Marshall Space Flight Center to Study Cause and Corrective Action of Space Shuttle External Tank Stringer Failures

Robert J. Wingate*

NASA Marshall Space Flight Center, Huntsville, AL

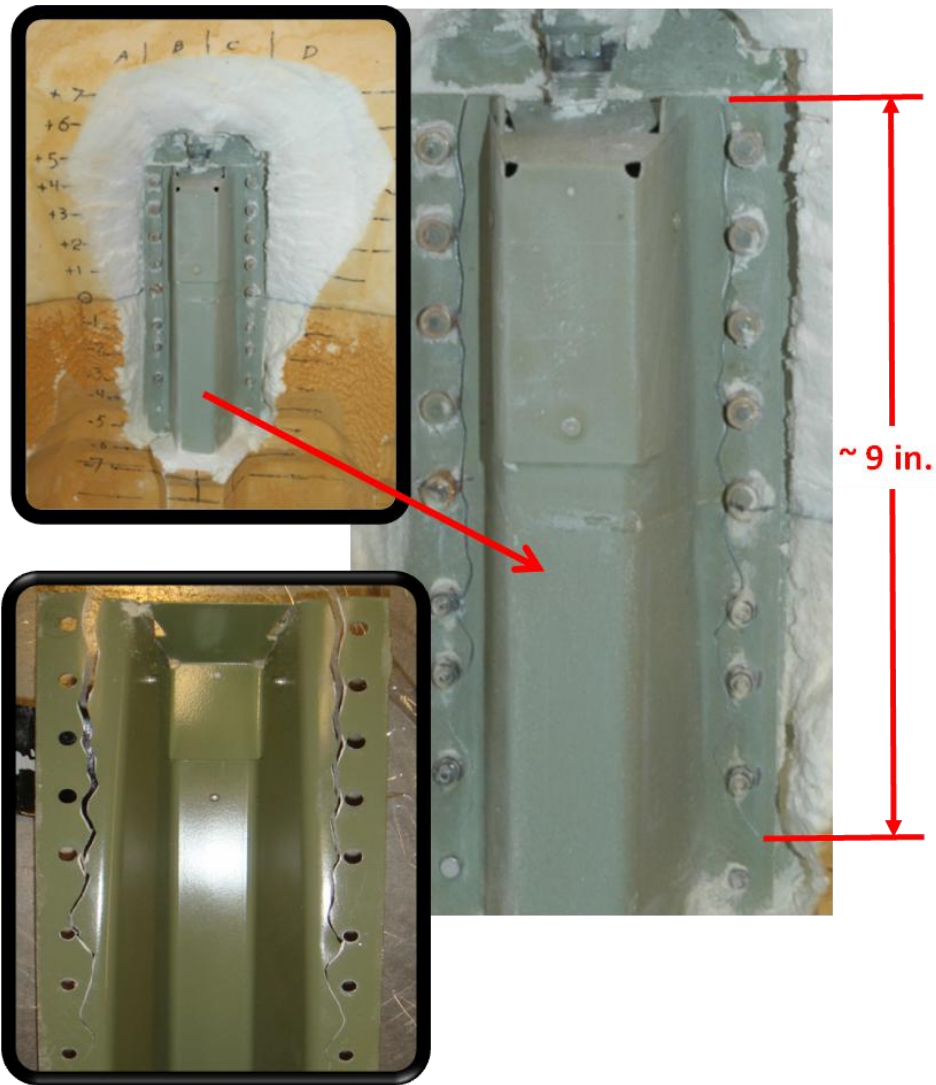
Removal of the damaged foam revealed that an underlying aluminum hat-section stringer had cracked approximately 9 inches along each side, just inboard of the fasteners that attached the stringer “feet” to the intertank forward flange chord (Figure 2). The crack in the foam was solely a result of the stringer failure. An adjacent stringer was also found to be similarly cracked on each side for about 3 inches along its forward end, although the SOFI directly over it had appeared undamaged.

Figure 2. Stringer cracks discovered after STS-133 launch scrub. ET-137 stringer S7-2 shown. (Bottom left inset: stringer S7-2 after removal from ET-137 and foam residue cleaned off.)

The two stringers were repaired in-situ at the launch pad by removing several inches of the forward end of each damaged stringer and splicing on an equivalent length taken from new stringers. Aluminum sheet stock doublers formed into a shape resembling the letter 'Z' were overlaid and fastened on the splice location to mechanically tie each portion of new stringer to the remaining portion of original stringer. The SOFI was then manually re-applied, allowed to cure, and trimmed to meet flight requirements. The remnants of the two stringers containing the cracks were shipped first to the MAF and later to the MSFC for forensic engineering.
