Stringer Bending Test Helps Diagnose and Prevent Cracks in the Space Shuttle's External Tank

Joseph B. Saxon¹, Gregory R. Swanson², William P. Ondocsin³, and Robert J. Wingate⁴
NASA Marshall Space Flight Center, Huntsville, AL

*Extended Abstract of Proposed Paper for the 53rd AIAA/ASME/ASCE/AHS/ASC Structures, Structural Dynamics, and Materials Conference,
April 23-26, 2012, Honolulu, Hawaii*

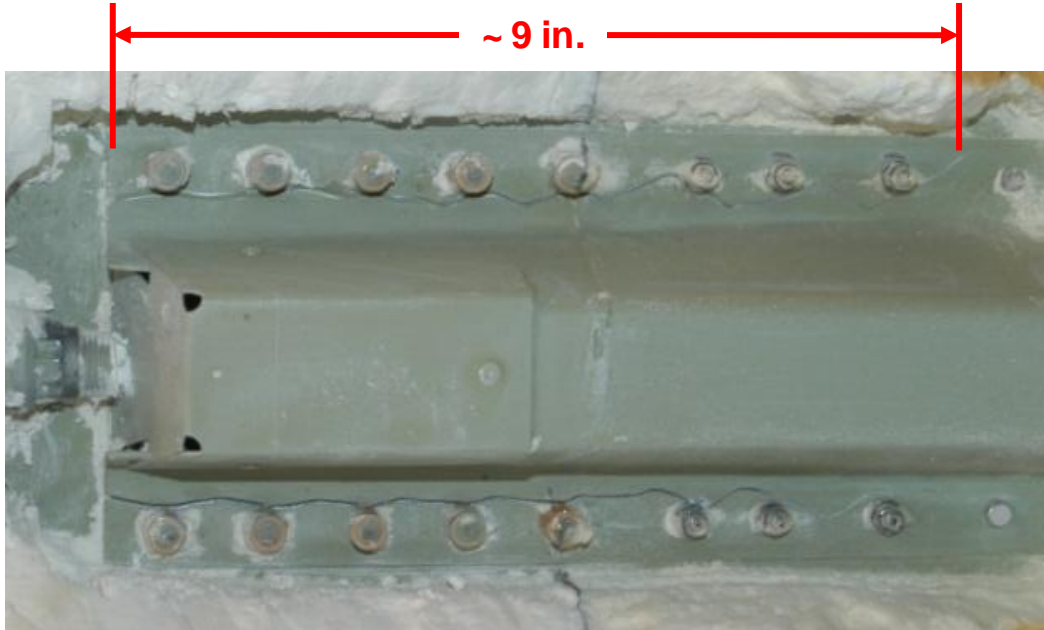
When the propellants are loaded, both ends of the Intertank approach cryogenic temperature and contract inward. The center of the Intertank remains at warmer temperature and resists contraction, causing considerable bending of the stringers, especially at the ends. Figure 3 shows cracks on the LOX end of a stringer that are consistent with this loading scenario, appearing as if the stringer end pulled away from the skin, fracturing the stringer foot along the fastener line. Fractography analysis indicated the ET-137 fractures were static, initiating on the bottom of the stringer foot (the tensile side of bending) between the 2nd and 3rd fasteners from the end. The video footage of the launch attempt indicated that the fracture occurred precisely when the LOX level should have reached the Intertank/LOX tank interface. No cracks were detected at the LH2 end of the ET-137 Intertank.

Figure 3. Cracks at LOX end of ET-137 stringer S7-2.

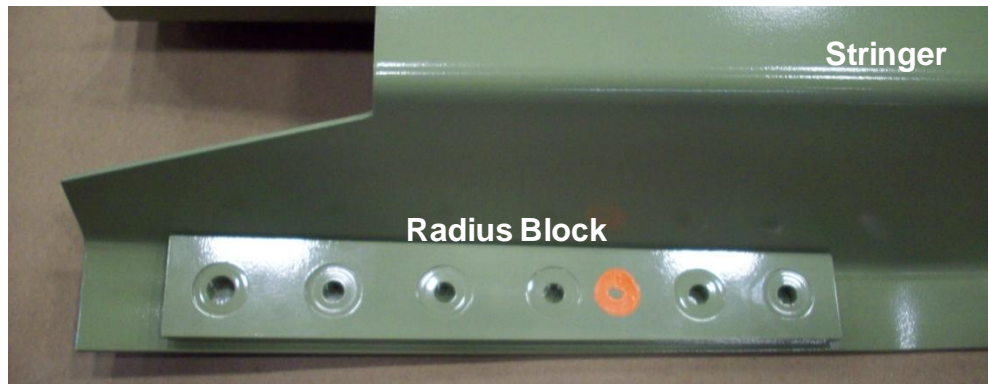
Figure 5. Radius block for proactive stringer repair.

Based on early indications from the crack investigation, NASA management made the proactive decision to reinforce all of the stringers on ET-137 by installing so-called radius blocks. The radius block (RB) placement is shown in Figure 5. Stringers with RB’s became another configuration that required testing.

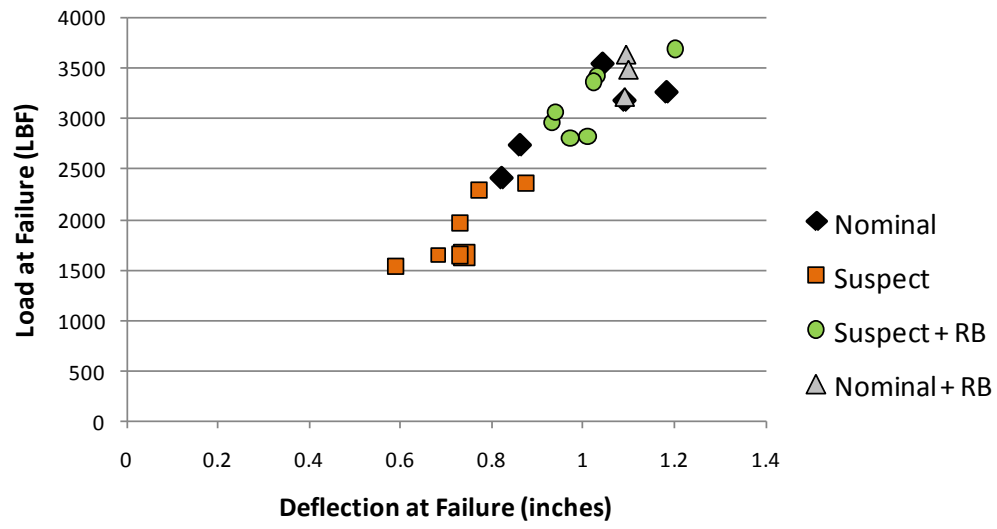
Comparative results from the stringer bending tests are summarized in Figure 6, where each article's failure point is plotted in load-deflection space. Three observations are noted:

- Suspect stringers as a group sustained less bending load and/or deflection prior to failure than nominal stringers.
- Suspect stringers reinforced with radius blocks demonstrated improved bending capacity, on par with that of the nominal stringers.
- Nominal stringers reinforced with radius blocks suffered no detrimental effects to bending capacity.

Figure 6. MSFC bending test results.
