STS-133/ET-137 Tanking Test Photogrammetry Assessment

Stanley T. Oliver¹

NASA Marshall Space Flight Center, Huntsville, AL

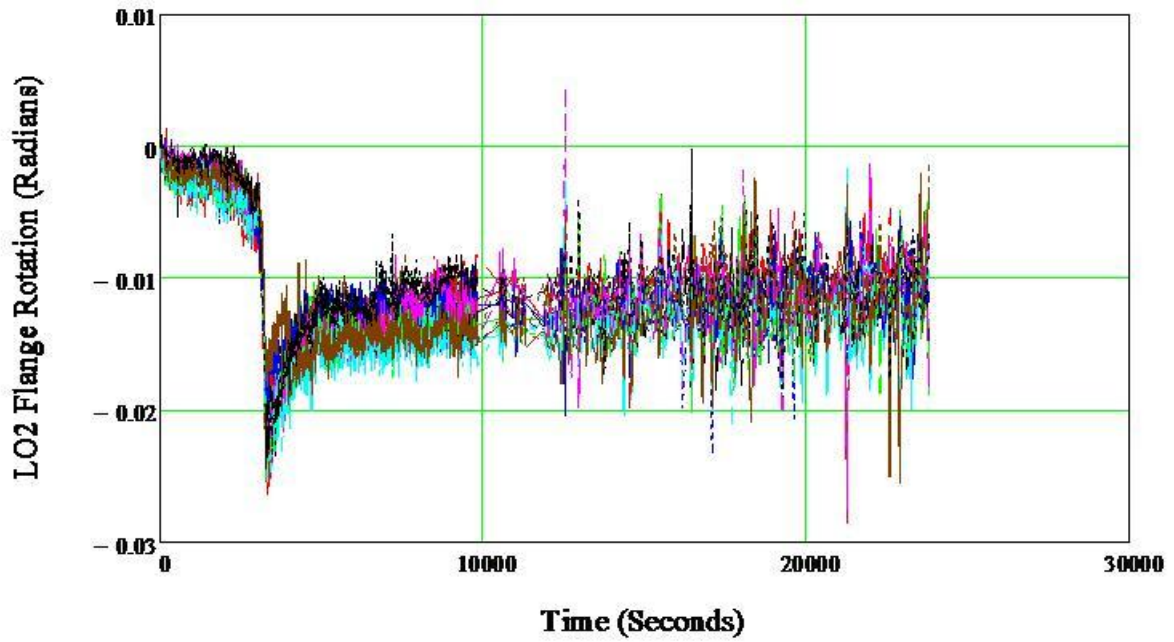
The computed values from the test data for the LO2 flange rotation are shown in Figure 10, showing the flange rotation as a function of time. As the LO2 filled the LO2 dome, the flange began to rotate due to the thermal gradients within the LO2 tank and IT. As the LO2 fluid level approached and passed the LO2 flange, a sharp increase in flange rotation was observed. As the thermal gradients continued to reach steady-state, the rotation angle relaxed to its steady-state position. In Figure 10, the flange rotations for fourteen of the sixteen lines are shown versus

Figure 10. Flange rotation result (14 of 16 lines).

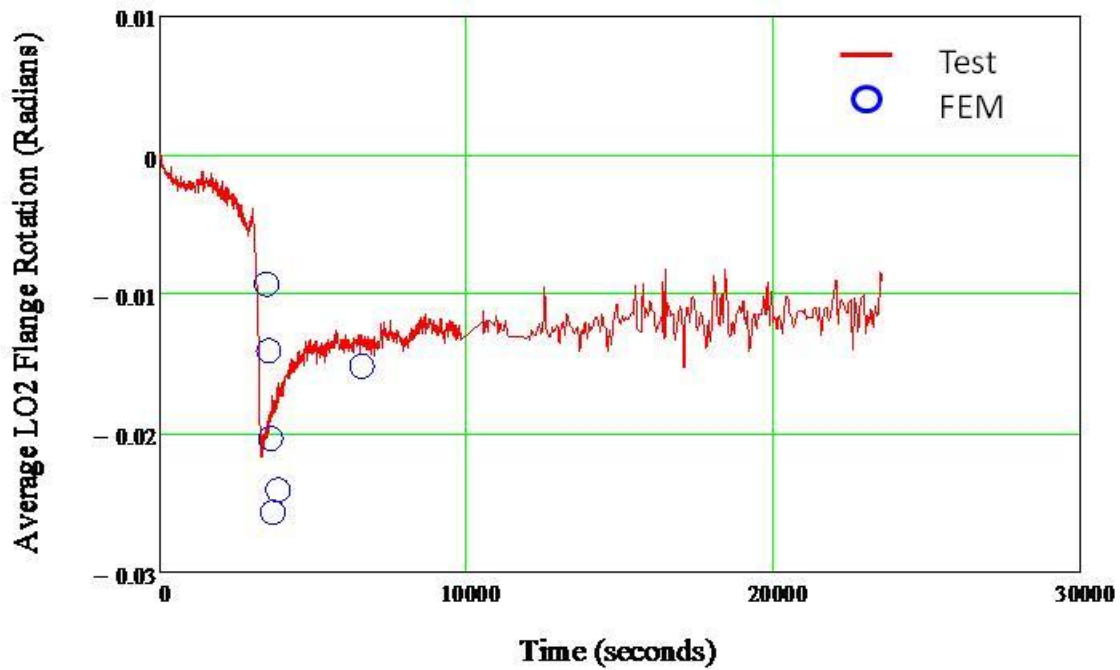
time. Two lines were omitted due to missing data in the area of interest. The average of the fourteen lines is shown in Figure 11. Also shown in Figure 11 are circular markers that represent finite element results using a single stringer finite element model, which utilized the temperature data from the tanking test.

Figure 11. Average of flange rotation compared to FEM results.

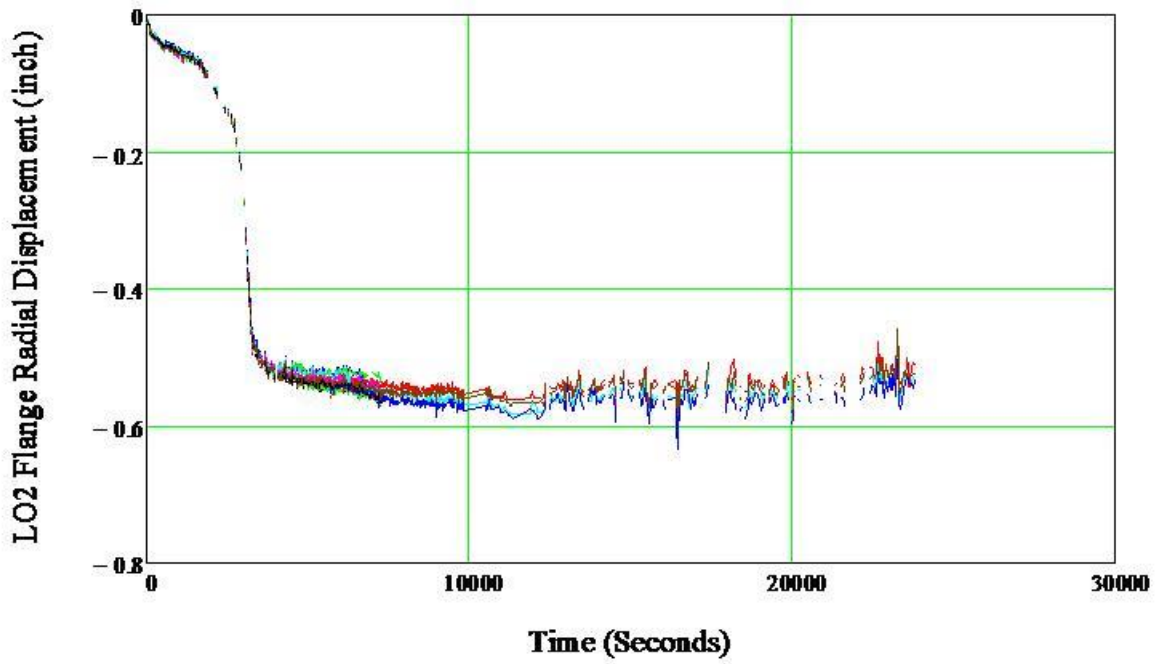
The radial displacement of the LO2 flange was also of interest. The LO2 displacement computation read the displacement data directly from the results file. However, this displacement includes the rigid body motion. All displacements were grounded to the radial motion of the IT internal frame. The resulting LO2 flange displacement as a function of time is shown in Figure 12. Similar to the LO2 flange rotation assessment, the radial displacement began small and then suddenly increased as the LO2 fluid level approached the LO2 flange. However, unlike the rotation, the displacements did not relax, but maintained their value through steady-state. The average displacement data is shown in Figure 13 which also contains circular markers representing the finite element displacement results.

Figure 12. Flange radial displacement result (14 of 16 lines).

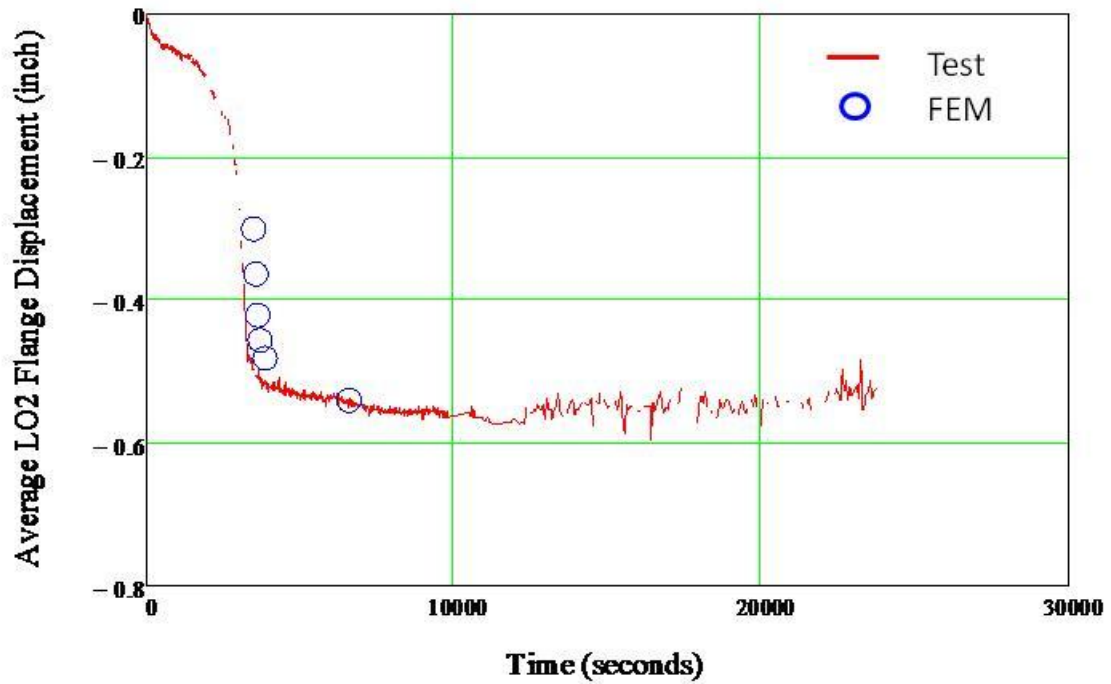
Figure 13. Average flange radial displacement compared to FEM results.

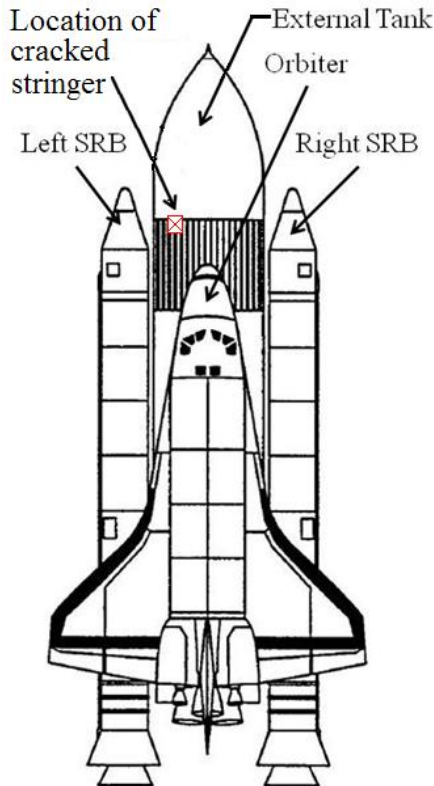
The Space Shuttle flight vehicle, an assembly of an Orbiter, two Solid Rocket Boosters (SRBs), and the ET, is shown in Fig. 1. A box with an 'X' in Fig.1 marks the approximate location of the cracked stringer on ET-137. The '137' is the production order number for the ET. An expanded view of the ET in Fig.2 shows the three primary structural components of the ET, the liquid hydrogen (LH2) tank, LO2 tank, and IT. Figure 3 shows a general view of the IT, with the forward (flight) direction identified as well as the identification a single thrust panel and hat-stiffened skin-stringer panel. Also shown in this general view of the IT are three of five circumferential ring frames inside the IT. Two diametrically opposed thrust panels receive and distribute the SRB loads. The thrust panels are single piece integrally machined panels. These two thrust panels plus six skin-stringer panels are mechanically joined to form the unpressurized IT. Figure 4 shows the basic construction of a typical skin-stringer panel. The hat-stringers span the full length of the IT except in locations where they would interfere with a large penetration. The forward and aft ends both have an L-shaped bolting flange to join to the LO2 and LH2 tanks respectively. Also shown are skin doublers, which are extra skin layers for increased strength. The cracked feet were at the forward end of the stringers, shown in the right-hand side of Fig. 4. The TPS was sprayed over the IT and LO2 tank, completely covering the stringers, skin, bolting flanges, and LO2 tank.

Figure 1. The Space Shuttle flight vehicle with the location of the cracked stringer identified.

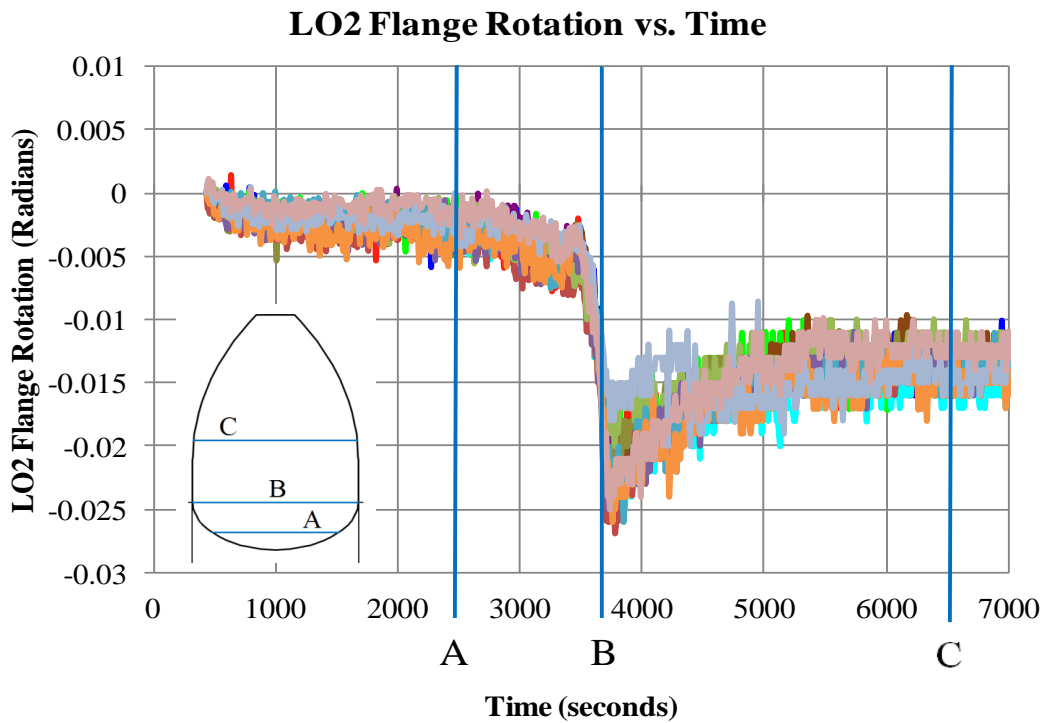
The computed LO2 flange rotation results are shown in Fig. 11, showing the flange rotation as a function of time for fourteen of the sixteen stringer/valley lines. Two lines were omitted due to missing data in the area of interest. As the LO2 filled the lower portion of the LO2 dome (fluid level A), the flange began to slowly rotate due to the thermal gradients within the LO2 tank and IT. As the LO2 fluid level approached and passed the LO2 flange (fluid level B), a sharp increase in flange rotation was observed. As the thermal gradients transitioned to steady-state the rotation angle relaxed to its steady-state position (fluid level C). The average of the fourteen lines is shown in Fig. 12. Also shown in Fig. 12 are diamond-shaped markers that represent finite element results using a single stringer finite element model⁵.

Figure 11. Flange rotation results (14 of 16 lines).

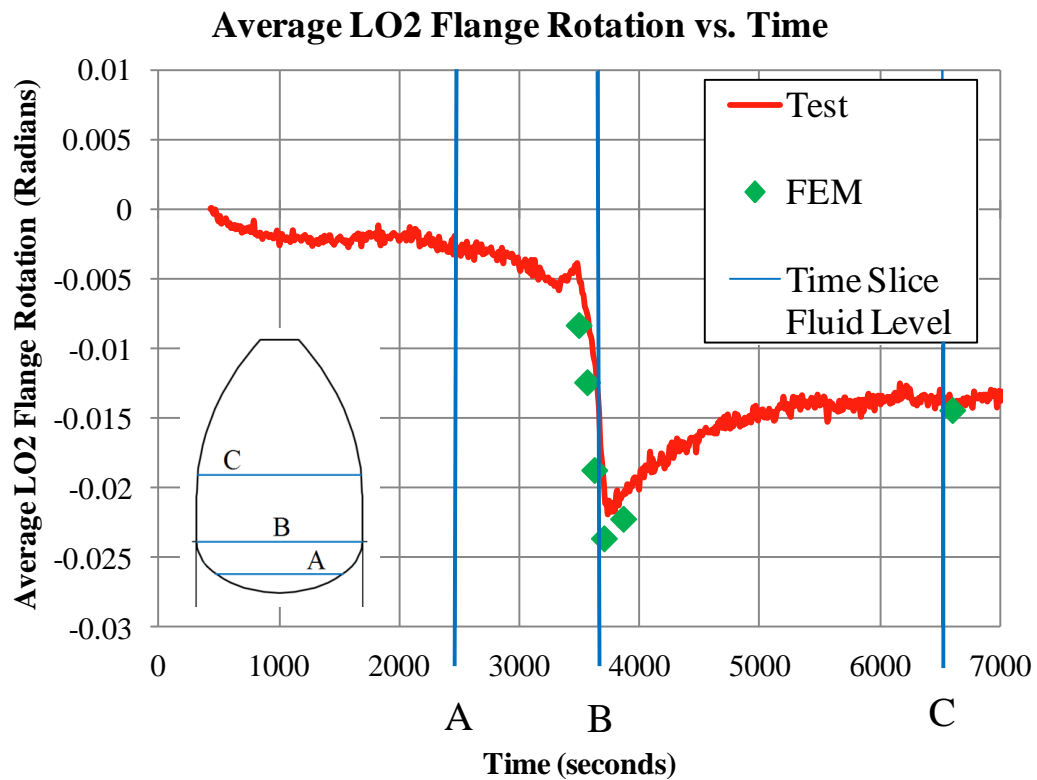
Figure 12. Average of flange rotation compared to FEM.

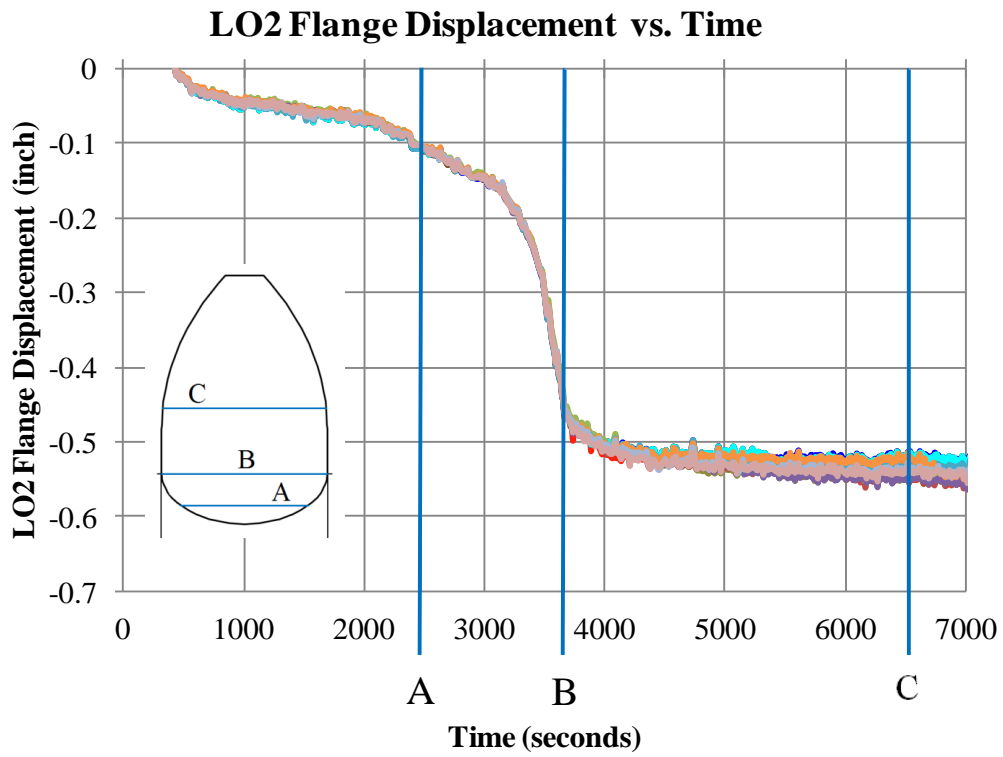
The radial displacement of the LO2 flange was also of interest. The resulting LO2 flange displacement as a function of time is shown in Fig. 13. Similar to the LO2 flange rotation assessment, the radial displacement began small and then suddenly increased as the LO2 fluid level approached the LO2 flange. However, unlike the rotation, the displacements did not relax, but maintained their value through steady-state. The average displacement data is shown in Fig. 14 which also contains diamond-shaped markers representing the finite element displacement results⁵.

Figure 13. Flange radial displacement result (14 of 16 lines).

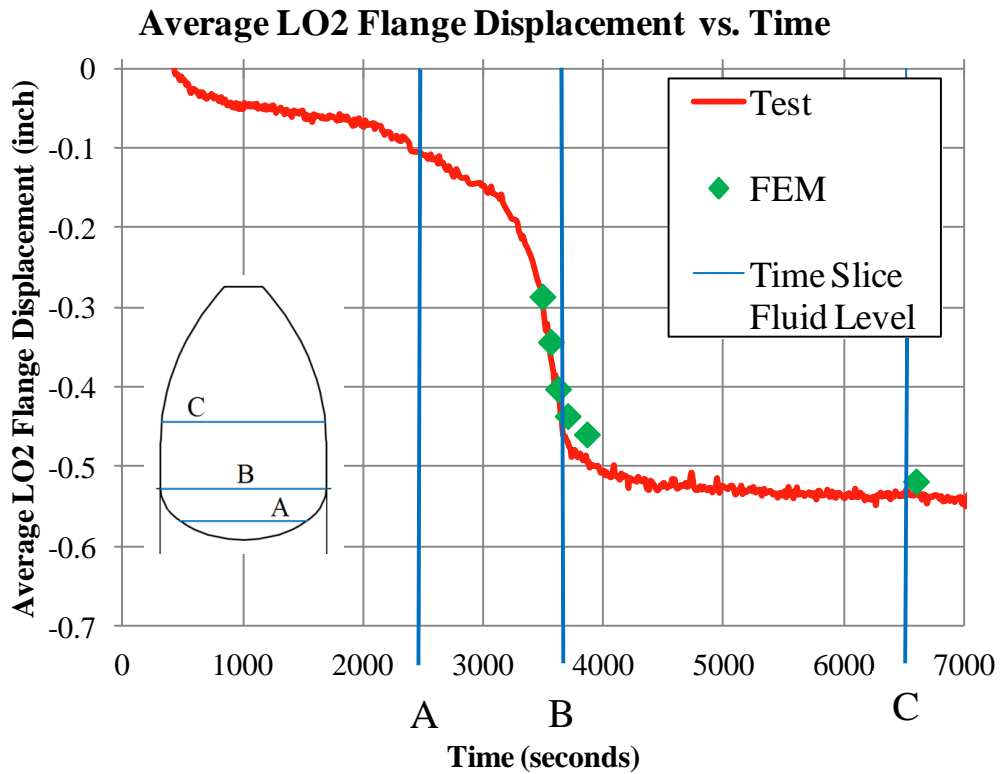
Figure 14. Average flange radial displacement compared to FEM results.
