# **STS-133 Space Shuttle External Tank Intertank Stringer Crack Investigation Stress Analysis**

*53<sup>rd</sup> AIAA/ASME/ASCE/AHS/ASC Structures, Structural Dynamics and Materials Conference  
April 23-26, 2012  
Honolulu, Hawaii*

# STS-133 Space Shuttle External Tank Intertank Stringer Crack Investigation Stress Analysis

**The structural failure of five hat-section stringers on the intertank of the Space Shuttle STS-133 External Tank prompted an investigation into the cause and the implementation of a repair. A detailed stress analysis of the failed hardware was performed by the Marshall Space Flight Center to help understand both the cause of the cracking and the effectiveness of the repair. The analysis showed how the stringers behaved as the External Tank is filled with cryogenic propellants. Assembly conditions that were considered potential contributors to the cause of the failure, due to induced assembly stress, were evaluated. The repair that was installed and flown was analyzed and shown to be effective in reducing the stress level in the stringer which contributed to the confidence in its performance. Results from the analysis were shown to be comparable with tankin

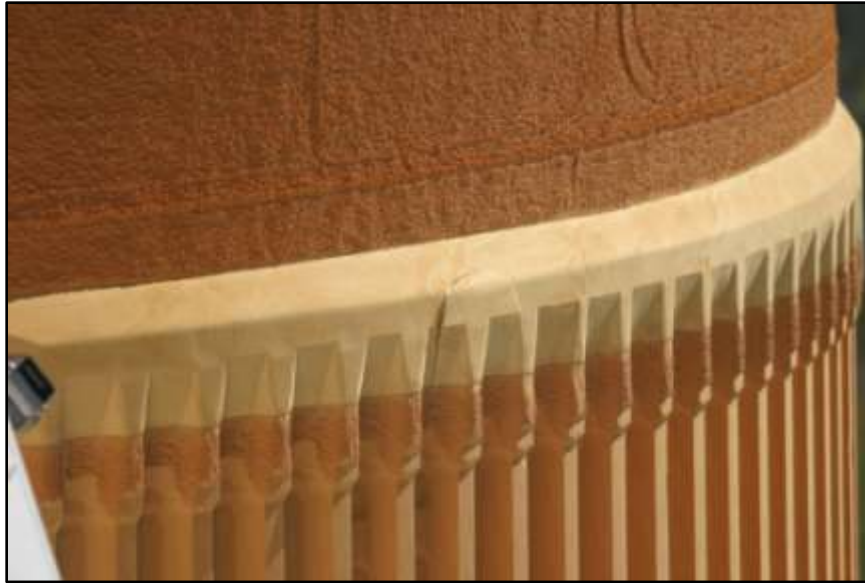
Figure 2 – LOX Tank to Forward End of Intertank Region Showing Crack in Foam Insulation

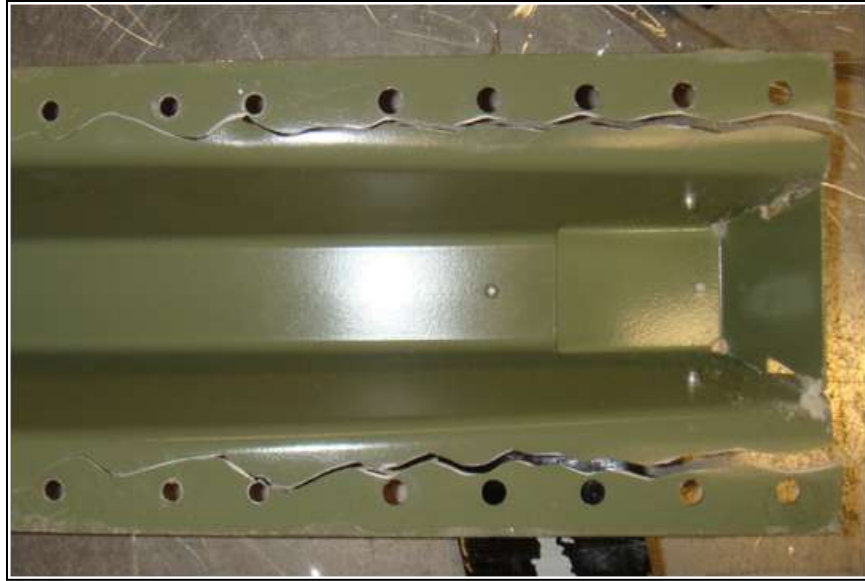
Figure 4 – Forward End of STS-133 Intertank Stringer Showing Cracks in Feet

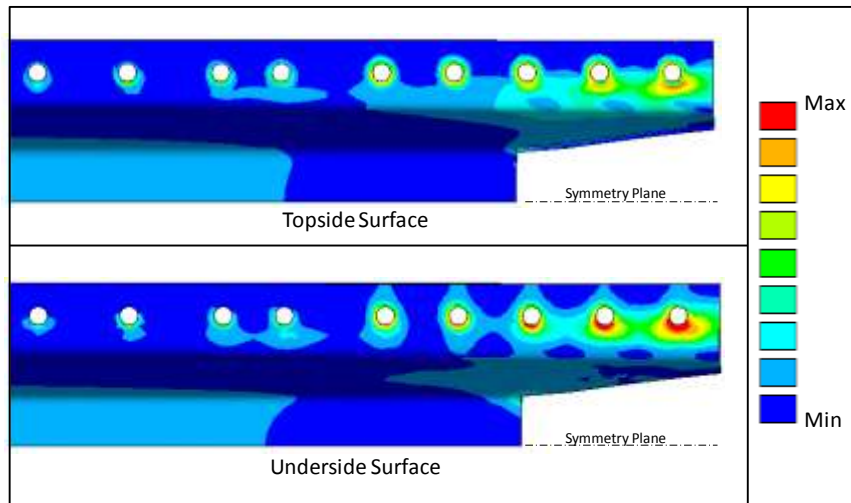
of the cracks observed on the STS-133 tank (figure 6). The amount and distribution of this localized bending around the fastener locations is found to be very dependent upon the amount of circumferential rotational restraint encountered by the intertank forward flange.

Figure 6 –High Stress Region around Forward Stringer Fastener Locations for Peak Tanking Transient Loading Condition

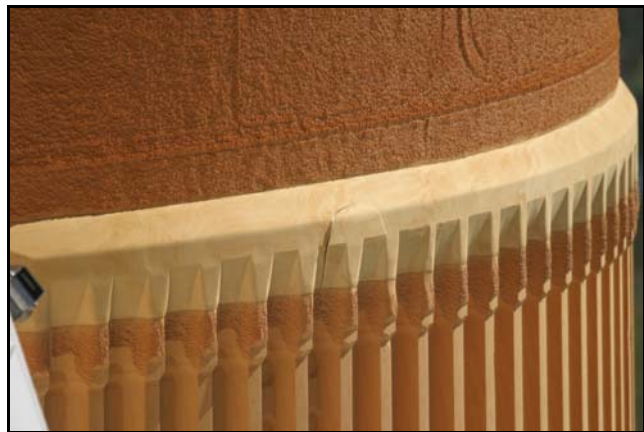
**Figure 1. LOX tank to forward end of intertank region showing crack in foam insulation.**

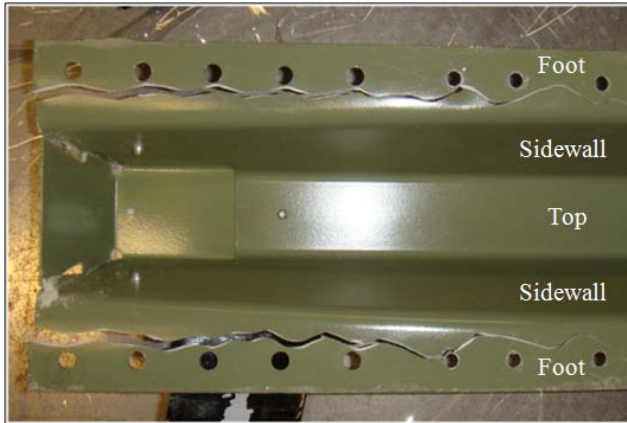
**Figure 2. Forward end of STS-133 intertank stringer showing cracks in feet.**

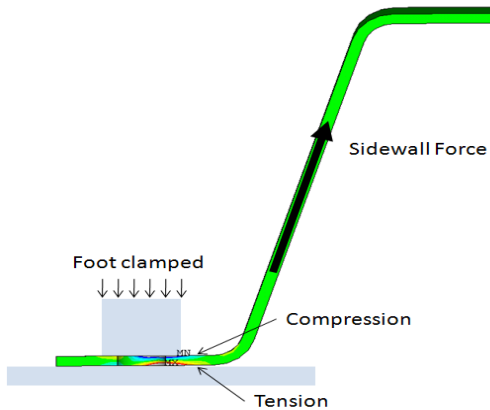
The pull force exerted through the forward fasteners causes significant bending to develop in the sheet metal of the stringer feet as illustrated in Figure 8.

**Figure 8.** Development of bending stress in stringer foot at fasteners.

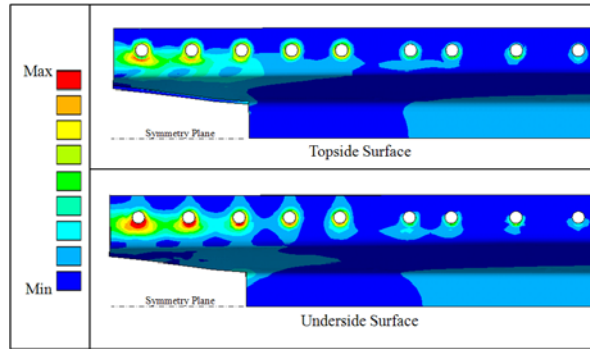
Figure 9 shows the high stress regions around the forward fastener holes. Since the analysis material properties are elastic, the stress magnitude is above the actual yield stress of the material. In reality, yielding of the material would be expected to occur locally around the fastener heads.

**Figure 9.** High stress region around forward stringer fastener locations for peak tanking transient loading condition.

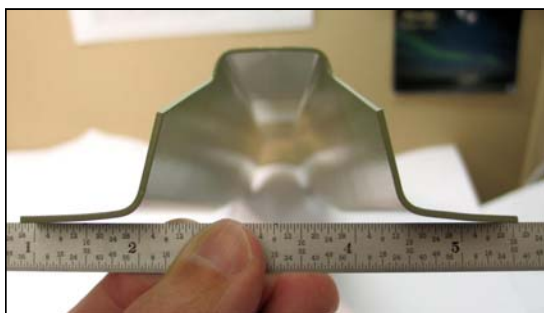
Another assembly condition that was examined was what was referred to as a “toe forward” condition. This condition is characterized by the outboard edge of the forward ends of the stringer feet being out-of-plane and more radially inward than other regions of the bottom of the feet (Figure 15). This condition was considered one of the more severe conditions relative to the stringer crack issue, since installation of the stringer to the intertank would force the feet at the ends of the stringer to bend in a manner that would introduce local bending in the feet in the same location and direction as experienced during chill-down.

Figure 15. Stringer "toe forward" condition.

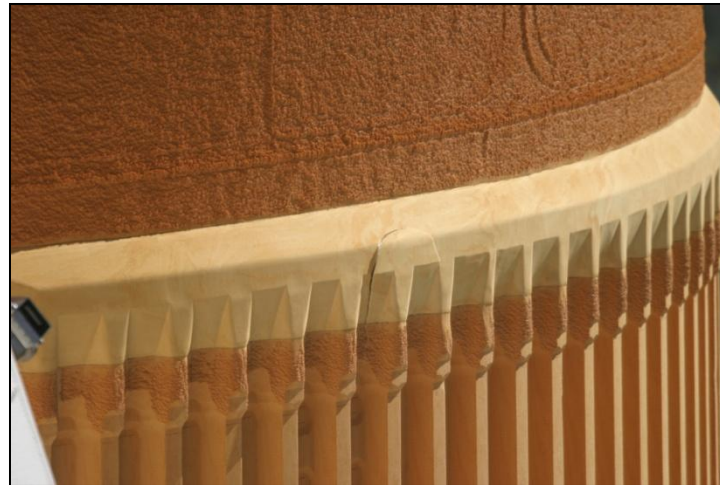
Intertank to LOX Tank Joint Region

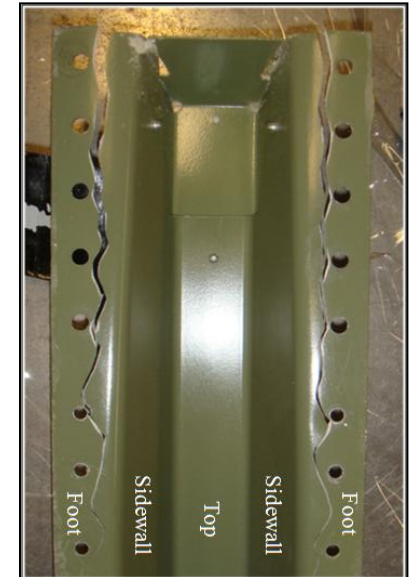
Cracked Stringer Forward End
