**Title: Assessment of Damage Containment Features of a Full-Scale PRSEUS  
Fuselage Panel through Test and Teardown**

## ABSTRACT

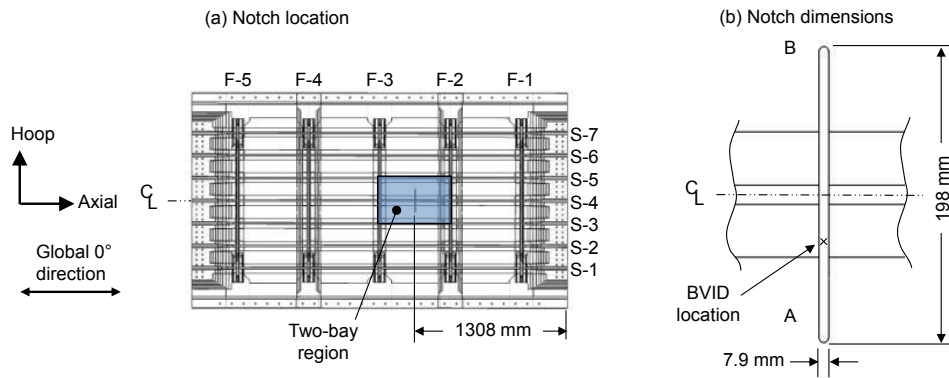
Figure 2. The two-bay notch.

In Phase III, notch tip damage growth was monitored throughout loading up to the panel's catastrophic fracture. The 200 mm, two-bay notch, was cut through the BVID to minimize any effect of the BVID on Phase III testing, as shown in Figure 2. Loading was applied in a series of loading steps (LS), in increasing severity, from pressure only to axial only, as the most likely sequence to achieve all loadings determined from the pretest analysis [24]. The five LS are as follows:

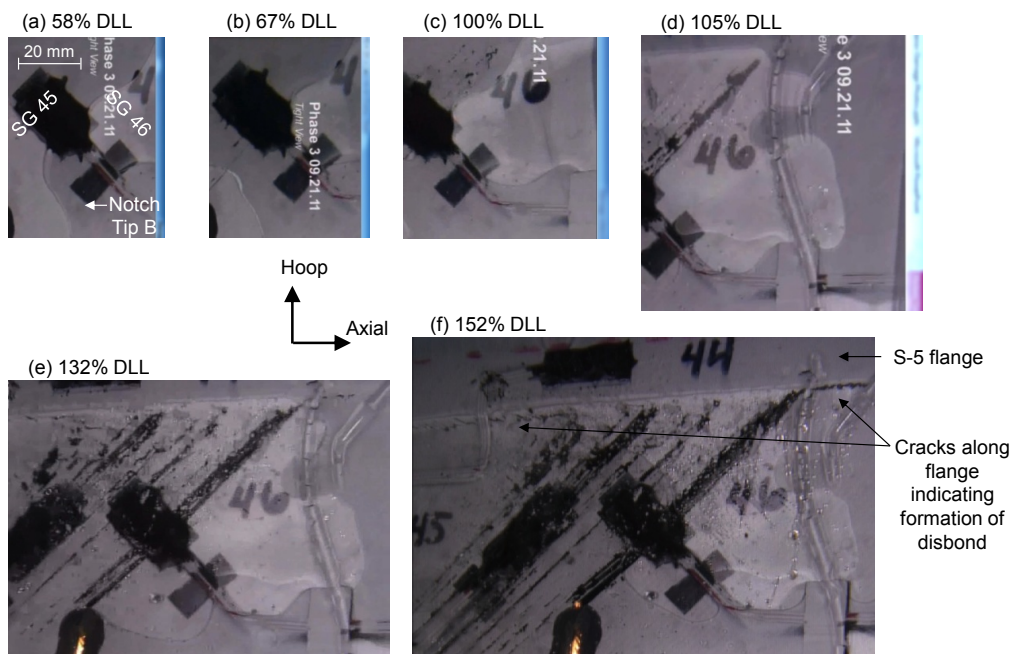
Figure 6. Photographs of notch tip A interior surface damage showing crack progression.

Photographs of the crack progression on the interior are shown in Figure 6. Visible damage formation was first observed at 58% DLL (point A in Figure 5) in the form of a matrix crack on the interior surface, propagating antisymmetrically from the two notch tips, as shown in Figure 6(a). Subsequent damage accumulation ahead of both notch tips was intermittent in the form of several 45° matrix cracks, which propagated to the adjacent stringer flange edges as axial load was increased, as shown in Figure 6(b) to (e).

At the load level of 140% DLL, point E in Figure 5, extensive skin/stringer disbonding progressed through the entire width of the bay, evidenced by visible cracks along the skin/stringer interface, as partially shown in Figure 6(f). The skin/stringer disbonds were arrested by the stitching in the frame flanges as load was increased, and remained completely contained between the frames F-2 and F-3 by the stitching up to fracture. A large number of matrix cracks were observed along the 45° inner surface ply, emanating from the notch tips and stringer flanges. Visible damage on the interior surface was widespread as compared with the single crack progression seen on the exterior surface, described in the following section.

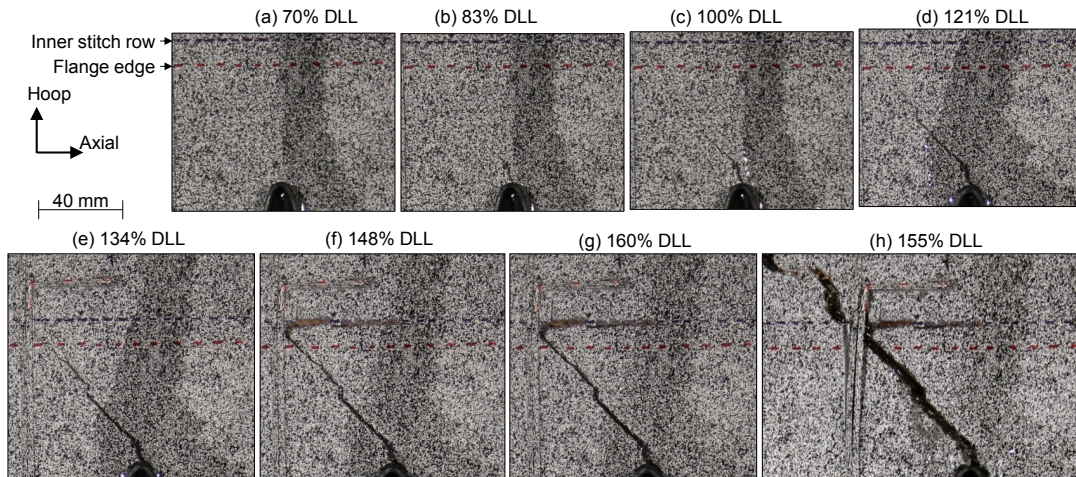
Figure 7. Photographs of notch tip B exterior surface damage showing crack progression.

Damage was observed visually on the exterior surface of the panel in a form of a crack along the 45° fibers of the outer ply, at 70% DLL (point B in Figure 5), as shown in Figure 7(a). Throughout the remainder of LS-2, damage progressed along the 45° direction, parallel to the outer ply fibers, in the form of a single matrix crack, as shown in Figure 7(a) to (c). Figure 7(c) shows the extent of damage at the end of LS-2, where the visible crack had extended 33 mm from the notch tip.

As the axial load was increased above 100% DLL up to 147% DLL, notch tip crack progression was slow, stable, intermittent, and along the 45° direction and was then arrested by the inner row of stitches, as shown in Figure 7(d) and (e). When the load was further increased to 148% DLL, the crack at notch tip progressed instantaneously from the edge of the stringer flange to the inner stitch row (point F in Figure 5), before being arrested the second time, as shown in Figure 7(f), apparently due to load redistribution.

Additional axial load was required to progress the crack beyond the stringer. When the load reached 160% DLL, the damage progressed instantaneously beyond the two-bay region (point G in Figure 5) and out of the field of view of the exterior camera, as shown in Figure 7(g) and (h). The energy stored in the panel was released by the sudden formation of extensive damage, including the extension of the crack beyond stringer S-2, which caused a 5% axial load drop (from 160% DLL in Figure 7(g) to 155% DLL shortly afterward in Figure 7(h)). High speed video footage showed that damage progressed beyond the stringer nearly instantaneously (less than 0.2 ms). Similar crack progression was observed along the other notch-tip in terms of the extent, rate, and the intermittent nature of crack progression. A nearly identical crack initiation and progression pattern was observed along the other notch-tip.

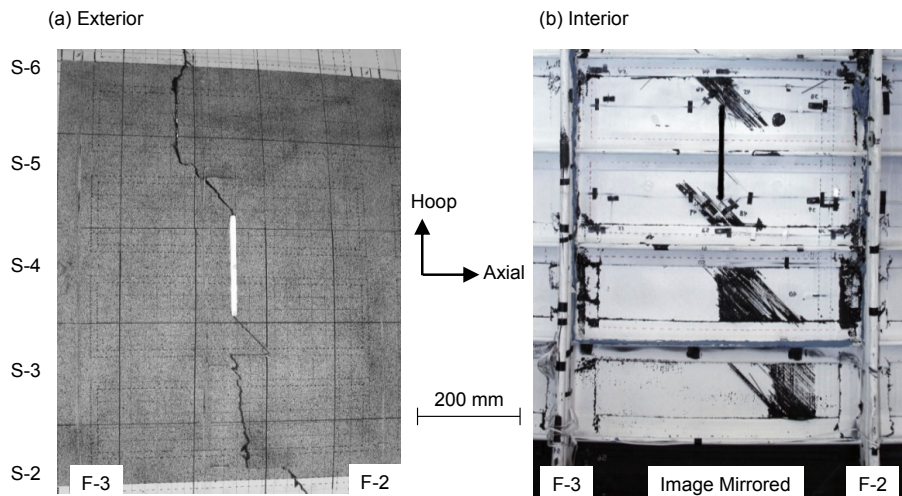
Figure 10. Post failure photographs of the panel.

Visible damage was found to be significantly more widespread on the interior than the exterior faces. Figure 10 shows a side-by-side comparison of exterior and interior surface photographs.

The exterior crack was contained between frames F-2 and F-3 whereas the interior damage extended throughout the interior of the panel. The outer surface crack path turned at several stitching rows. The interior surface damage includes numerous matrix cracks, all oriented along the 45° direction, apparently emanating from the progressing through-the-thickness crack and stringer flanges, in an anti-symmetric manner.

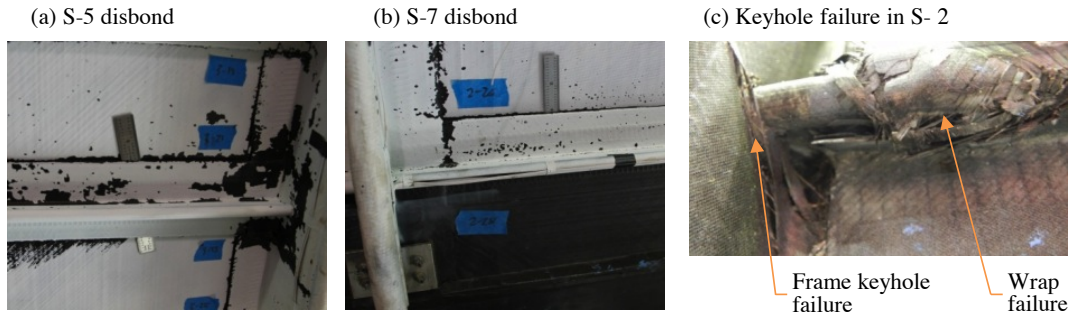
Figure 11. Post fracture photographs of several stringers and frames.

No evidence of failed stitches was detected during loading by the interior or exterior cameras; however numerous stitches appear to have failed during the dynamic events of the catastrophic fracture. Posttest, complete disbonding between the stringers and the skin was observed in all stringers except S-4. Typical disbonds are shown in Figure 11(a) and Figure 11(b). The disbonding was accompanied by additional matrix cracking along the 45° direction as portions of the interior skin were delaminated, as shown in Figure 11(a). Such disbonding also occurred between the frame and the skin, as seen in the intersection between stringer S-7 and frame F-2 in Figure 11(b).

Additionally, no evidence of damage to the frame-stringer intersection or the stringer itself was observed prior to catastrophic fracture. However, severe damage, such as shown in Figure 11(c), was evident in the posttest evaluation. It should be noted that the cameras recorded panel motion at failure, when a large and sudden release of energy was manifested in a dynamic damage event. The failures shown in Figure 11 could have occurred at maximum load or during the subsequent dynamic event.

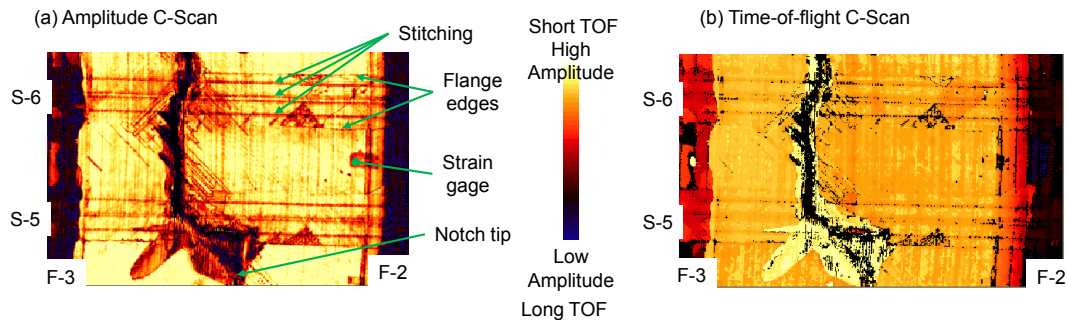
The pulse-echo ultrasonic inspection encompassed an area that measured 610 mm x 406 mm, which included frames F-2 to F-3 in the axial direction and from notch tip B to stringer S-6 in the hoop direction. Amplitude and time-of-flight results clearly indicate a large delaminated region in the skin ahead of the notch tip, as shown in Figure 12. The reduction in amplitude and increase in time-of-flight in the frame areas indicate the frames are still partially attached to the skin, Figure 12(a) and Figure 12(b), whereas the stringers are completely disbanded. The time-of-flight near F-2 is longer than near F-3 because the structure was thicker near F-3 due to a skin splice joint. The time-of-flight C-Scan, shown in Figure 12(b), indicates that the nearest delamination to the outer surface, which surrounds the crack path, occurred at approximately the same location through-the-thickness throughout the inspected region. Due to limitations of this inspection, conclusions regarding the number of delaminations through-the-thickness could not be drawn. Some of the 45° matrix cracking around the crack path is visible in both the amplitude and time-of-flight results.

Flash thermography inspection showed very similar results as seen from the pulse-echo ultrasonic C-Scan. However, the 45° cracks on the interior surface were less clearly shown in the flash thermography results.

Figure 12. Pulse-echo C-Scans of the notch tip B region showing significant delamination at the notch tip and partial frame/stringer disbonding.

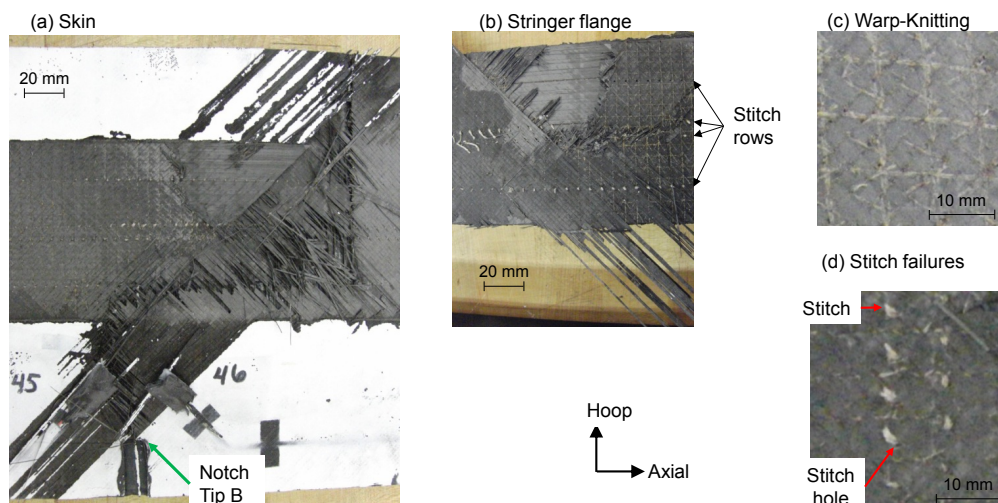
Visual inspections of teardown of stringer S-5 confirmed that it was not attached to the skin. Figure 13(a) and Figure 13(b) show the skin and stringer segments and the disbond surfaces. In the photo shown in Figure 13(b), the stringer was lifted off the skin and rotated 180° about the hoop axis. The disbond surface revealed the mostly intact warp-knitting and broken stitches, as shown in Figure 13(c) and Figure 13(d).

Figure 13. Visual inspection of tear down segments of the S-5 skin stringer disbond

The failed stitches appeared similar on both the skin and stringer disbond surfaces with small segments of the stitch protruding approximately 0.5 mm from each surface, indicating that the stitches mostly failed at the skin/stringer interface and that the stitches stretched. In some instances, particularly along the translaminar damage path, a much longer segment of the stitch (up to several millimeters) was observed protruding from the laminate, indicating the stitch failure occurred somewhere other than the skin/stringer interface. In two regions delamination of the skin and stringer flange occurred such that the failure between the skin and stringer did not occur uniformly at the skin/stringer interface. In these areas, the warp-knitting failed, in addition to the stitches.

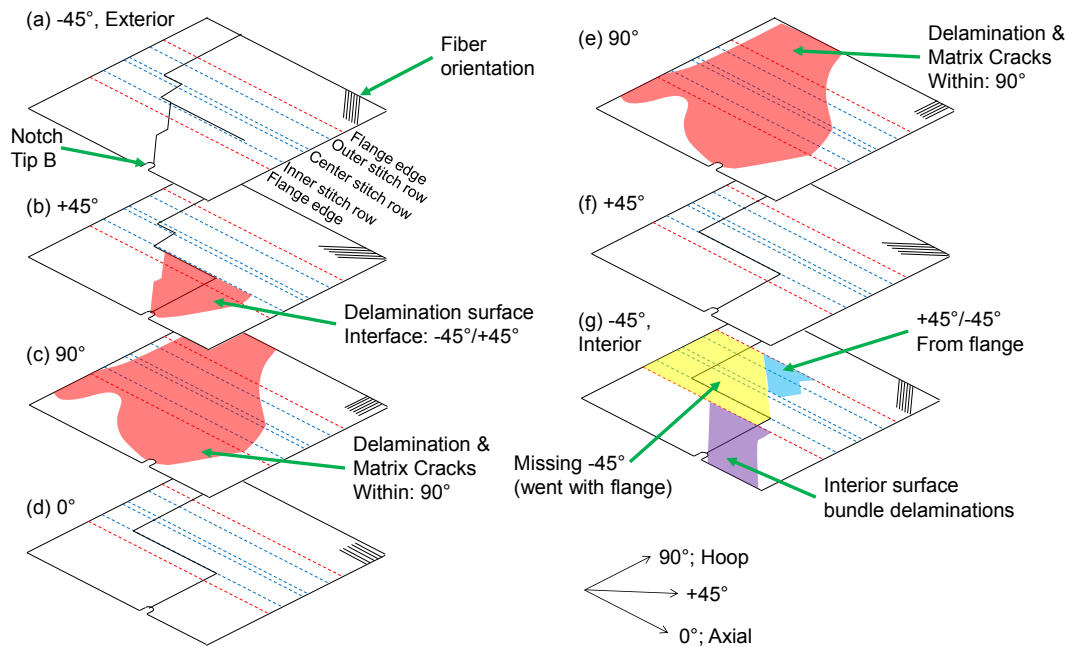
Teardown of the skin showed delaminations, extensive matrix cracking in nearly all plies, and a well-defined crack path in all but the 90° plies. A schematic representation of the major crack path and delaminations are shown in Figure 14 for each ply through-the-thickness from the exterior ply shown in Figure 14(a) to the interior ply shown in Figure 14 (g). The exterior ply (-45°) shows the damage that was visible on the exterior surface, as shown in Figure 14(a). A crack extends in the -45° direction, parallel to the ply fiber direction, from the notch tip to the inner stitch row. The crack branched at this point, and the secondary crack progressed along the stitch row approximately 80 mm before terminating. The main crack progressed along the stitch row in the opposite direction briefly, and then continued in the hoop direction. The next ply (+45°) shows a slightly different crack path, as shown in Figure 14(b). The crack progressed in the hoop direction to the inner stitch row, and then continued along the same path as seen on the exterior ply.

Figure 14. Schematic of significant failure extent, ply-by-ply.

A delamination was seen between the +45° and -45° ply, bounded by the inner stitch row and the 45° crack in the outer ply, as shown highlighted in red in Figure 14(b). The third ply (90°, double thickness) showed extensive delamination within the ply, as shown by the large region highlighted in red in Figure 14(c). In the select areas which were destructively examined, this delamination matched the delamination size and shaped detected by the ultrasonic inspection. The fourth ply (0°, center ply in layup) showed a crack in a similar location as the second ply with slightly different path between the inner stitch row and the outer stitch row, as shown in Figure 14(d). The fifth ply (90°) showed very similar damage as the third ply, which had the same orientation. The sixth ply (+45°) showed the same crack path seen in the central ply (0°) and no delaminations. The last ply, (-45°, interior surface) showed the same crack path as the central and sixth plies. In the region highlighted in blue in Figure 14(g), delamination in the stringer flange left the +45° and -45° plies from the flange on the skin. The yellow highlight region shows where the -45° ply from the skin delaminated and stayed with the stringer flange. Extensive delaminated bundles occurred between the notch and the flange, as shown highlighted in blue. This ply-by-ply damage map will be used for comparisons with damage predicted by future progressive failure analysis.

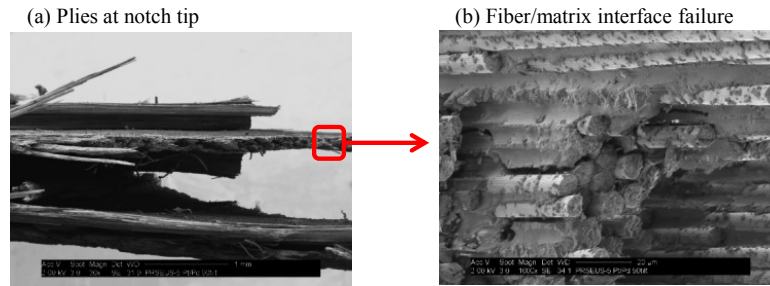
Fracture surface morphology in the notch tip region and in the stringer/skin interface is described in this section. The fracture surface across the skin thickness (segment SEM-A in Figure 4), along the crack emanating from the notch tip, shows typical failure modes in graphite/epoxy laminates, including matrix cracking, delamination, and fiber breakage, as shown in Figure 15(a). Most of the adjacent plies at the notch tip have delaminated. A representative close-up view indicates that most fibers fractured perpendicular to their axis with no fiber pullout, Figure 15(b). Fiber surfaces in the 0° and 45°-plies were clean of matrix residue, with scattered matrix debris remaining on the fiber surface, as shown in Figure 15(b), indicating a complete fiber/matrix interface disbonding and relatively weak fiber/matrix interface.

Figure 15. Fracture surface morphology across the skin thickness and along a crack emanating from the notch tip, segment SEM-A (see Figure 4).

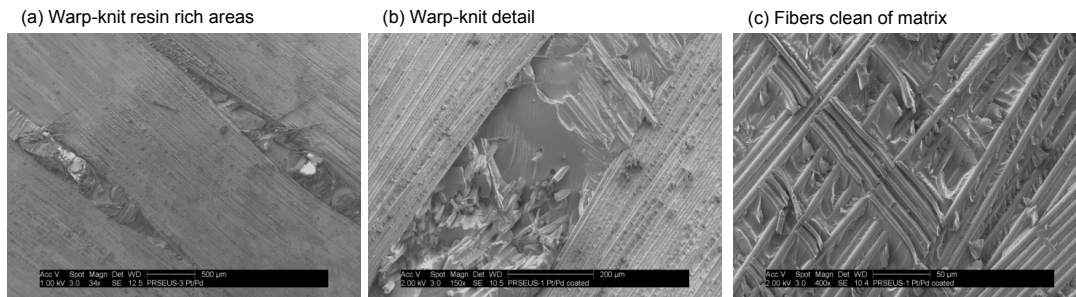
The ultrasonic inspections revealed a relatively wide delaminated area ahead of the notch tip (see Figure 12). Examination of this delamination surface (segment SEM-B in Figure 4) revealed resin-rich areas around the warp knitting, as shown in Figure 16(a). The warp knitting process disturbs the path of the fibers causing the fibers to bend around the knitting, resulting in resin rich pockets and non-uniform fiber distribution and orientation. The width of the resin rich area is the width of the warp-knit thread, which is approximately 400  $\mu\text{m}$ . The length was observed to be 6 to 8 mm. Figure 16(b) shows a detail view of a representative warp-knit failure region showing interface failure between the matrix and knitting fibers as well as knitting fiber pull-out and cleavage type fracture surfaces, characteristic of brittle fracture, in the resin-rich pocket surrounding the knitting. Previous studies [28] indicated warp-knitting may reduce the in-plane properties. Results from this investigation show that warp-knitting did affect the failure mechanism, and therefore may be important to the failure process. Close examination of the delaminated fracture surface also reveals that the fiber surface is clean of matrix indicating weak fiber/matrix bonding and matrix serrations characteristic of shear failure, as shown in Figure 16(c).

Figure 16. Fracture surface of a delaminated region ahead of the notch tip, segment SEM-B (see Figure 4).

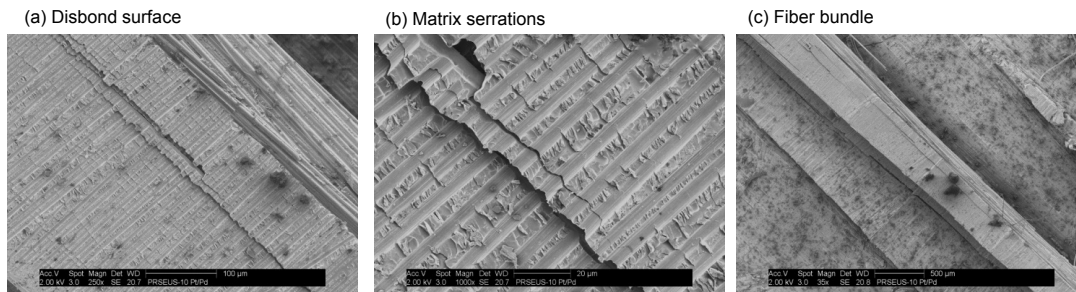
The skin stringer disbond area (segment SEM-C in Figure 4) exhibited regularly spaced matrix serrations, apparently as a result of shear failure, as shown in Figure 17(a) and Figure 17(b). Fiber imprints on the disbond surface indicate failure at the fiber/matrix interface. The surface was generally covered with matrix debris and some areas showed fiber bundles, Figure 17(c). A typical broken stitch, from the inner stitch row of stringer S-5 closest to the notch tip on specimen SEM-C, is shown in Figure 18(a). As seen, the stitch failed in tension, as a result of the skin/stringer disbonding, with its end spreading-out in a broom-like failure. The stringer flange and the skin apparently came in contact during the dynamic fracture process, pressing and crushing the end of the stitch. No indication of stitch/matrix interfacial disbonding was observed.

Figure 17. Fracture surface morphology of the resin-rich disbond region ahead of the notch tip, segment SEM-C (see Figure 4).

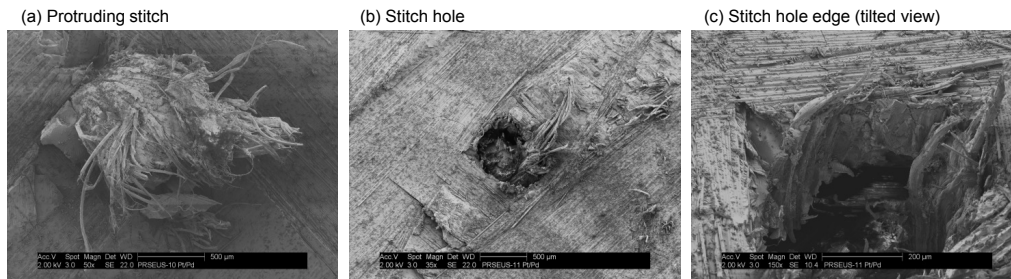
Figure 18. Characteristic failures of stitches located in the first stitched row of S-5, immediately ahead of the notch tip, segment SEM-C (see Figure 4).

However, because stitch stretching was noted, it is likely there was some degree of stitch/matrix interfacial disbonding; further investigation is required to examine this interface. As mentioned previously, in some areas, the stitches failed inside the laminate, resulting in a hole on the flange surface. One example is shown in Figure 18(b) with a tilted detail view of holes surface shown in Figure 18(c). Imprints and portions of the stitch thread remained on the resin-rich surface.
