NASA  
Engineering Directorate  
Materials Science Division  
Kennedy Space Center, Florida

KSC-MSL-2009-0297

SUBJECT: Failure Analysis of Main Flame Deflector Nelson Studs

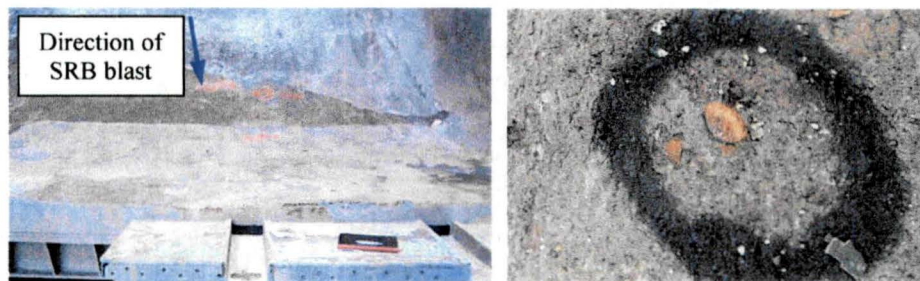
NASA Structures engineers submitted two Nelson refractory studs from the flame deflector at LC-39 A for analysis when they were observed to be missing a significant amount of material after launch (Figure 1). An additional, unused, stud was submitted for comparison. The installation date of the stud was unknown, but was thought to be for several years due to the absence of repair history of the flame deflector in this area.

Figure 1. Customer supplied images of the location of damaged Nelson studs (orange paint) in the main flame deflector.

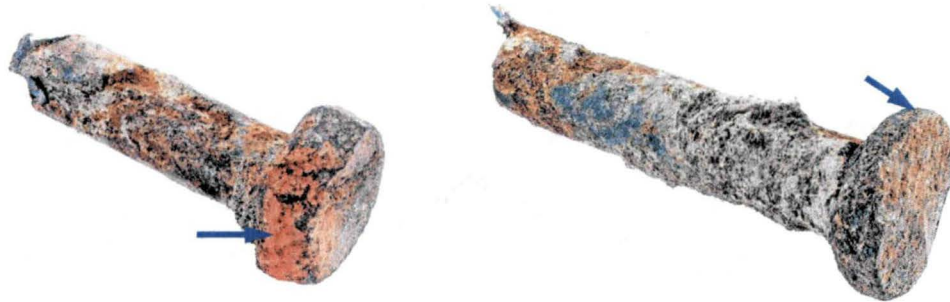
- 3.1. The damaged and the unused flame deflector Nelson studs were photographed, as received (Figures 2 and 3). Both orange-red and black corrosion product were observed on the damaged studs, along with remnants of refractory material from the flame deflector and orange paint used to mark the studs. The studs were preferentially damaged on the side of the stud that was facing the solid rocket motor blast when they were installed (Figure 2, arrows).

Figure 2. Flame deflector studs, as received. The arrows indicate the side of the stud that sustained the most damage, which correlated with the direction of solid rocket motor blast. Scale is two inches.

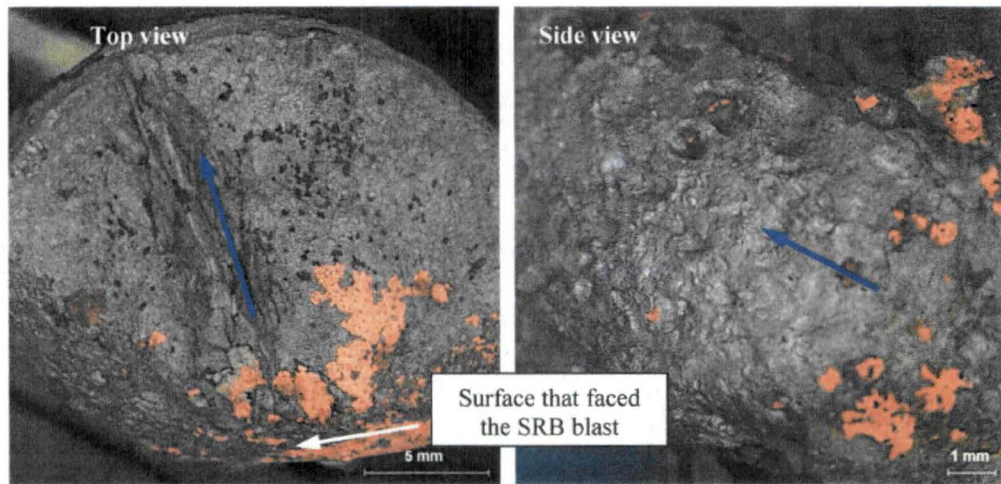
- 3.2. One of the studs was cleaned in an ultrasonic cleaner using Branson Oxide Remover (OR) to remove the corrosion product. Stereomicroscope observation of the cleaned stud revealed directional indications of erosion on the stud head that correlated with the blast direction (Figure 4, arrow).

Figure 4. Stereomicroscope images of the top of the stud head (left) and the side (right) showing directional markings on the stud that correlated with the blast direction (arrows). Original magnifications: 6.3X (left), 12.5X (right)

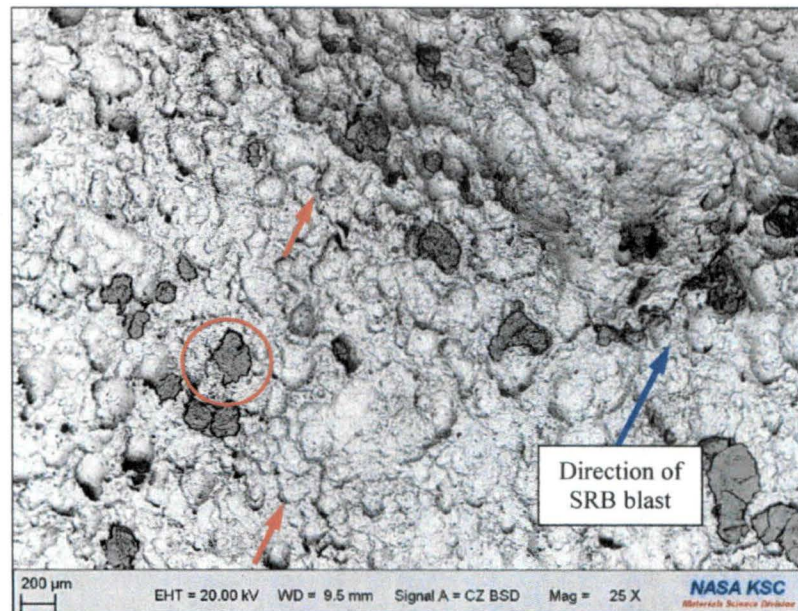
- 3.3. SEM observation of the cleaned stud surface revealed a directional “horse-shoe” appearance to the eroded surface, which is typical for surfaces undergoing a combination of an erosive and corrosive process (Figure 5). Corrosion product (Figure 5, circled) remained adherent to the cleaned fracture surface.

Figure 5. SEM image of the damaged surface showing a “horse-shoe” appearance to the eroded surface (red arrows). The circle indicates corrosion product that remained adherent to the fracture surface after cleaning. Original magnification: 25X

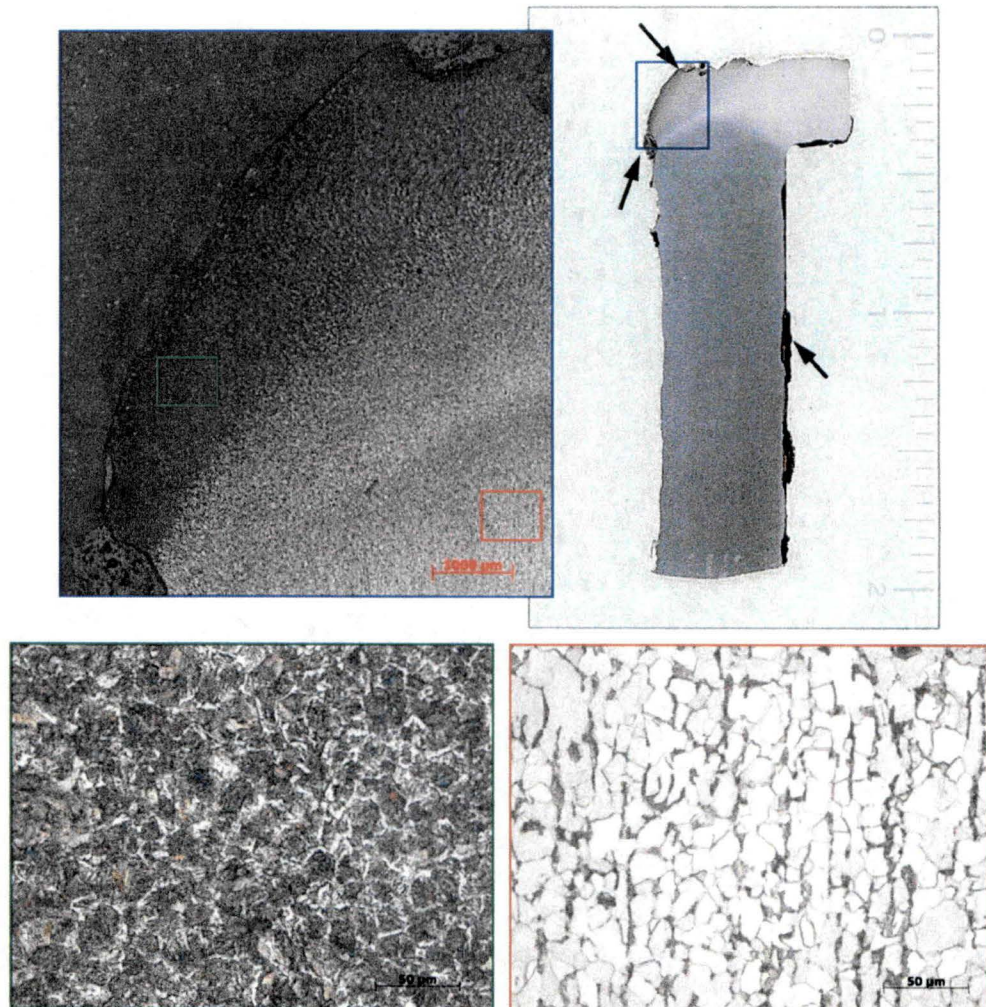
- 3.5. The damaged stud was cross-sectioned, mounted, and prepared for metallographic examination. Some of the oxide layer that was not removed during cleaning remained on the surface of the stud (Figure 7, arrows). The half

of the head that was not damaged still had a typical forged macro- and microstructure. The damaged side of the stud head consisted of pearlite with ferrite at the grain boundaries (Figure 7, bottom left). The base of the stud consisted of ferrite grains with minor amounts of pearlite (Figure 7, bottom right). The changed microstructure in the damaged area of the head is an indication of heating in the stud. No dendrites were observed, which would be an indication of melting and resolidification of the stud material.

Figure 7. Micrographs of the used stud cross section, showing the macrostructure (top row) and the microstructure (bottom row). The microstructure in the damaged portion of the stud head (bottom left) consisted of pearlite (dark) with ferrite (light) at the grain boundaries. The microstructure of the body of the stud (bottom right) consisted of ferrite grains (light) with minor amounts of pearlite (dark). Original magnifications: 1.5X (top right), 10X (top left), 300X (bottom row)

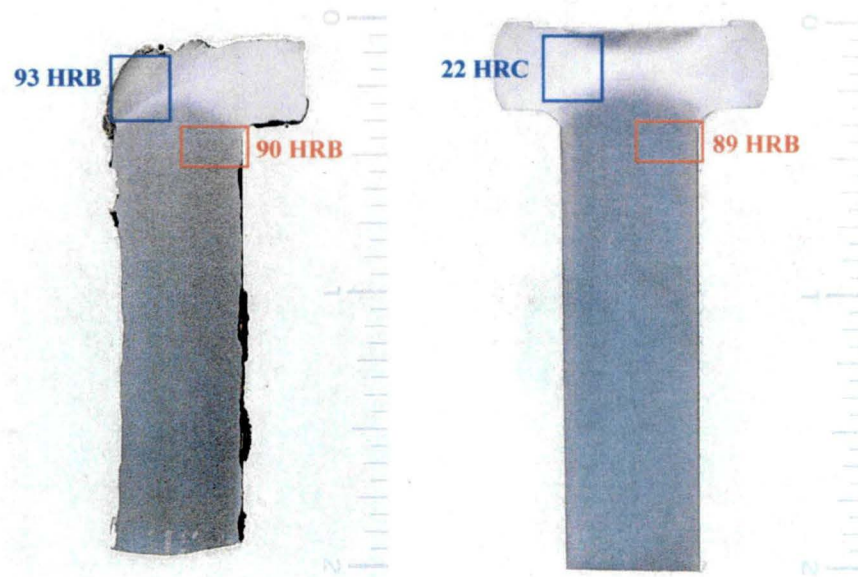
Figure 8. Images showing the locations of the microhardness measurements.

- 3.7. Microhardness measurements using a Vickers indenter and a 500 g load were taken on cross-sections of the damaged and unused studs (Figure 8). The microhardness of the shaft of the used stud averaged 185 Vickers scale (HV), which converts to a hardness of 90 Rockwell B scale (HRB), per ASTM E 140, *Standard Hardness Conversion Tables for Metals*. The microhardness of the shaft of the unused stud averaged 180 HV, which converts to a hardness of 89 HRB. These hardness values are typical for rolled plain carbon steel. The microhardness of the damaged area averaged 200 HV, which converts to 93 HRB. The microhardness of the undamaged stud in the head location averaged 250 HV, which converts to 22 Rockwell C scale (HRC). The reduced hardness of the used stud in the damaged area is due to the relieved cold work, indicative of heating in this area.
