# Unbonded Thermal Blankets in Orbiter Aft Compartment

KSC Independent Assessment

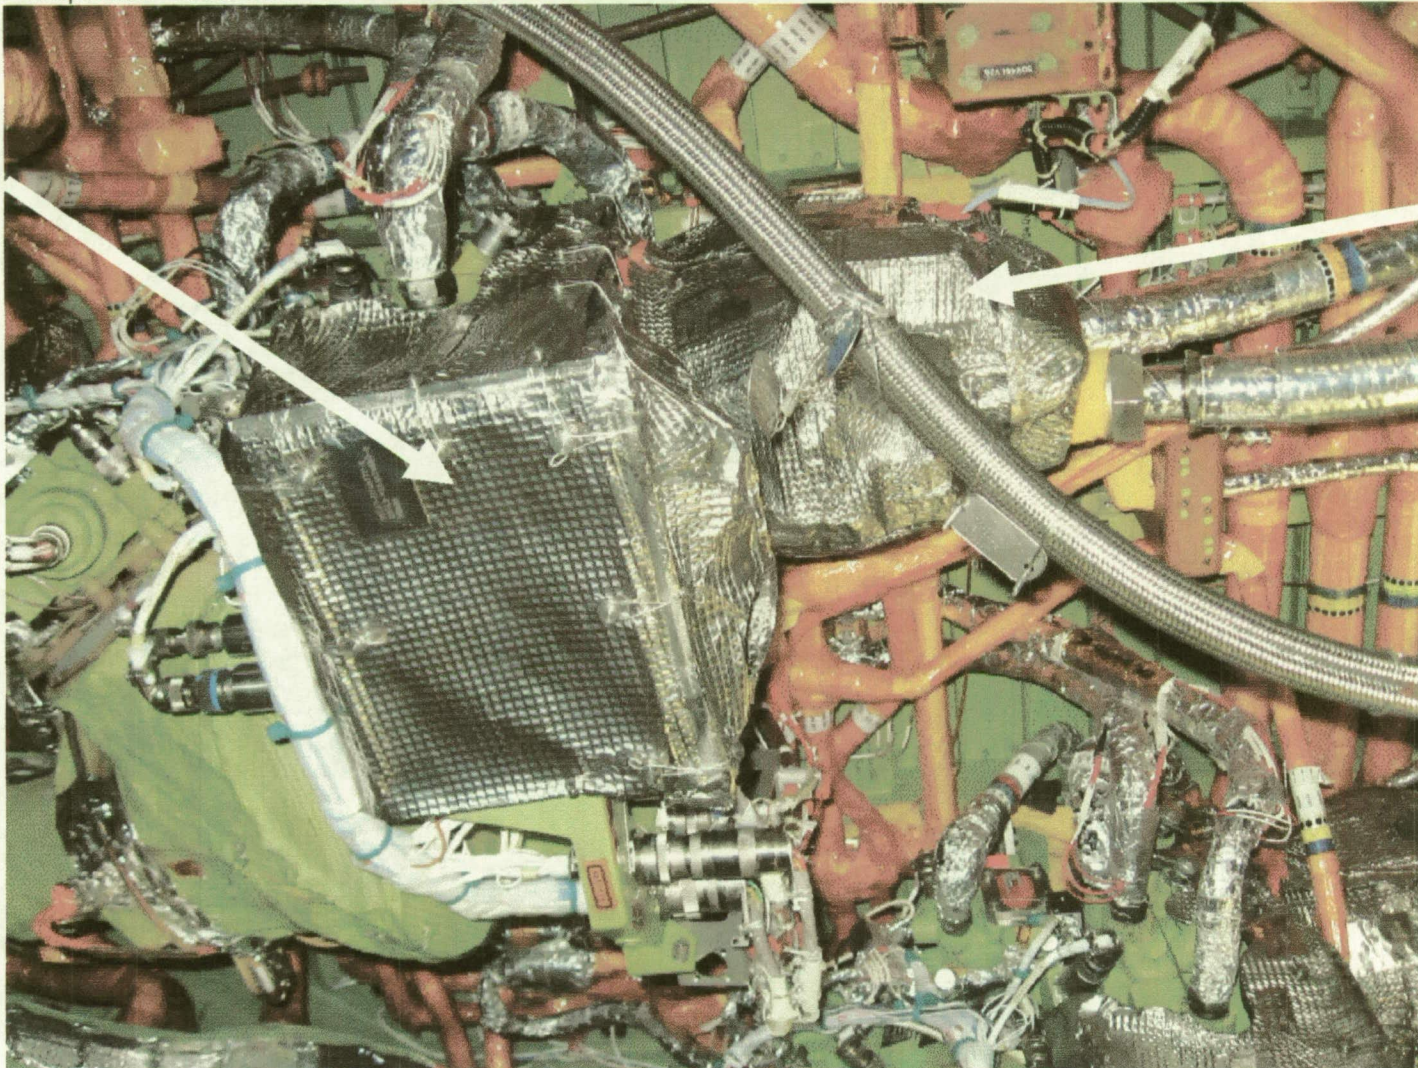
- Thrust Vector Control blankets are bonded now (Ref. SR3880 PRCB - 29 May 07)
  - Auxiliary Power Unit (APU) component blankets are not bonded
- Risk is very low (Improbable-Catastrophic)

- Multiple (6-7) unlikely events required to produce catastrophic result
- Orbiter Project is reviewing need to bond APU blankets
