NASA/TM—2013–216321

# **Refractory Materials for Flame Deflector Protection System Corrosion Control: Flame Deflector Protection System Life Cycle Cost Analysis Report**

January 2009

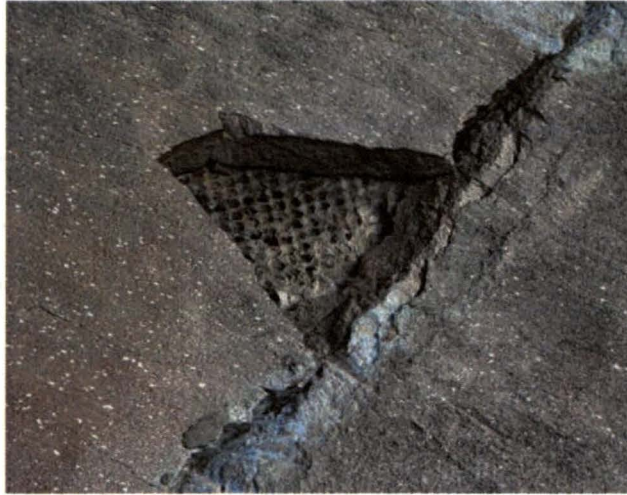
**Figure 6. STS-126 Spalled and Dislodged Concrete Section**

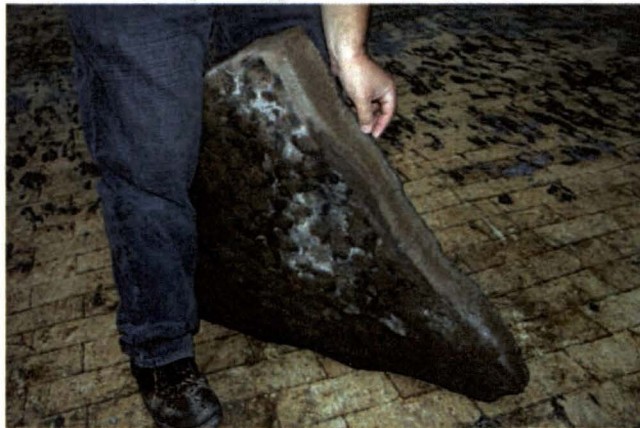
halfway down the length of the flame trench. A picture of the dislocated concrete section is shown in Figure 7.

**Figure 7. Section of Refractory Concrete Dislodged During the Launch of STS-126**

This anomaly may have resulted from the seepage of water through the cracked refractory concrete. It is possible that corrosion of the grid steel reduced the adhesion between the refractory and base material. During launch, the water under the concrete section may have turned to steam, lifting the section from the surface.
