LOGISTICAL AND ANALYTICAL APPROACH TO A FAILURE ABOARD THE INTERNATIONAL SPACE STATION

Steve McDanel, M. Clara Wright, Victoria Salazar, David Lubas, Bryan Tucker
National Aeronautics and Space Administration (NASA)
Kennedy Space Center, Florida

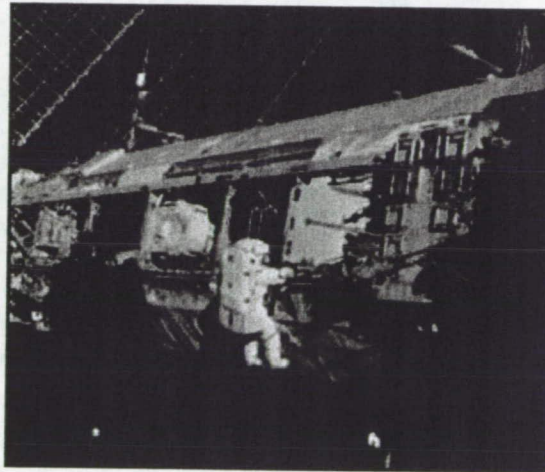
Figure 4
Astronaut Dan Tani, Expedition 16 flight engineer, harvesting debris from the SARJ.

During this and subsequent EVAs, as Dan Tani removed insulation covers protecting the SARJ and its hardware, he found that the outboard raceway of the SARJ appeared mottled. The inboard race ring and gear teeth did not display similar damage. Likewise, he reported the appearance of metallic debris decorating portions of the race, particularly near TBAs 4 and 5. Areas away from the TBAs and DLAs still appeared damaged although they did not display as much contamination. After photographing the assembly, Astronaut Tani collected samples of the debris on adhesive tape for later analysis back on Earth. He replaced the covers and completed a nearly seven hour EVA. The collected samples were returned to Earth aboard the shuttle *Discovery*. Figure 5 shows the general area where damage and debris was observed, along with a larger picture of the debris area.

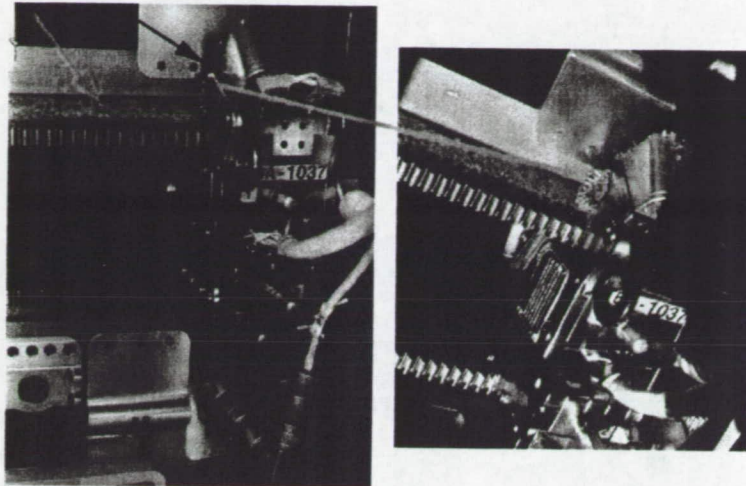
Figure 5

Section of damaged outer race (red arrow) adjacent to Trundle Bearing Assembly (TBA) on starboard SARJ. Debris (black arrow) was evident adhering to TBA.

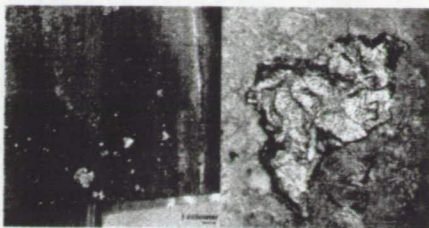
Figure 6

Stereomicroscopy of the debris was performed. The shavings, shards, and slivers appeared to range from powdery to small chip-like fragments. Particle size distribution for the various samples varied greatly, from less than 100 μm to greater than 1mm. Although the majority of the number of pieces of debris were less than 50 μm , the relatively few larger fragments constituted the majority of the weight and surface area of the collected debris. Many of the larger flakes displayed what appeared to be fracture surfaces, Figure 6. Some fragments also displayed a weak magnetic response in the vicinity of a magnetic field.

Typical debris with wide size distribution (left) and fracture features (right). Scale is mm.

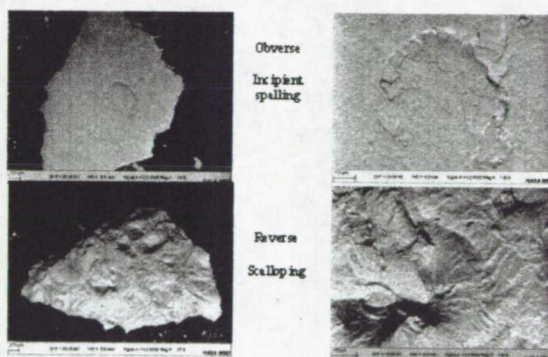
Figure 7

SEM analysis identified two predominant types of debris, Figures 7 and 8: finer, apparently crushed debris, and larger, relatively intact flakes. While much of the finer debris appeared compacted and agglomerated, several of the larger fragments still had original machine marks intact, indicating that they had not yet been pulverized. Incipient spalling was apparent on the machined surfaces of one of the larger flakes examined. The reverse of this flake showed original fracture features which had not been obliterated, including scalloping and crack arrest marks, typical of spalling via contact stress fatigue with subsurface initiation. Brittle features such as cleavage steps perpendicular to primary fracture surfaces and cleavage feathering were also observed.

Incipient spalling (obverse) and scalloping and crack arrest features (reverse). Fractograph magnifications: 29X, 115X (upper left, right); 27X, 134X (lower left, right)

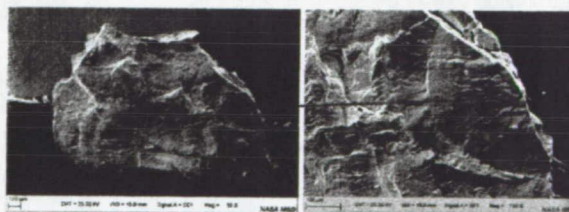
Figure 8

Fractograph depicting intact fracture surface (left) displaying initiation site, propagation region, and crack arresting (right). Original magnifications: 50X (left), 150X (right)

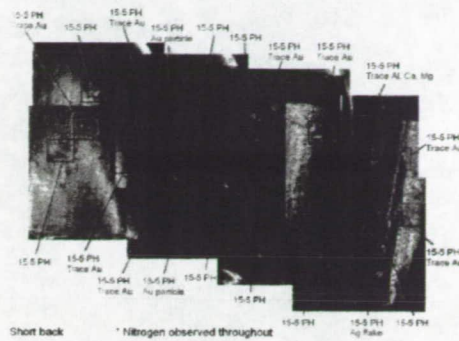
Figure 9

The samples were examined via EDS, Figure 9. The majority of debris of all sizes was composed of nitrided 15-5 PH stainless steel; no base 15-5 PH stainless steel was detected. Further, the lack of fluorine verified that no fluorinated lubricant was present. Additionally, gold particles and silver flakes were found. Aluminum, magnesium, and calcium contamination was also revealed.
