**Space Shuttle Stiffener Ring foam failure analysis, a non-conventional approach.**

## Solid Rocket Booster Stiffener Ring Foam Failure

Philip M. Howard  
July 9, 2007

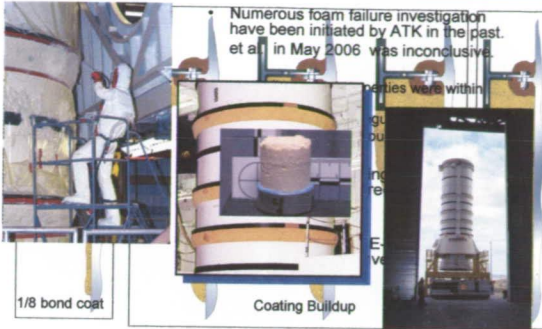
1/8 bond coat  
Coating Buildup

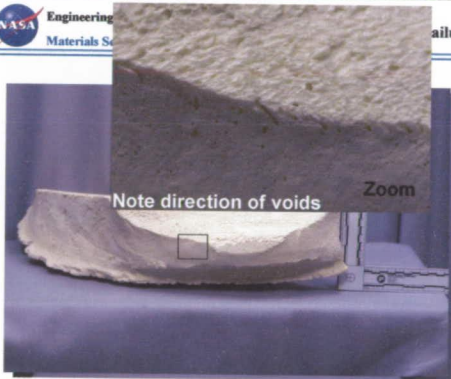
Note direction of voids  
Zoom

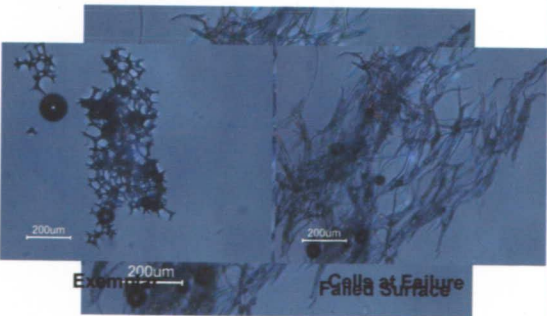
Cells at Failure  
Failed Surface
