## Space Shuttle Columbia Reconstruction Effort - An Analysis of the Thermal Protection System.

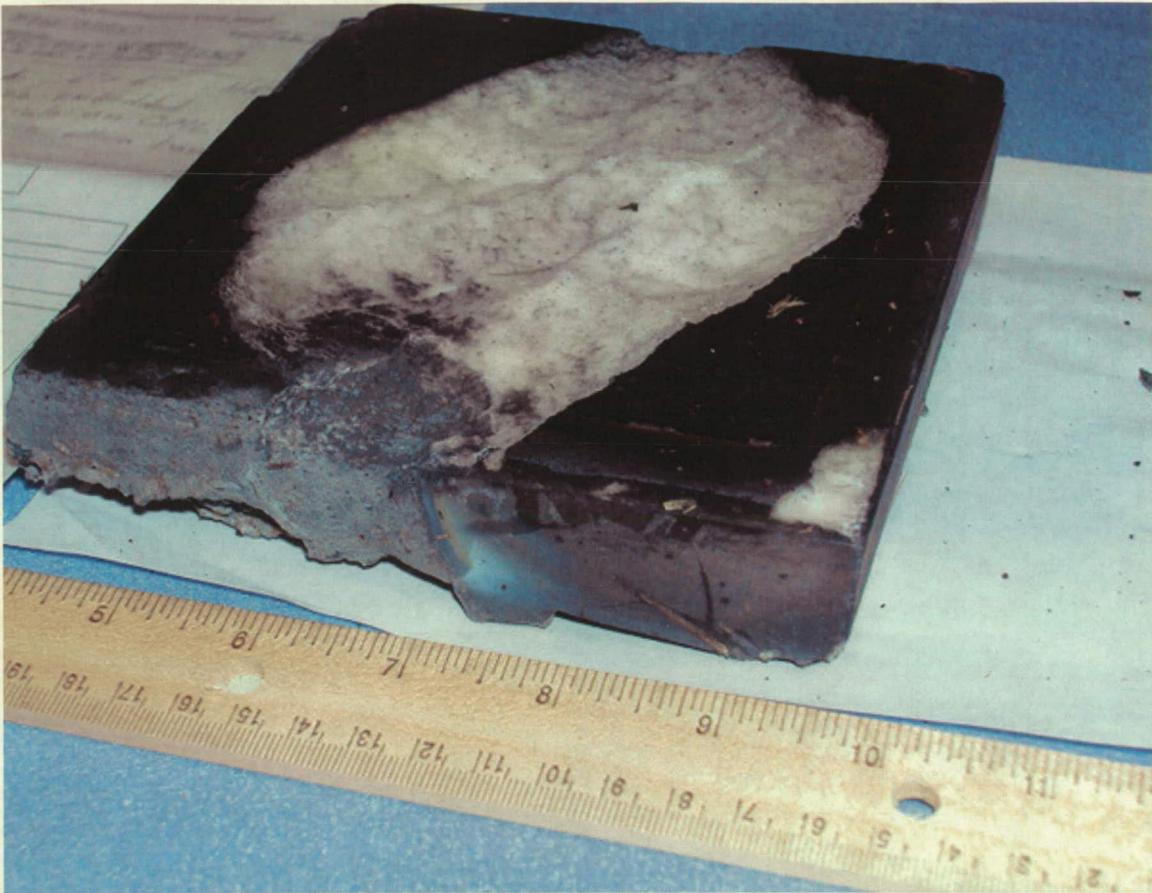
**Figure 1.0 - Recovered Columbia Tile.**
