# SPACE SHUTTLE AGING ELASTOMERS

Session: Space - Aging Orbiter

Cris Curtis

United Space Alliance – Space Systems Engineering  
Orbiter Subsystem Area Manager

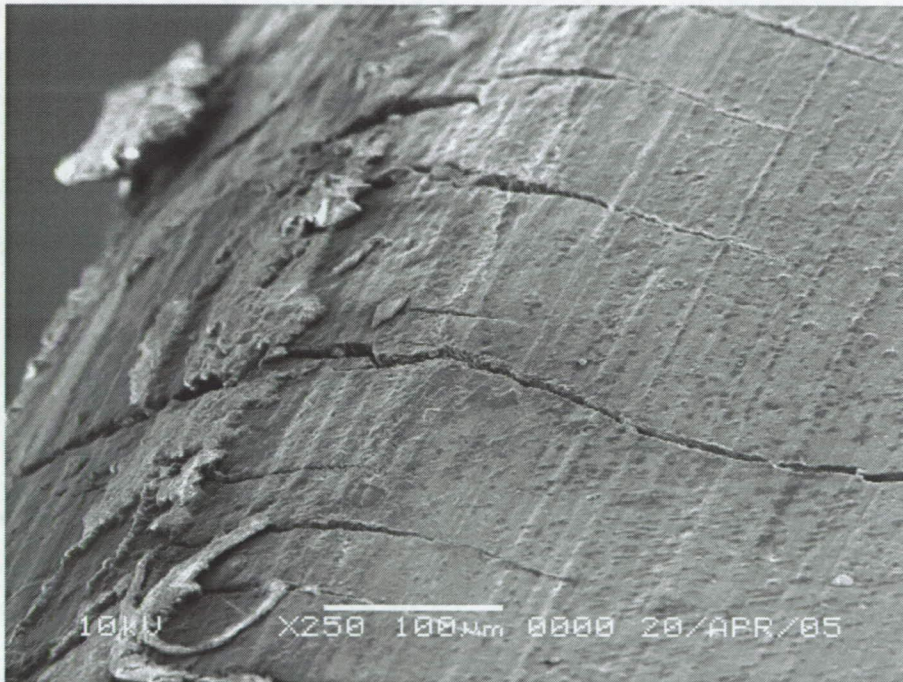
The Orbiter contains three gaseous hydrogen (GH<sub>2</sub>) flow control valves (FCV) that regulate pressure in support of the three main engines. During pre-launch helium leak checks it was determined that one of the three FCV's leaked helium. The analysis of leak rate directed that the Buna-N o-ring from the leaking FCV, identified as LV-58 for main engine #3 be removed and replaced. The high magnified inspection of removed o-ring identified radial cracks that could have provided leak paths across sealing surfaces.

Figure 1: Radial cracks on failed o-ring

The failed o-ring also had white frosting discoloration providing more evidence that the radial cracks could be attributed to ozone attack. These o-rings are exposed to dry purged air the majority of their post installed static environmental life. The purged air is provided with electrical motors and frequent lightning strikes increase the normal ozone levels.

The remaining o-rings on the other two FCVs were also removed and replaced with new o-rings to insure no leakage and successful launch of Discovery. Atlantis and Endeavour had their FCV o-rings removed and replaced. FA investigation determined that 6 of the 9 o-rings from all three Orbiters contained cracks. The one that leaked and initiated the problem was the most severe. Additional FA work included laser dimensional, Shore A hardness and properties from a dynamic mechanical analyzer (DMA) and an Instron tensile machine. The FCV by design has a 9-mil (0.009 in.) gap that allows exposure of o-ring to ozone, air and elevated temperatures, accelerating the weathering process leading to cracking.

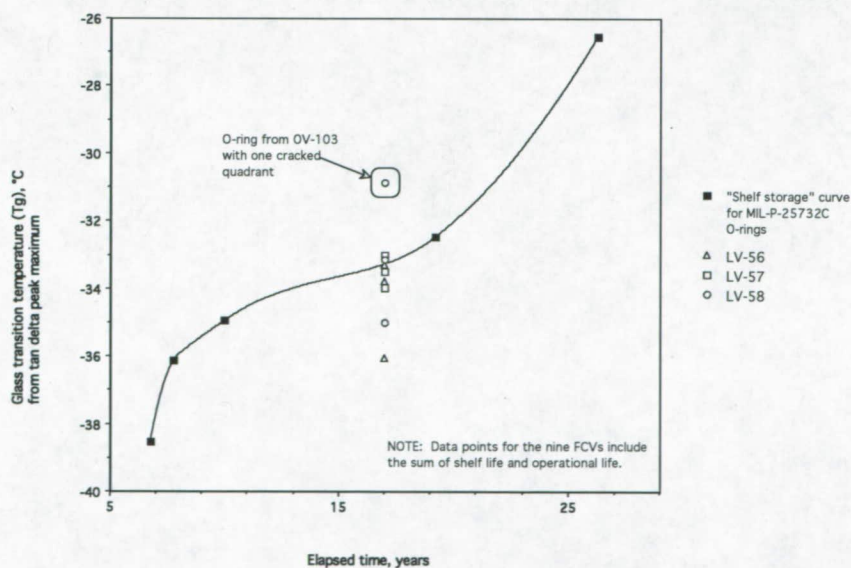
Additional o-rings were found in storage at both Marshall Space Flight Center and Kennedy Space Center of various ages. A reference curve was generated for DMA glass transition temperature ( $T_g$ ) versus shelf life storage time ranging from 8 to 26 years. There was a difference noted for modulus and shore A hardness on the cracked o-ring that initiated the investigation.

Figure 3:  $T_g$  versus age of used and unused Buna-N o-rings

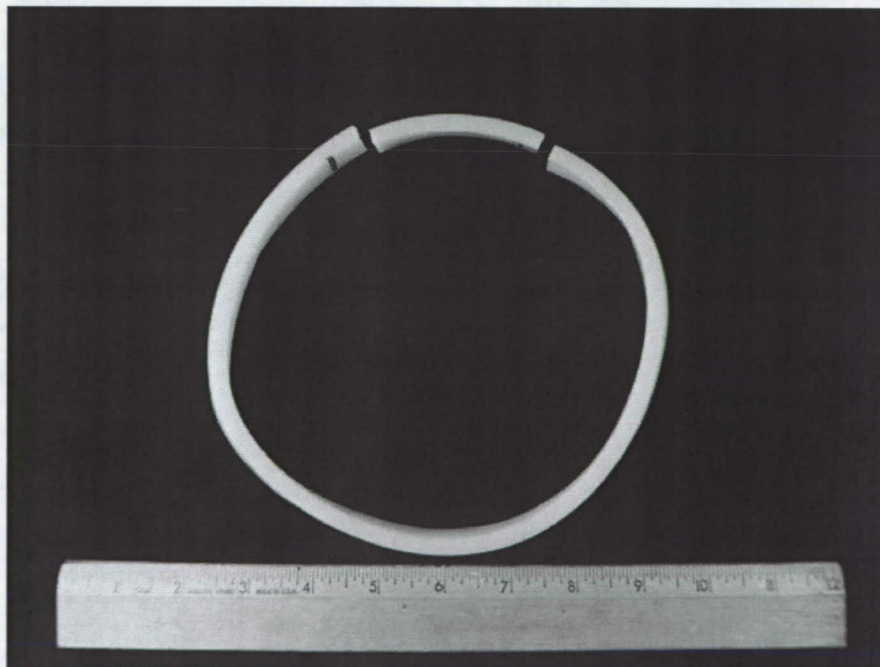
The sabot seals used in parachute mortar assemblies are compounded with polyurethane material. They were found cracked, yellowing and embrittled prior to use but after installation. The storage conditions after installations and age may have contributed to dry rotting and degrading material to the point of where they could not be used. These seals were older than 10 years and are installed early in the build up of the mortar assembly. Shore A hardness readings indicated material did not meet requirements. Upon requesting new seals to be manufactured the material used previously was not available due to obsolescence. A new material was chosen and post installed storage conditions were improved with a controlled environment to minimize the aging process.

Figure 5: Failed polyurethane mortar assembly seal

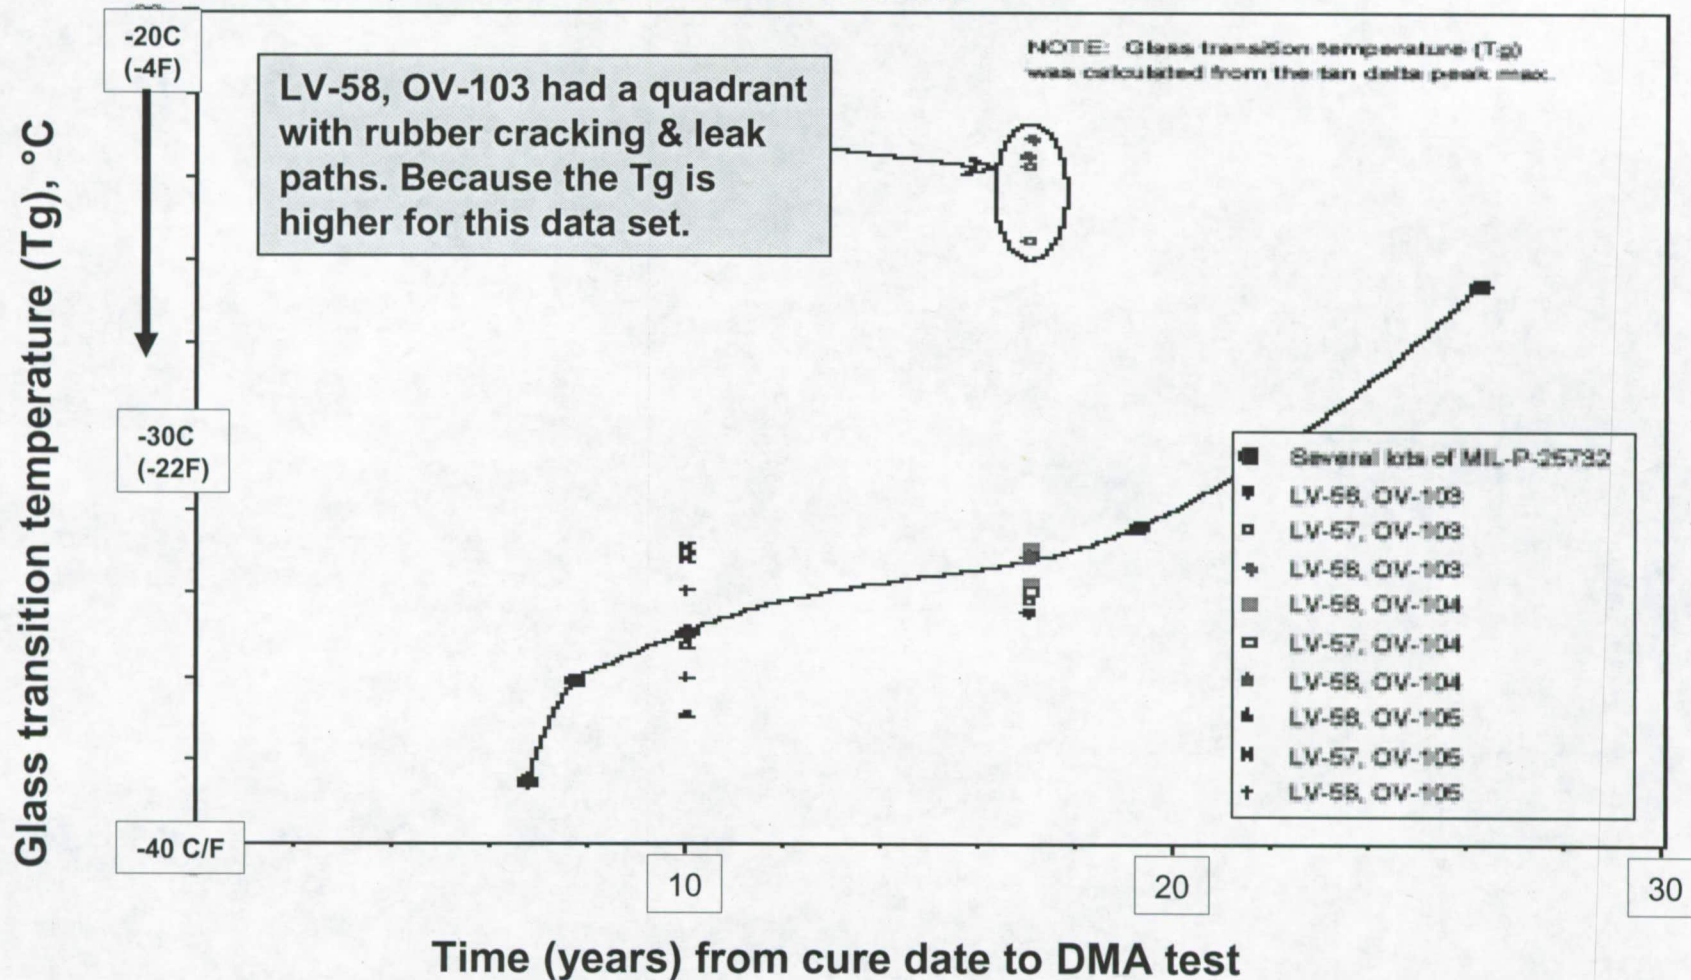
Dynamic Mechanical Analysis (DMA) glass transition temperature ( $T_g$ ) for MIL-P-25732 nitrile o-rings: several cure dates, and for 3 FCVs on each of 3 Orbiters.
