# Testing and Analysis Validation of a Metallic Repair Applied to a PRSEUS Tension Panel

**A design and analysis of a repair concept applicable to a stiffened composite panel based on the Pultruded Rod Stitched Efficient Unitized Structure was recently completed. The damage scenario considered was a midbay-to-midbay saw-cut with a severed stiffener, flange and skin. Advanced modeling techniques such as mesh-independent definition of compliant fasteners and elastic-plastic material properties for metal parts were utilized in the finite element analysis supporting the design effort. A bolted metallic repair was selected so that it could be easily applied in the operational environment. The present work describes results obtained from a tension panel test conducted to validate both the repair concept and finite element analysis techniques used in the design effort. The test proved that the proposed repair concept is capable of sustaining load levels that are higher than those resulting from the current working stress allowables. This conclusion enables upward revision of the stress allowables that had been kept at an overly-conservative level due to concerns associated with repairabi

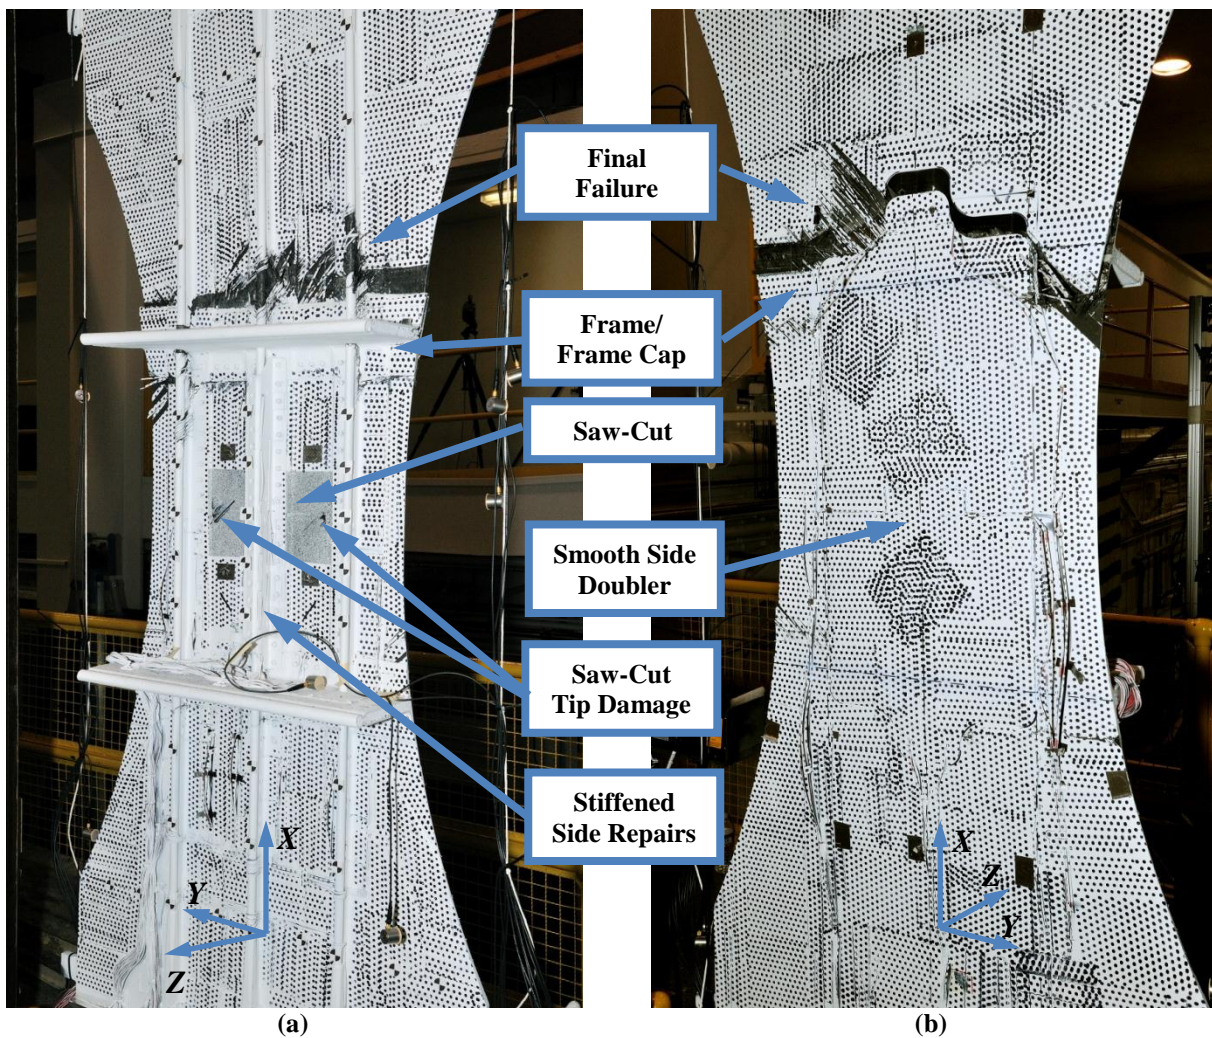
The final panel failure occurred at the loading of 243,992 lb. Failure mode is illustrated in Figure 9. The failure occurred away from the center section of the panel, i.e., away from the initial saw-cut damage, generally in the vicinity of the top foam-filled frame. While pin-to-pin elongation of the panel presented in Figure 10 shows linear global behavior up to approximately 213.5 kip load level, i.e., greater than DUL+10%, subsequent sections detail several localized effects not identifiable in the global displacement plot. Some of these local events did not significantly influence the final failure, but nevertheless it is worthwhile to trace the damage progression, as it helps in understanding the mechanics of the structure. Identification of test behavior before embarking on FE predictions assessment is also helpful in the process as the adopted modeling assumptions and analysis fidelity can be placed in the context of the actual article behavior.

**Figure 9. Failure of the repaired tension PRSEUS panel: (a) stiffened side, (b) smooth side. The speckle pattern applied for VIC-3D measurements is visible.**

As indicated before, the final failure of the panel occurred in the vicinity of the top foam-filled frame away from the repaired saw-cut area. The final failure mode was presented in Figure 9. The panel and the repair components were disassembled after the test to allow examination for damage modes not visible in the assembled configuration and to correlate gage readings, especially their discontinuities, with a probable damage sequence scenario. The two general areas where additional examination was enabled by disassembling the repair were the center stringer and fastener holes.

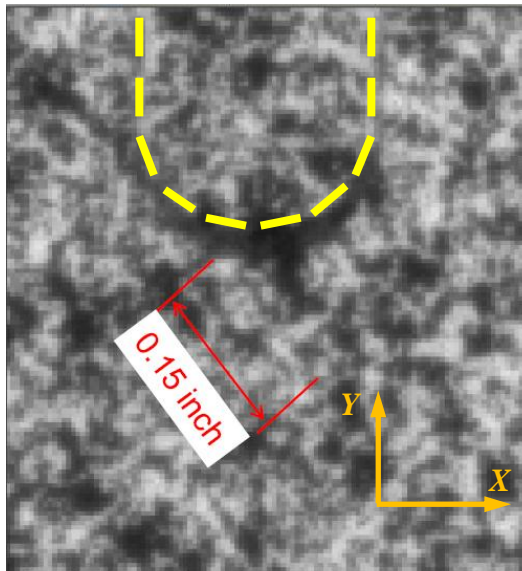
The first identifiable local failure was initiated in the region of the right-hand-side saw-cut tip (when looking at the panel from its stiffened side) at a load of 102.5 kip or 86.1% of DLL and is shown in Figure 11. The tip of the saw-cut is highlighted with a yellow dashed line in Figure 11 and the speckling visible inside the saw-cut area is on the smooth side doubler. The surface fiber splitting is not easily visible in Figure 11, however, the extent of the splitting was 0.15 in. and was determined based on displacement contours from the high-resolution VIC-3D acquisition. Both left- and right-hand-side saw-cut tip openings and surface splitting lengths were traced using the high-resolution VIC-3D acquisition throughout the entire loading sequence. For brevity, only the surface openings are presented in Figure 12 along with strain readings from the two closest strain gages, SG-155 and -156, located one inch to the side of the left- and right-hand side saw-cut tips, respectively. It is seen in Figure 12 that the initial saw-cut tip event at 102.5 kip was so minor that it did not result in a noticeable strain reading disruption in the two aforementioned strain gages. It is therefore concluded that this local event did not significantly affect the behavior of the panel away from the saw-cut for load less than DLL.

Figure 11. Initial surface opening at the right saw-cut tip at 102.5 kip.

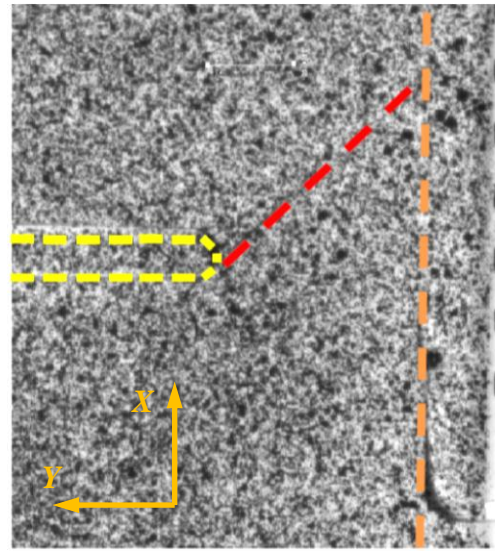
Further growth of surface splitting originating from the saw-cut tips was observed at loading greater than DUL. The two events presented below are distinct from the ones observed at the lower load regimes in the sense that the surface splitting reached the stitch lines, as shown in Figure 2, which prevented their further length growth. Despite the fact that only raw VIC-3D images are presented below in Figure 15 and Figure 16, the splitting and damage arrestment assessment was supported also by reviewing post-processed displacement contours. The damage arrestment occurred first on the right-side of the panel at 189.5 kip, an event visible in Figure 12 between the DUL and DUL+10% lines. Examination of a high-resolution VIC-3D image acquired at this load and shown in Figure 16 revealed that this event was associated with the previously existing splitting extending further in the diagonal direction (i.e. along the red dashed line) from the saw-cut tip (the right end of the yellow dashed contour) to the flange edge of the right-most stringer (marked with the orange dashed line). A similar event followed on the left-side of the panel at 208.0 kip and is also visible in Figure 12 for loading slightly greater than DUL+10%. The associated VIC-3D image is shown in Figure 15, with the same type of markings as in Figure 16. A slightly different surface splitting path is seen in Figure 15. After the initial growth in the diagonal direction for about 2/3 of the distance between the saw-cut tip and the left-most stringer flange, the surface splitting turned to the direction perpendicular to the stringers before being arrested at the flange edge. Note, that the single stack skin where the splitting developed was oriented perpendicular to the stringers. Therefore, the percentage of diagonal fibers was 42.9 and the percentage of fibers perpendicular to the stringers was 44.9 and these two directions dominated splitting development paths. Note also that in the global sense, the two events were still contained within the load range that did not produce any visible departure from a linear relation between the load and extensional displacement, as seen in Figure 10.

**Figure 16. Saw-cut tip surface splitting arrested by the right-side stringer flange at 189.5 kip.**

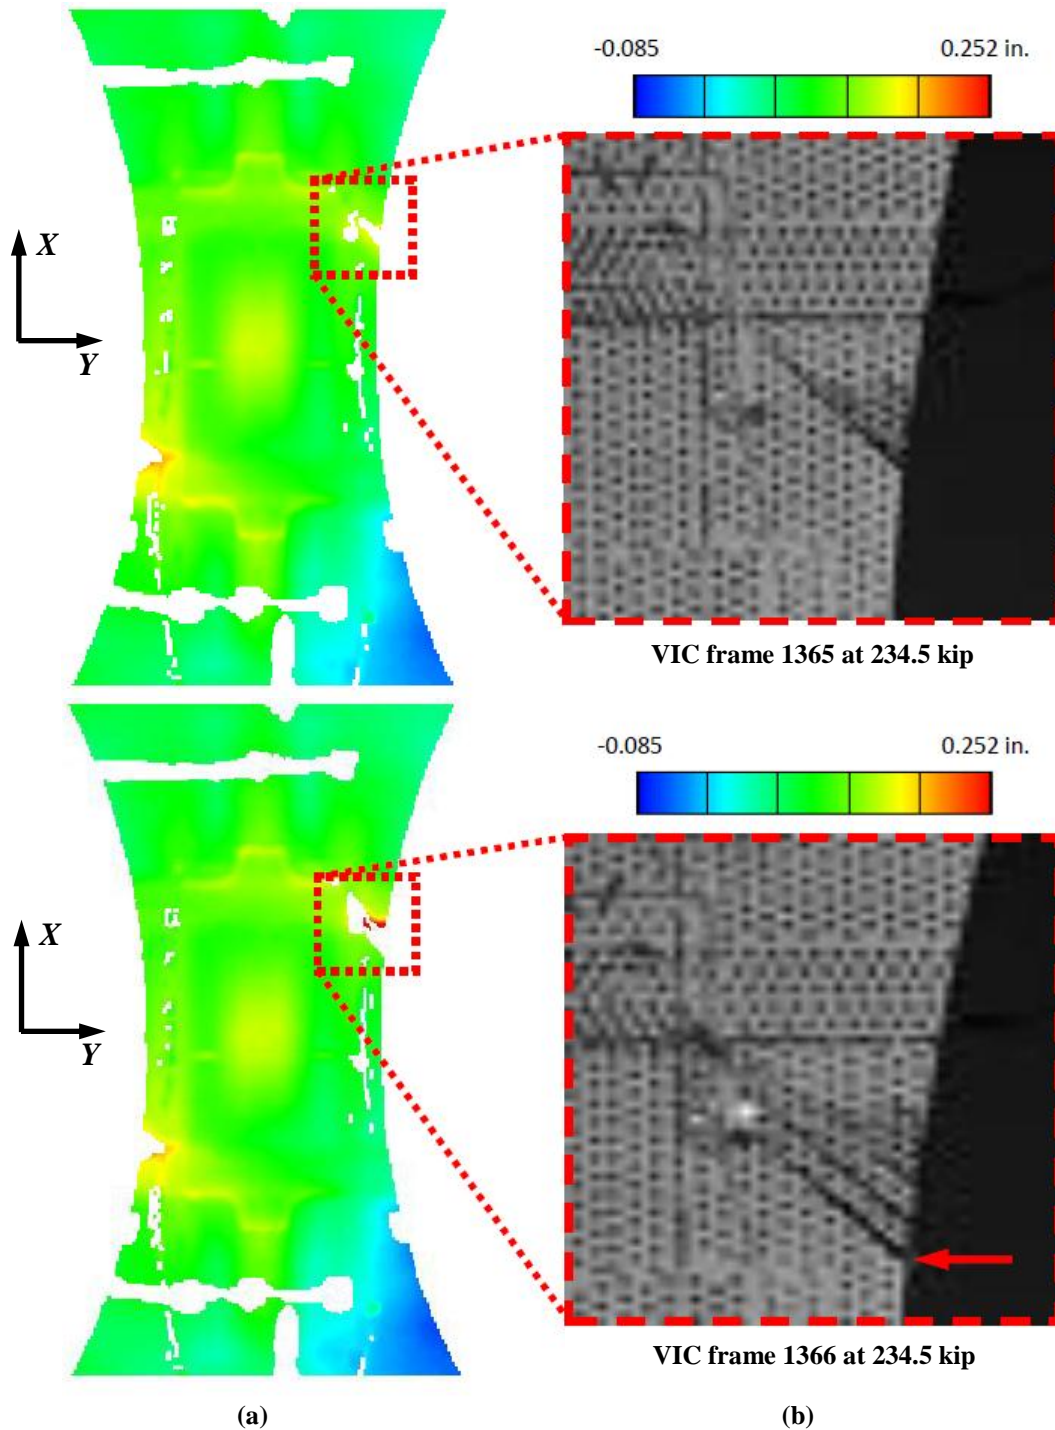
Video recordings and VIC-3D images indicated that prior to the final failure, damage was gradually introduced from the lateral free edges of the panel in the vicinity of the frame caps. Since the first three out of four above-mentioned events were very similar in nature, only the third one (i.e. the first event in the second load reduction at 234.5 kip) is illustrated in Figure 17. Figure 17 comprises of the VIC-3D out-of-plane displacement plots presented along with close-up images of the section of the panel where the damage was introduced. Two consecutive frames captured by the VIC-3D system in one second interval are presented. The two top images show the pre-existing damage that occurred at the 213.5 kip load (the aforementioned first event associated with the first load reduction) and did not progress any further up to the load of 234.5 kip. It is seen that the initial cracks in the skin section of the panel developed at the 45-degree angle and arrested in the vicinity of the top frame cap and the right-hand-side stringer flange intersection, where the through-the-thickness stitching is present. The bottom images in Figure 17 show additional damage in the form of a new distinct 45-degree crack highlighted with a red arrow in the VIC-3D image. Local change in the out-of-plane displacement is also visible in the area highlighted in the left plot. Recall that the panel frame caps were four stacks thick (0.208 in.) and their intersections with stringer flanges were six stacks thick (0.312 in.) while the skin was only one stack thick (0.052 in.). These abrupt changes in the panel thickness near the frame caps likely resulted in stress concentrations that contributed to damage initialization. Finally note that shortly after the first crack shown in the top images of Figure 17 developed, a second event (i.e., the second event very similar in nature to the first in the first load reduction) occurred on the opposite side of the panel near the bottom frame. The damage was nearly identical to the one shown in the top section of Figure 17 and its presentation is omitted here for brevity.

**Figure 17. Edge failures as first event in the second load reduction: (a) out-of-plane displacement, (b) close-up image.**

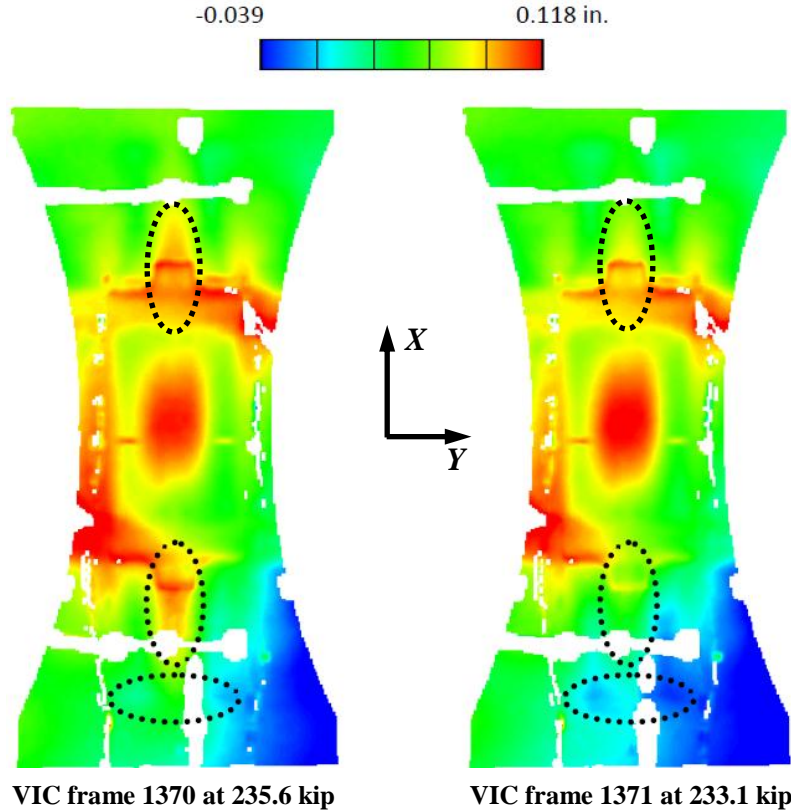
While the first three out of four previously mentioned events associated with the two load reductions in Figure 10 were similar in nature, the last event could not be traced to regions near the free lateral side edges of the panel. However, the event was also identified by examining the out-of-plane displacement fields acquired from the VIC-3D system. This change in displacement field is illustrated again with two consecutive frames in Figure 18. Sections of the panel where the change was most noticeable are enclosed within dashed contours. It is observed that the event had its predominant impact in the vicinity of the center severed stringer.

**Figure 18. Second event of the second load reduction: out-of-plane displacement, regions of dominant displacement change highlighted with dashed contours.**

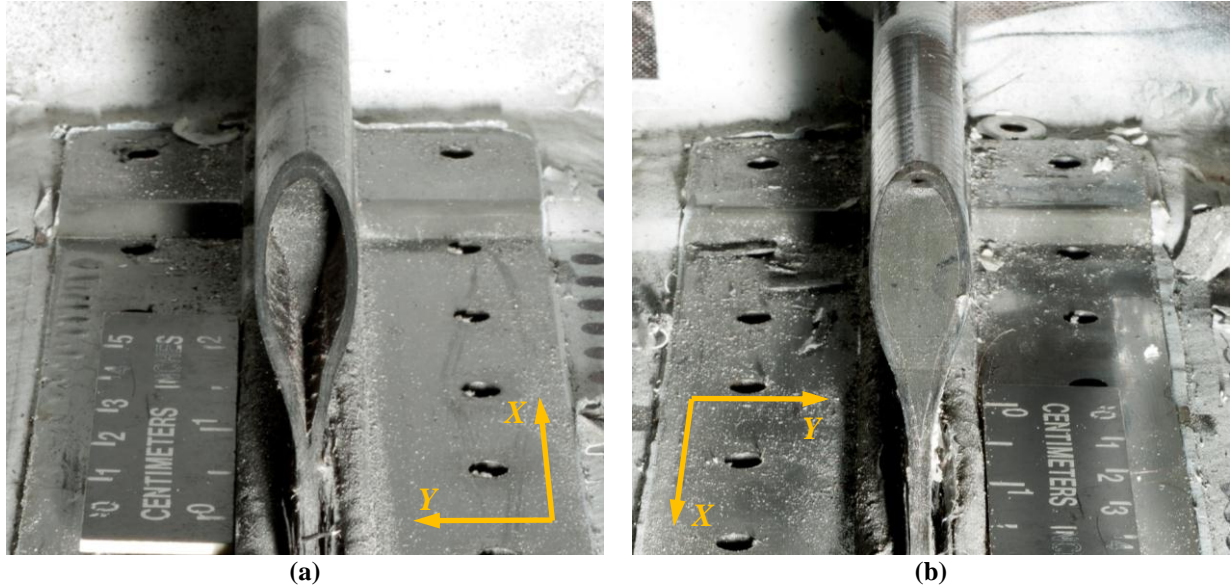
Post-test examination after removing the repair assembly revealed that the upper section (as installed in the test machine) of the severed pultruded rod was delaminated from its overwrap beginning in the tapered section of the web, as shown in Figure 19(a). No visible rod delamination was identified in the lower section of the stringer, as shown in Figure 19(b). Recall from Figure 8(d) that the upper stringer section was not instrumented under the repair assembly but the lower section had four strain gage rosettes installed in the web section of the stringer. Recall also, that when discussing discontinuities in the principal strain direction and the maximum principal strain (Figure 13 and Figure 14, respectively), a delamination of the pultruded rod was cited as their possible cause. The fact that a visible rod delamination occurred only in the stringer section that was not instrumented does not invalidate the previously provided explanation. Delamination of either of the rod sections, i.e., lower (instrumented) or upper (not

instrumented) results in the same outcome, specifically, an abrupt stiffness change and a significant shift in the location of the neutral bending axis. This shift influences the out-of-plane displacement of the panel not only directly over the delaminated section but more globally, which is consistent with the behavior shown in Figure 18. It is therefore probable, that the extensive delamination of the pultruded rod from the overwrap occurred as the second event in the second load reduction shown in Figure 10, after which the panel was still capable of sustaining additional load before the final failure.

**Figure 19. Tapered section of the center stringer: (a) pultruded rod delaminated and partially pulled out of overwrap in upper taper, (b) pultruded rod and stringer overwrap not delaminated in lower taper.**

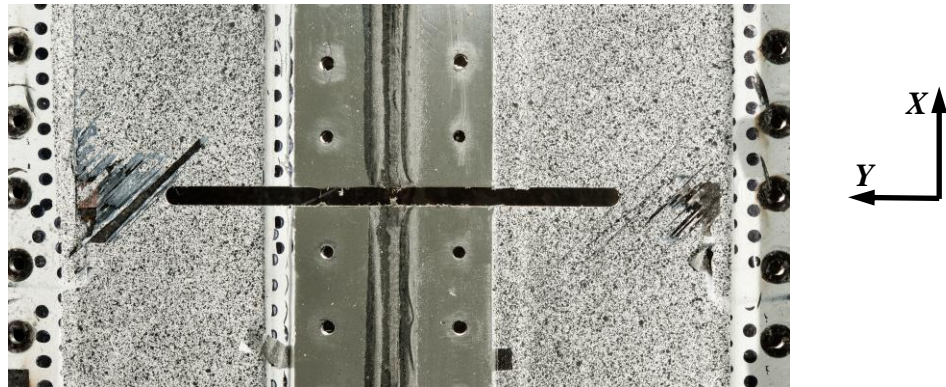
Fastener joints were examined next. While the titanium fasteners were compromised during the disassembling process, examination of fastener holes yielded meaningful observations. No visible elongations of fastener holes were observed in the composite panel, as shown in Figure 20 for highly-loaded fastener holes in the direct vicinity of the saw-cut. In the same figure it is also seen that extensive surface splitting in the saw-cut area developed further beyond those previously shown in Figure 15 and Figure 16. Despite the much larger extent, splitting propagation was also arrested by the through-the-thickness stitching reinforcement at the side flanges.

**Figure 20. Fastener holes in the center stringer of the panel in the vicinity of the saw cut.**

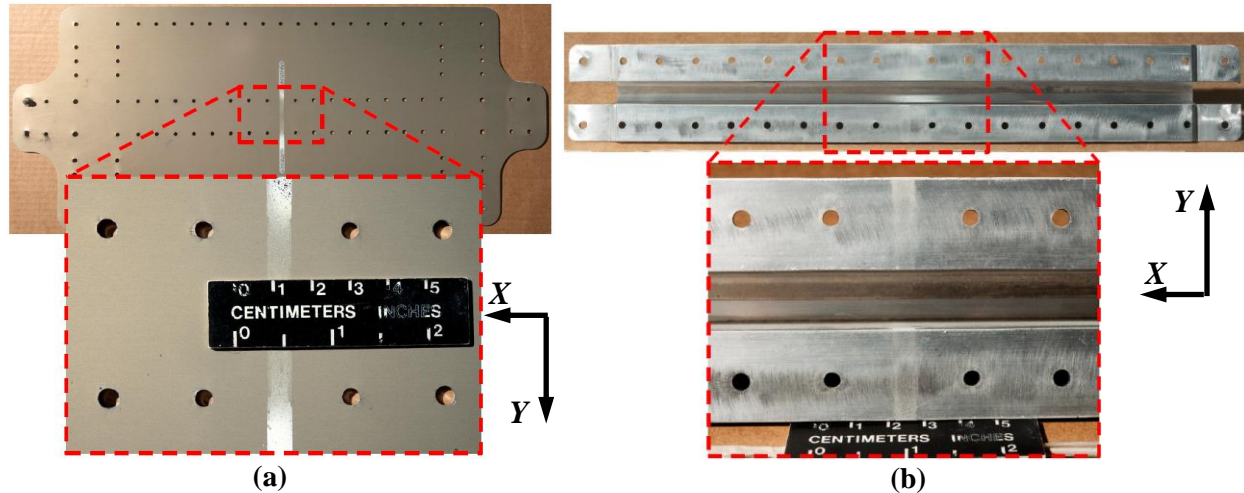
Fastener holes in the composite panel showed no signs of damage while some highly-loaded holes in the metallic components of the repair assembly revealed elongations as shown in Figure 21(a) for the doubler and in Figure 21(b) for the two repair angles. The above behavior was predicted by a supplemental hand calculations to be discussed at the end of section V.E. Close-up sections in Figure 21 show the eight fastener holes corresponding to the fastener holes in the center section of Figure 20 near the saw-cut. A careful examination of the metallic repair assembly components clearly shows the elongations but they are difficult to see in photographs. While the exact

elongations in the metallic repair components were not measured, their presence was verified by inserting pristine fasteners into the holes while orienting them vertically. The holes which did not elongate during the test would not permit fasteners sliding freely due to tight initial tolerances being maintained. Elongated holes were not able to sustain fasteners as they would easily slide out from the holes under their own weight. Note that the close-up areas in Figure 21 are only selected examples and do not show all the elongated fastener holes. Additional elongated fastener holes were identified at the end sections of the doubler and the two angles.

**Figure 21. Elongated fastener holes in the repair assembly: (a) smooth side doubler and (b) stiffened side angles.**

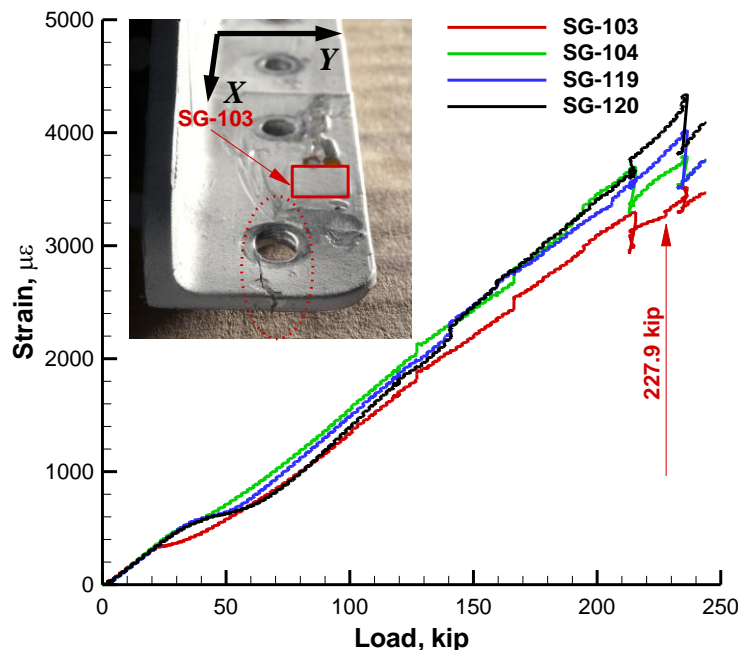
Finally, one more isolated example of a damage mode was noticed when examining fastener holes. Namely, a crack in the top left fastener hole propagated to the end of the angle is shown in Figure 22. The crack occurred on the side of the fastener hole closer to the fillet between the web and flange section of the angle, i.e., closer to a more rigid angle section due to the fillet thickness build up. To identify a possible load at which this event occurred, the closest strain gage SG-103 recording was examined and compared to the other three similarly placed strain gages SG-104 (top right), -119 (bottom left) and -120 (bottom right). Figure 22 shows that SG-103 recorded a small discontinuity at 227.9 kip which was not identified in the other three gages at this load level. Therefore, it is likely that the fastener hole crack developed gradually over lower load levels and reached the free edge of the angle at 227.9 kip.

**Figure 22. Crack at the top fastener hole of the left repair angle and pertinent strain gage data.**
