NASA/TM-2013-217993

# Evaluation of Acoustic Emission SHM of PRSEUS Composite Pressure Cube Tests

*Michael R. Horne*  
*National Institute of Aerospace, Hampton, Virginia*

*Eric I. Madaras*  
*Langley Research Center, Hampton, Virginia*

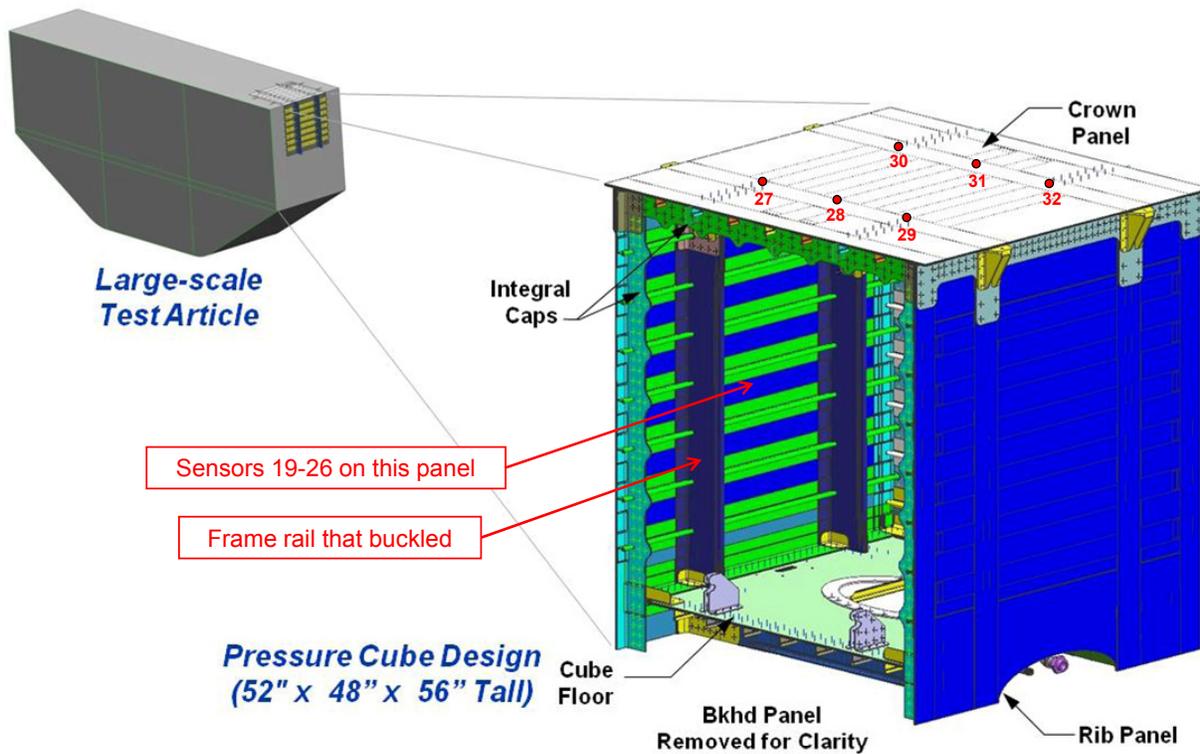
Figure 2. Schematic of Pressure cube with approximate locations of some of the AE sensors (red dots) mounted on the crown panel and other notations in red by the author. [4]

The AE sensors applied to the crown and one of the rib panels, as well as the section of the frame that buckled first during failure, are shown in figure 2. For purposes of illustration the bulkhead panel indicated as “blkhd panel removed for clarity” can be considered as the panel that blew out during failure, leaving the cube looking much as the figure illustrates, albeit, a little more ragged and fractured.

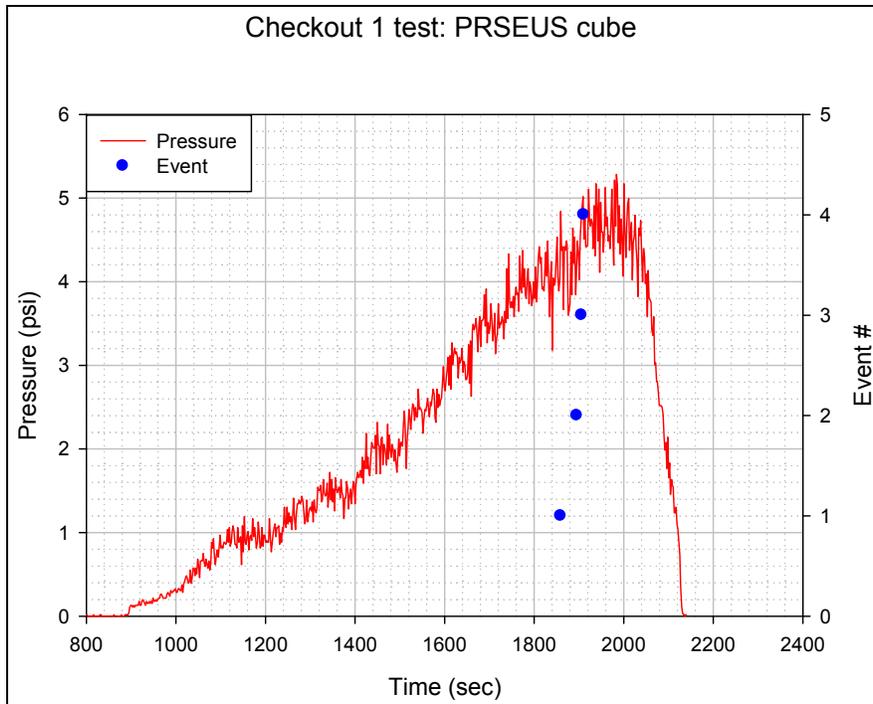
Figure 6. Checkout test 1 (0.5P, P=9.2 psi) Load profile and AE events

During checkout test 1, only four AE events occurred, near the peak pressure, as seen in the “Load profile and AE Events” plot in figure 6. The load profile (vs. time in test) is the red trace and AE events are indicated by the blue dots. Three events occurred at sensor 16 on the bulkhead panel that did not fail, and one at sensor 31 in the center of the crown panel, between the regions later discovered to have delaminated. Please note, as seen in figure 7 of the waveforms captured at all the sensors for event 1, there does not seem to be much signal on the sensors other than 16, indicating a source very local to that sensor. However, after filtering out frequency content below 50 kHz, neighboring sensors 11, 14, 17, 18 do indicate some wave content other than noise. None of these sensors are near the panel that eventually failed but these events are either much smaller than the ones from the second checkout test or, as in the case of the channel 16 signal, are not particularly similar to that of a damage induced AE signal. Sensor 20 is showing a type of continuous AE not seen on the other sensors, although its frequency content (50-75 kHz) is much lower than the 400 kHz seen at sensor 16 and neighbors.

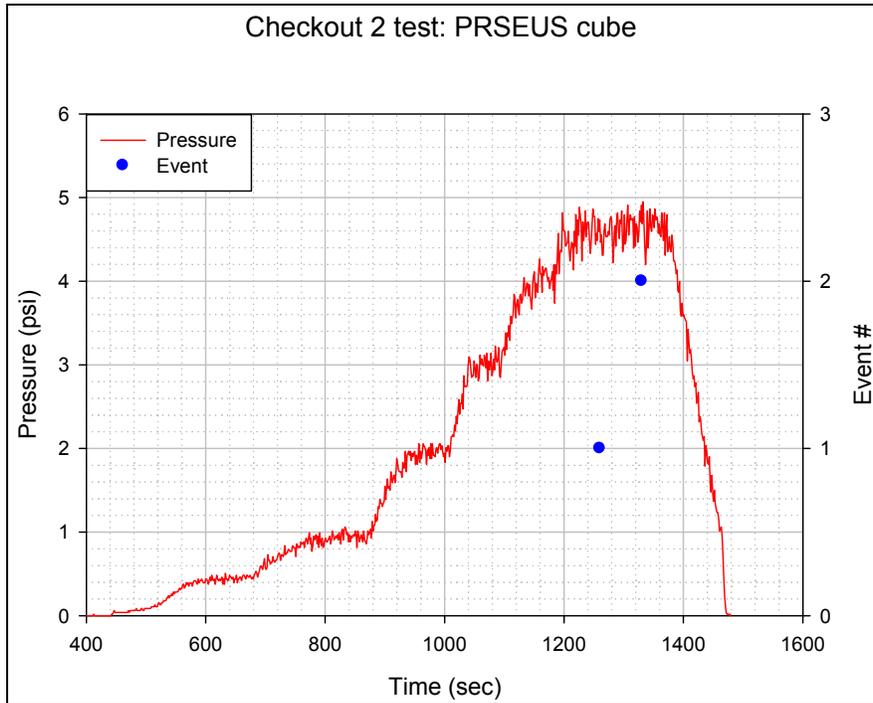
Figure 8. Checkout test 2 (0.5P) Load profile and AE events

During checkout test 2, only two AE events occurred, near the peak pressure, as seen in the “Load profile and AE events” plot in figure 8. These events show less localized (geographically) and longer (in time) activity, indicated by the number of sensors with significant waveform, as illustrated in figure 9 of event 1. The event registered significantly on sensors 19 to 26, as indicated by the red arrowhead line. These signals look more like typical damage-induced AE signals. Also, these sensors are on the speckle-pattern rib panel which suffered a metal splice fracture and frame buckling during later tests. Compared to the signals from checkout test 1, these signals are more likely to be from a distributed structural “damage” source. The response of event 2 is similar and has indications on sensors 1-6, 8, and 10. Note that sensors 1-6 are on

the panel that eventually blew out entirely during the failure test. Sensors 8 and 10, albeit on another panel, are closest to the edge contiguous to the “failure” panel.

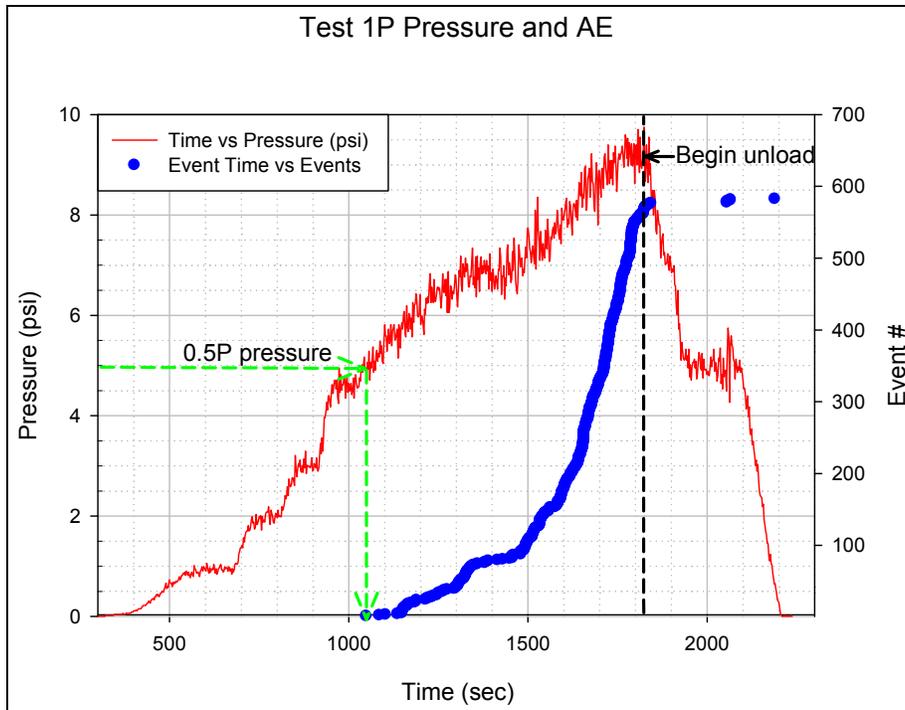
Figure 10. Pressure 1P Test Load profile and AE events

The load profile and AE event plot for the 1P test is shown in figure 10. The dotted green lines indicate the point in time where the pressure reaches the previous peak pressure achieved during the 0.5P tests. A Felicity Ratio of 1 indicates that no structurally destabilizing damage occurred during the 0.5 P tests. The black vertical line indicates the beginning of the unloading. Events after this point indicate that some damage, which created new surface, had occurred during this test. As the load reduces, the friction of these surfaces coming together creates acoustic emission as they interfere.

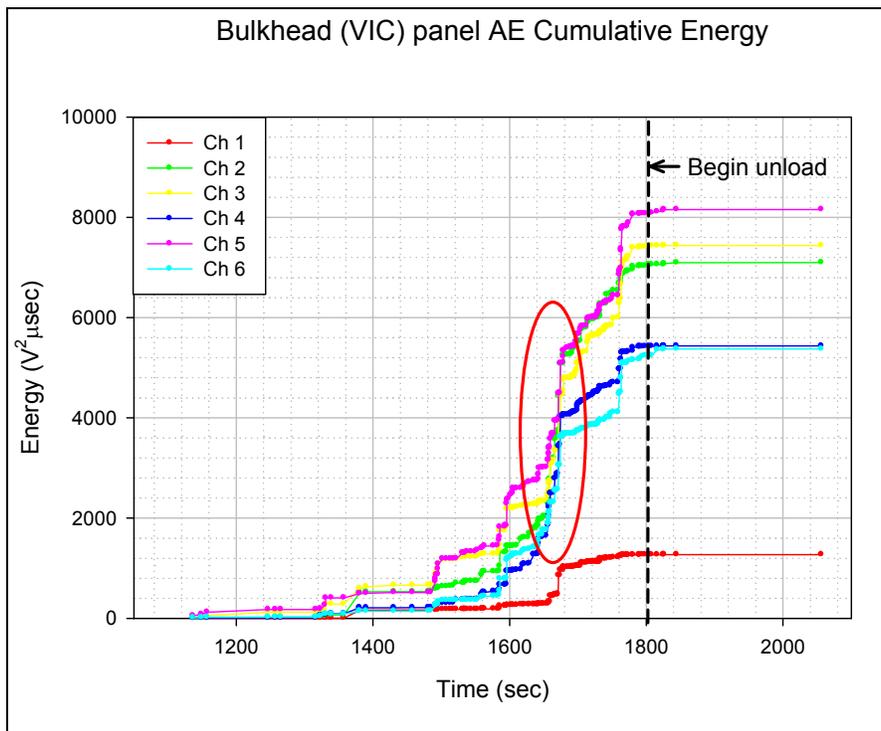
Figure 11. Pressure 1P Test: Speckled bulkhead panel AE energy

For this analysis, the cumulative energy of the events was calculated for each channel (sensor) and is plotted, versus time, for each panel as seen in figures 11-15. Red ovals indicate items of interest. In figure 11, the speckled bulkhead panel that blew-out during the failure test, has a significant rapid coordinated jump in energy occurring on all sensors around 1680 seconds (~ 8.6 psi). Sensor 1 with the lowest cumulative energy is bay-located. This bulkhead panel had the next-to-the-highest cumulative energies per sensor. Figure 12 shows the cumulative energy plot for the gray rib panel, which is opposite the failure initiating speckled rib panel. It has the lowest sensor energies of all the panels. Now, note that the cumulative energies of the gray bulkhead panel, as seen in figure 13, includes the highest energies, with the largest increases occurring at 1790 seconds right before unloading. This panel is farthest from the later failure locations, so hindsight allows us to suggest that these events were “structurally stabilizing” because their location is not involved in the final failure. However, they did occur on a bulkhead panel, suggesting that these types of panels may be more likely to fail and should be monitored more closely. Significant coordinated increases also occur on most sensors of that panel at 1610 seconds (~ 8.0 psi) and 1660 seconds (~ 8.5 psi), especially sensors closer to the floor (16, 17, and 18). The smallest increases occurred at sensor 13 (bay-located), and 15 (failed). Figure 14 shows a significant coordinated increase at 1720 seconds (~ 9.0 psi) of the cumulative energies of the speckled rib panel which later had initiated the final catastrophic failure. It also has the next lowest cumulative energies of the side panels. Comparable cumulative energies are noted for the crown panel as seen in figure 15. There is a coordinated increase around 1650 seconds (~ 8.4 psi) with sensor 27 having the greatest increase by 1700 seconds. Sensor 27 is closest to the metal splice failure on the affected frame. The greatest total cumulative energy occurs on sensor 31. After the 2P test, delaminations were discovered that run along the edges of the crown panel contiguous to the rib panels. Sensors 31 and 28 are closer to both of those edges than the other crown sensors. An explanation for the large total cumulative energy at 31 may be that the delamination damage (or delamination-initiating damage) was already occurring near both sensors 30 and 32. Although the energy at sensor 30 or 32 would be greatest from the damage nearest to each, the sum of the energy from both damage regions could be greater at the sensor in the middle, 31. This may also account for the higher total cumulative energy (vs. others on same

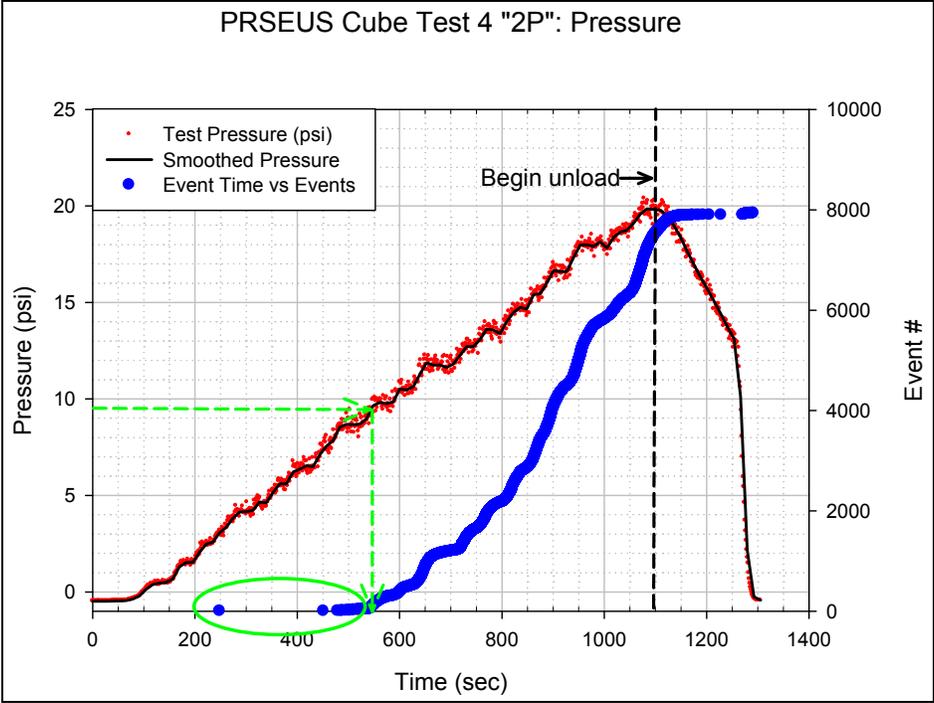
Figure 16. Pressure 2P Test Load profile and AE events

The load profile and AE event plot for the 2P test is shown in figure 16. Some randomness was seen in the test pressure values (red dots), so a smoothed version was calculated and is plotted as the black curve. The dotted green lines indicate the point in time where the pressure reaches the previous peak pressure achieved during the 1P tests. A Felicity Ratio of approximately 0.3 supports the conclusion that significant damage did occur during the 1P test. Since the trigger gain was reduced 3 dB from the 1P test to the 2P test, this FR is especially indicting because AE may have been sensed even earlier if the higher gain had been used. The overall larger number of events during 2P test compared to 1P test indicates more rapid damage progression. The larger number of events during unloading after 1100 seconds (~ 20 psi), than has occurred during previous unloadings, also indicates more significant damage had occurred during the 2P test than previously. Figure 17 is a closer view of the same data with a region of interest shaded in yellow between 16-18 psi (885-950 sec) indicated because of increasing strain gauge activity at that time.

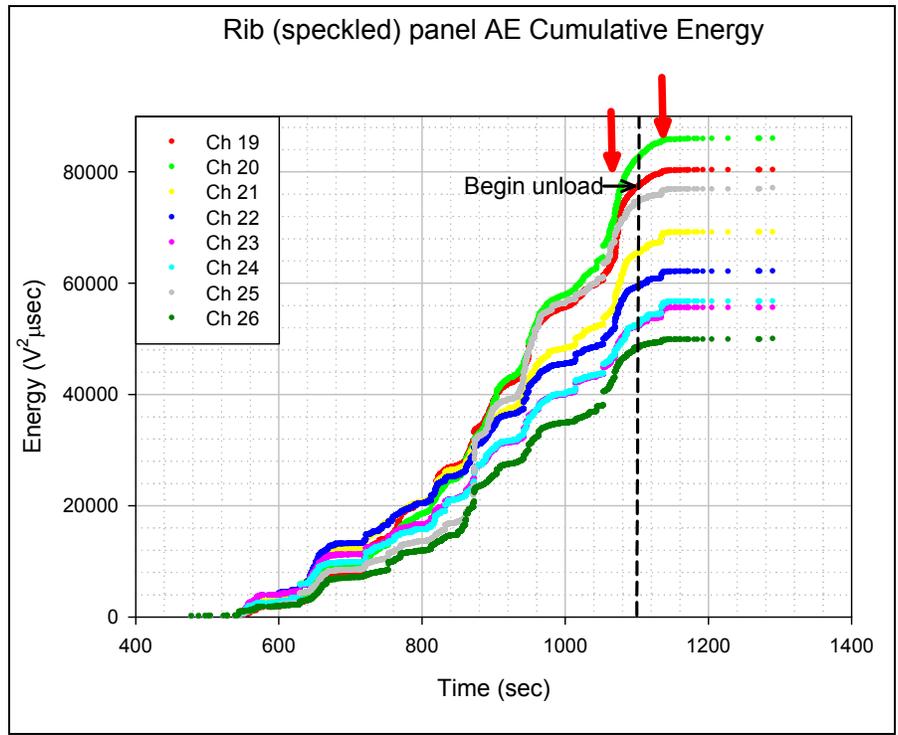
**Figure 21.** Pressure 2P Test: Speckled rib panel AE energy

The vertical black lines indicate the beginning of unloading. In figure 21 of the speckled rib panel that initiated failure during the failure test, a significant increase occurred during unloading; suggesting that the metallic frame splice failure began during the 2P test. Figures 23-27 are close-ups of the cumulative energy plots with the yellow shaded region of strain gage activity-increase between 16 and 18 psi. The red ovals highlight significant increases in cumulative energy, most of them occurring well before the strain gages indicated damage.

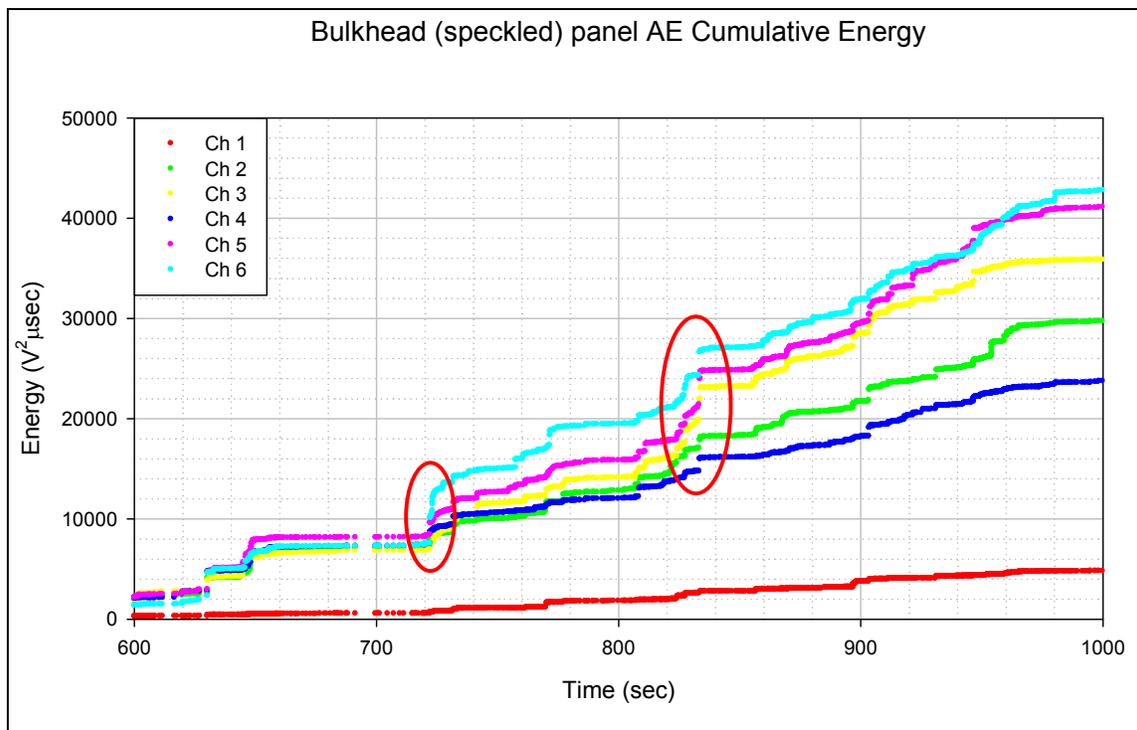
Figure 23. Pressure 2P Test: Close-up of speckled bulkhead panel AE energy near window of strain gage activity

During the 16-18 psi window, higher rates of increase (excluding the noted jumps) in the cumulative energy, occurred on the speckled bulkhead panel (figure 23) and the speckled rib panel (figure 26). Also, on all the panels except the gray bulkhead panel, around 18 psi (950 seconds) at the end of the yellow shaded region, more rapid increases in cumulative energy occurred, especially on speckled rib and crown panels (noted for the delaminations that were discovered after this test). The largest cumulative energy at that point (around 1000 seconds, still approximately 18 psi) are on the speckled rib panel followed by the speckled bulkhead. Sensors 19 and 20 leading on the speckled rib panel may be due to delamination growth in the crown away from sensor 30 toward 27. On the crown, sensor 27 lead with highest cumulative energy for most of the test, followed by sensors 28 and 31. Sensor 27 is the closest crown sensor to the metal frame splice that had failed, suggesting damage development that lead to the splice failing. Both sensors 28 and 31 being high indicate that both delaminations in the crown were growing. As noted previously sensor 29 was weak during the entire series of tests.

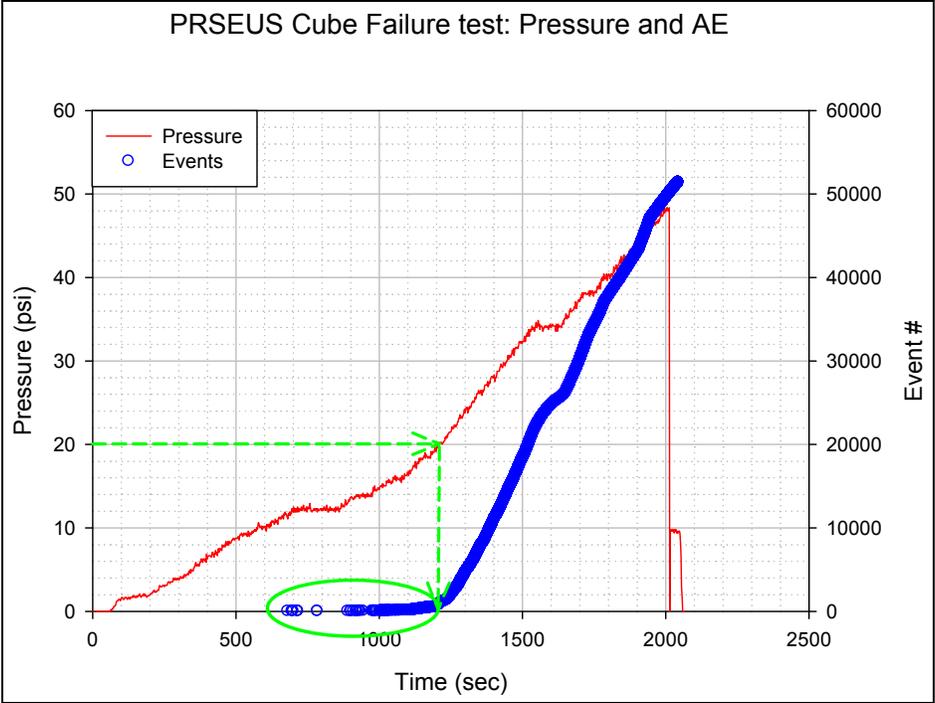
**Figure 28.** Failure Pressure Test Load profile and AE events

The load profile and AE event plot for the failure test is shown in figure 28. The dotted green lines indicate the points in time when AE starts and the time when the pressure reaches the previous peak pressure achieved during the 2P tests. A Felicity Ratio of approximately 0.6 indicates that more damage did occur during the previous 2P test Failure occurs a little after 2000 seconds at a pressure of approximately 48 psi (approximately 5 times the design pressure  $P=9.2$  psi). Figures 29-33 are the cumulative energy plots. All of the plots show a leveling off or reduction of AE rate around 1550-1600 seconds, which coincides with a pressure hold of approximately a minute. This illustrates the extent that AE event rate is affected by load rate.

Variations in load rate should be kept to a minimum during testing, especially when analyzing the AE for onset of different failure mechanisms. The overall behavior, more obvious in this test, but also occurring during previous tests, is that the sensors nearer the floor (especially 6, 12, 18) tend to lead in cumulative energy for each side panel. This could be due to the hatch or the different construction of the floor (relative to the other panels) either making more noise or increasing stresses at the edge of the other panels.

- The AE event rate is affected by load rate. Variations in load rate should be kept to a minimum during testing, especially when trying to analyze the AE for onset of different failure mechanisms.

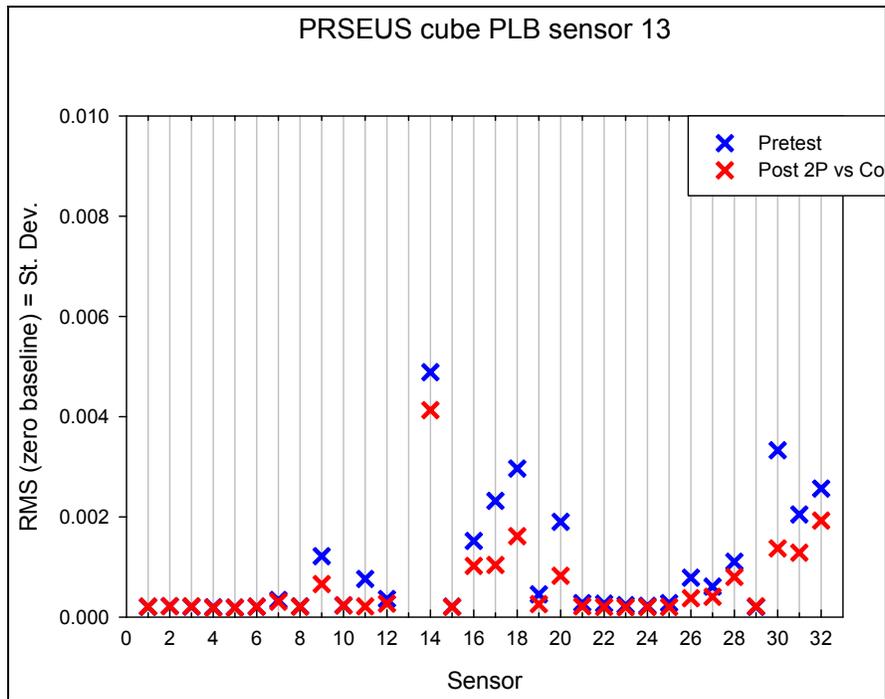
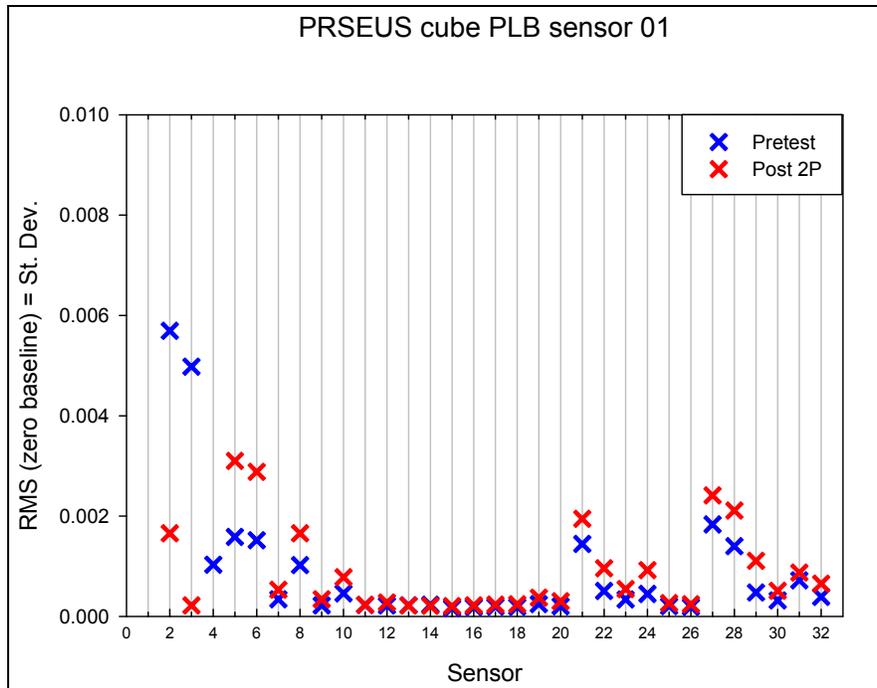
For these tests, an indication of the energies collected at all sensors due to one PLB is made by calculating the RMS (root-mean-square) value for each collected waveform. This is plotted in figures 36-37 with respect to each sensor. Figure 36, for a PLB at sensor 13, shows the expected behavior of attenuation from damage development because all the RMS values prior to testing (blue X) are higher than after the 2P test (red X). To accentuate the sometimes small differences in RMS value, the scale for RMS is such that the values collected at the PLB sensor are off the graph. Figure 37 illustrates the opposite behavior where the post test RMS values are larger than the pretest. Figures 38-41 are spectra of the waveforms collected at a PLB sensor and its nearest neighbors. The pre-test to post comparison of spectra of the “expected-behavior” responses, seen in figures 38 and 39, respectively, shows a decrease in energy post-2P across most all frequencies. Figures 40 and 41, illustrating the inverse behavior for the PLB at sensor 1, show the increase occurring predominantly in the frequencies below 150 kHz. Note that sensor 1 is on the panel that blew out during failure.
