## ***STS-114: Engine Cut-Off Sensors Are a No-Go***

### **Launch Rationale**

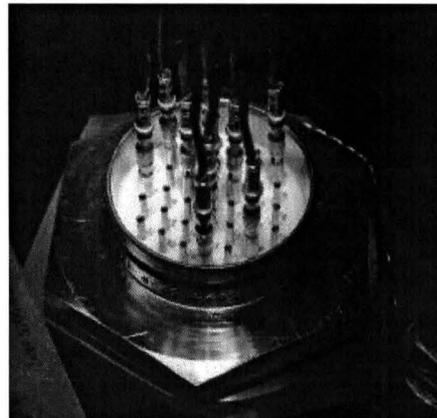
Several launch attempts in which the anomalies were repeated led to successful detection of the problem area. As Robert Kichak points out, “Ultimately the cause of the problems was conclusively determined to be in the external tank cryogenic feed-through connector. We were finally fortunate enough to have the problem occur and persist with the extra instrumentation in place to determine exactly where it was happening,” [2]. Due to the use of time domain reflectometry (TDR) installed during a December 2007 tanking test, the team was capable of pinpointing an open circuit should it recur. ECO-2 and ECO-3 exhibited erratic behavior during testing while ECO-1 failed wet about 25-30 minutes after sensors were initially wetted. An open circuit was indicated somewhere outside of the PSB according to the ECO voltages. TDR equipment was then plugged into staged break points and the open circuits were isolated to the area of the feed-through plate, the part that connects wires from the interior to the exterior of the liquid hydrogen tank, were identified as the culprit causing false readings during launch

*Fig. 2: Soldered pins/sockets [4].*

attempts and tanking tests. Modifications were made to solder the external harness sockets and the feed-through pins of these connectors together. Once subjected to temperature, pressure, and vibration environments identical to those experienced during a Shuttle launch, the new configuration was verified as adequate and led to successful performance thereafter.

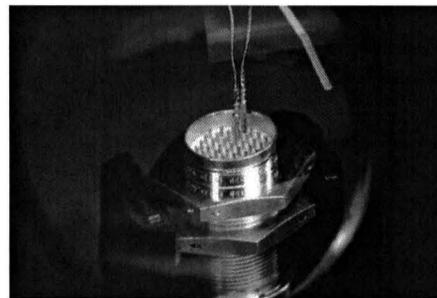
*Fig. 3: Modified feed-through connector [6].*
