## ***So Close Yet So Far: The Jammed Airlock Hatch of STS-80***

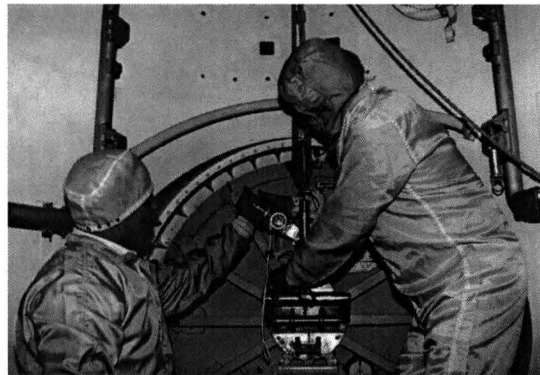
*Figure 4: Engineers continue testing on the interior side of the outer airlock hatch to identify malfunctions. NASA Image*

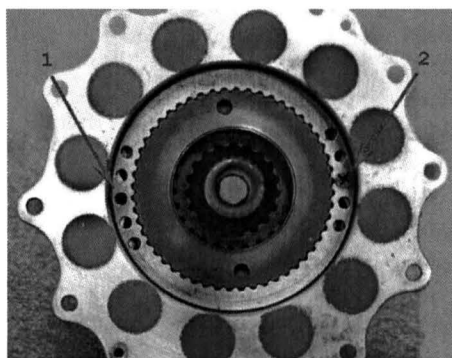
During a post-landing inspection, engineers concluded a faulty actuator assembly was to blame for the malfunction. A new actuator assembly was installed on the orbiter and worked flawlessly. Upon further inspection of the faulty actuator, engineers discovered a screw lodged in between a planetary gear and ring gear in the gearbox. The loose screw originated from a clutch assembly and most likely fell between the gears during launch or once in orbit. A second screw from the clutch assembly was found loose, but caused no operational issues with the actuator.

Engineers also concluded that improper thread inserts were used with the screws, which allowed them to loosen over time and eventually back out of the clutch assembly; non-locking thread inserts were used when design specifications called for locking thread inserts to be used. Additionally, appropriate torque values were not included in the engineering drawings of the assembly.

A detailed maintenance investigation was completed for the faulty actuator. Results determined that the screws were removed and re-installed five times without replacing the proper thread inserts. Investigations performed on the rest of the fleet identified another 12 actuators with improper inserts (some with one locking and one non-locking insert), all of which contained loose screws. As a result, all orbiters were re-fitted with the proper thread inserts and engineering drawings were updated to include torque specifications.

Figure 6: STS-80 actuator assembly showing missing and loose screws. NASA Image

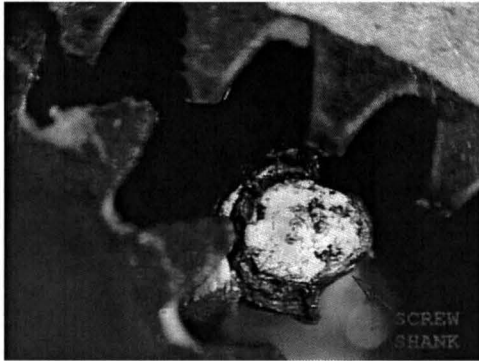
Figure 7: Close-up of jammed screw between ring and planetary gears. NASA Image

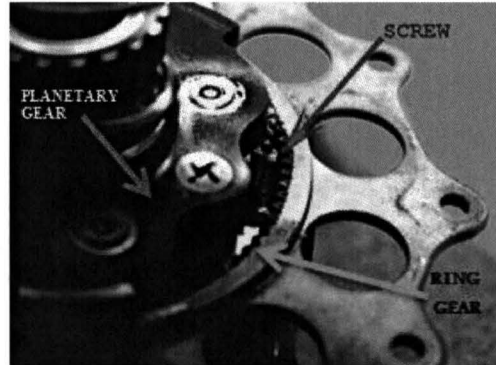
Figure 8: Screw lodged between planetary gear and ring gear. NASA Image
