International Space Station (ISS) Soyuz Vehicle Descent Module Evaluation of Thermal Protection System (TPS) Penetration Characteristics

Hypervelocity Impact Technology Group

February 2013

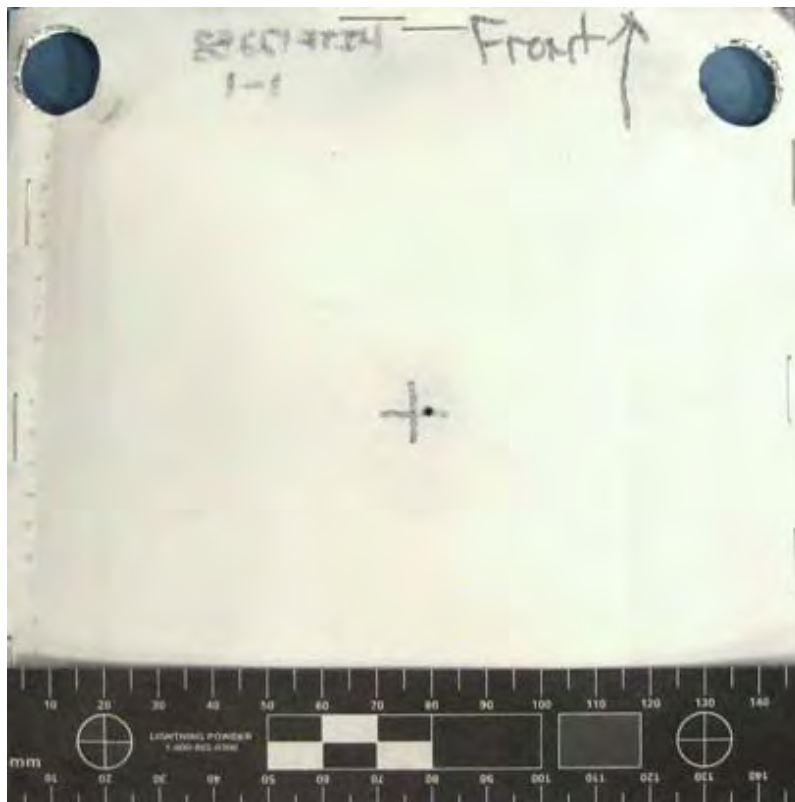
Figure 11 Overall View of Damage to Front of MLI (scale in 5mm increments / black arrow indicates flight path of projectile)

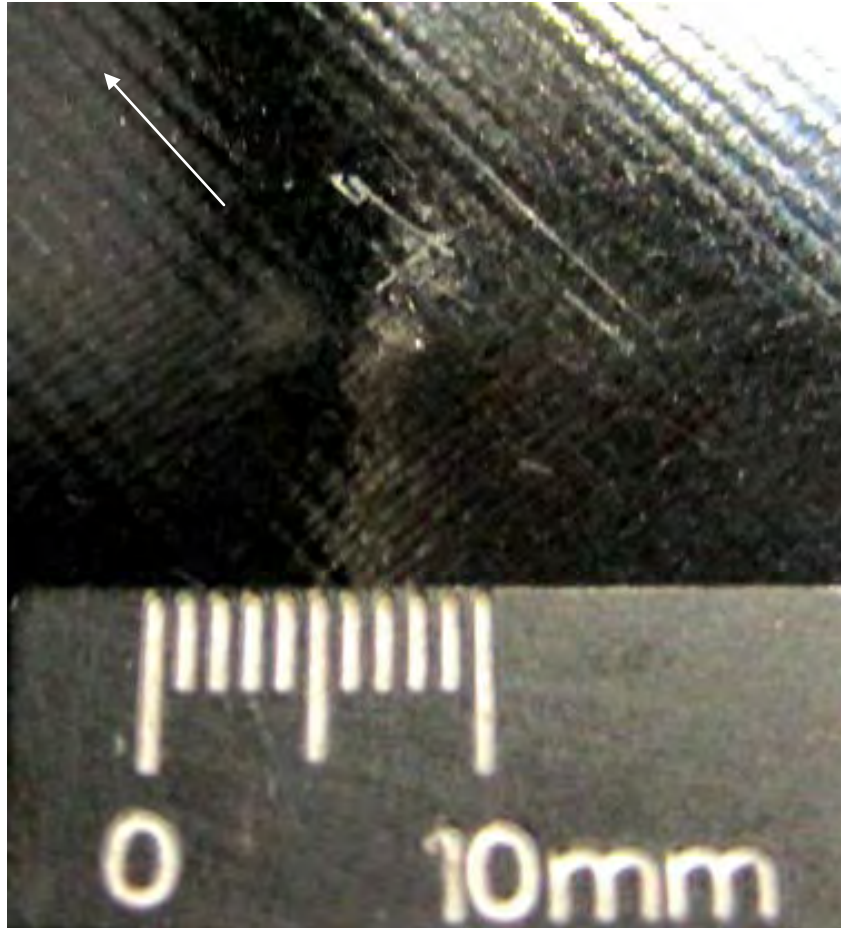
Figure 20 Close-up Oblique Side View of Damage to Back Side of NP 504 Substrate (scale in 1mm increments / white arrow indicates flight path of projectile)

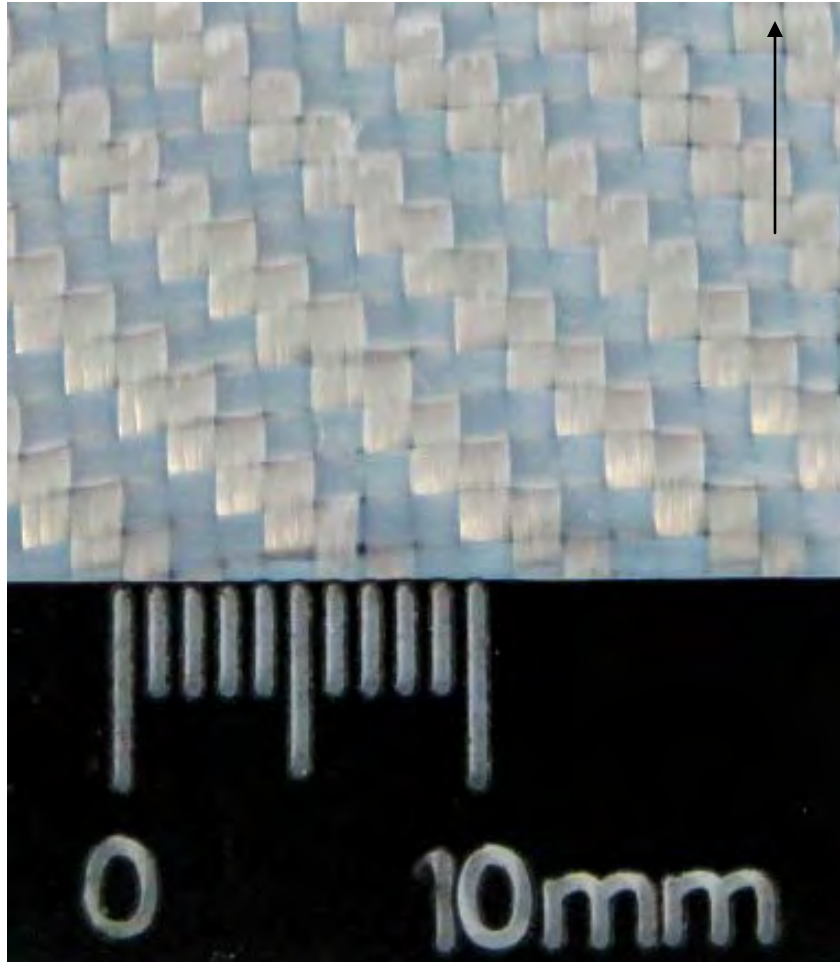
Figure 35 Close-up View of Damage to Back Side of 1st Fiberglass Layer (scale in 1mm increments / black arrow indicates flight path of projectile)

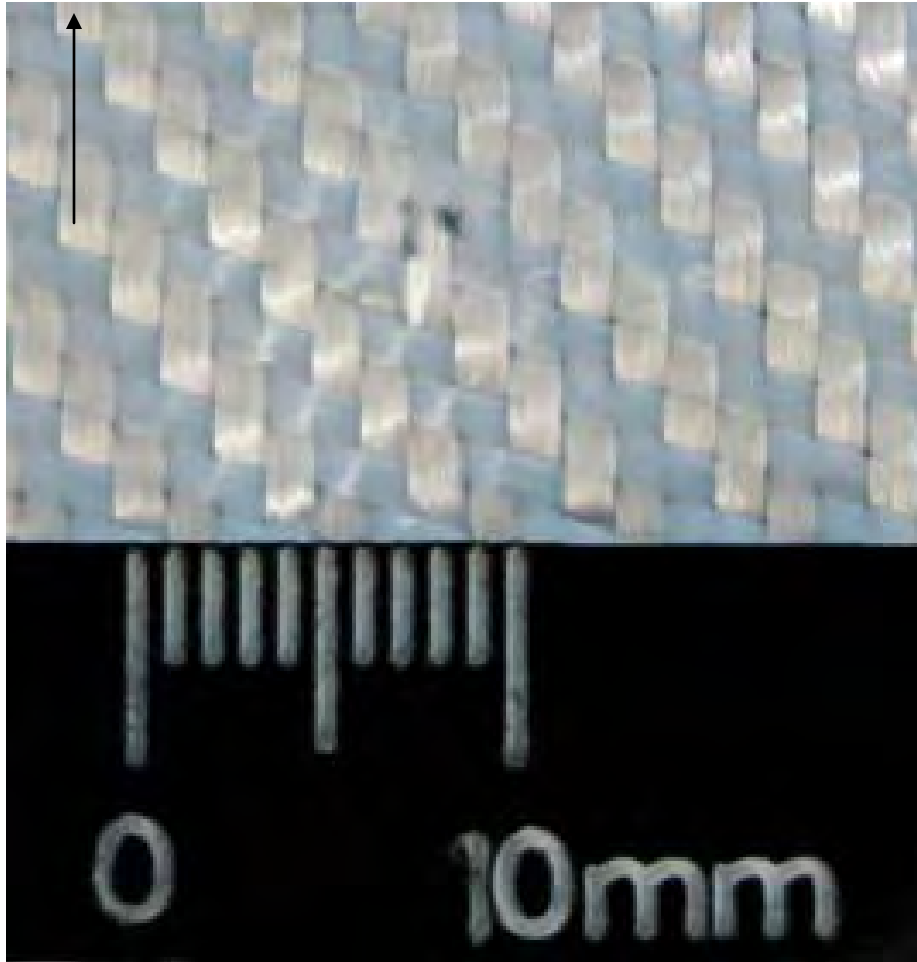
3 HITF12285	Type 1 Average thin	Steel 440C	1.00	0.00400	5.04	30	<p>NP 504 Substrate = Pass / Pressure Shell = Pass Beta cloth entry damage = 2.3 x 1.9 perforation MLI exit damage = 11.0 x 8.4 petalled perforation with ripping propagating away from the perforation with the largest rip being 28.9 tip to tip NP 504 entry damage = impacts present within 34.9 x 22.6 area with exposed severed ply's present within 5.8 x 4.9 area, no perforation present (light tight) NP 504 exit damage = 16.7 x 15.1 bump present on back side that has a maximum height of 0.7, there is a 5.3 x 2.9 detached spall area on top of bump, no perforation present (light tight) FG 7725 damage = 1.6 x 1.5 darkened area on back side of 2nd layer, no perforation present Rear wall damage = none present</p>

Figure 50 Close-up View of Damage to Back Side of 2nd Fiberglass Layer (scale in 1mm increments / black arrow indicates flight path of projectile)

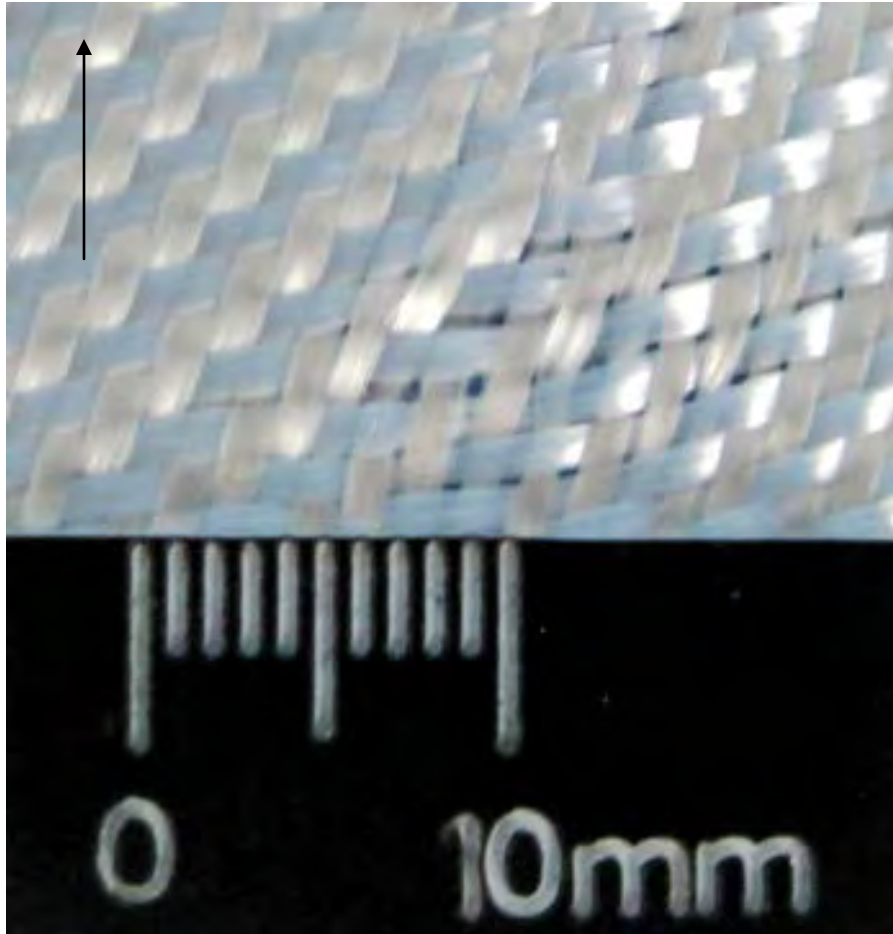
Figure 65 Close-up View of Damage to Back Side of 1st Fiberglass Layer (scale in 1mm increments / black arrow indicates flight path of projectile)

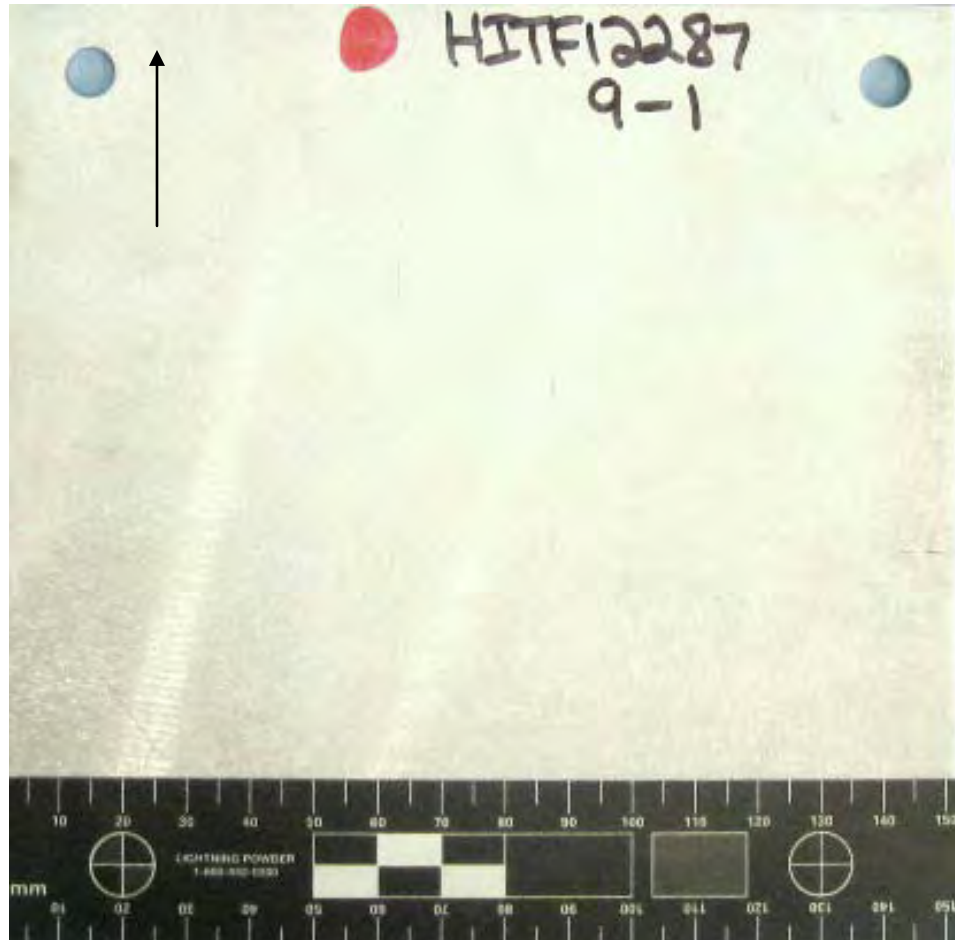
Figure 84 Overall View of Back Side of Rear Wall (scale in 5mm increments / black arrow indicates flight path of projectile)

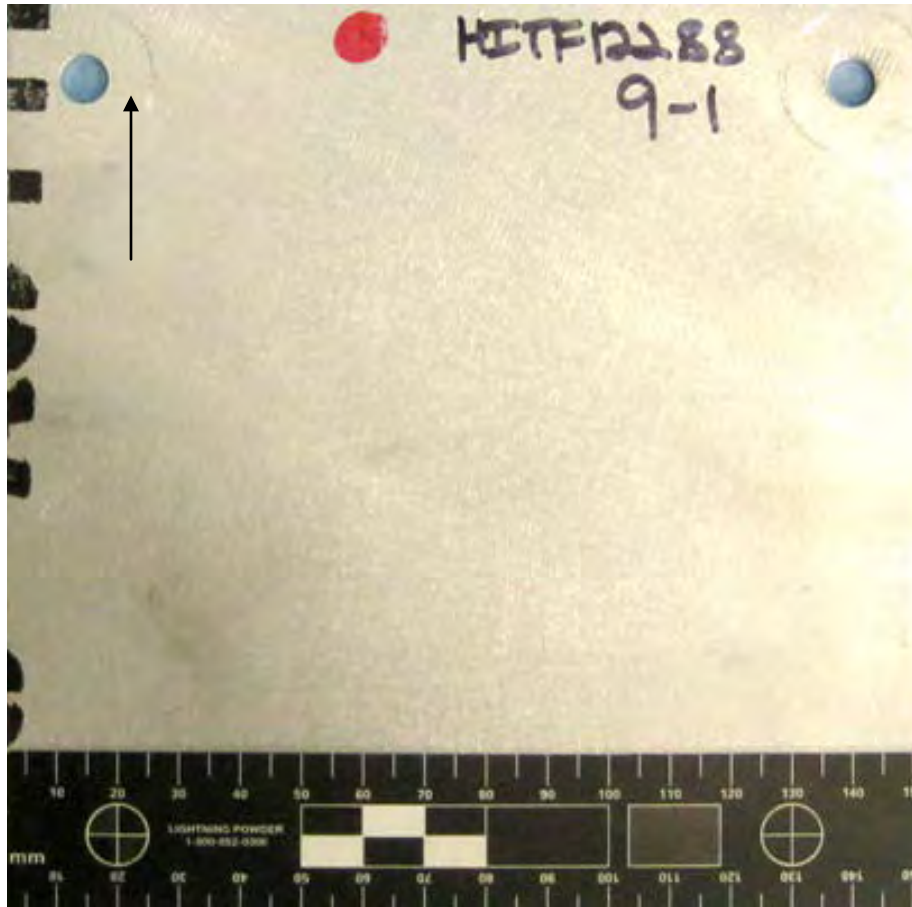
Figure 103 Overall View of Damage to Front of Rear Wall (scale in 5mm increments / black arrow indicates flight path of projectile)

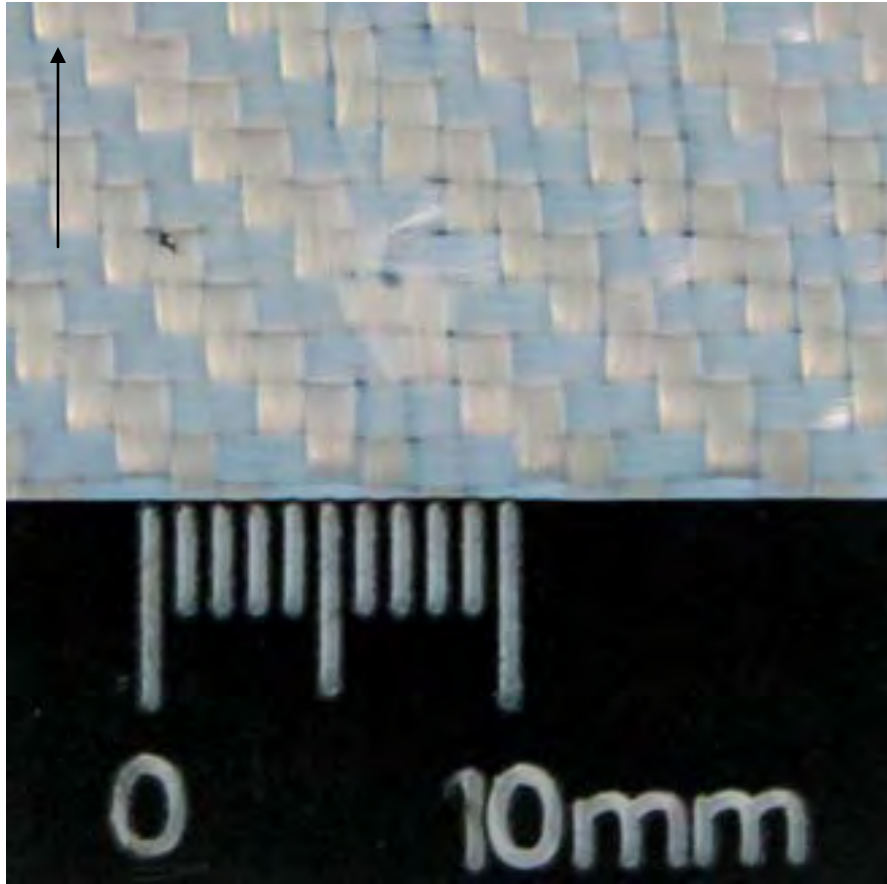
Figure 136 Close-up View of Damage to Back Side of 7th Fiberglass Layer (scale in 1mm increments / black arrow indicates flight path of projectile)

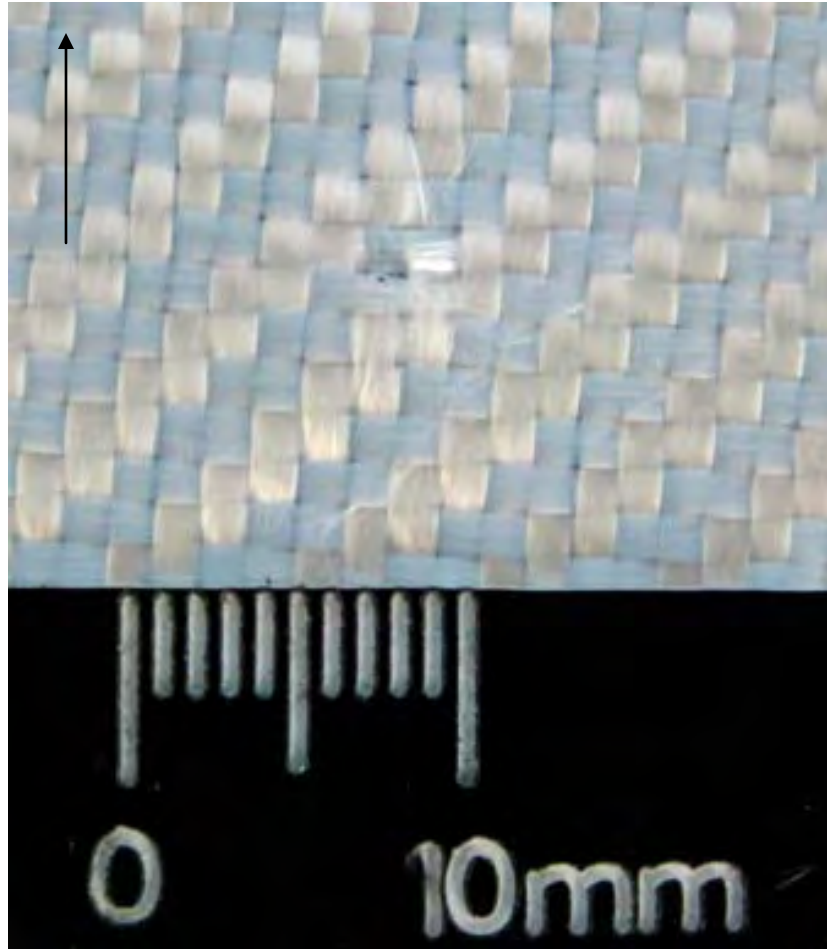
Figure 151 Close-up View of Damage to Back Side of 8th Fiberglass Layer (scale in 1mm increments / black arrow indicates flight path of projectile)

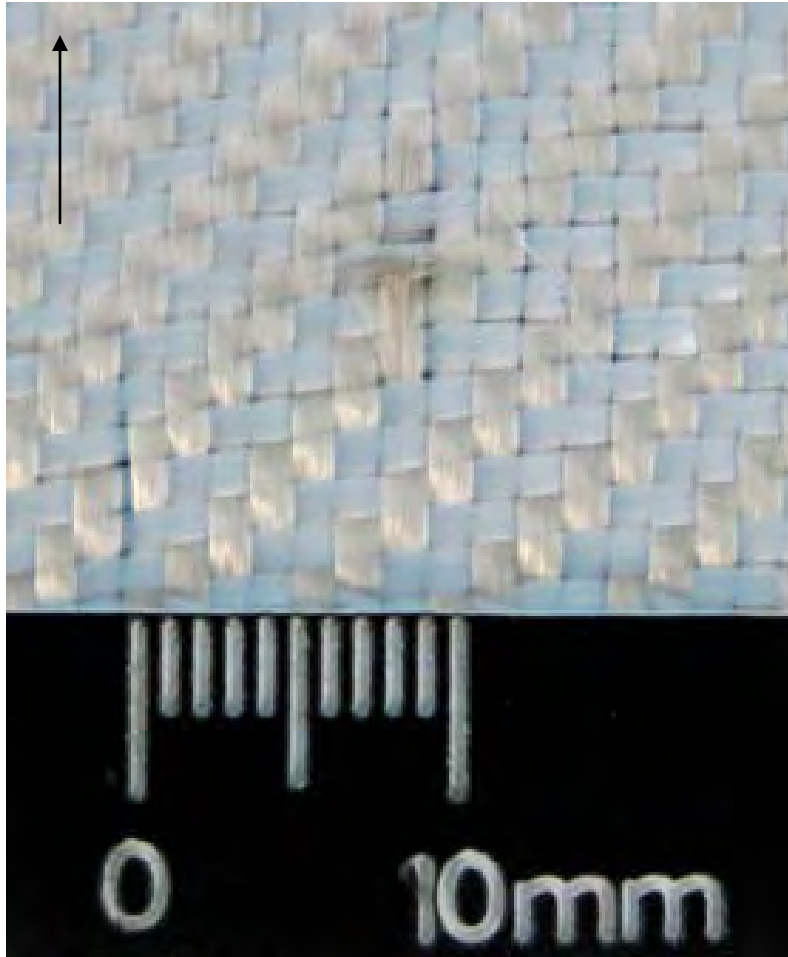
Figure 166 Close-up View of Damage to Back Side of Last Fiberglass Layer (scale in 1mm increments / black arrow indicates flight path of projectile)

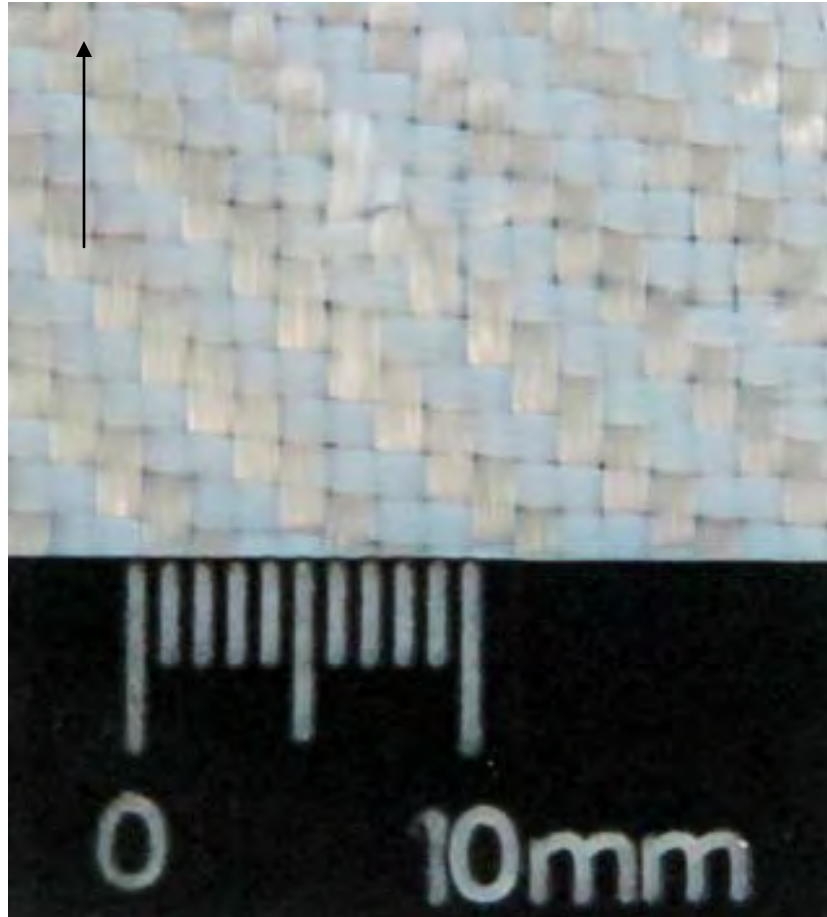
Figure 181 Close-up View of Damage to Back Side of 9th Fiberglass Layer (scale in 1mm increments / black arrow indicates flight path of projectile)

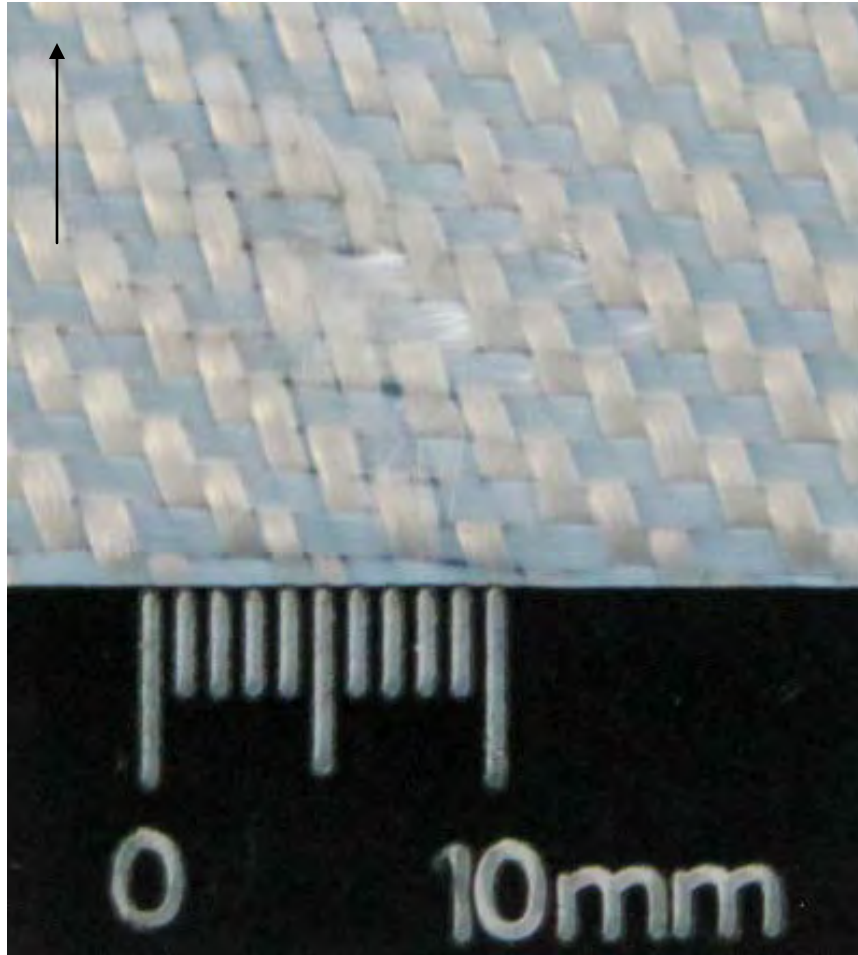
Figure 196 Close-up View of Damage to Back Side of 7th Fiberglass Layer (scale in 1mm increments / black arrow indicates flight path of projectile)

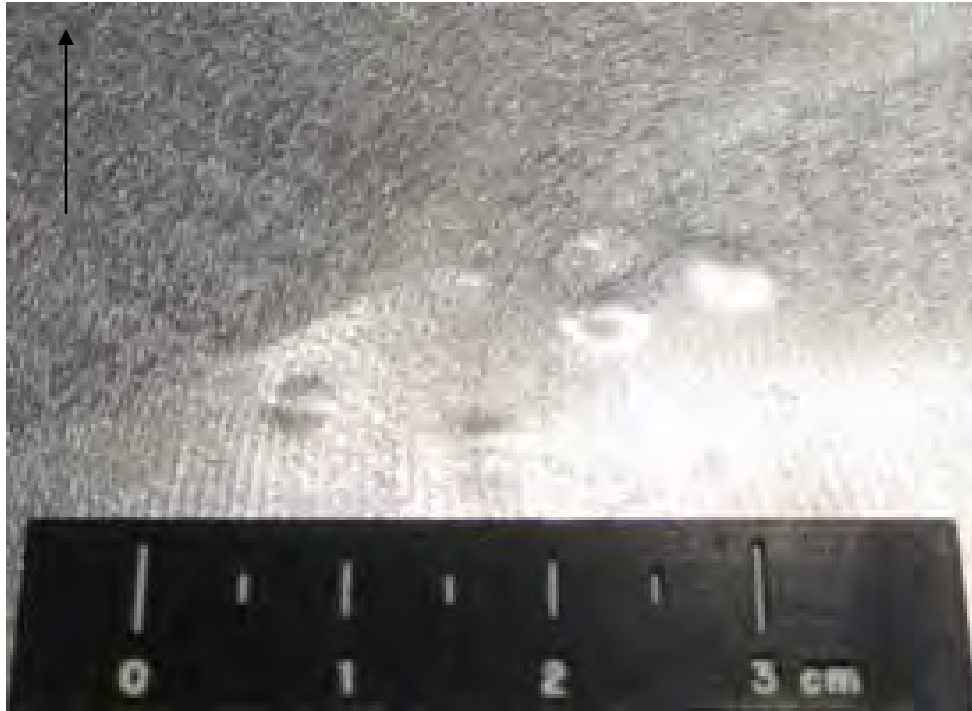
Figure 406 Close-up Oblique Side View of Damage on Back Side of Rear Wall (scale in 5mm increments / black arrow indicates flight path of projectile)

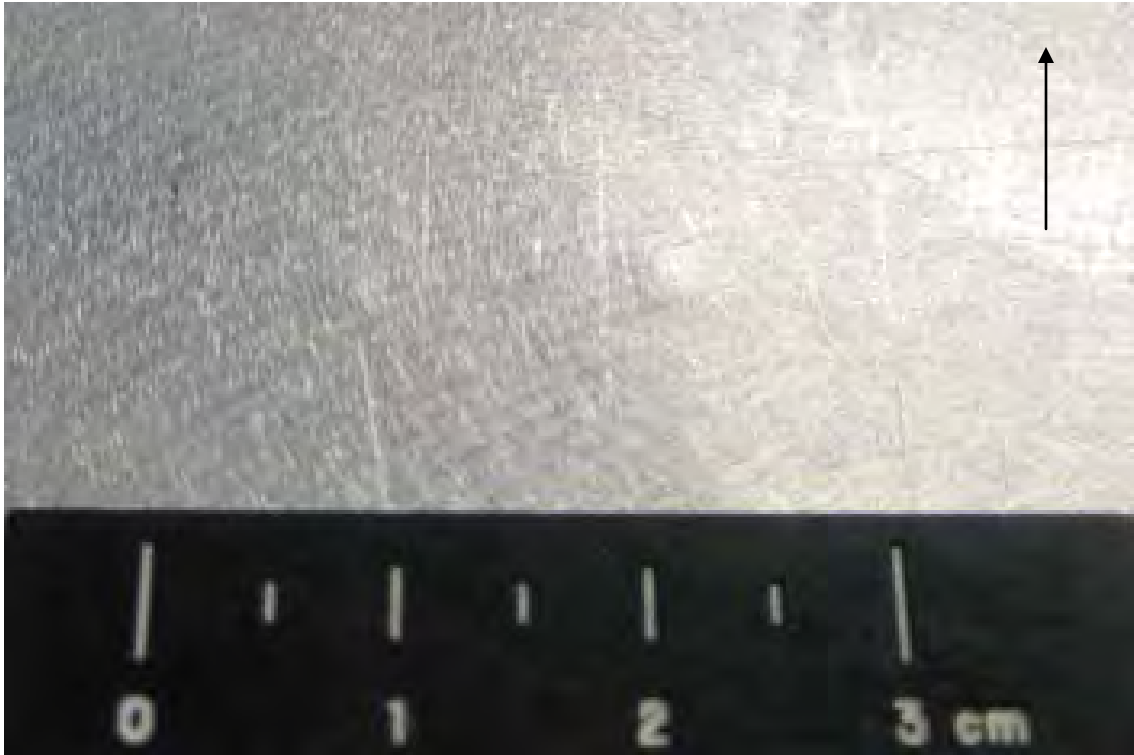
Figure 485 Close-up Oblique Side View of Damage to Back Side of Rear Wall (scale in 5mm increments / black arrow indicates flight path of projectile)

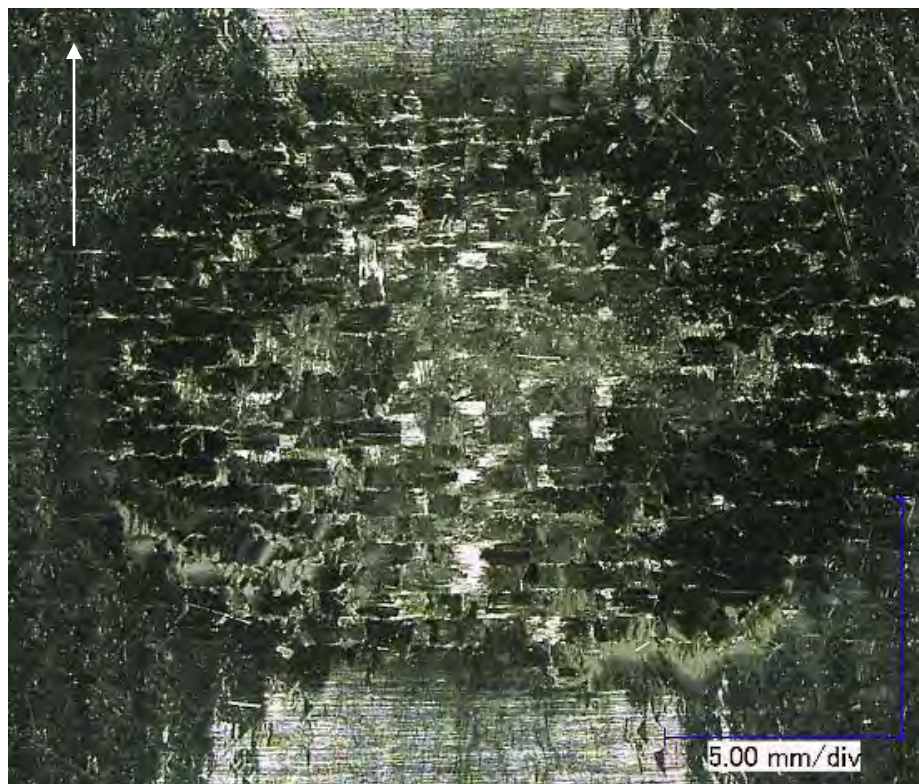
Figure 515 Close-up View of Most Significant Damage to Back Side of NP 504 Substrate (black arrow indicates flight path of projectile / damage within red circle in Figure 514)

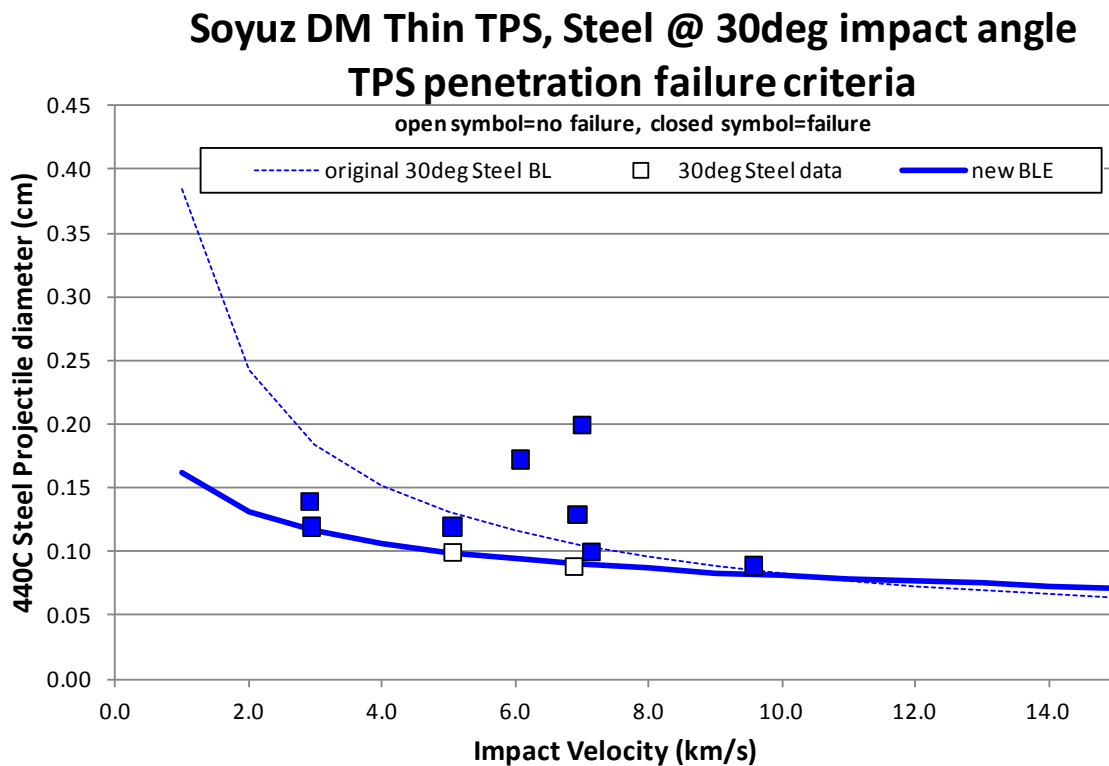
Figure B4. Predicted BLE versus test data for 30 deg impacts by steel projectiles on thin TPS (target type 1)

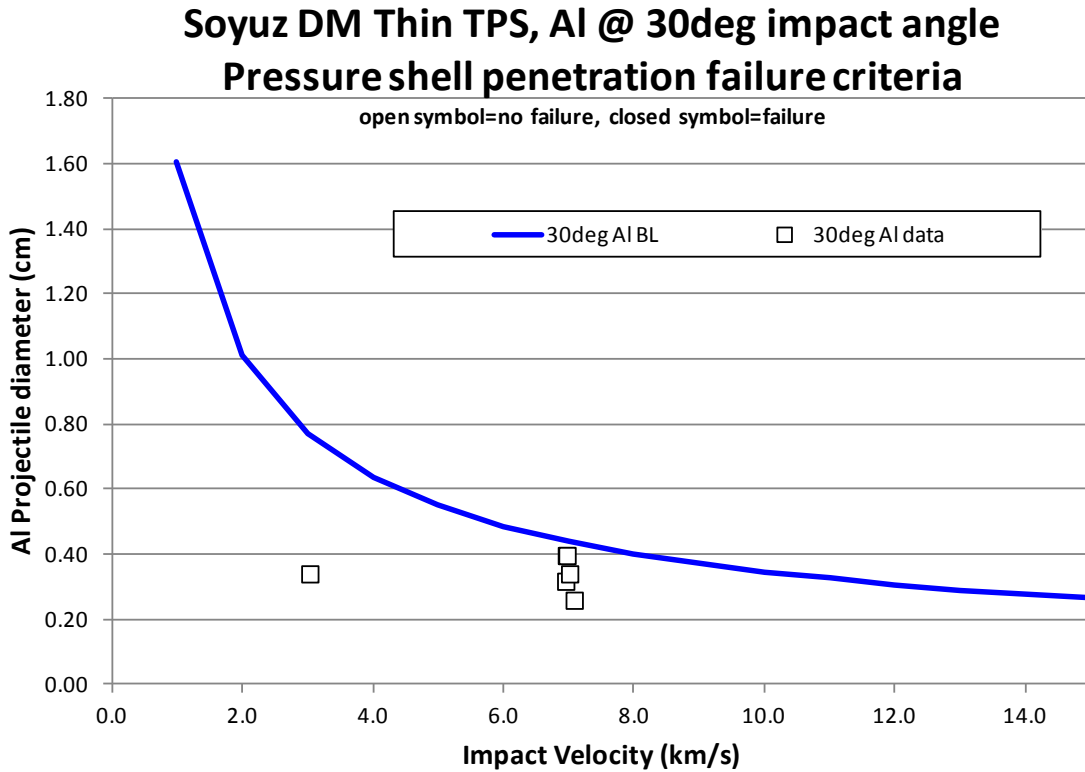
Figure B10. Predicted BLE for perforation failure of the pressure shell behind the TPS versus test data for 30 deg impacts by aluminum projectiles on thin TPS (target type 1)
