DETERMINE ISS SOYUZ ORBITAL MODULE BALLISTIC LIMITS FOR STEEL PROJECTILES HYPERVELOCITY IMPACT TESTING

Hypervelocity Impact Technology Group (HVIT)
Astromaterials Research and Exploration Science (ARES) Directorate
Human Exploration Science Office, KX

July 2013

Prepared for the
ISS Systems Engineering and Integration Office

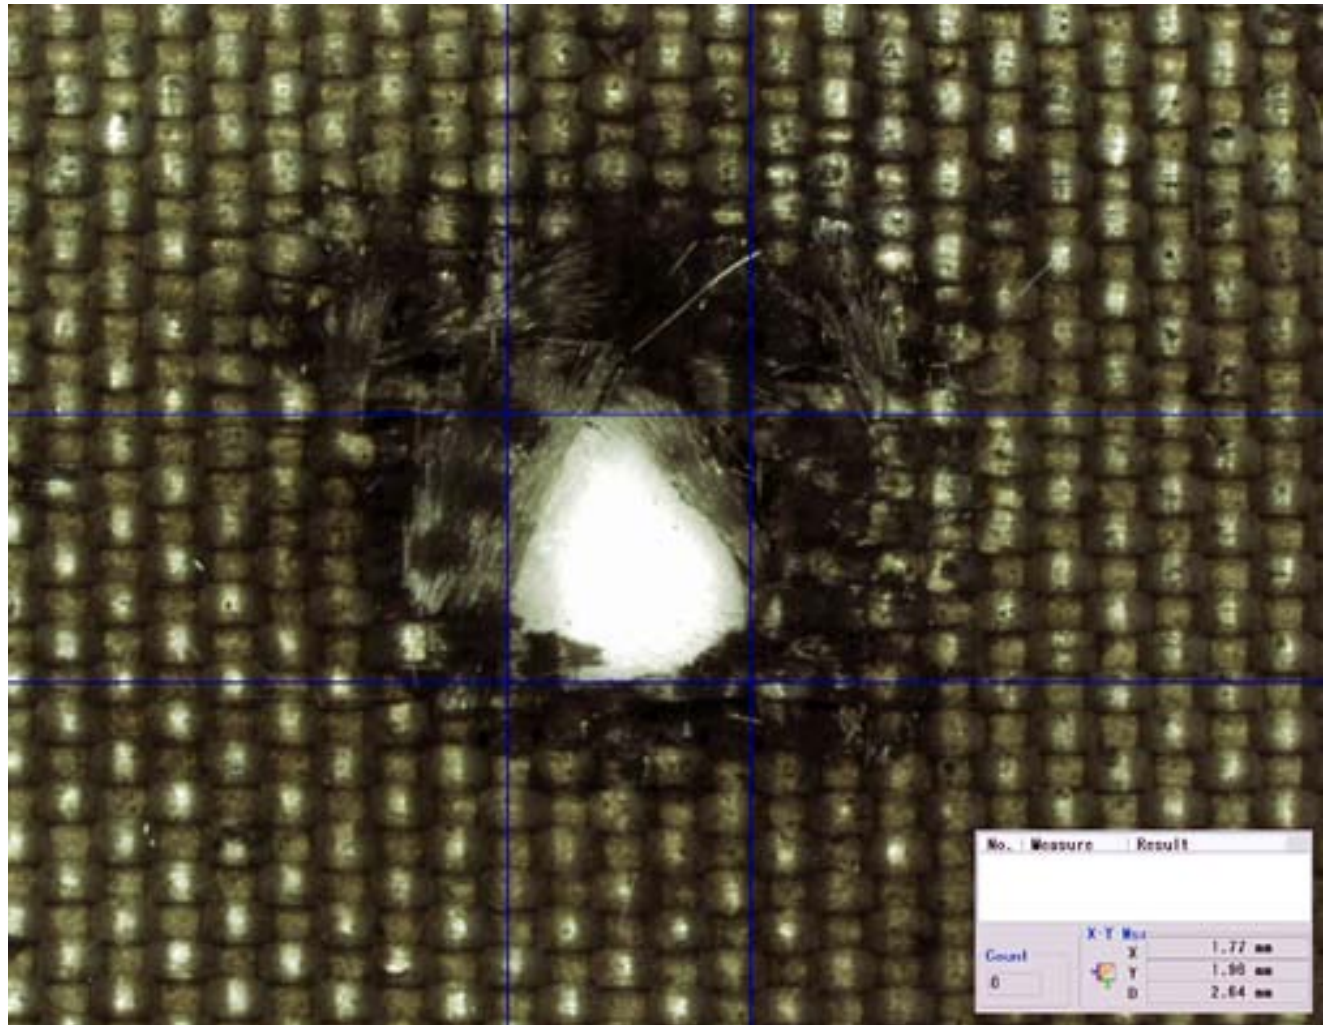
Test #1, HITF12257

Figure 18: Beta Cloth Bumper Layer 1 of ISS Soyuz OM Test #1 (Keyence 3D Microscope Image)

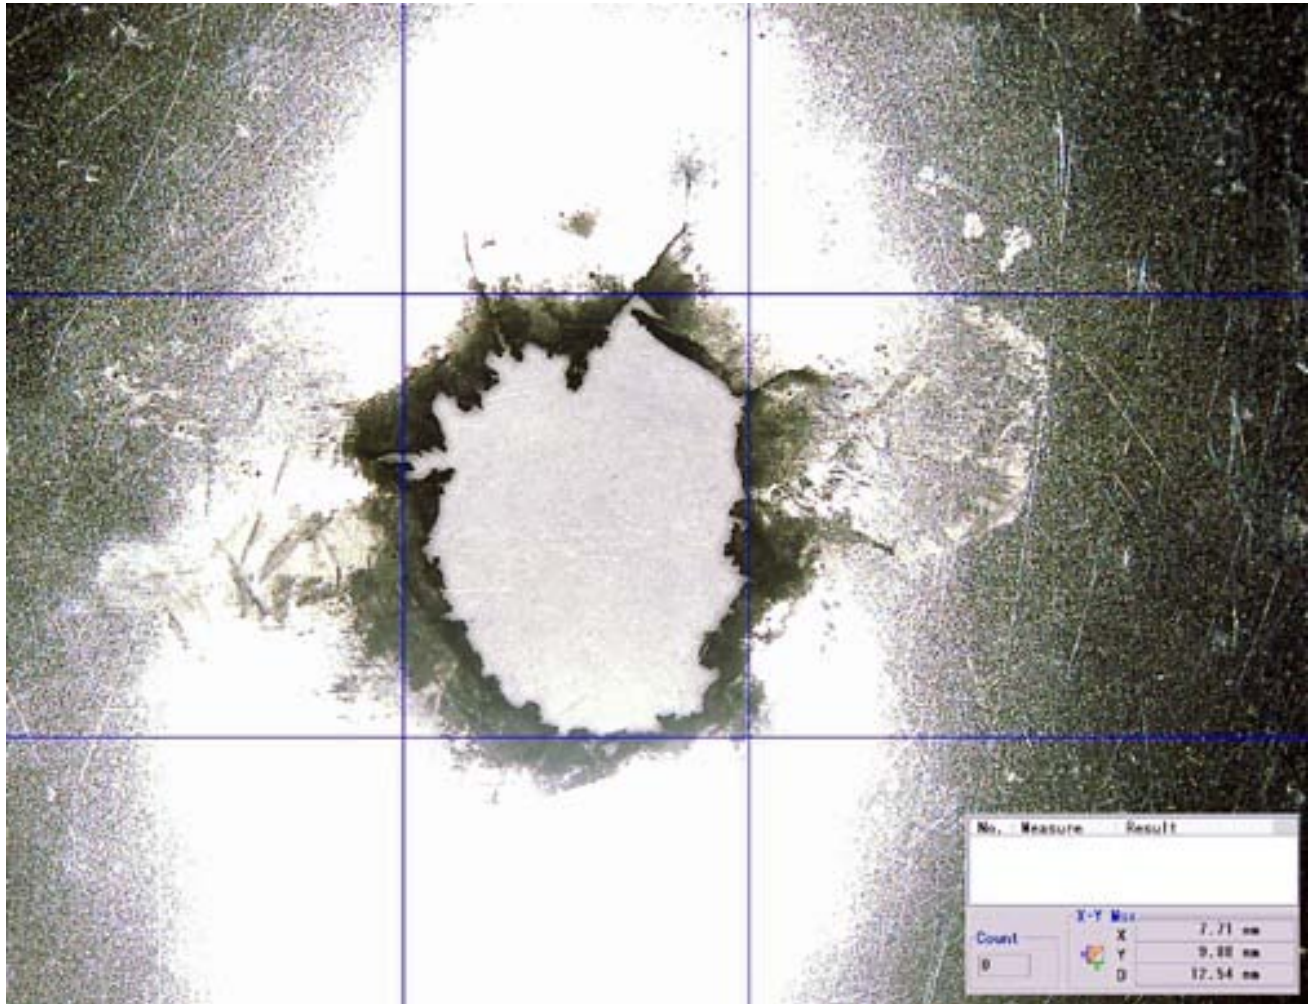
Test #1, HITF12257

**Figure 24: Multi-layer Insulation Aluminumized Mylar Layer 6 Back of
ISS Soyuz OM Test #1
(Keyence 3D Microscope Image)**

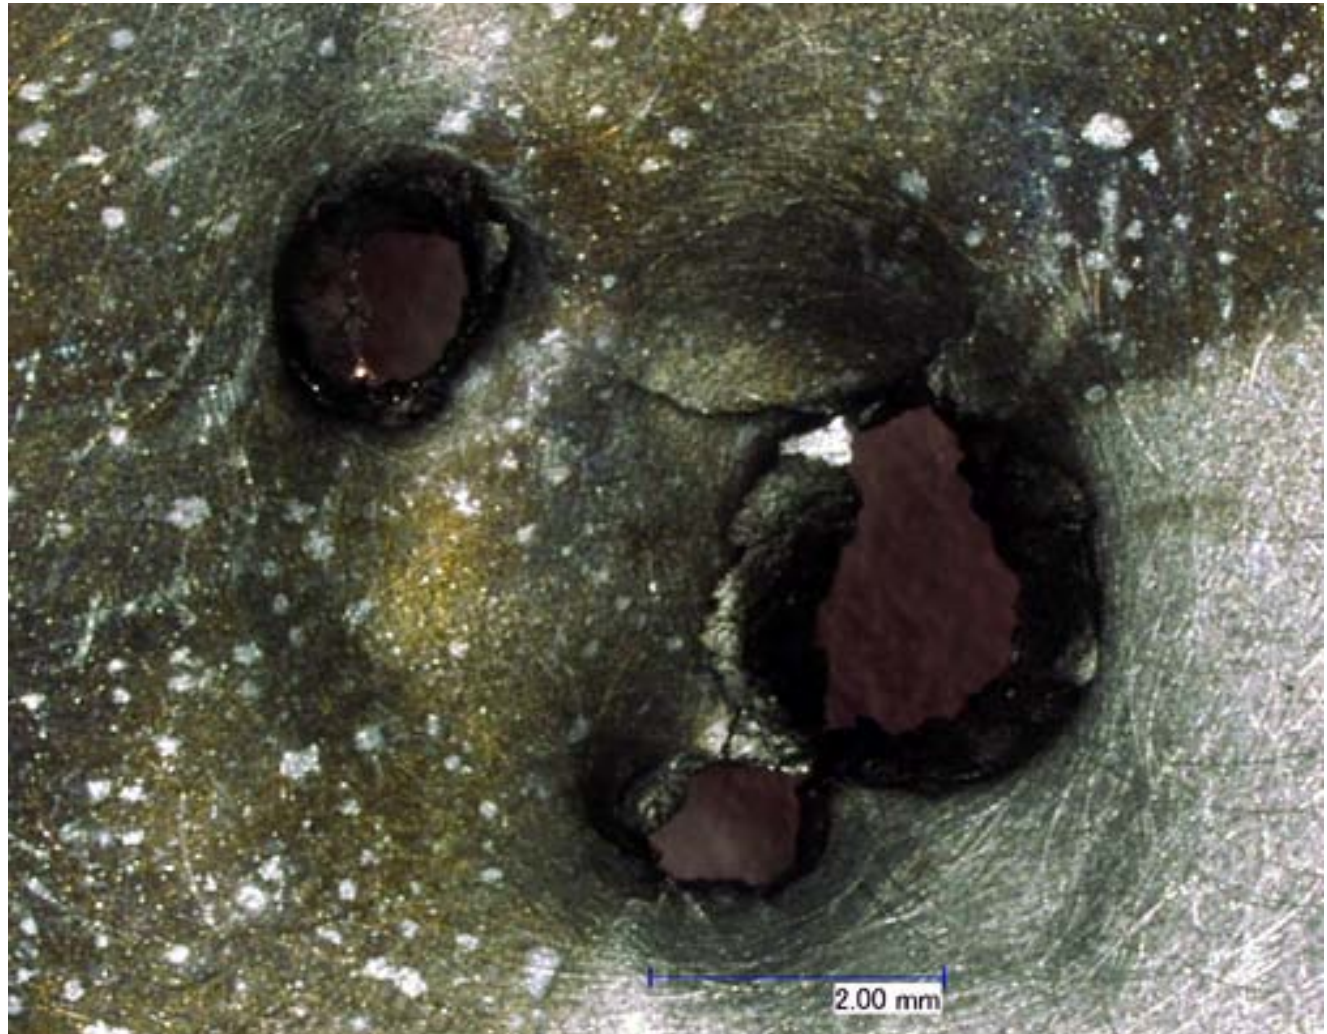
Test #1, HITF12257

Figure 28: Al 5456-0 Rear Wall Layer 8 Back of ISS Soyuz OM Test #1
(Keyence 3D Microscope Image)

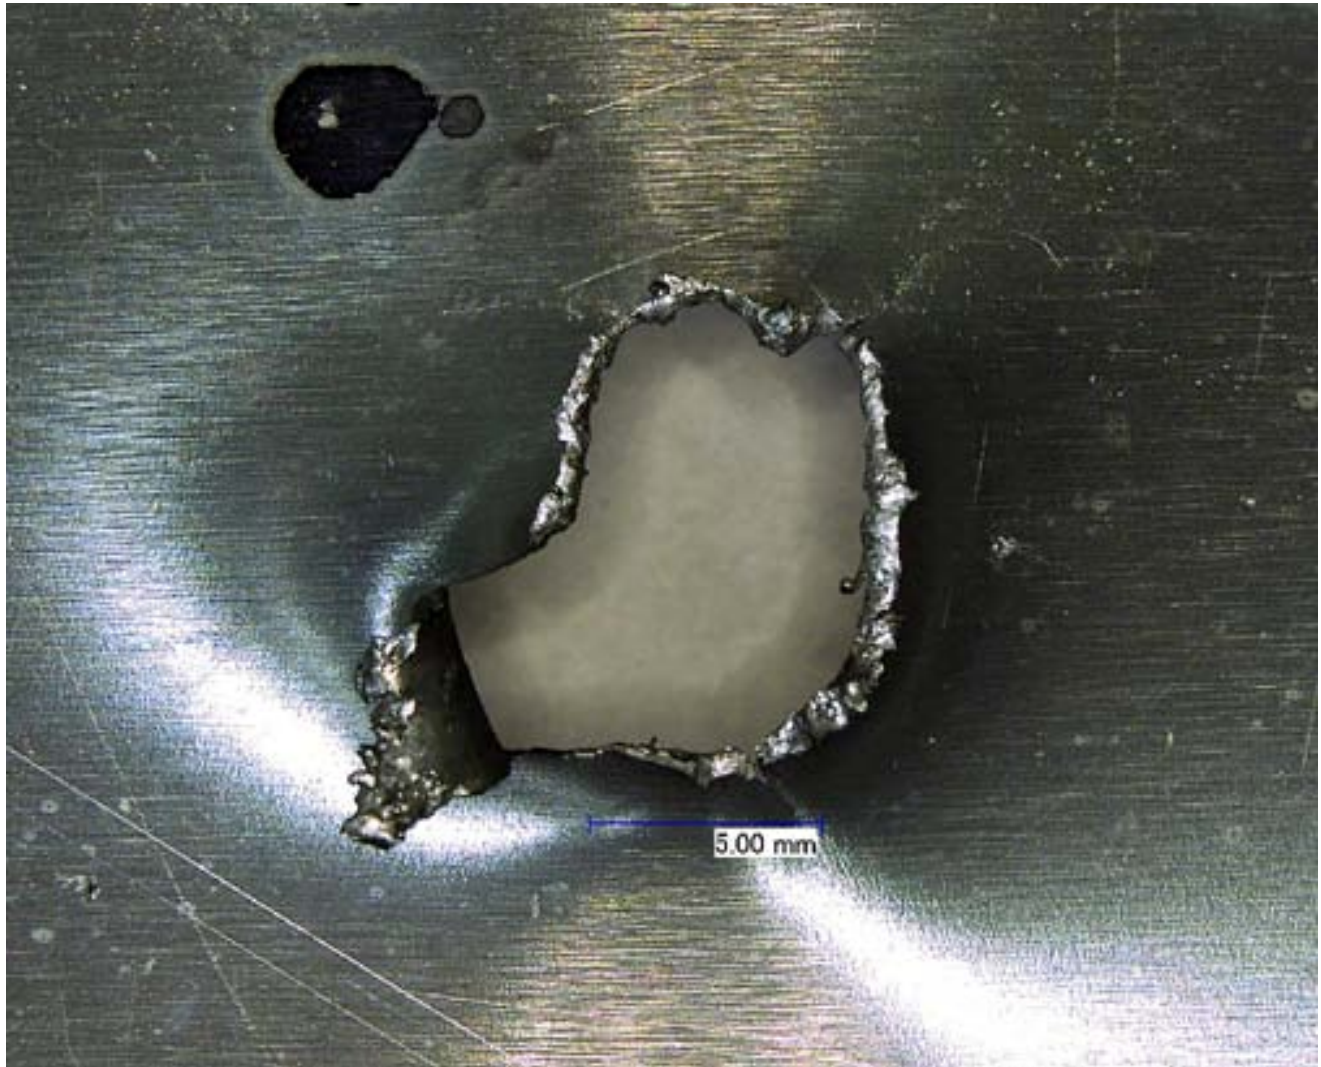
Test #9, HITF12265

9 HITF12265	1.6	0.01615	7.14	45	<p>Fail</p> <p>Beta cloth entry damage = 5.49mm x 17.51mm hole Mylar Film damage = 35.16mm x 19.19mm hole Fiberglass damage = 13.55 x 14.32mm hole Al 6061 Foil damage = 9.50 x 14.24mm hole Fiberglass damage = 14.57 x 16.36mm hole MLI exit damage = 8.51mm x 11.30mm hole Al 6061-T6 plate damage = 8.93mm x 9.57mm hole Al 5456-0 RW damage = 1.50 x 2.39mm hole Al 2024-T3 WP damage = 31mm x 30mm area of aluminum specks</p>
10 HITF12266	1.39	0.01075	3.19	30	<p>Fail</p> <p>Beta cloth entry damage = 1.56mm x 1.50mm hole Mylar Film damage = 13.80mm x 15.43mm hole Fiberglass damage = 2.67 x 2.27mm hole Al 6061 Foil damage = 2.50 x 2.74mm hole Fiberglass damage = 2.45 x 2.93mm hole MLI exit damage = 3.83mm x 4.66mm hole Al 6061-T6 plate damage = 2.53mm x 2.92mm hole Al 5456-0 RW damage = 2.84 x 3.09mm hole Al 2024-T3 WP damage = 1.48mm x 1.93mm x 0.089mm deep crater & many smaller</p>

Figure 157: Al 6061-T6 Layer 7 Back of ISS Soyuz OM Test #9
(Keyence 3D Microscope Image)

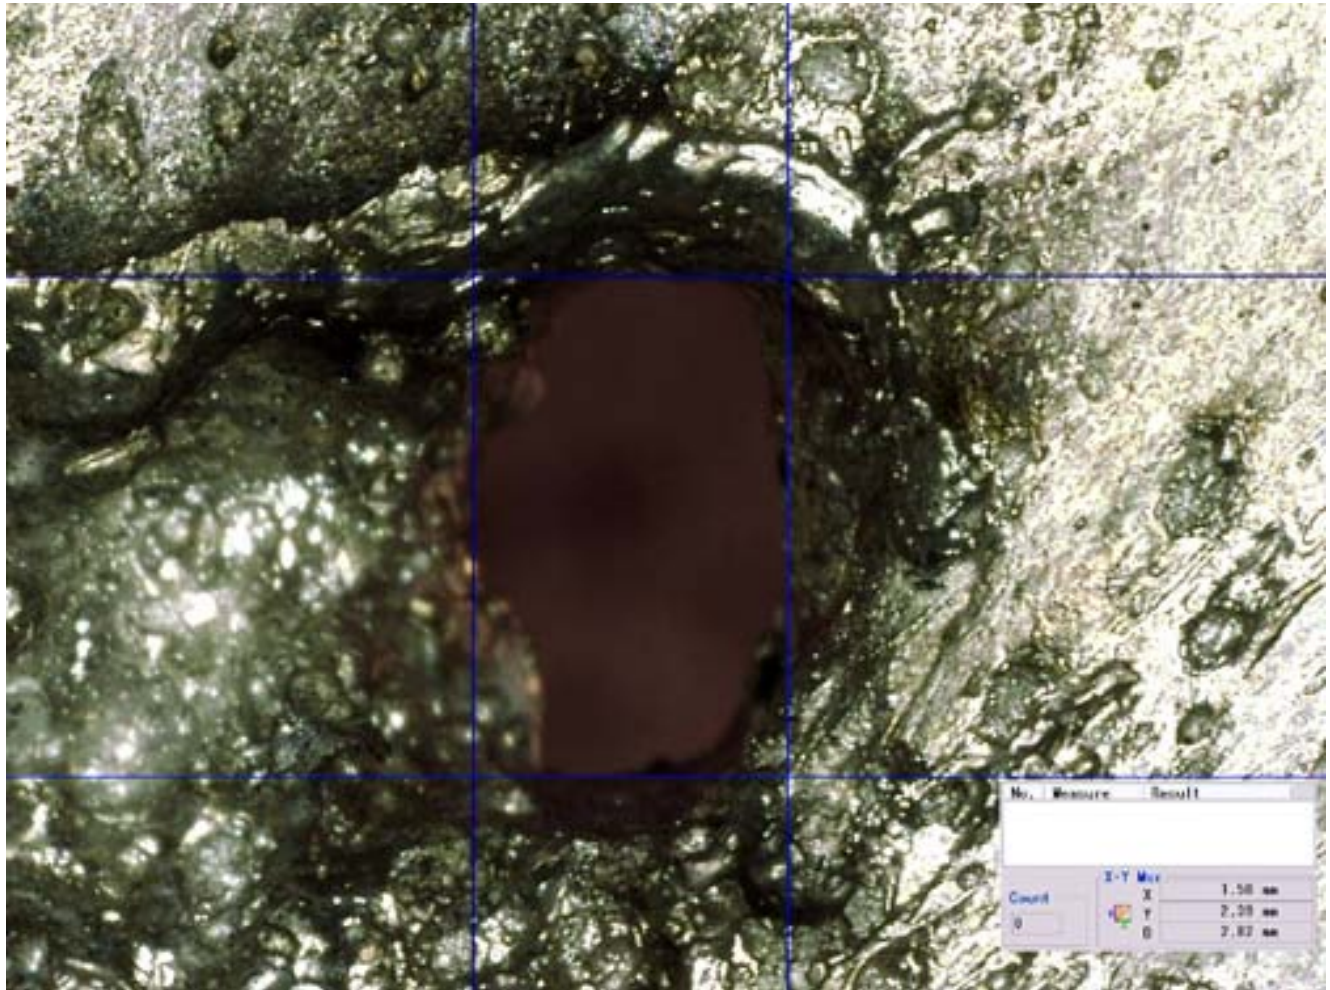
Test #9, [HITF12265 Rear Wall](#)

**Figure 158: AI 5456-0 Rear Wall Layer 8 Front of ISS Soyuz OM Test #9
(Keyence 3D Microscope Image)**

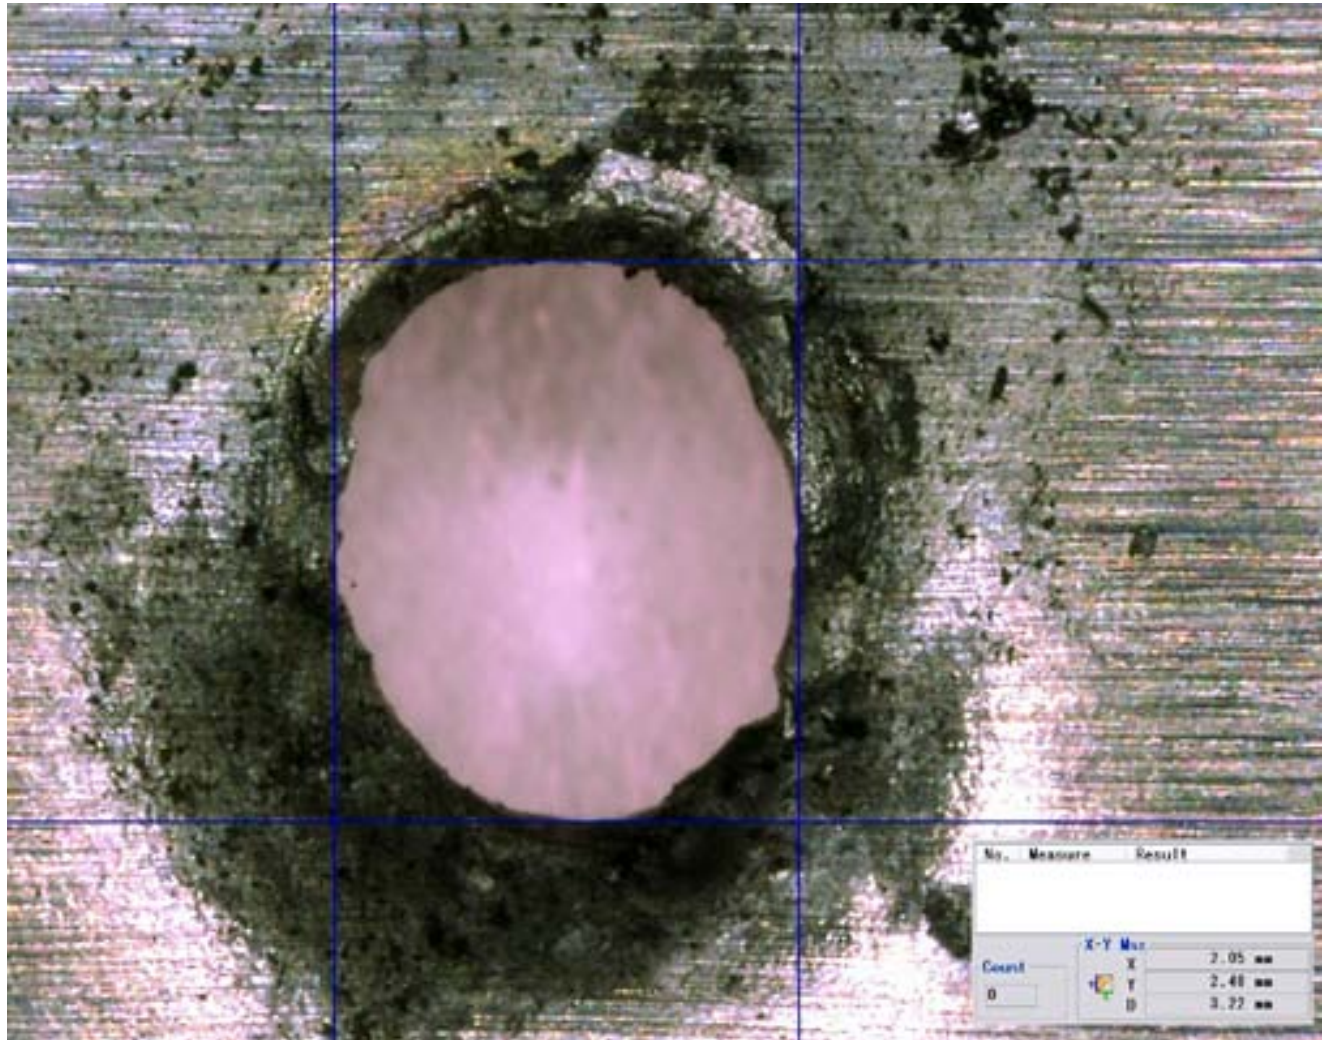
Test #13B, HITF12273

13B HITF12273	1.29	0.00863	2.87	30	<p>Fail</p> <p>Beta cloth entry damage = 1.39mm x 1.35mm hole Mylar Film damage = 6.54mm x 5.89mm hole Fiberglass damage = 2.42mm x 2.98mm hole Al 6061 Foil damage = 2.53mm x 2.50mm hole Fiberglass damage = 2.84mm x 2.95mm hole MLI exit damage = 3.03mm x 4.17mm hole Al 6061-T6 plate damage = 2.05mm x 2.48mm hole Al 5456-0 RW damage = 2.23mm x 2.33mm hole Al 2024-T3 WP damage = 0.64mm x 0.74mm x 0.1mm deep crater & several smaller</p>
6B HITF12262	1.49	0.01332	7.14	30	<p>Pass</p> <p>Beta cloth entry damage = 1.97mm x 1.72mm hole Mylar Film damage = 24.76mm x 31.83mm hole Fiberglass entry damage = 7.66mm x 11.22mm hole Al 6061 Foil damage = 8.67mm x 6.48mm hole Fiberglass exit damage = 12.33mm x 11.26mm hole MLI exit damage = 8.01mm x 8.64mm hole Al 6061-T6 plate damage = 6.66mm x 5.18mm hole Al 5456-0 RW damage = 0.97mm x 1.11mm x 1.09mm deep crater of many with a 0.94mm high bump on back Al 2024-T3 WP damage = no damage</p>

Figure 223: Al 6061-T6 Layer 7 Front of ISS Soyuz OM Test #13B
(Keyence 3D Microscope Image)

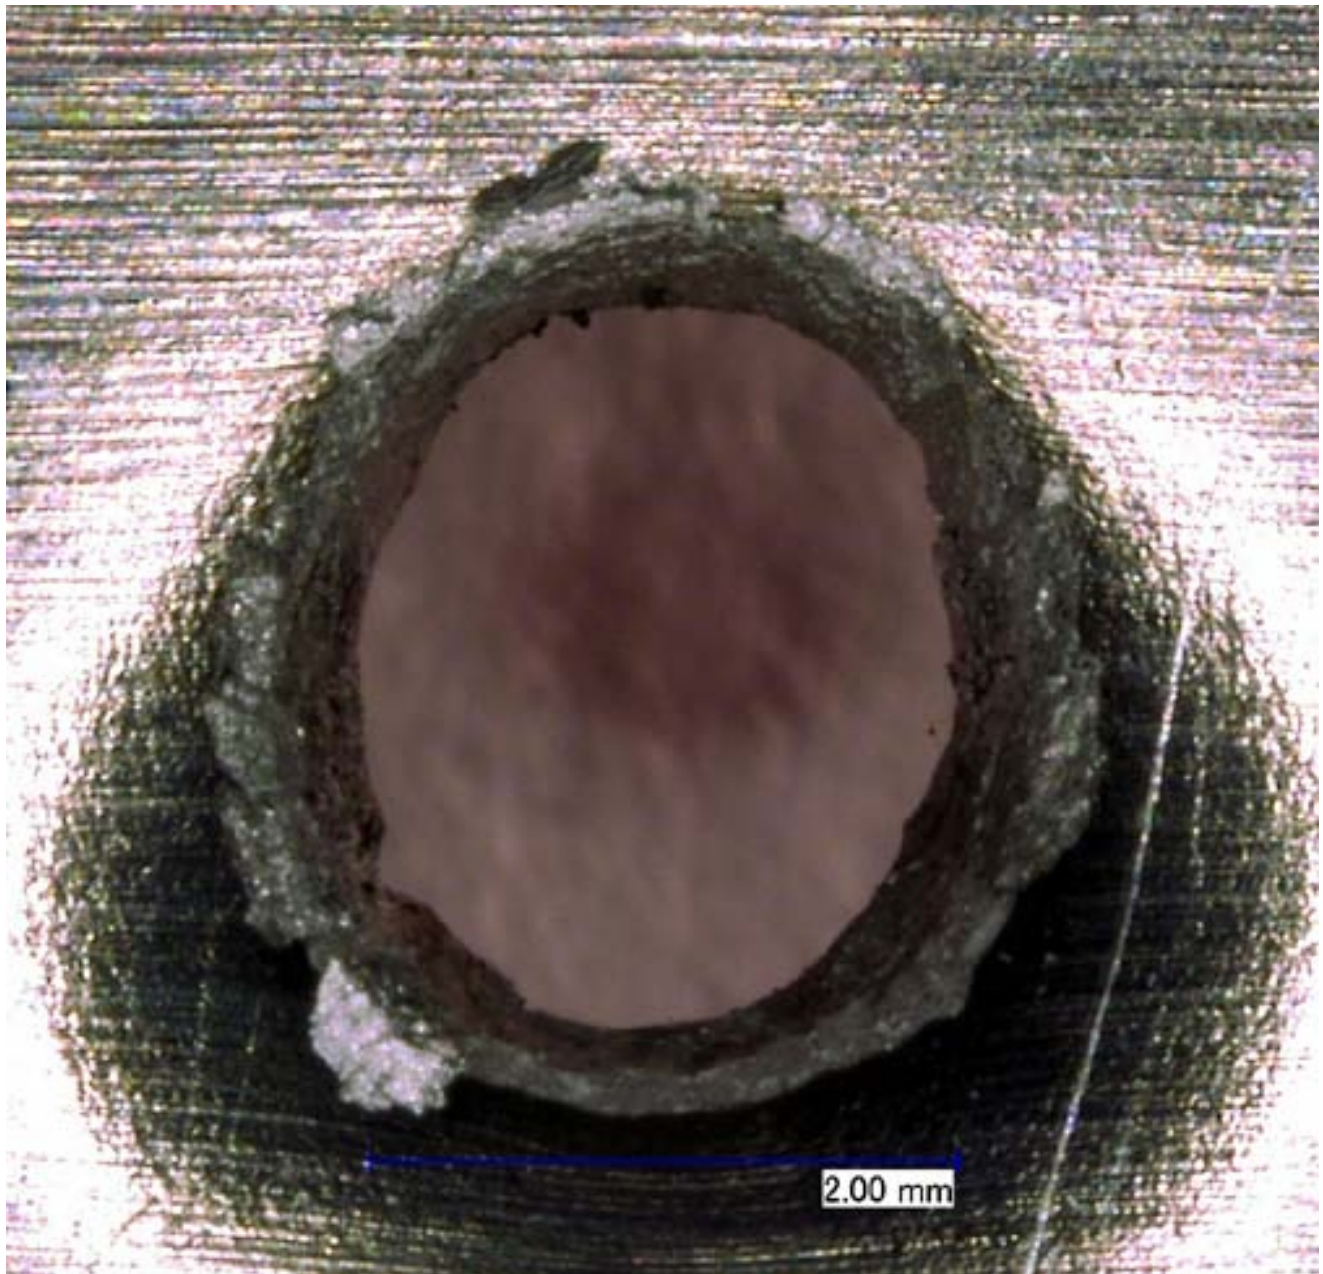
Test #13B, HITF12273

Figure 224: Al 6061-T6 Layer 7 Back of ISS Soyuz OM Test #13B
(Keyence 3D Microscope Image)

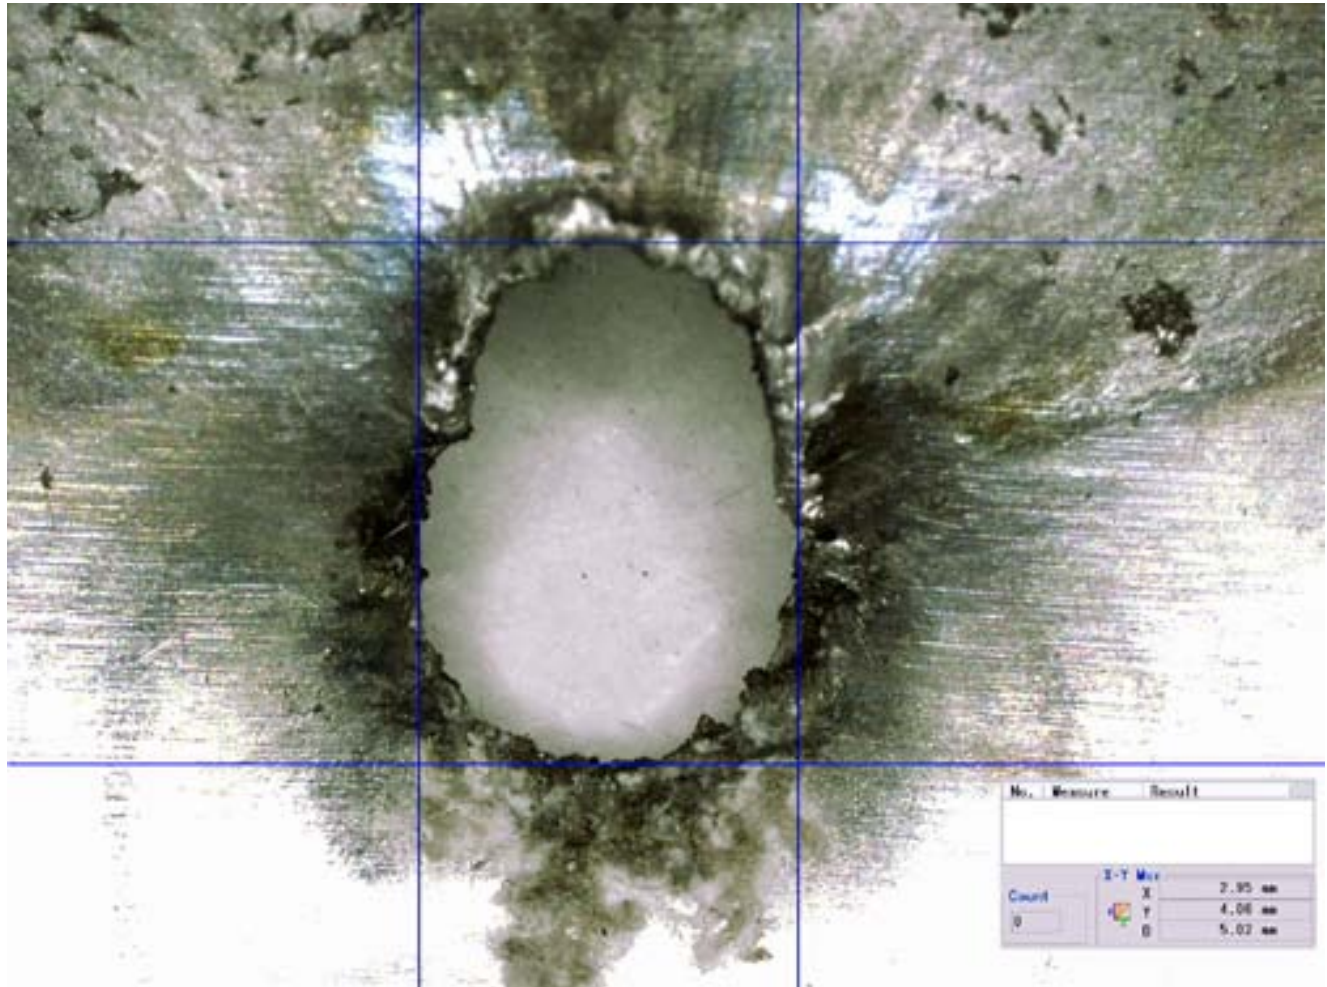
Test #14, HITF12274

14 HITF12274	1.3	0.00864	4.18	45	<p>Fail</p> <p>Beta cloth entry damage = 1.43mm x 1.87mm hole Mylar Film damage 33.26 x 22.20mm hole Fiberglass damage = 3.10 x 5.92mm hole Al 6061 Foil damage = 2.95 x 4.06mm hole Fiberglass damage = 3.46 x 4.32mm hole MLI exit damage = 5.07mm x 6.72mm hole Al 6061-T6 plate damage = 3.05mm x 5.04mm hole Al 5456-0 RW damage = 0.87mm x 0.99mm hole Al 2024-T3 WP damage = 0.50mm x 0.85mm x 0.056mm deep crater</p>
15C HITF12275	1.0	0.00400	3.93	45	<p>Pass</p> <p>Beta cloth entry damage = 1.23mm x 1.68mm hole Mylar Film damage 24.03 x 20.59mm hole Fiberglass damage = 1.72 x 2.52mm hole Al 6061 Foil damage = 2.23 x 3.04mm hole Fiberglass damage = 2.20 x 3.15mm hole MLI exit damage = 4.10mm x 5.64mm hole Al 6061-T6 plate damage = 2.70mm x 3.95mm hole Al 5456-0 RW damage = 1.10mm x 1.21mm hole Al 2024-T3 WP damage = no damage</p>

Figure 238: Al 6061 Foil Layer 4 of ISS Soyuz OM Test #14
(Keyence 3D Microscope Image)

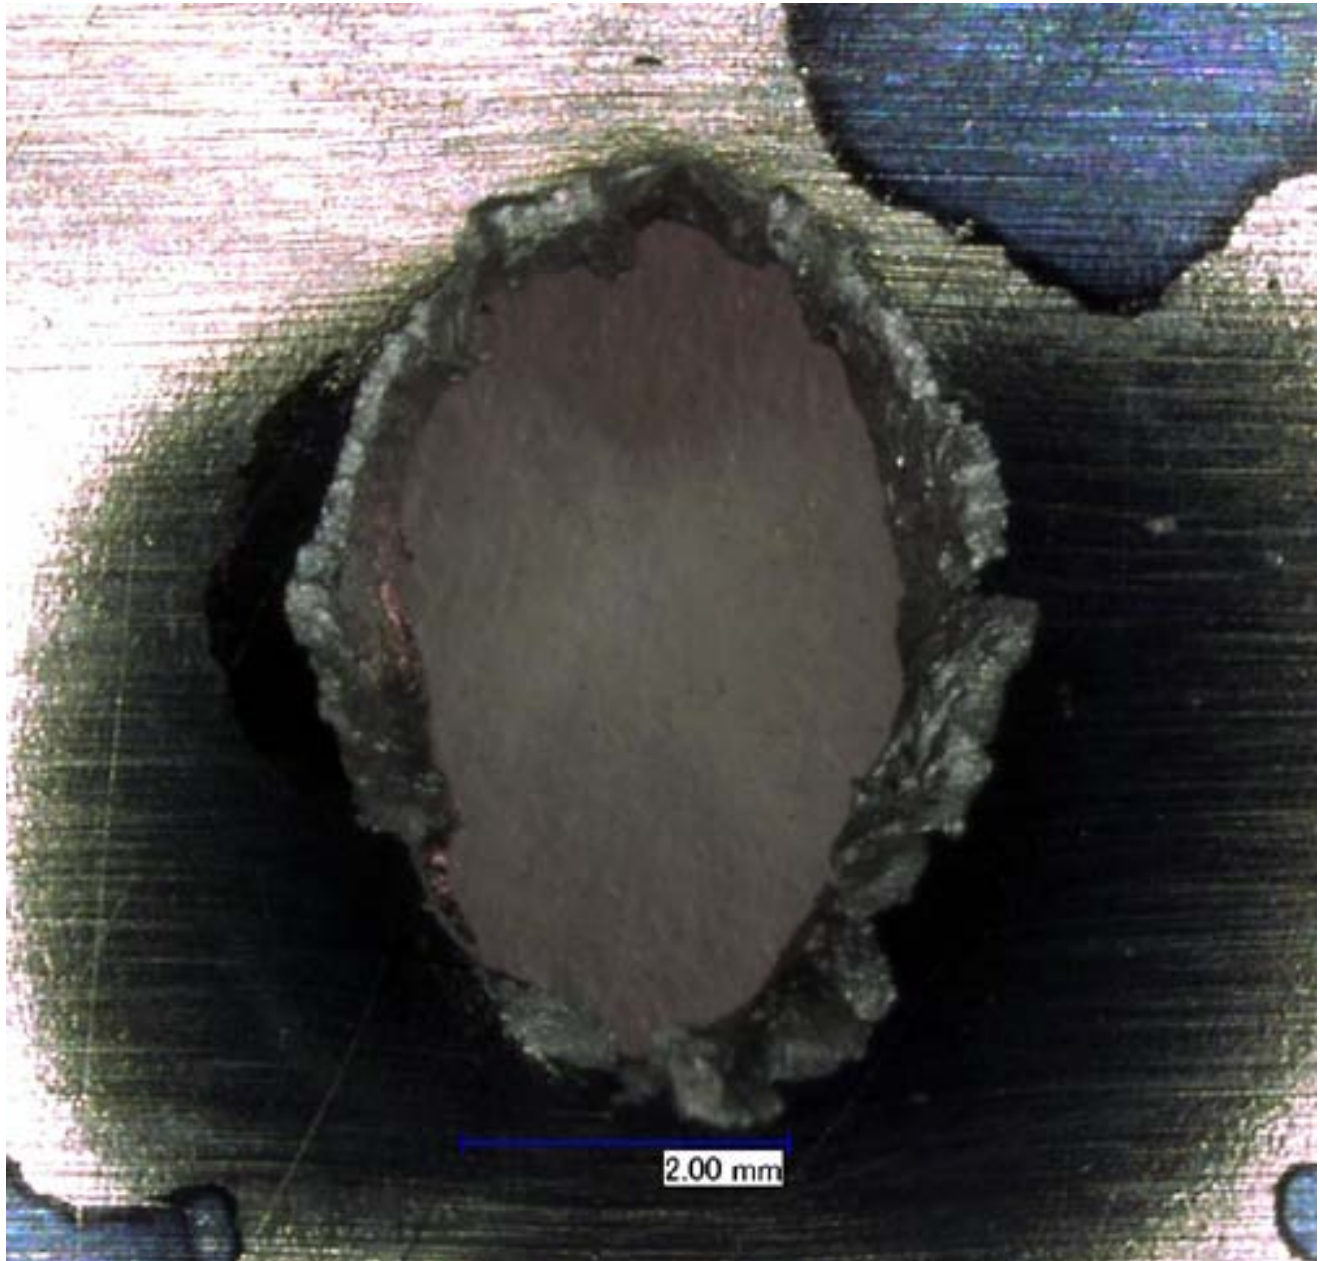
Test #14, HITF12274

Figure 242: Al 6061-T6 Layer 7 Back of ISS Soyuz OM Test #14
(Keyence 3D Microscope Image)

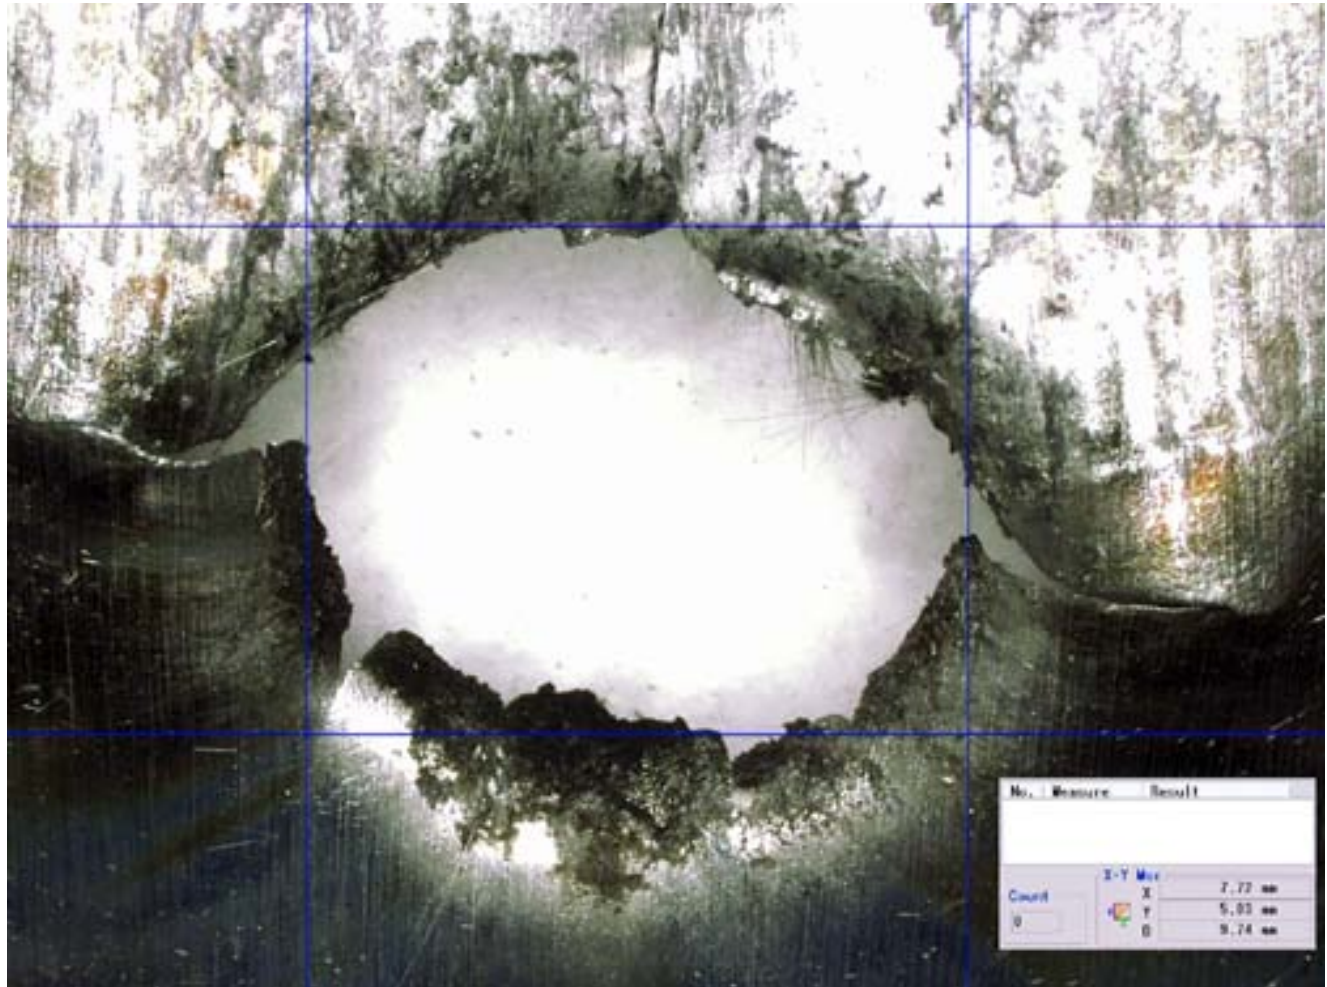
Test #16, HITF12276

Test No.	Actual Projectile Diameter (mm)	Actual Projectile Mass (g)	Actual Impact Velocity (km/s)	Impact Angle (deg)	Results
16 HITF12276	1.6	0.01610	7.00	30	<p>Fail</p> <p>Beta cloth entry damage = 1.69mm x 1.84mm hole Mylar Film damage 23.55 x 18.53mm hole Fiberglass damage 10.23 x 10.29mm hole Al 6061 Foil damage = 7.72 x 5.93mm hole Fiberglass damage 11.36 x 12.23mm hole MLI exit damage = 8.75mm x 9.62mm hole Al 6061-T6 plate damage = 6.66mm x 7.91mm hole Al 5456-0 RW damage = 1.77mm x 1.75mm hole Al 2024-T3 WP damage = 52mm x 63mm area of aluminum specks</p>
17 HITF12277	1.5	0.01331	4.83	30	<p>Fail</p> <p>Beta cloth entry damage = 1.66mm x 1.70mm hole Mylar Film damage 15.62 x 12.15mm hole Fiberglass damage = 3.63 x 4.03mm hole Al 6061 Foil damage = 4.32 x 5.02mm hole Fiberglass damage = 4.62 x 5.64mm hole MLI exit damage = 6.47mm x 7.43mm hole Al 6061-T6 plate damage = 4.63mm x 6.11mm hole Al 5456-0 RW damage = 2 holes largest is 1.54mm x 2.20mm Al 2024-T3 WP damage = 0.487mm x 0.536mm x 0.372mm deep crater & many smaller</p>

Figure 270: Al 6061 Foil Layer 4 of ISS Soyuz OM Test #16
(Keyence 3D Microscope Image)

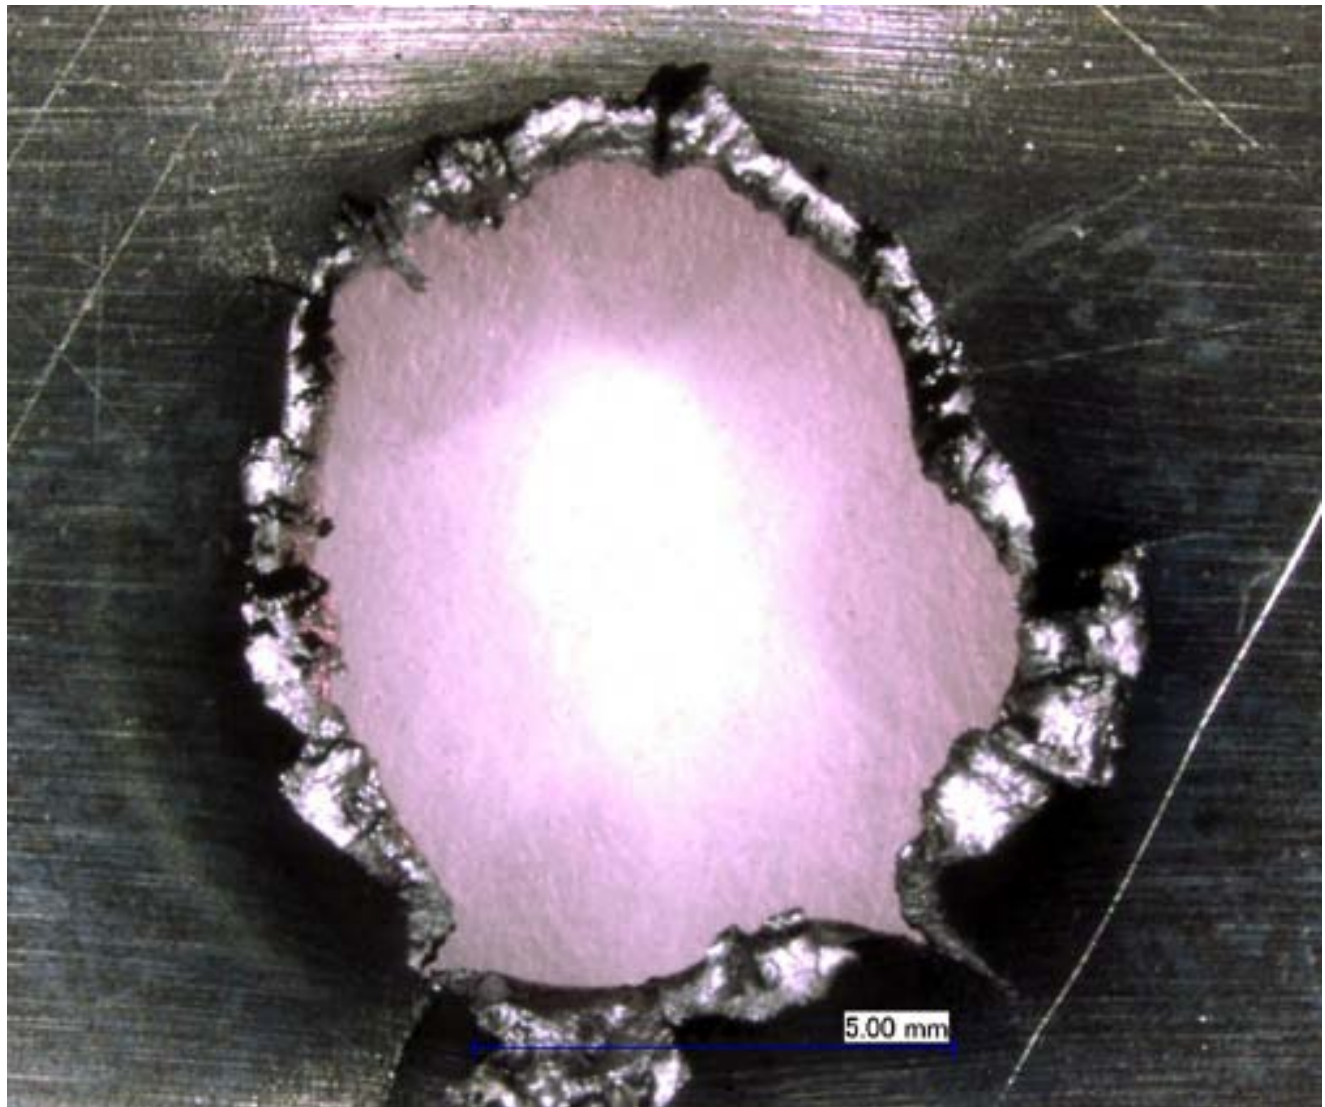
Test #16, HITF12276

Figure 274: Al 6061-T6 Layer 7 Back of ISS Soyuz OM Test #16
(Keyence 3D Microscope Image)
