Morpheus Free Flight 2 Test Failure Investigation

Steve Munday & Jon Olansen
NASA Johnson Space Center
Engineering Directorate
November 2012

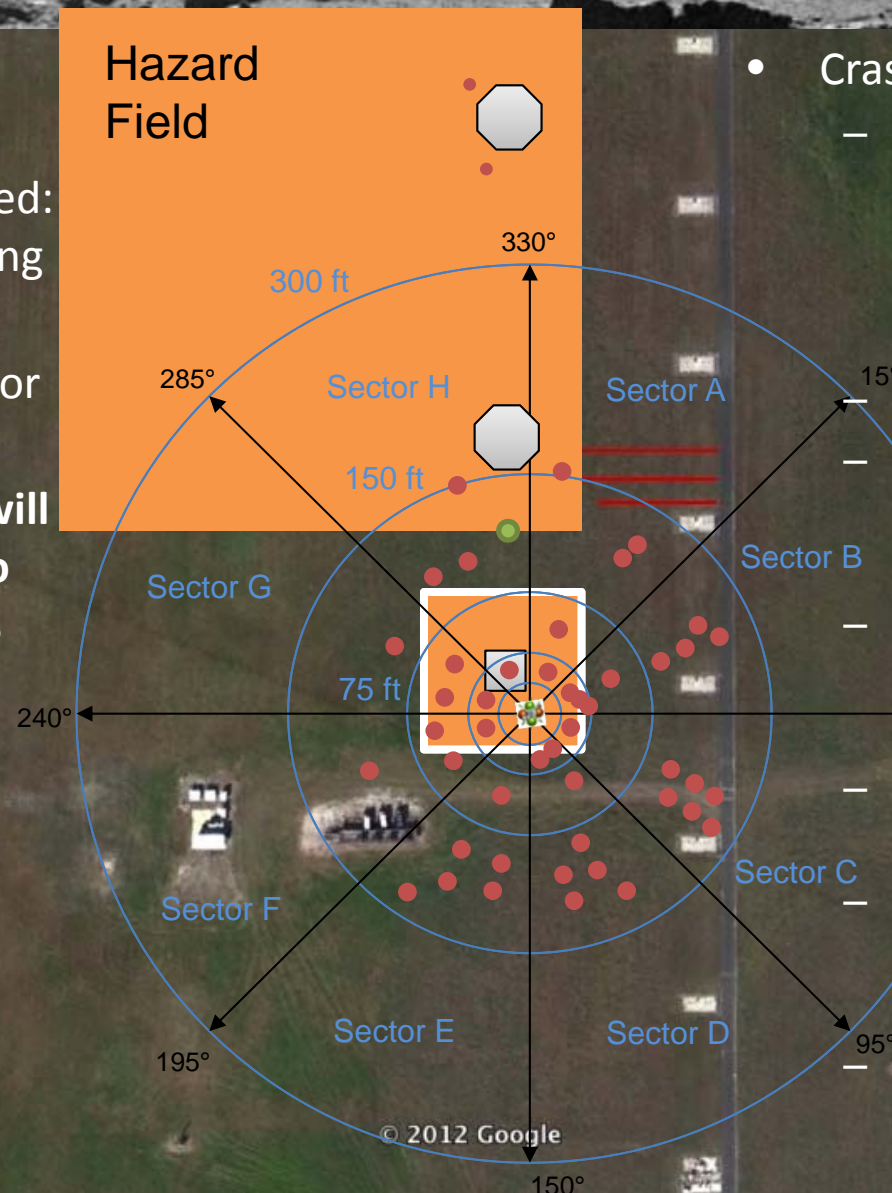
Debris Field

- Polar grid set up around impact point
- ~100 items catalogued: mass, radius & bearing
- Remaining items weighed by sectors for mass distribution
- **NESC & KSC Safety will use debris catalog to anchor blast models**

- Crash site observations
 - Nearly all debris < 50m, << **1000ft clear distance** for Pad Crew (Max estimates: JSC = 325ft, KSC = 653ft, WSTF = 1000ft)
 - Methane tanks burned
 - LOX tanks exploded (BLEVE), +Z tank separated at lower boss & rolled 37m
 - Engine plume dug a small crater; chamber burned, but **injector is recoverable**
 - Top deck melted into crater, including GN&C plate & SIGI
 - Onboard camera SD card experienced too much heat damage for data recovery
 - **APU Solid State Disk Drive data and DFI box recovered**

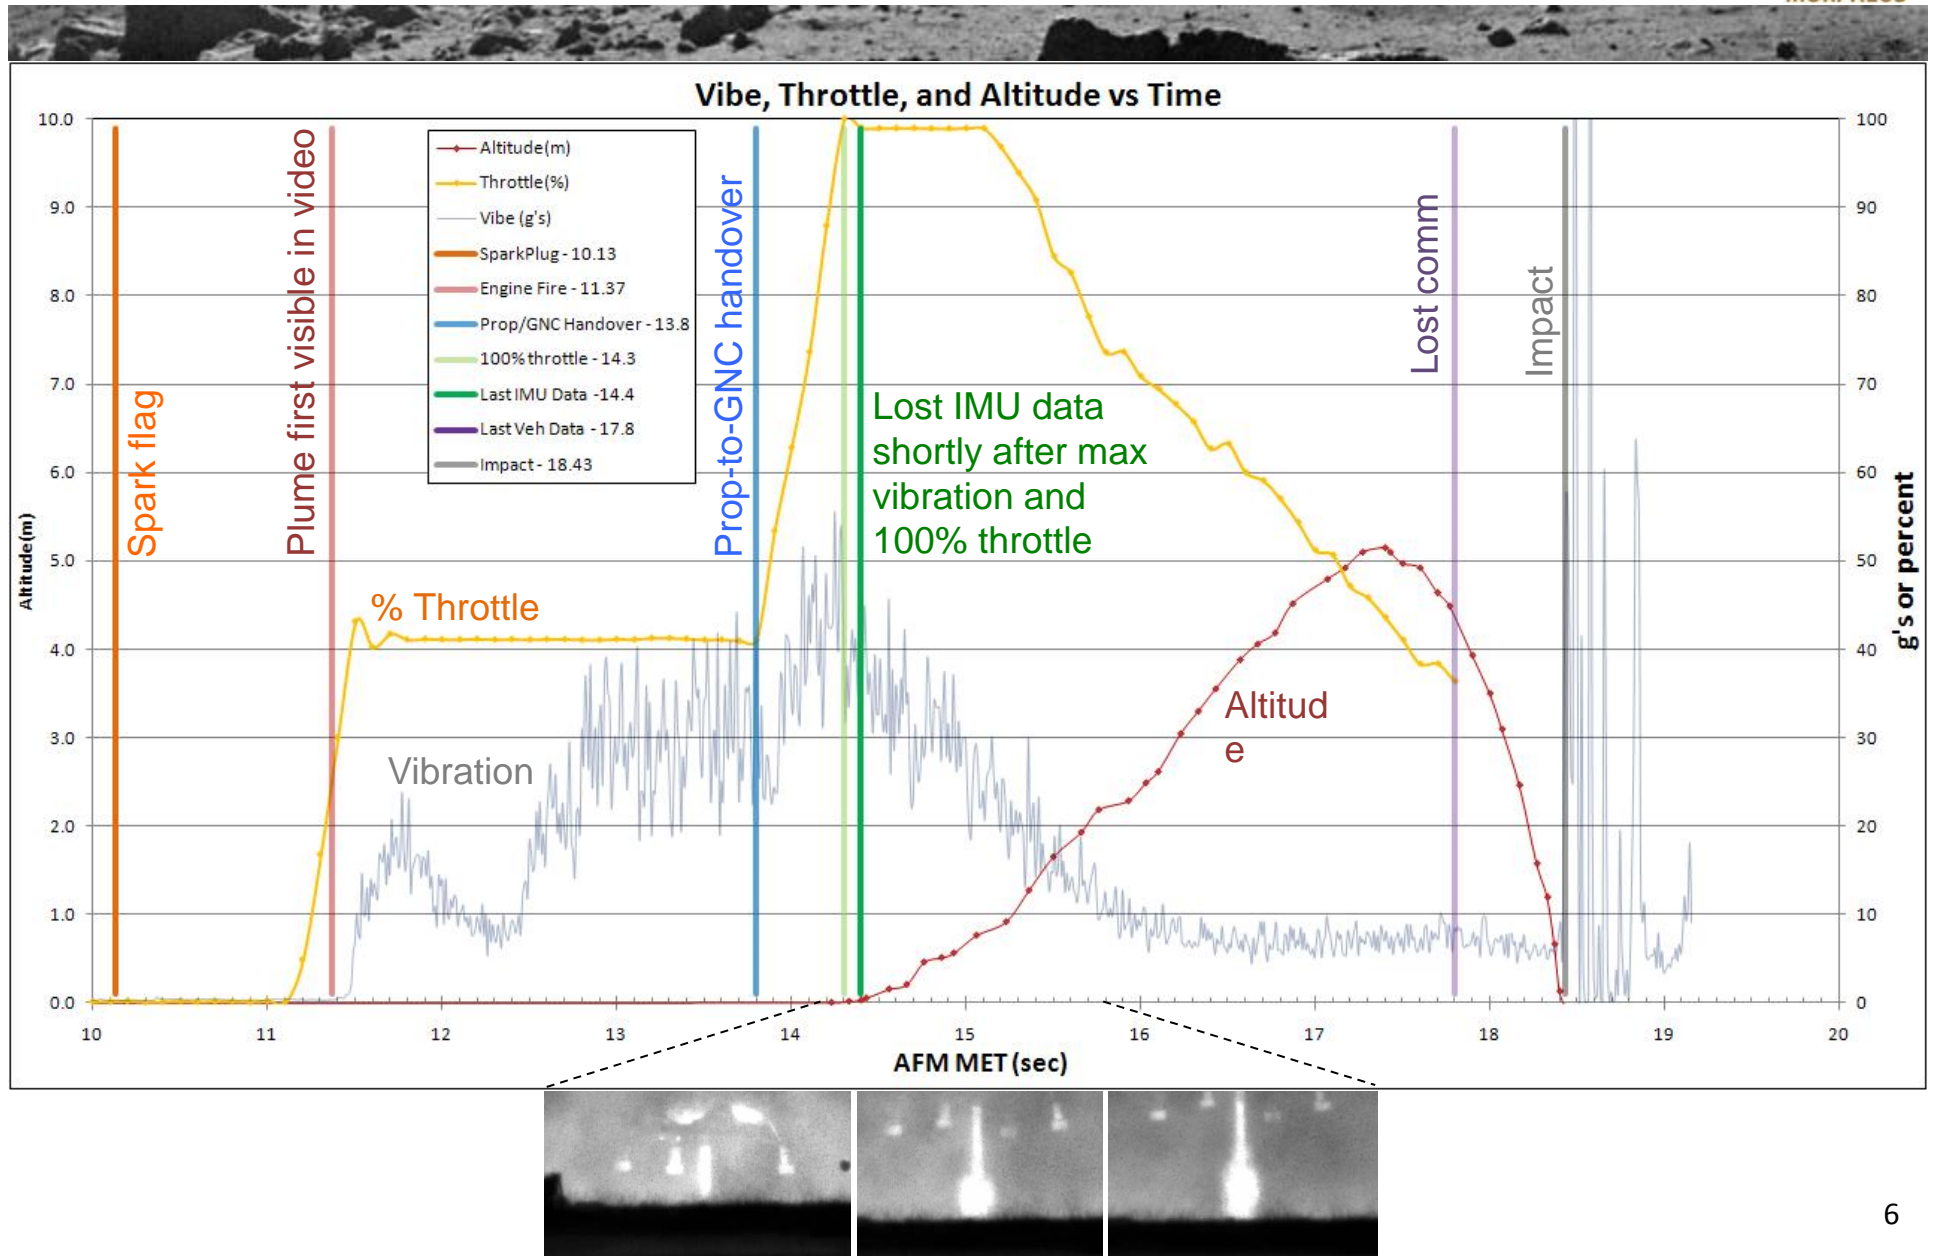
Vibration, Throttle & Altitude

0:14.3	Throttle reaches 100% (actual thrust lags throttle slightly)	Nominal
	0:14.4	IMU nav data flow to CPU stops <ul style="list-style-type: none"> Lacking new IMU data, FSW flags "bad" SIGI data and feeds stale nav data into GNC nav state propagation GNC responds appropriately to static/stale body rates & acceleration with positive pitch correction, steadily pitching over VTB, eventually throttling down from 100% to 50% between MET = 15-17 sec 	Failure

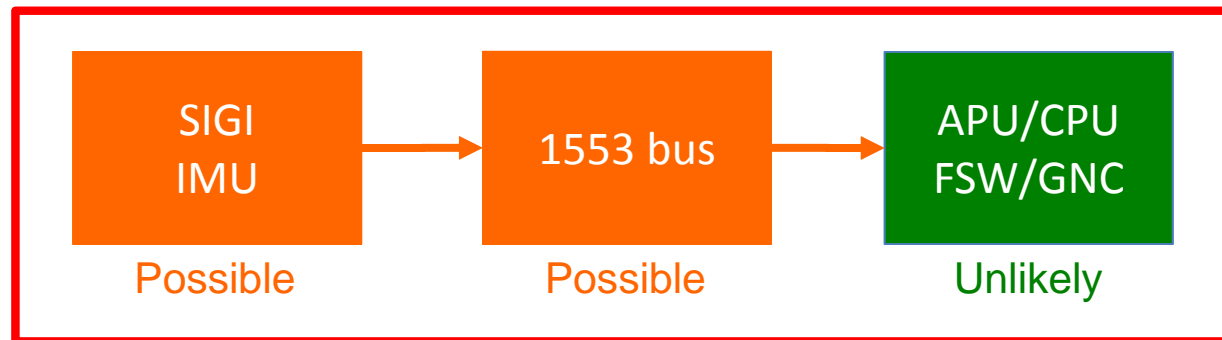
What Failed?

HW failure in IMU data path => loss of nav data to GNC

- Hardware failure along IMU data path => loss of navigation data
 - Autonomous VTB GNC requires IMU nav data to correctly propagate nav state & maintain stable flight
 - VTB became “blind” during initial ascent, unable to sustain stable flight
 - Available data does not isolate a root cause; no single “smoking gun”
- Prime suspects:
 - **SIGI**, source of IMU nav data, hard-mounted (not vibe-isolated by design)
 - **1553 bus**, carries SIGI data to APU, mostly hard-mounted, partially vibe-isolated
 - **Avionics & Power Unit (APU)**, contains CPU with GNC FSW, vibe-isolated

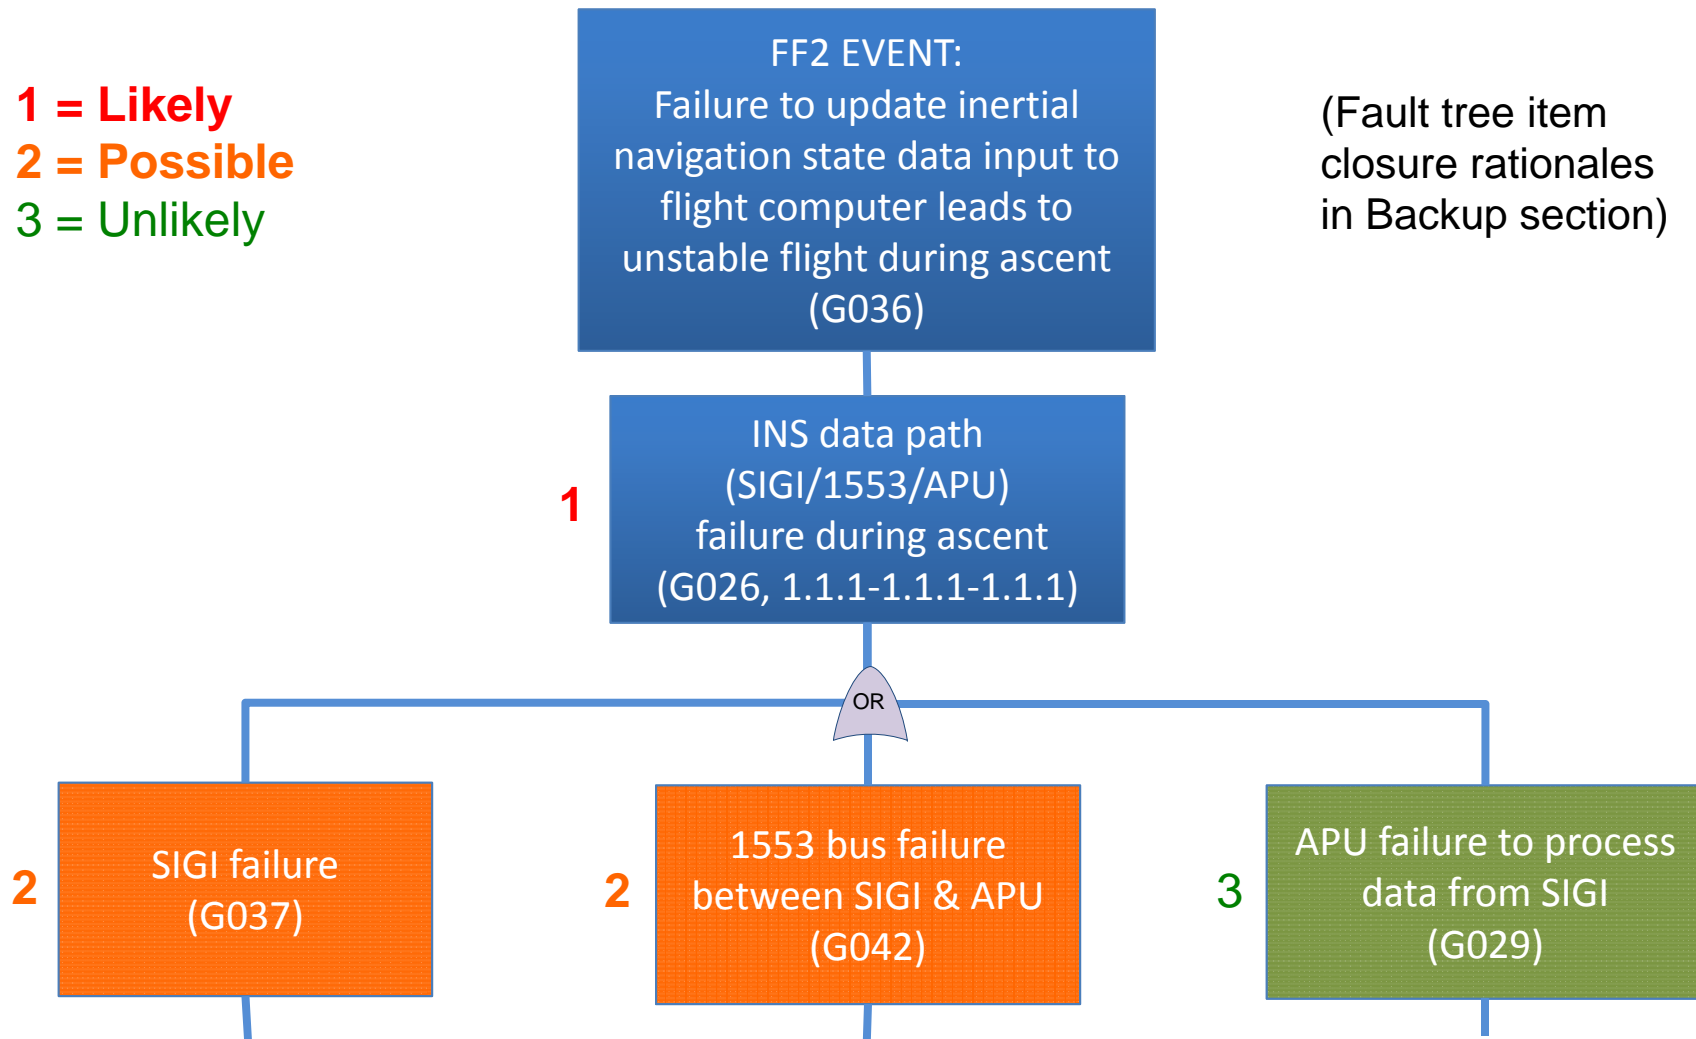
Fault Tree, Top

- Probable or possible causes:
 1. **Vibro-acoustic environment near ground** repeatedly exceeding component qual limits and eventually causing fatigue failure during FF2

2. Non-flight components not sufficiently robust to environment (1)
 - Lab grade 1553 bus components
 - Development unit CRV SIGI (s/n 1580) believed to be “flight-like” due to same internal part numbers as ISS flight units built 2 months later, one of which was used for HTV3

3. Workmanship Quality Assurance provided insufficient robustness for environment (1)
 4. Production imperfections in primary components reduced robustness to environment (1)

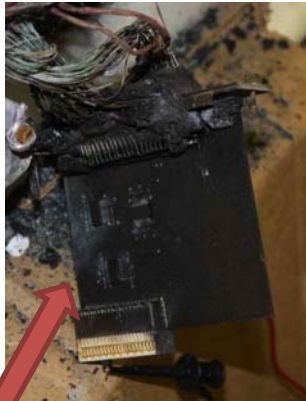
DIO/1553 TM

Card to cPCI connection has good continuity

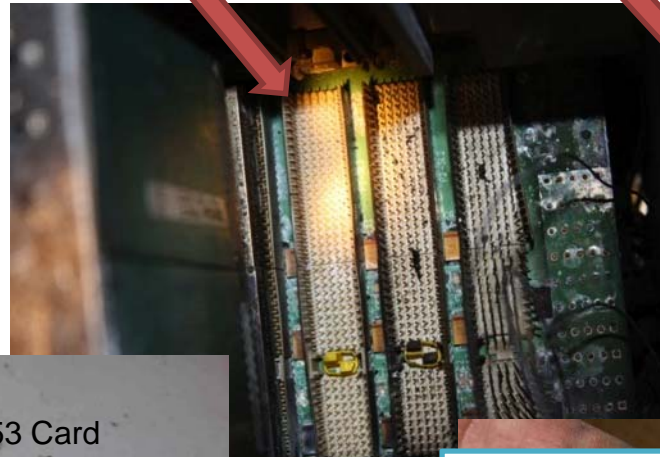
Backplane looks good

Wires are firmly in connectors but no continuity through melted connectors

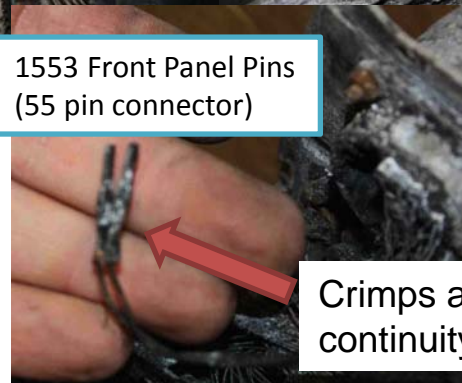
1553 Front Panel Pins (55 pin connector)

Crimps and wires have good continuity and pass pull test

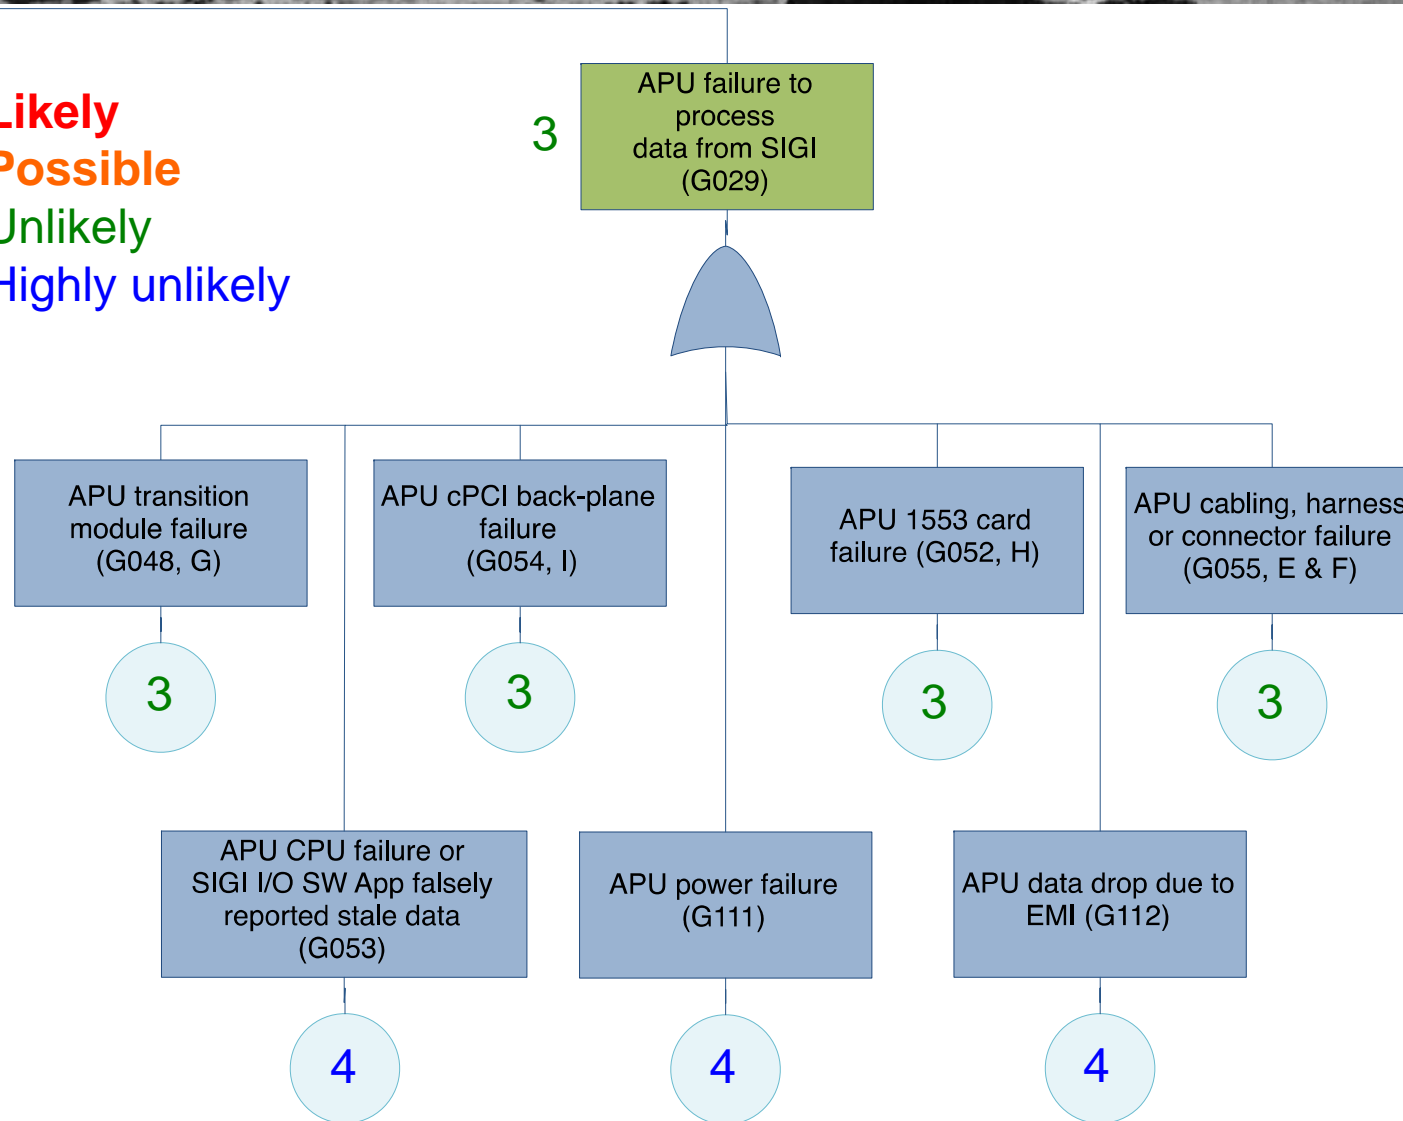
Fault Tree, APU

1 = Likely
2 = Possible
3 = Unlikely
4 = Highly unlikely

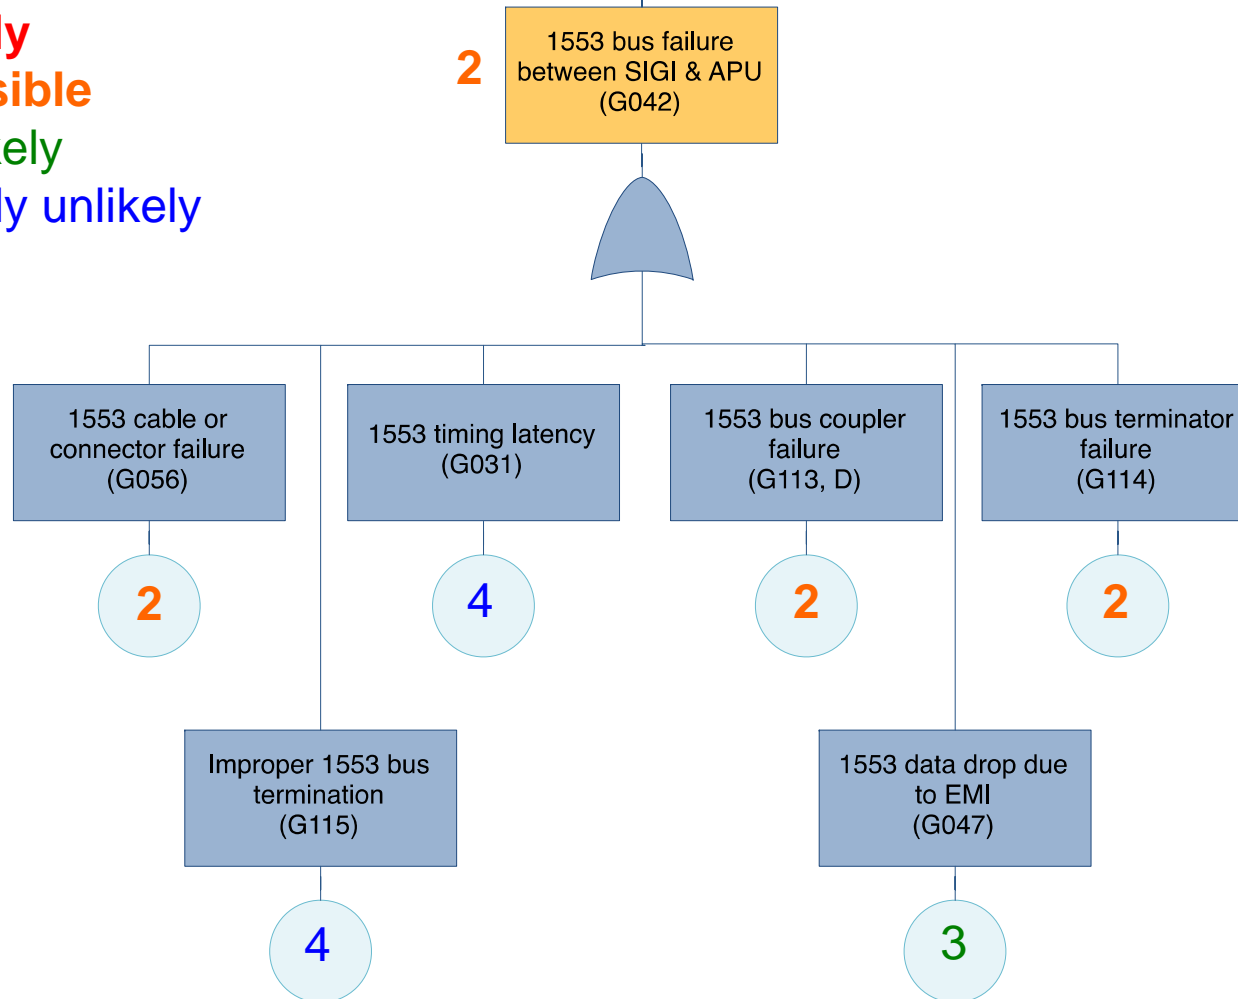
Fault Tree, 1553 Bus

- 1553 bus **couplers**
 - GNC plate coupler hard-mounted to plate, deck & primary structure, not isolated from vibration; coupler on APU vibe-isolated.
 - In 2009, L-M Mission Success Bulletin #09-17 cited a few lots of couplers (from a different manufacturer) for having cracked solder joints on terminal lugs due to vibration & thermal environments, affecting Atlas and Orion PA1
- 1553 bus **connectors**
 - Spring-pressure over-center BNC connectors
 - Can be connected without locking if there is sufficient friction in connection; unlikely given no connector issues in previous tests, not demated since Feb
 - High vibration environment could cause connectors to back off, even if locked
- 1553 bus **terminators**
 - Same unlikely connection issue as connectors, not demated since Feb
 - Long, cantilevered terminators are susceptible to high vibration environment

Lab grade 1553 bus harnesses may have been susceptible to high vibration. VTB 1.5B will have higher quality 1553 bus harnesses and more vibe isolation.

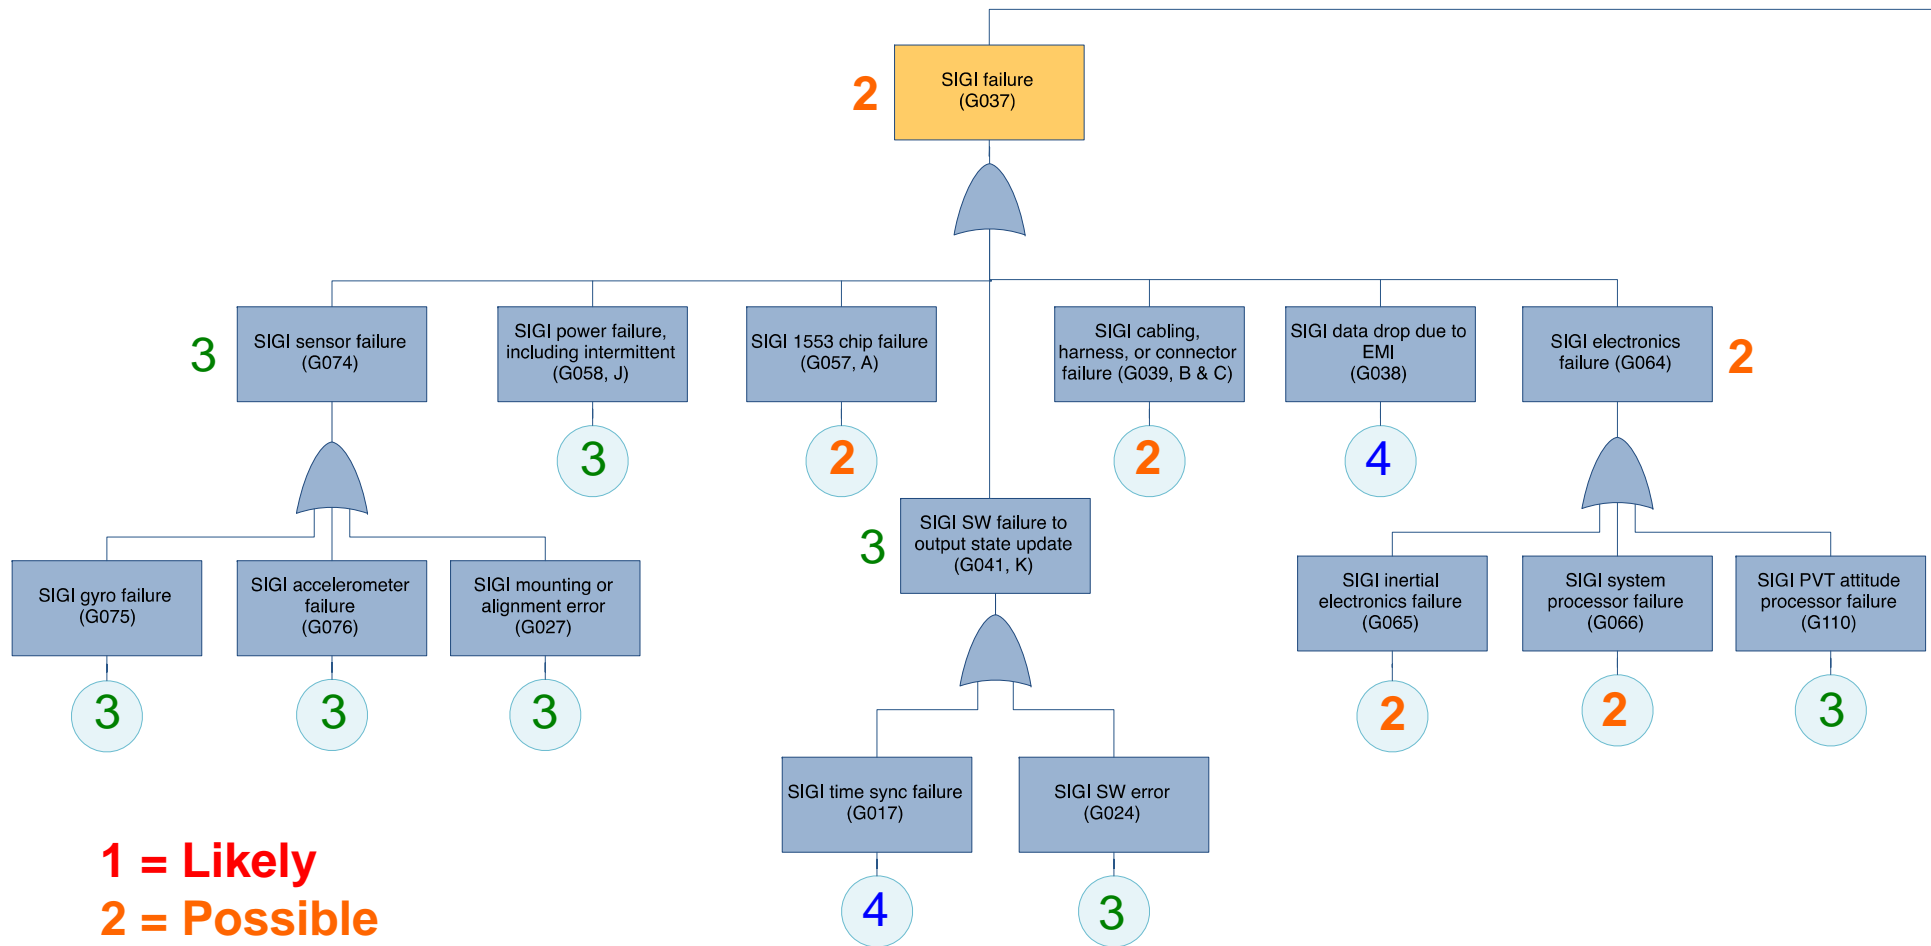
Fault Tree, SIGI

1 = Likely
2 = Possible
3 = Unlikely
4 = Highly unlikely

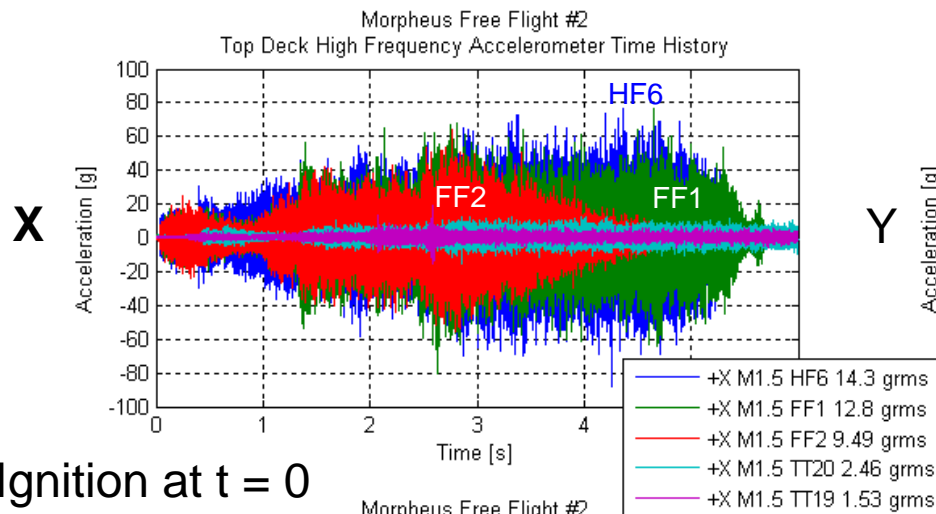
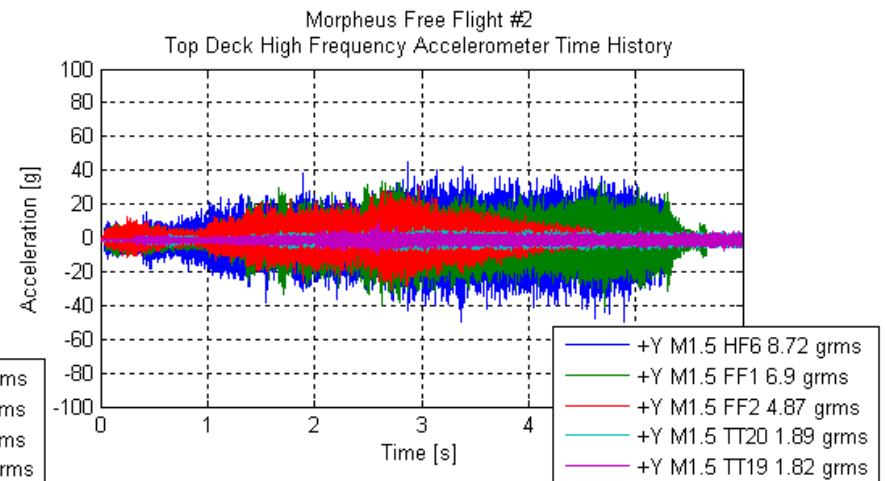
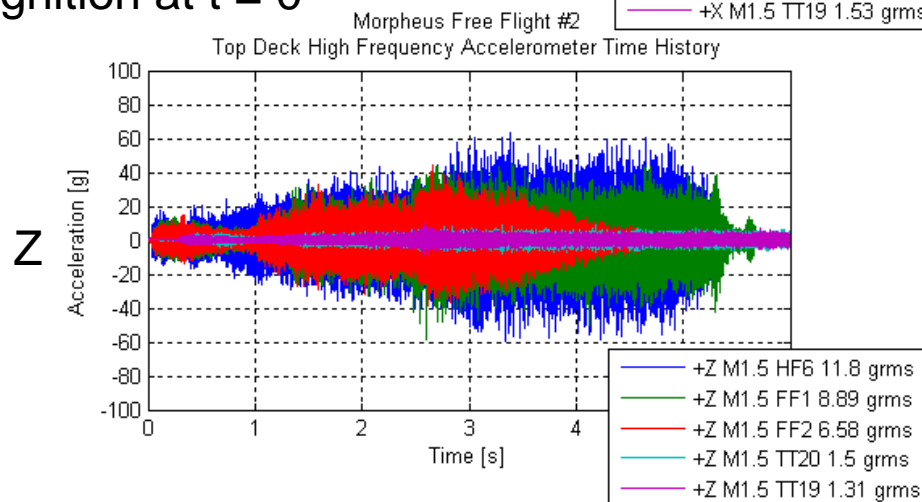
Vibration Flight Experience

Tether Test ignitions "at altitude" produce far less vibration than HF6 & FF ground ignitions.
FF2: VTB escaped vibro-acoustic ground effect ~4 sec after ignition, ~1 sec after liftoff.

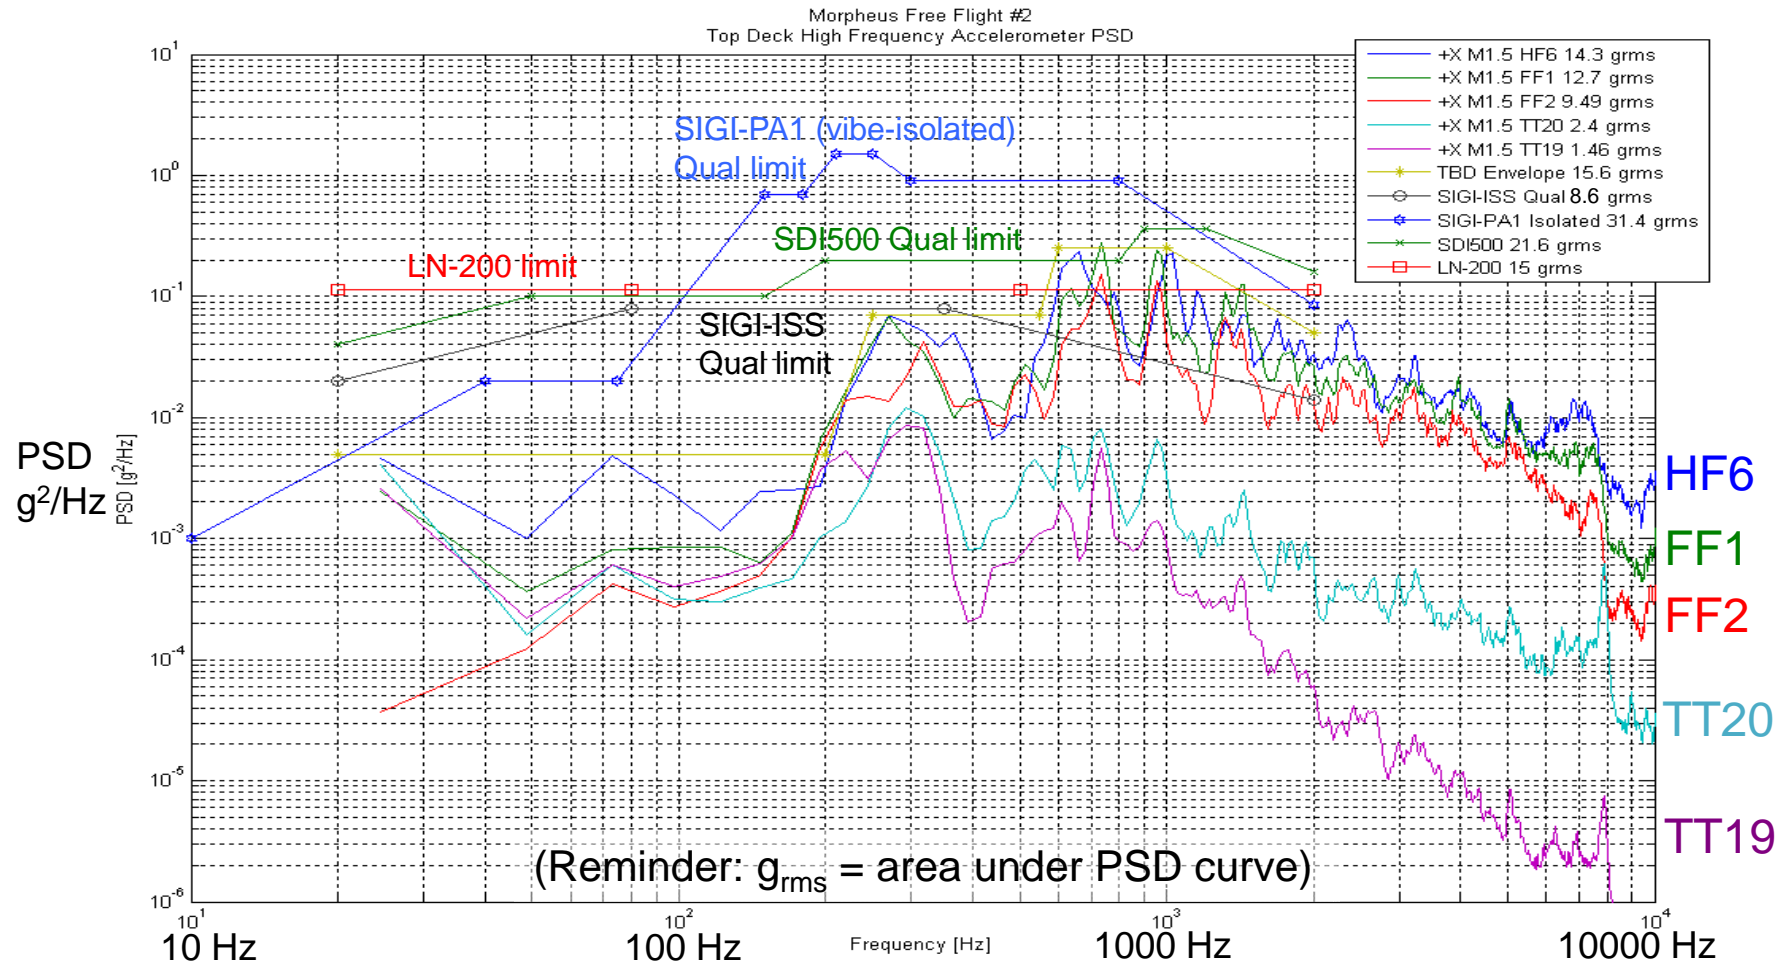
Vibration Flight Levels & IMU Qual Specs, +X

HF6, FF1 & FF2 vibration briefly exceeded ISS SIGI qual limits at high frequencies. Vibe-isolated PA1 SIGI has much higher qual limits, above Morpheus test experience.

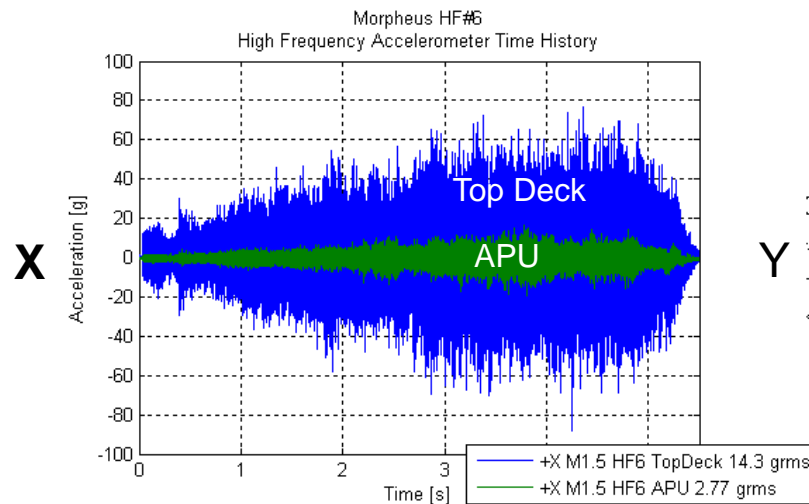
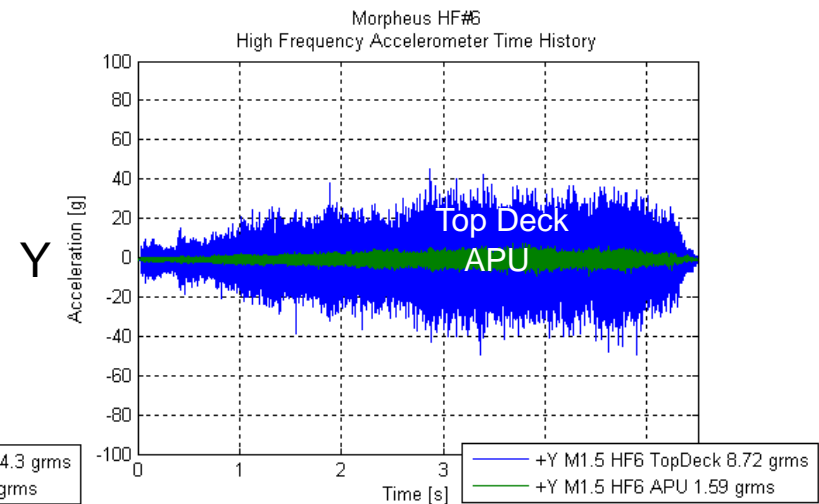
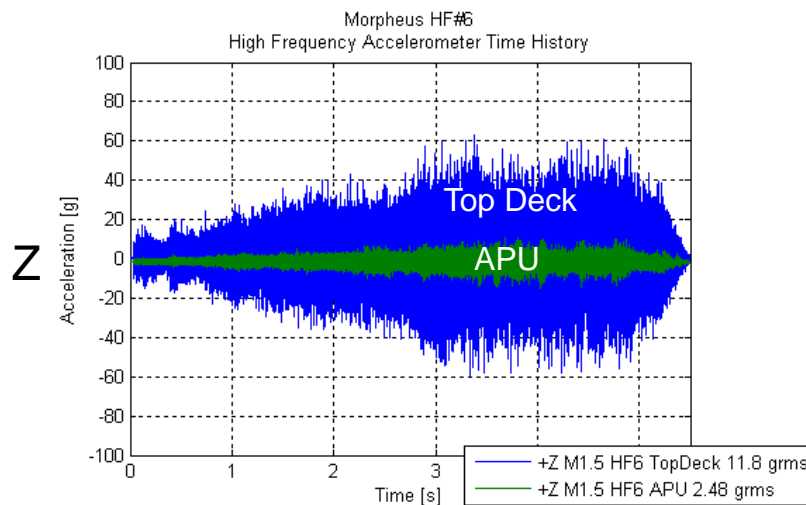
Vibe Isolation Effectiveness in HF6

Top Deck accel was hard-mounted.
APU accel was vibe-isolated.

Vibe isolation reduced peak
g's by an order of magnitude.

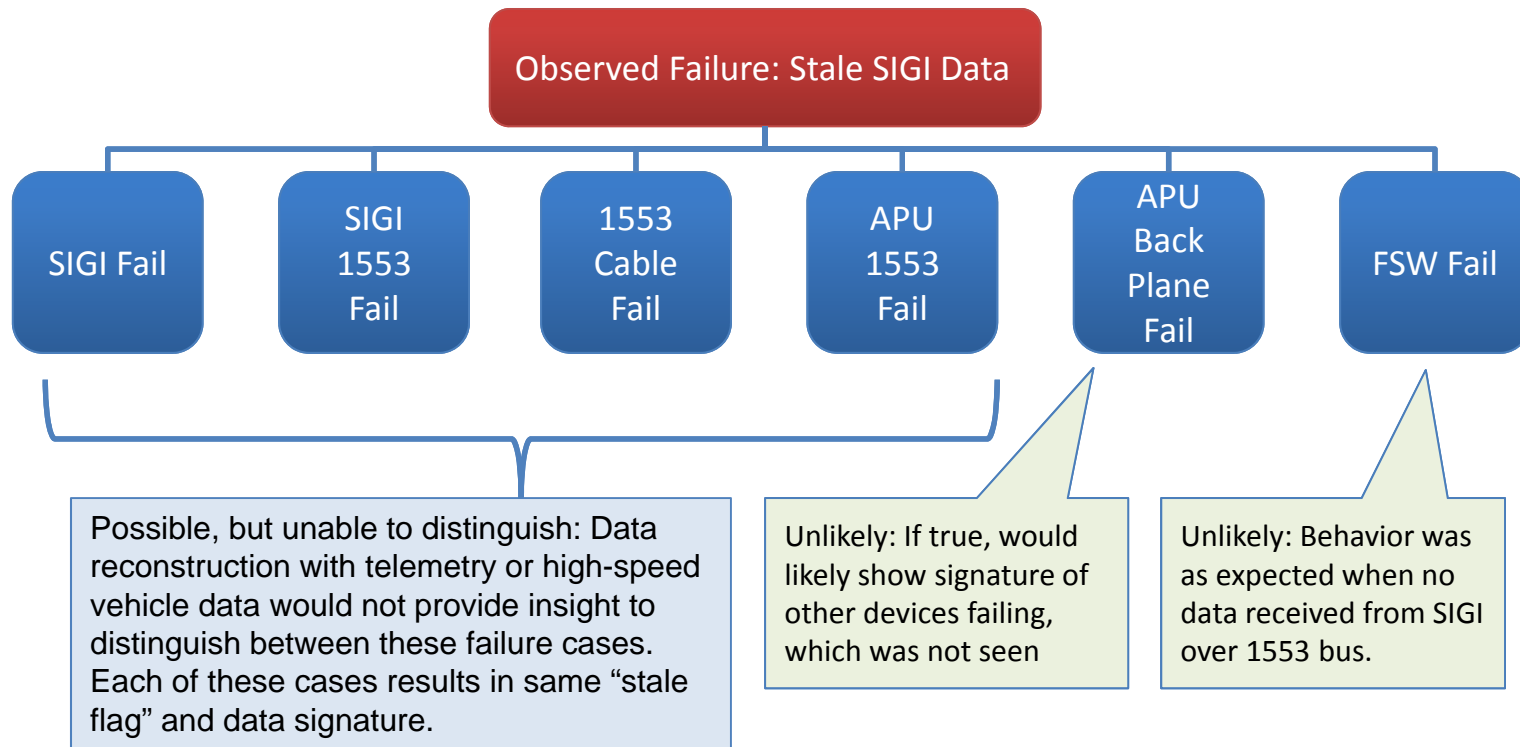
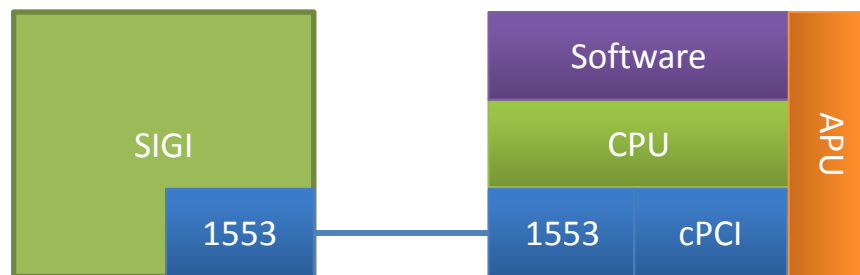
Stale SIGI Data

1. Last SIGI data indicated no internal failures (sigiModeWord = 0) and good GPS antenna lock (pvtOKMasterAntID_ID = 1)
2. SIGI I/O SW on CPU flags & sends stale SIGI data to GNC if no new data is received from 1553 Bus
3. Although STALE flag from SIGI was not downlinked, it can be deduced from stale eo24bustime. SIGI did not send stale data, but in fact no more SIGI data was received on the 1553 Bus.
4. GNC/AFM time is 10ms greater than the IMU_Pre timestamp, from data analysis
