Micrometeoroid and Orbital Debris (MMOD) Risk Overview

**Eric Christiansen
NASA Johnson Space Center
July 2014**

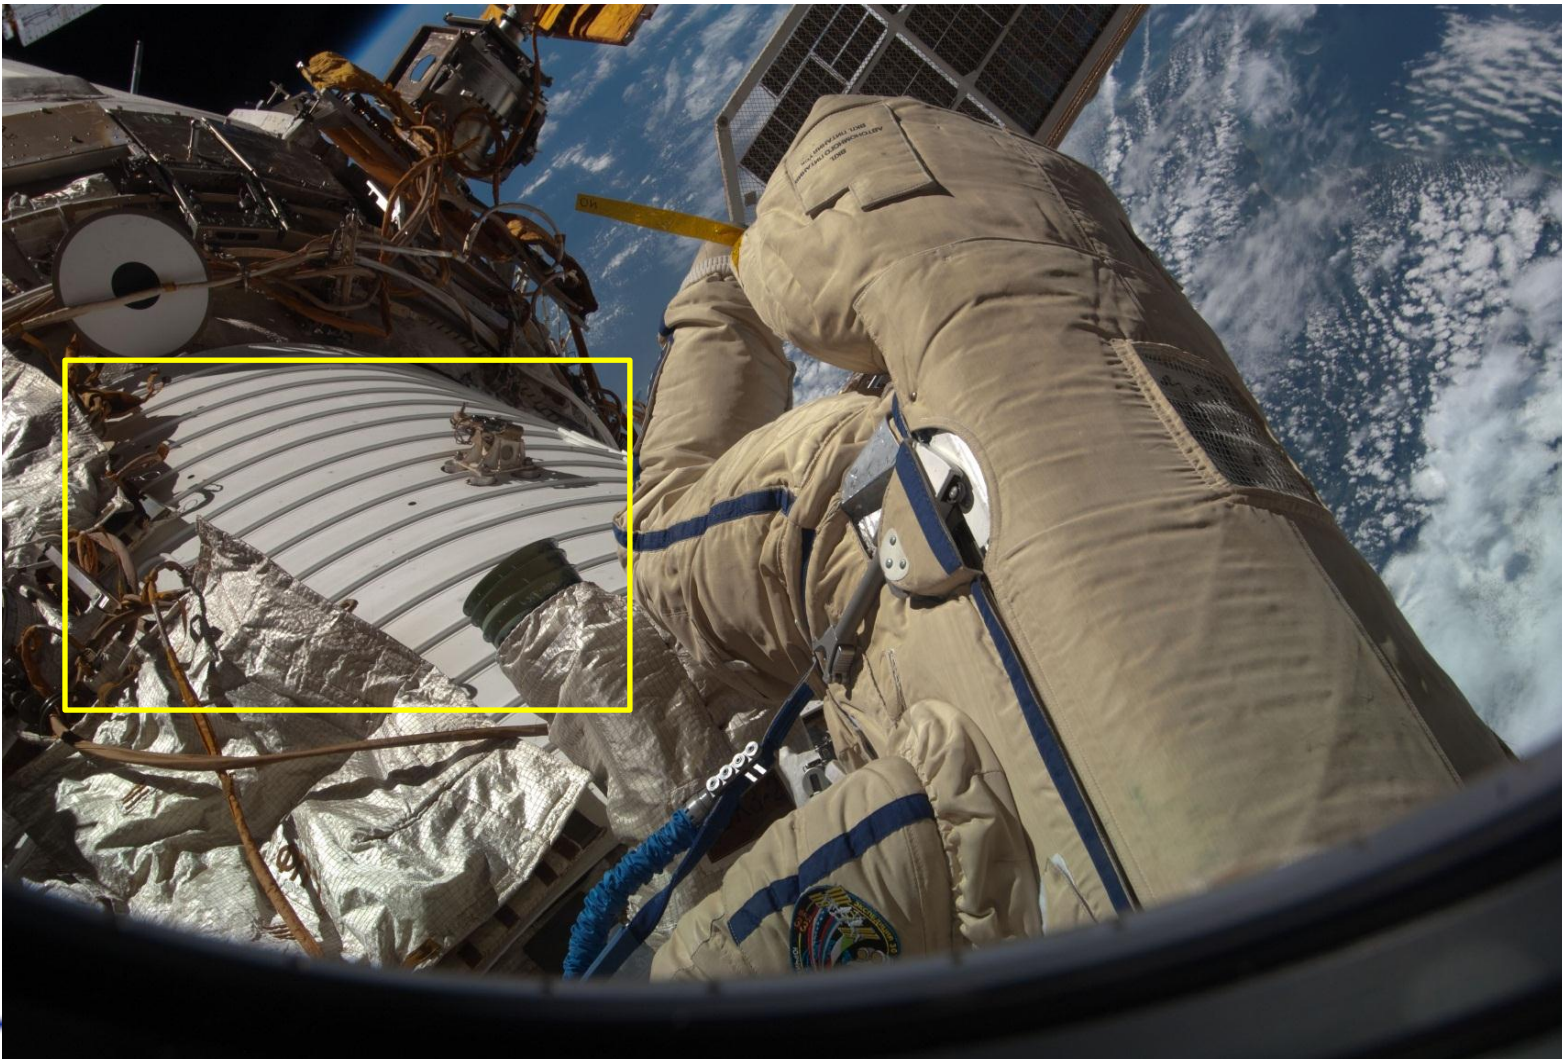
- **MMOD impact damages observed to ISS radiator panels during Russian EVA (June 2013)**

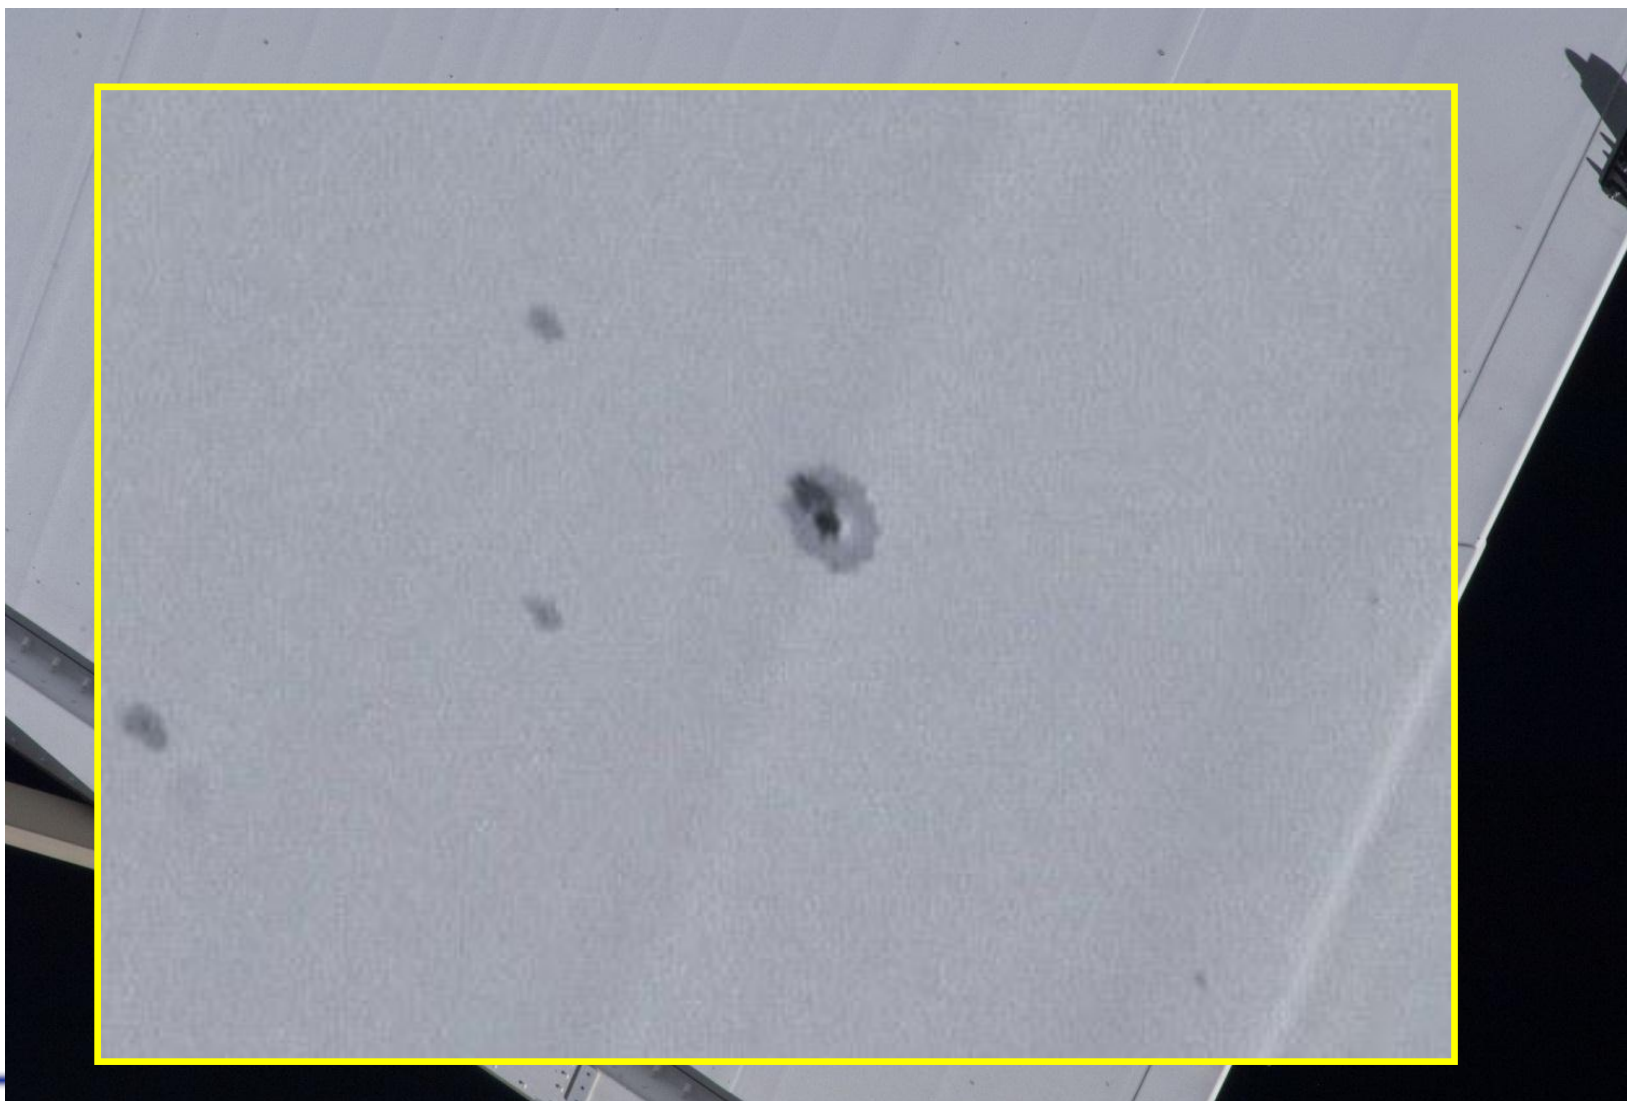
- **MMOD impact damages observed to ISS radiator panels (Aug. 2013)**

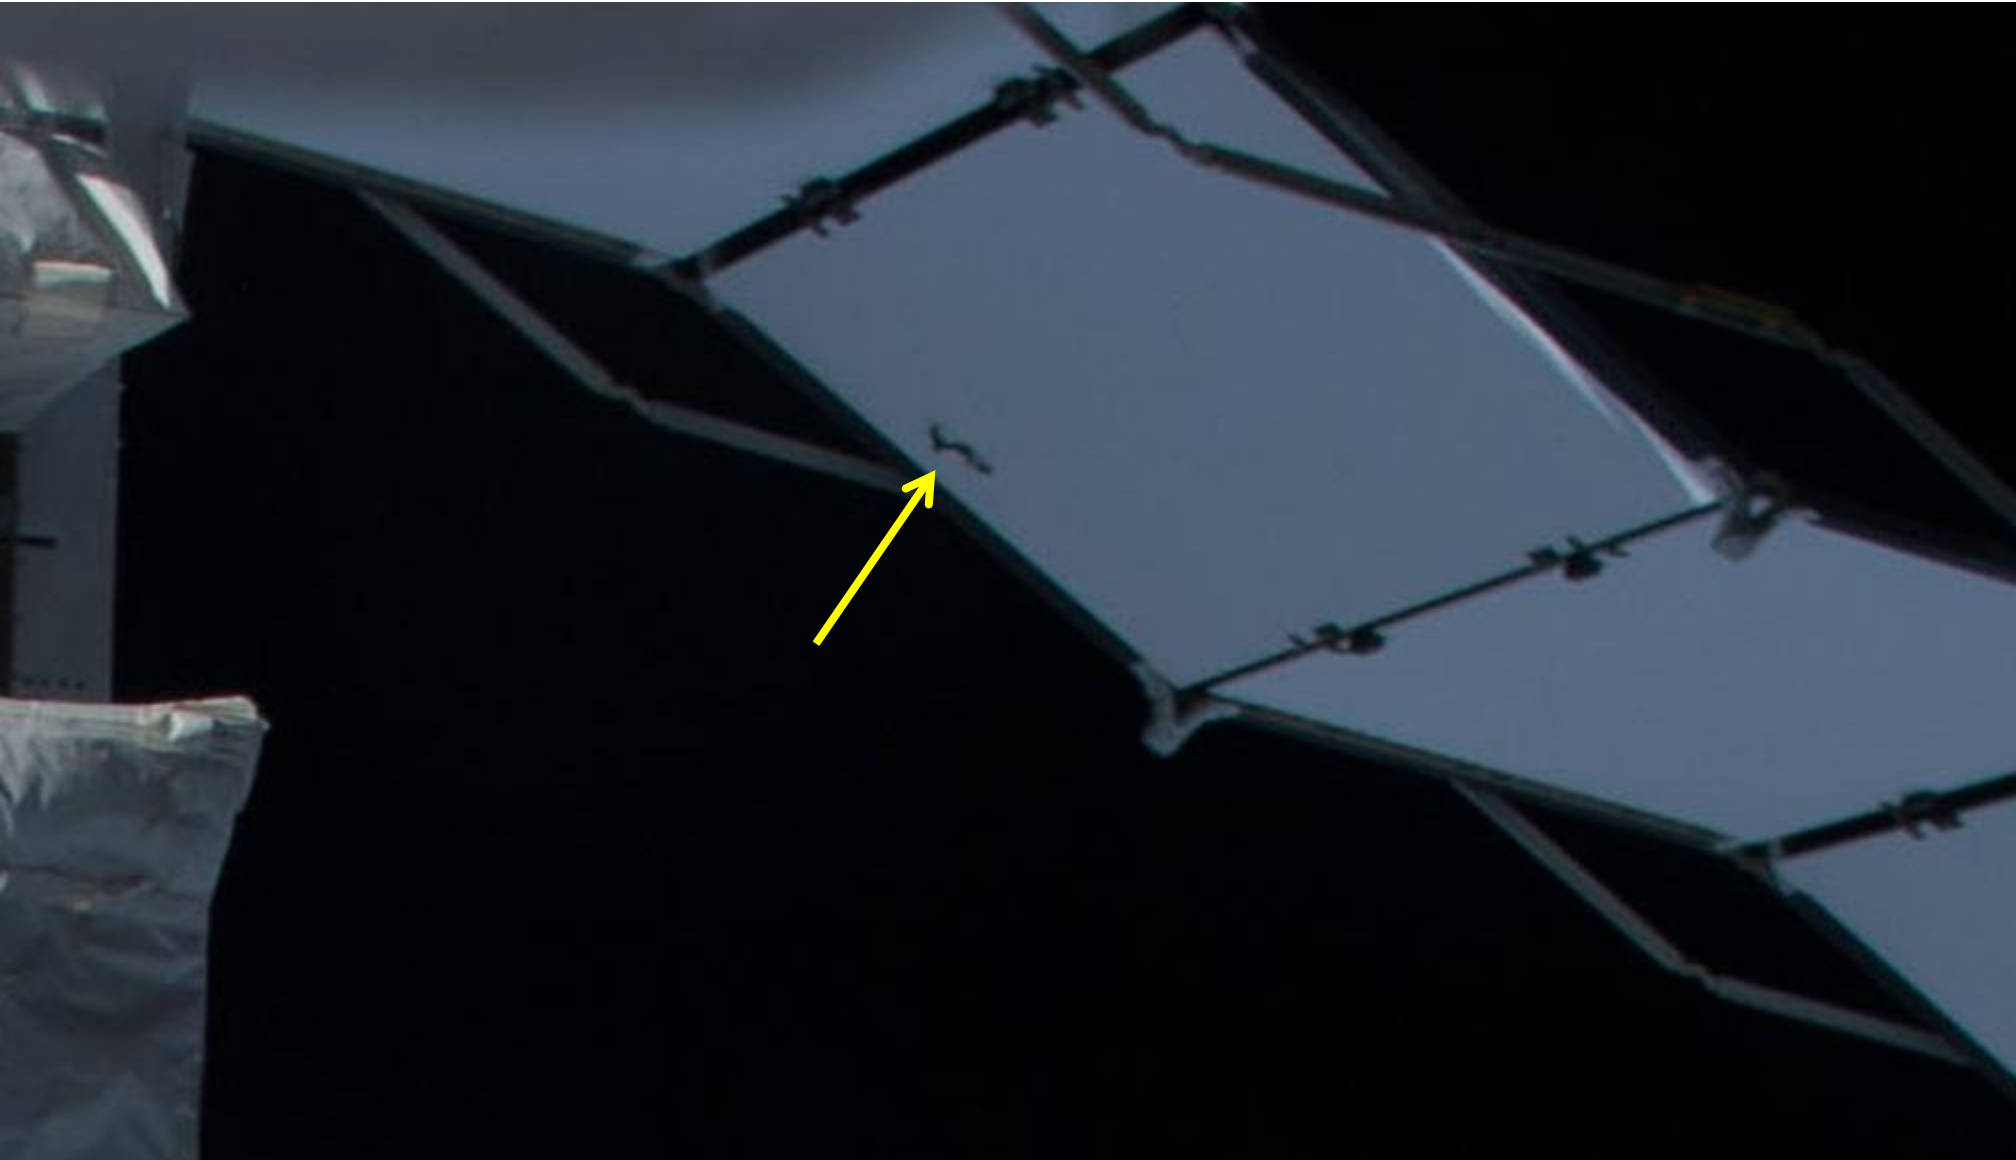
P4 photovoltaic radiator

- **Initial indication found on 6/30/2014**

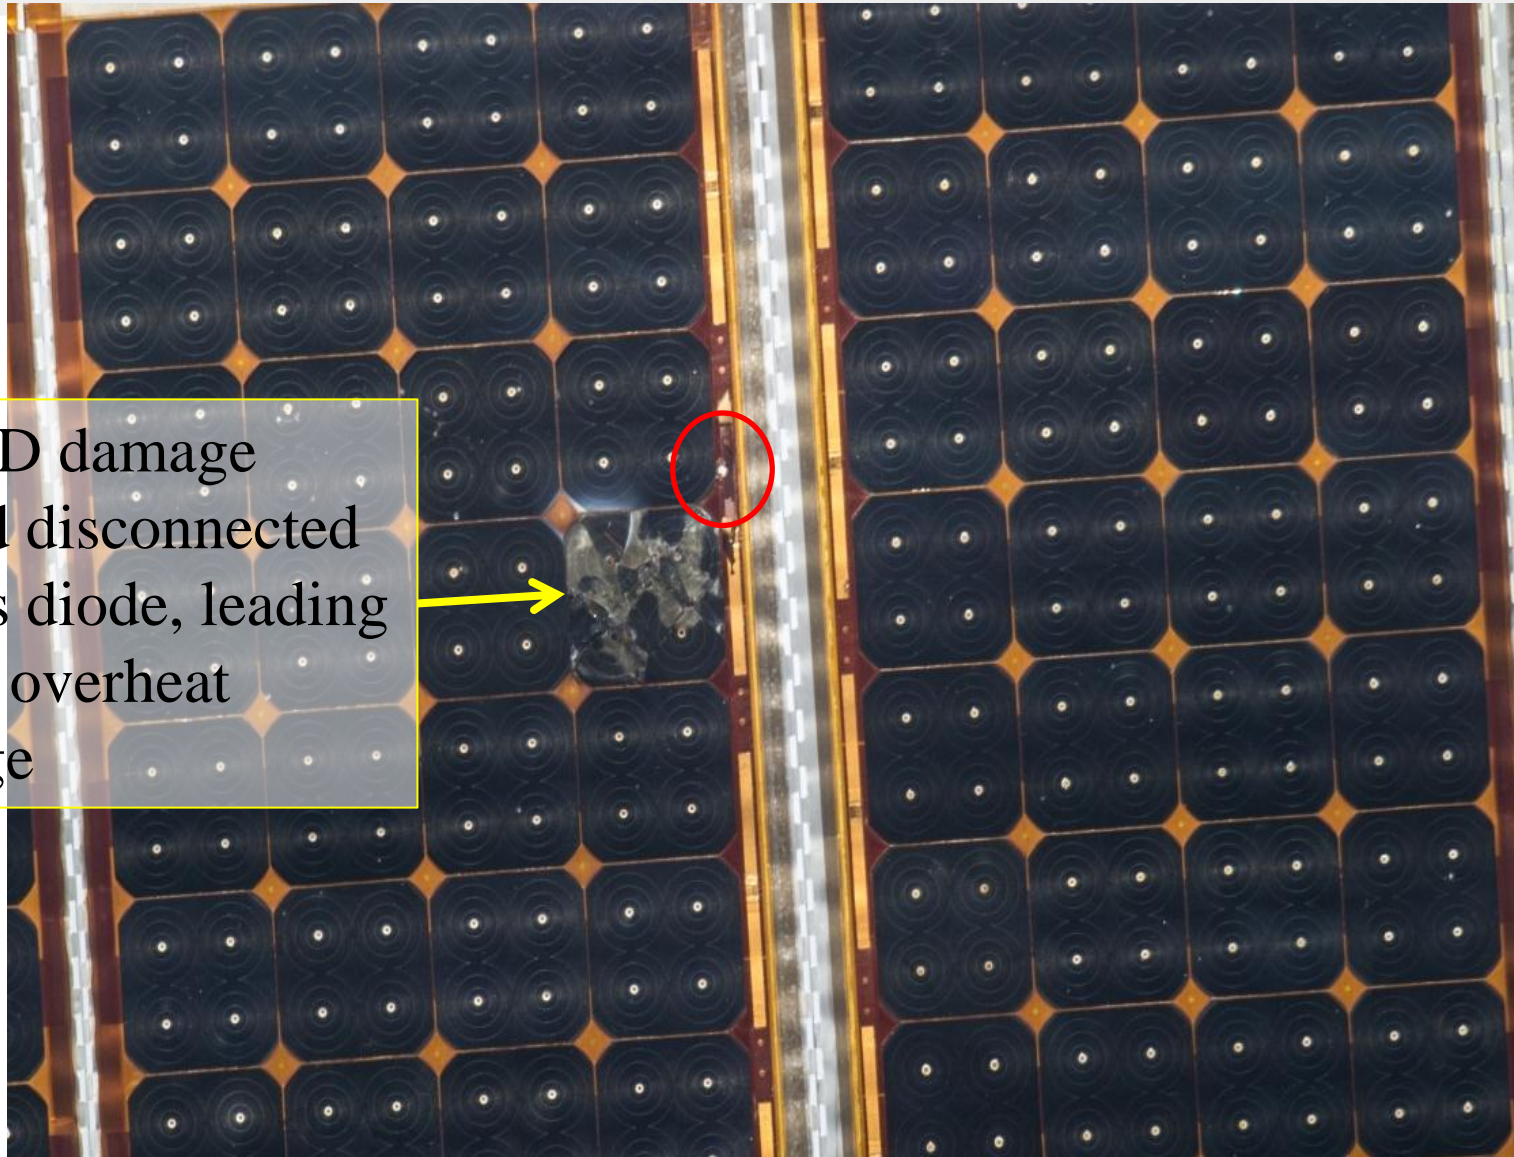
ISS Solar Array Damage

MMOD damage caused disconnected bypass diode, leading to cell overheating damage

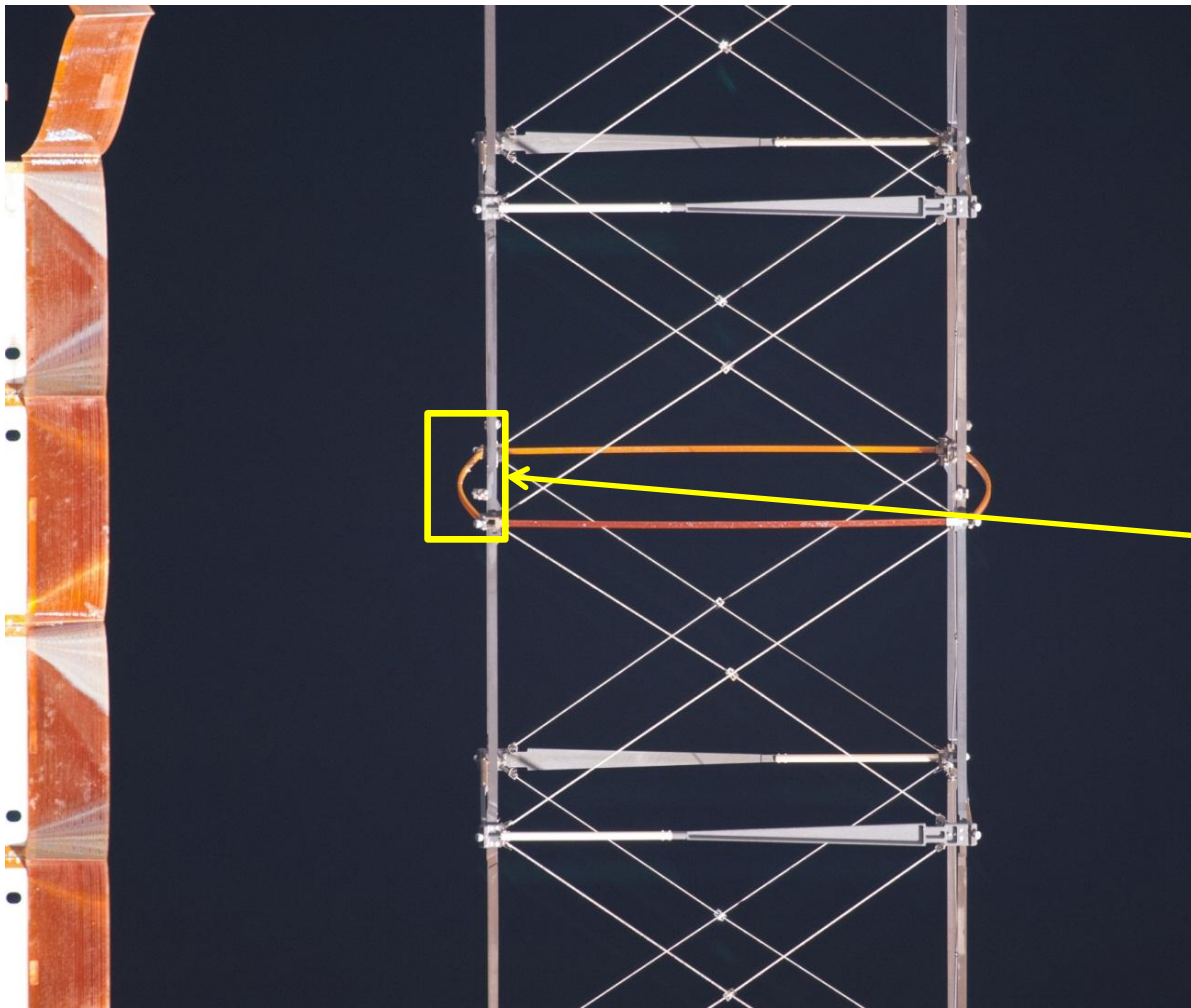
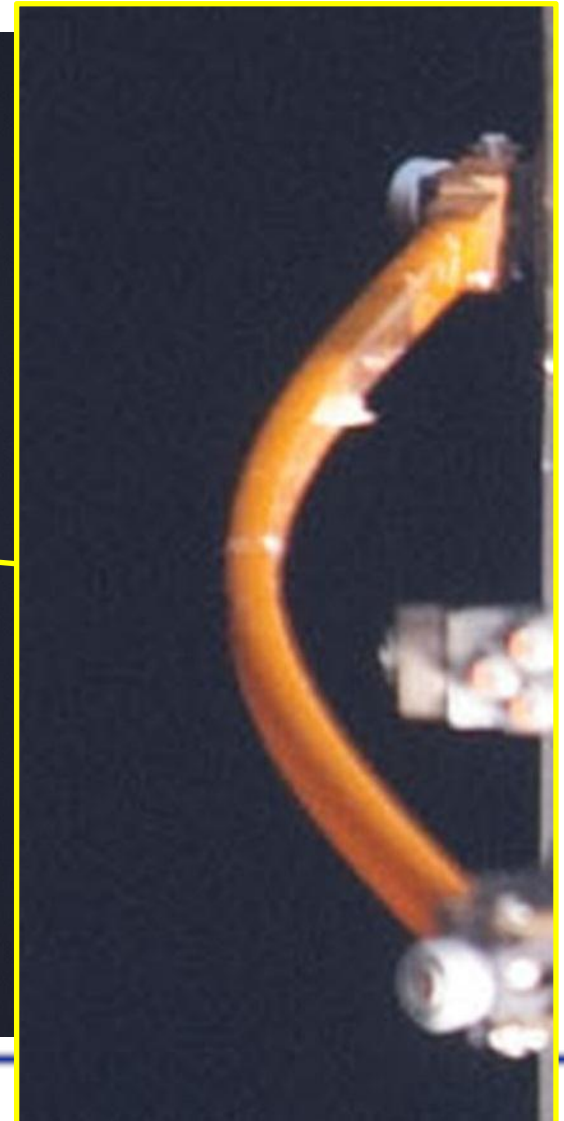
MMOD Damage to ISS Solar Array Masts

- Elements of the solar array masts have been damaged from MMOD impacts

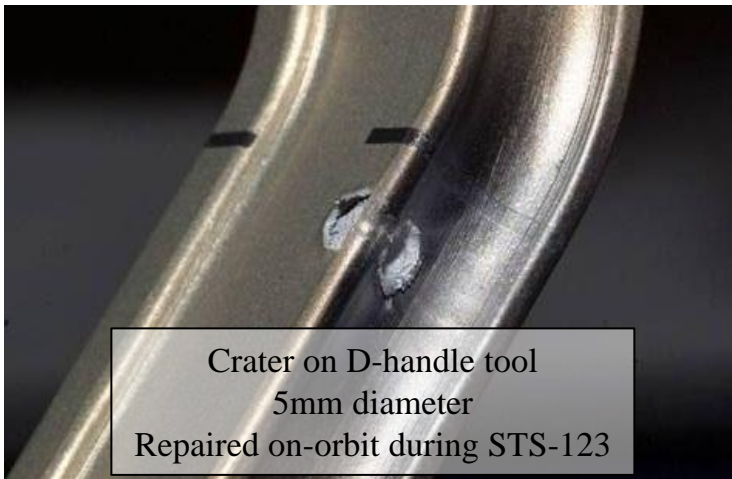
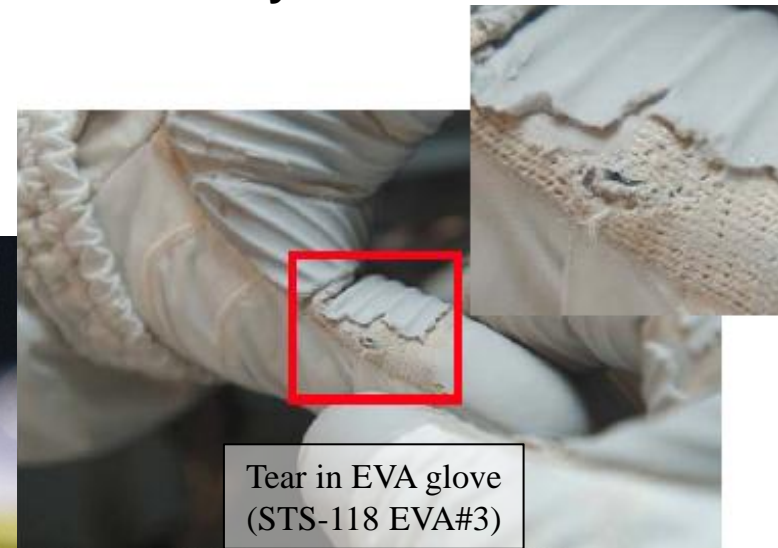
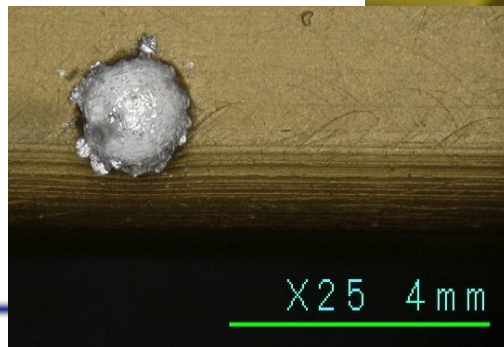
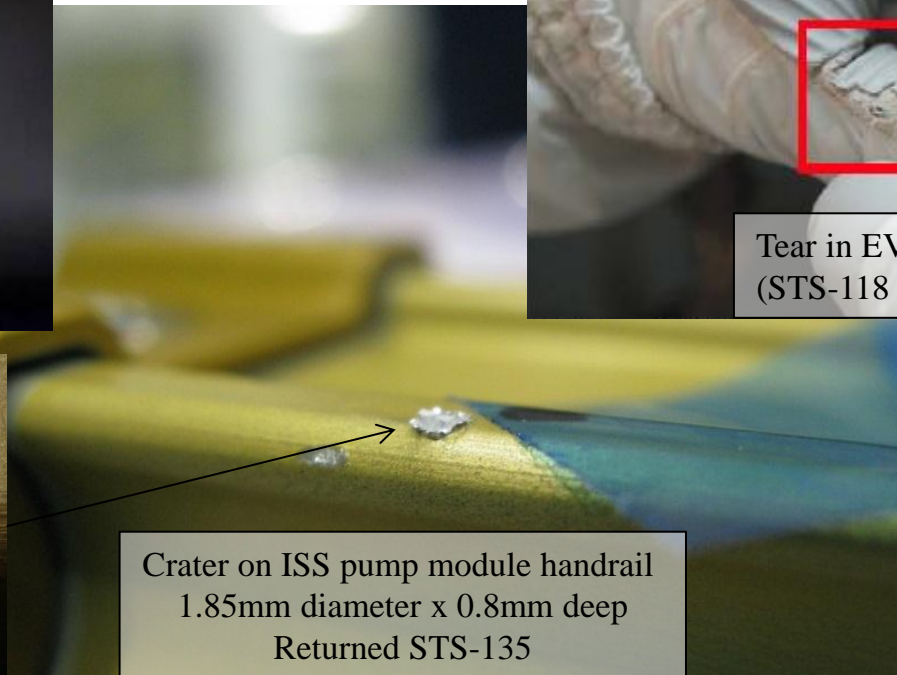
Handrail and EVA tool MMOD damage

- Many craters noted to ISS handrails and EVA tools
- Sharp crater lips have lead to cuts on EVA gloves
- EVA terminated early on STS-118 due to glove cuts
- Modifications to EVA suit and ISS EVA procedures necessary to reduce cut glove risk from MMOD damage

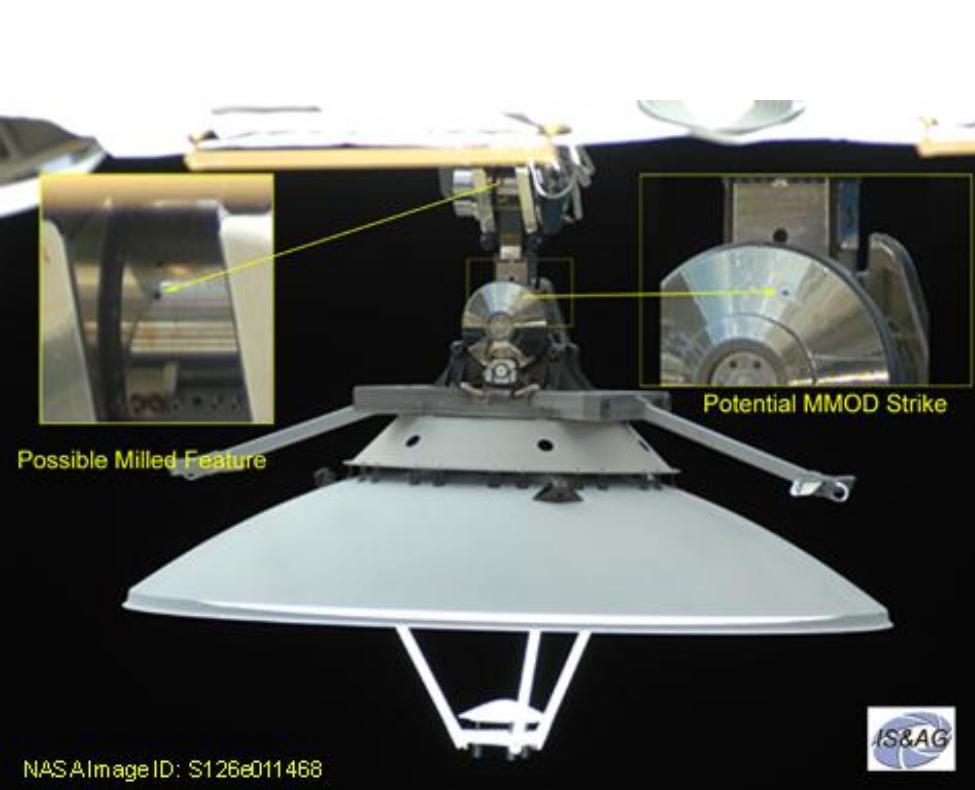
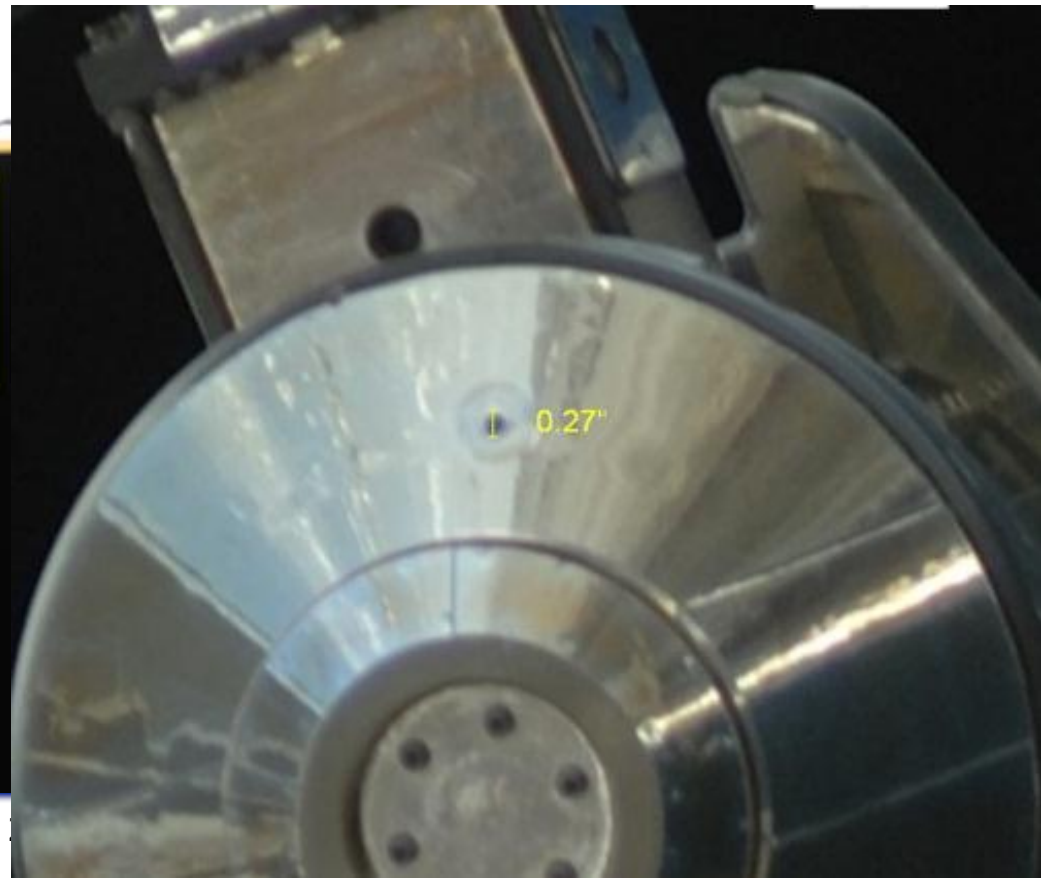
Ku-band antenna

- An MMOD Strike was seen on the ISS Ku Antenna Gimbal Gear Cover. The image was captured during Mission ULF2 / STS-126.
- Interior damage?

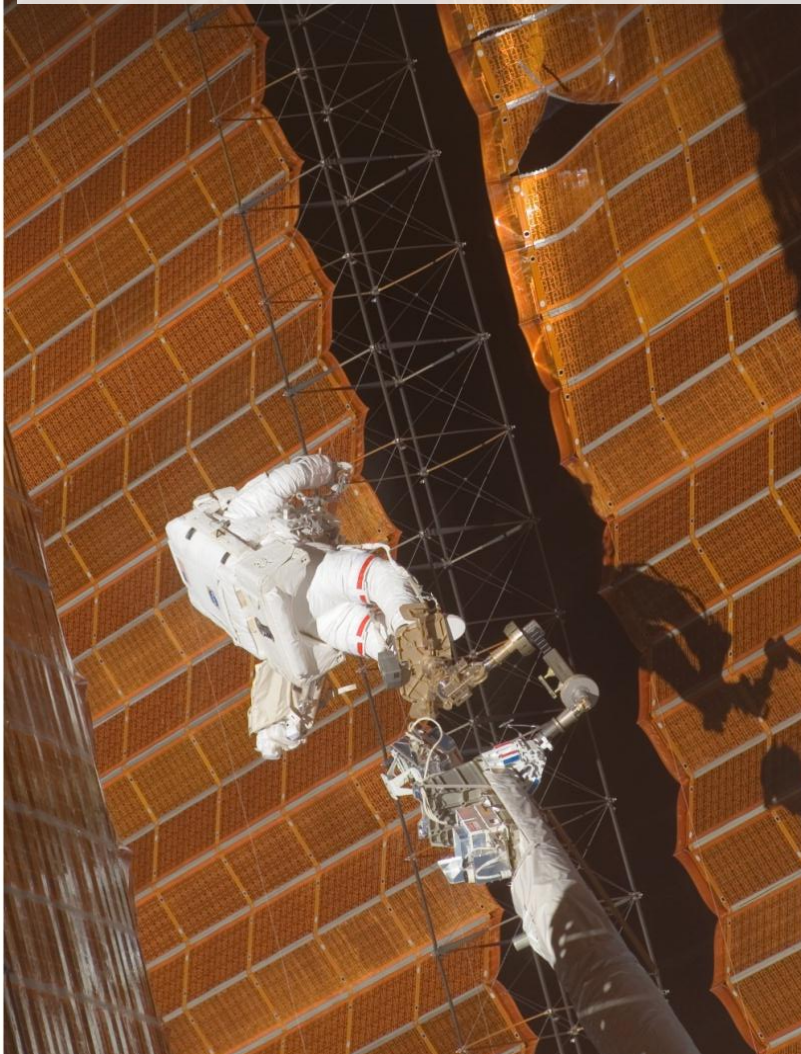
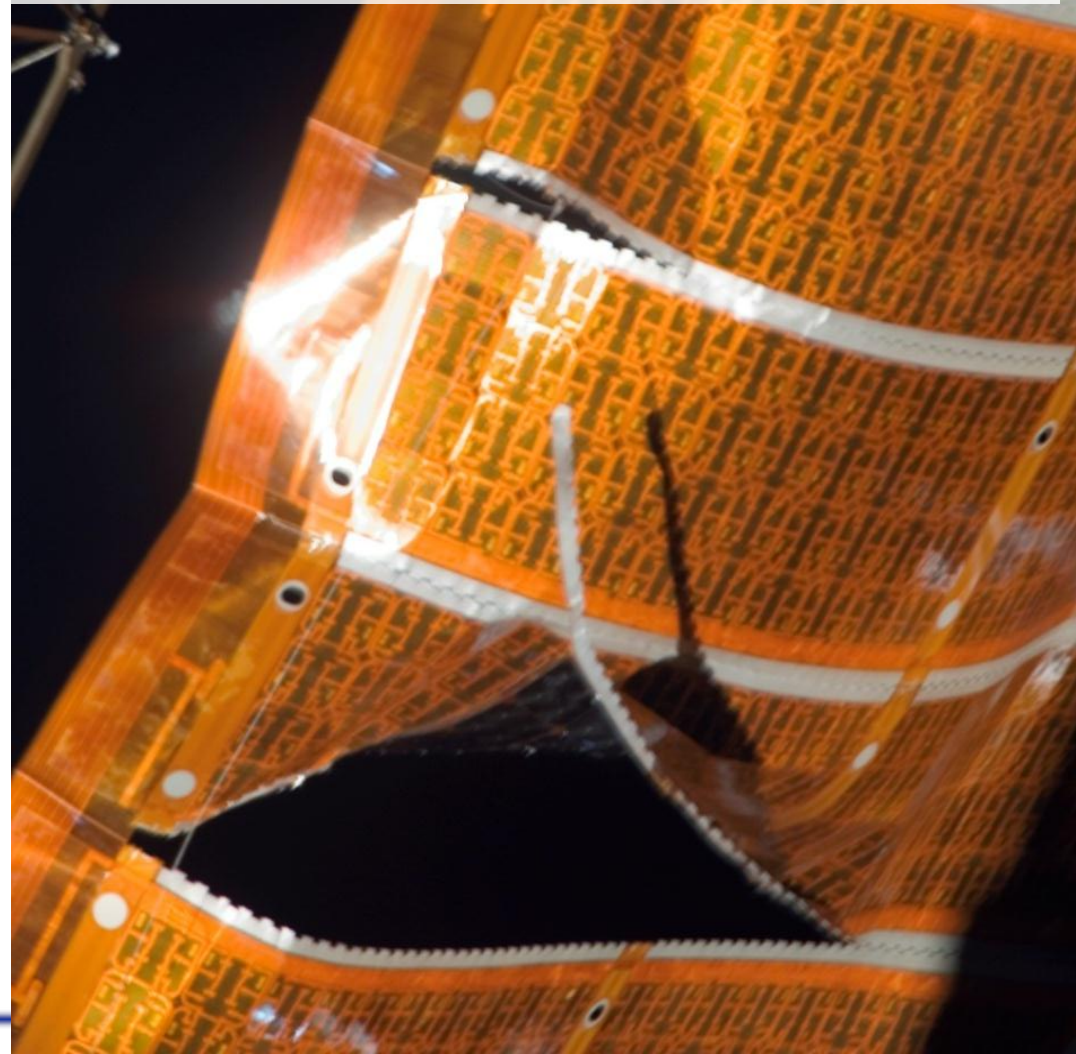
STS-120 Solar Array Wing (SAW) EVA repair was caused by MMOD impact damage

During STS-120 two solar array wings were removed from Z1 truss and relocated to P6 location. During re-deployment, the 4B solar array wing was torn in two places, due to a snagged guide wire. The guide wire was removed and “cuff-links” added to stabilize the array.

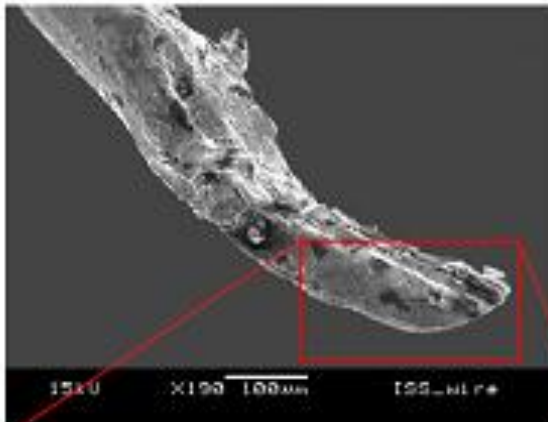
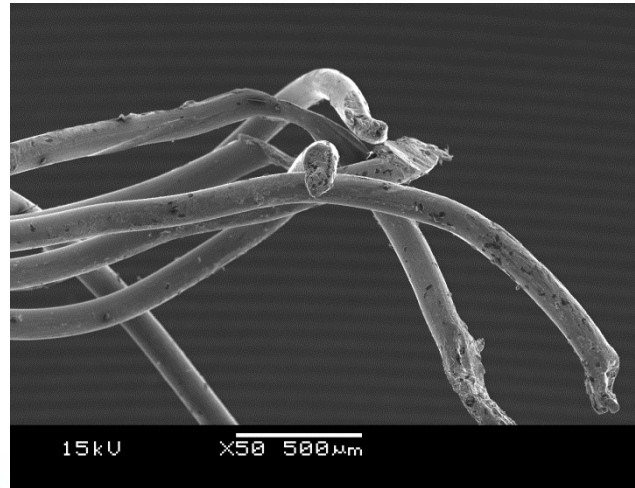
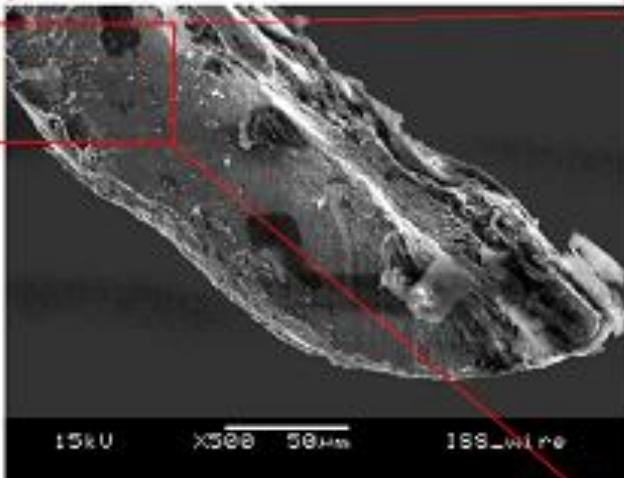
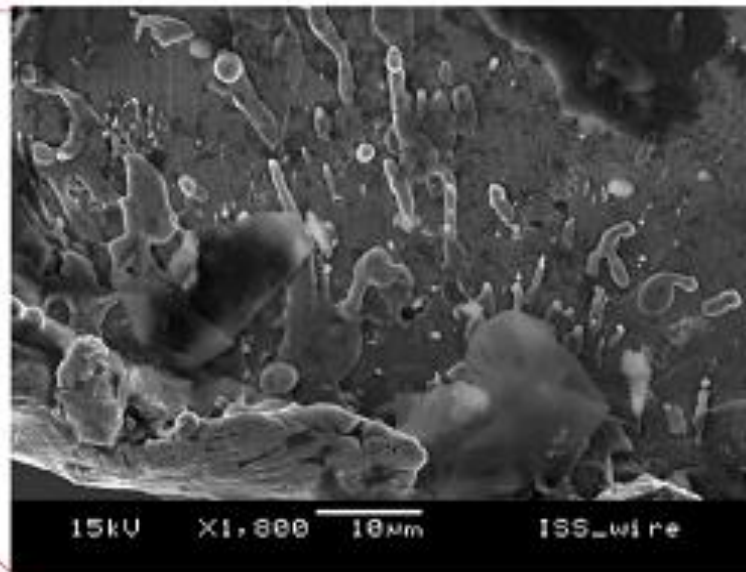
Scanning Electron Microscope EDXA Evaluation of retrieved guide wire

7 of 21 wires in the guide wire cable were broken, causing the guide wire to hang-up in a solar array grommet.
3 of the 7 cut wires exhibited evidence of extensive melt at broken ends, indicative of MMOD impact.

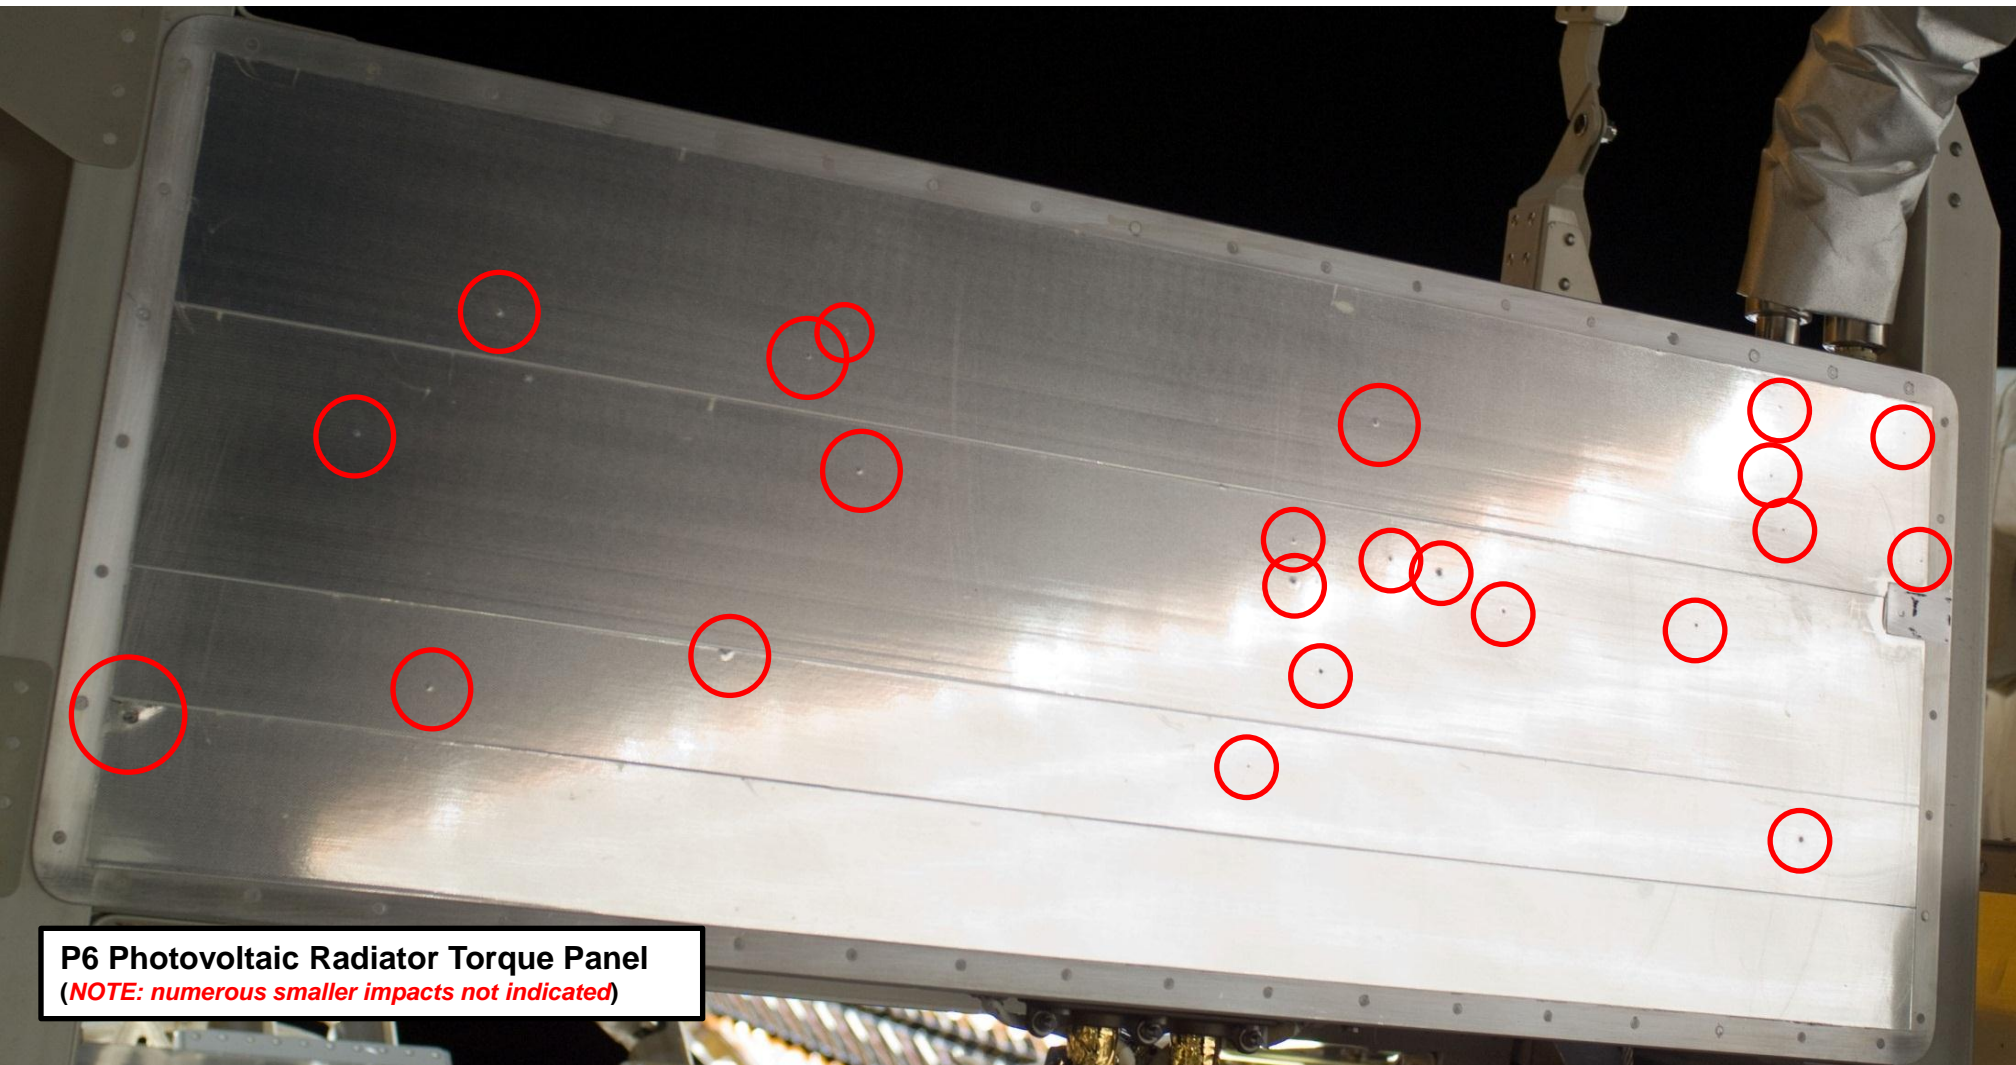
P6 Photovoltaic Radiator Torque Panel
(NOTE: numerous smaller impacts not indicated)

- **MMOD impact damages observed to radiator panel during EVA-20 (Nov. 2012)**

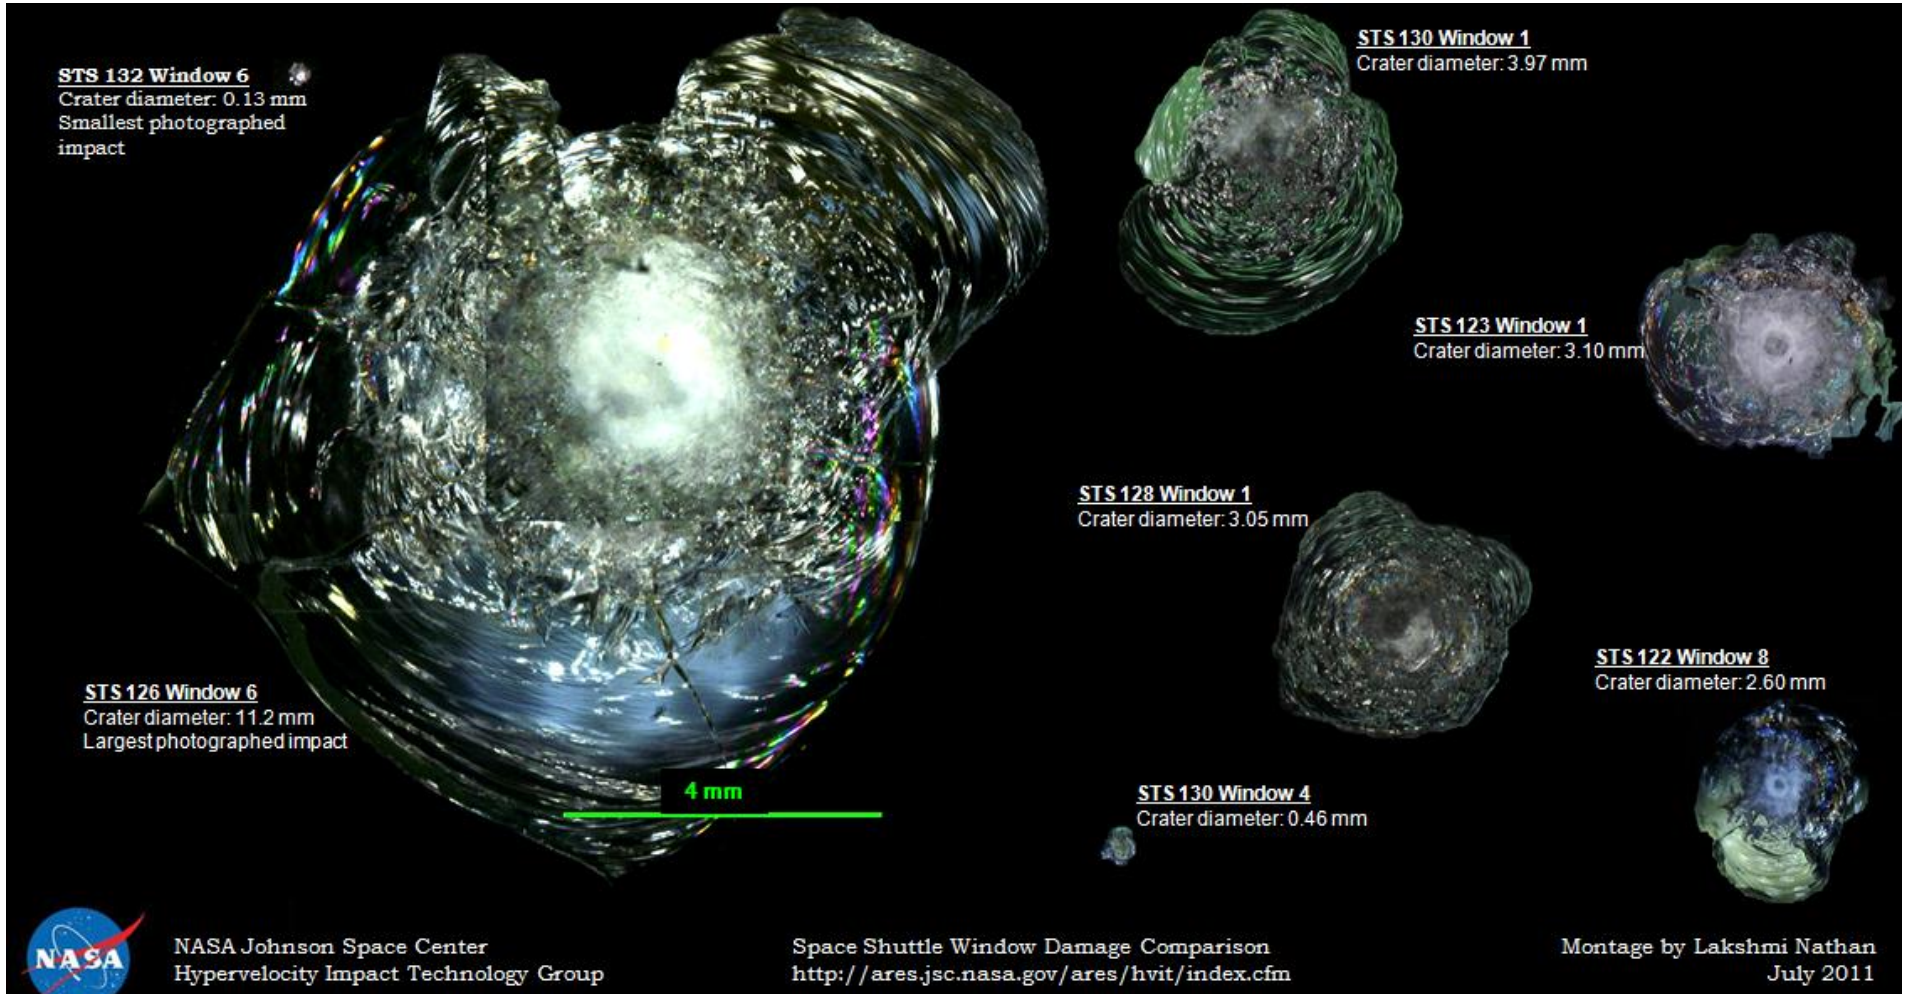
Sampling of Shuttle Window MMOD Impact Craters
(all displayed on same dimensional scale)
